Skellig Michael

Works Report for the 2014 Season

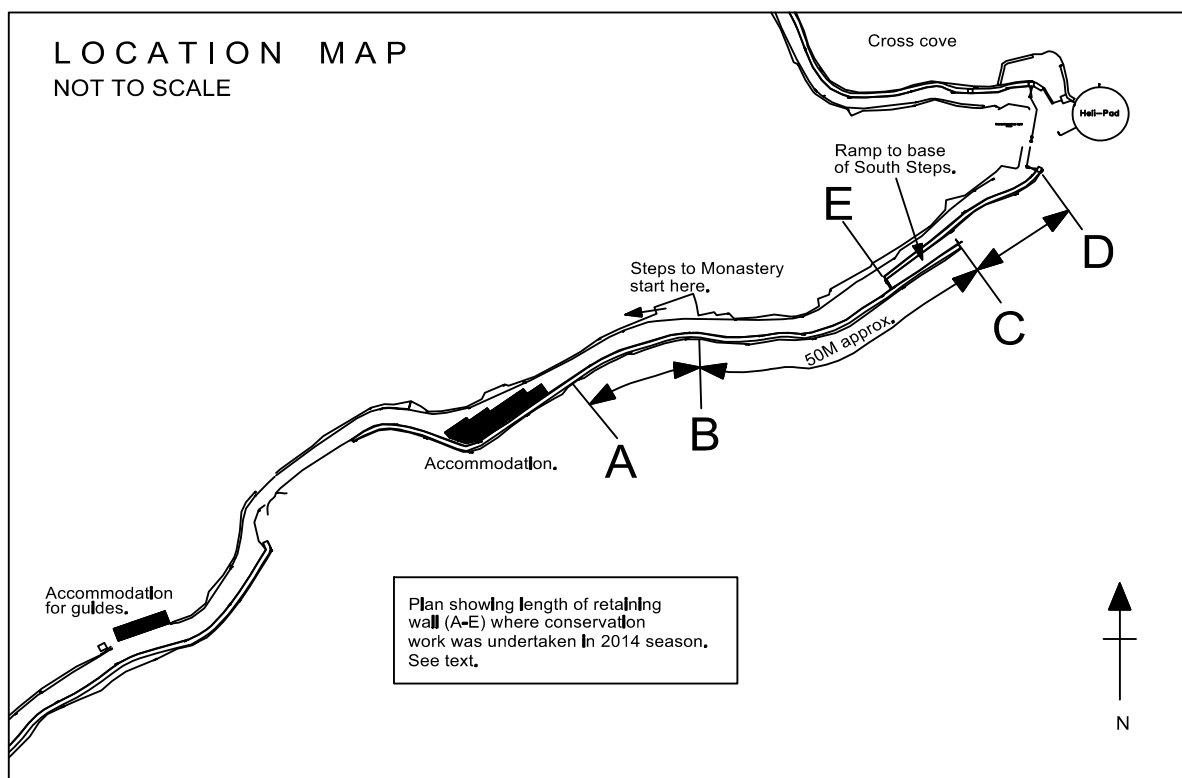
Refer to plan below with notation A-E which is the length of retaining wall under consideration in this report. It had been envisaged that works to a section of this walling would have been started in the 2013 season but these works had to be delayed for reasons of bad weather towards the end of the season and issues generally relating to nesting seabirds.

A considerable length of scaffolding on the exposed face was erected between points A and E. Works focused at either end with a 50 m length section in the centre set aside to be undertaken in the 2015 season. The same procedure for works was adopted as the previous years. The lengths of walling completed are designated A-B and E-D on the above plan. Some work to the interior face of the parapet wall was undertaken along the stretch B-C.

The cement pointing and concrete wall-top repairs were removed in the few places they existed and were replaced with a compatible lime-based mortar to match the existing. On the exterior the open joints were tightened according to the methodology agreed with *Birdwatch Ireland*. The works were inspected regularly by a representative of that organisation who was on-site to supervise the repair of a large hole in the section AB, close to the point B. The walling was completed on the exterior and much of the interior but it was impossible to repair all the tops of the parapets due to time limitations.

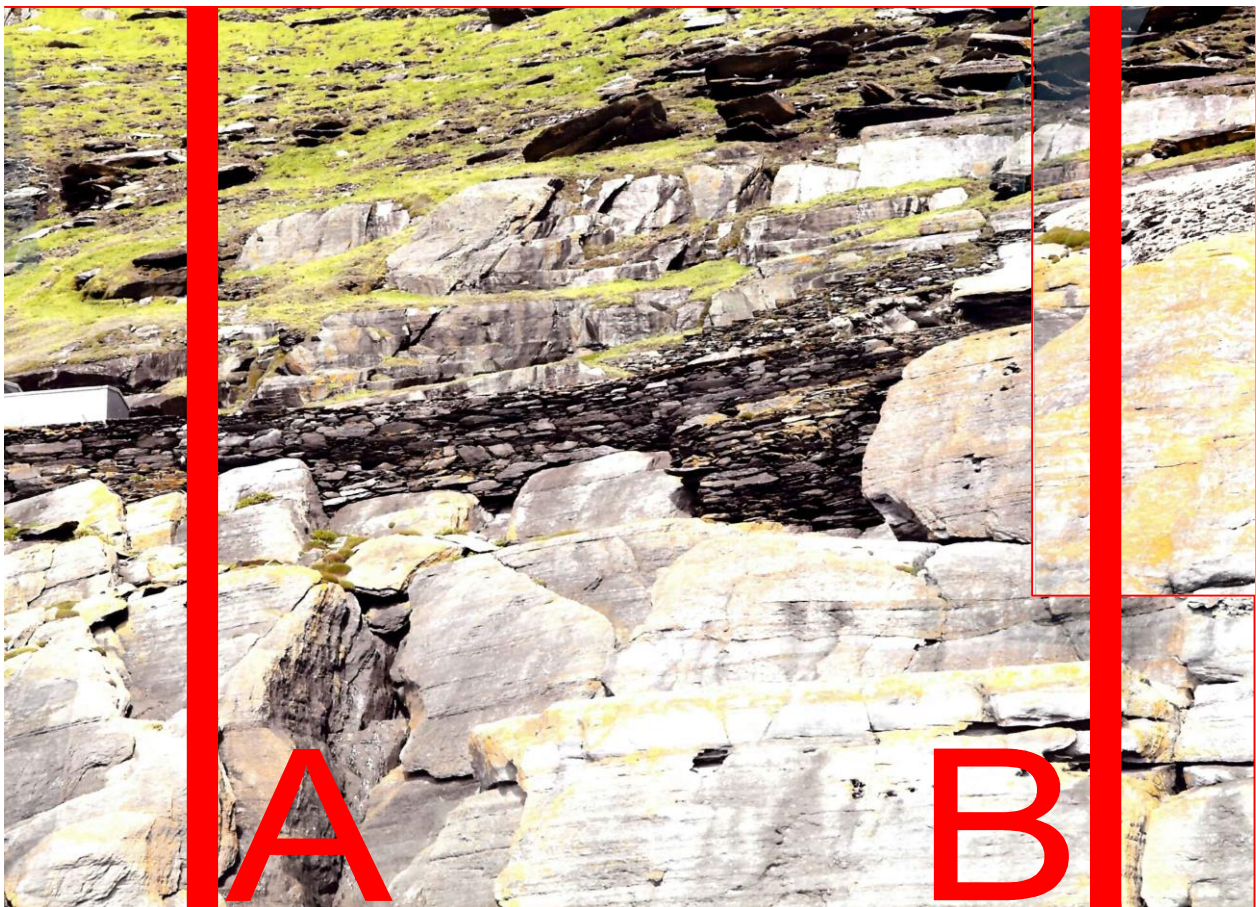
Retaining wall A-B. This section was completed in 2014.

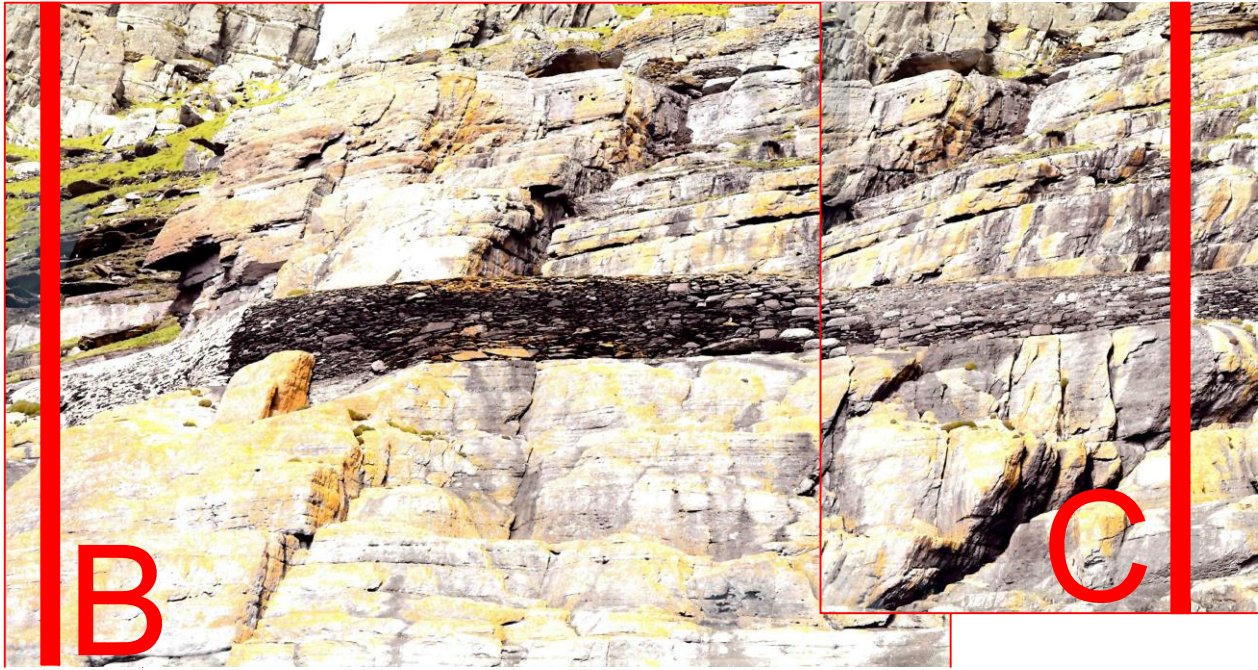
Retaining Wall B-C. This section of walling (c. 50 m length) was not undertaken in 2014.

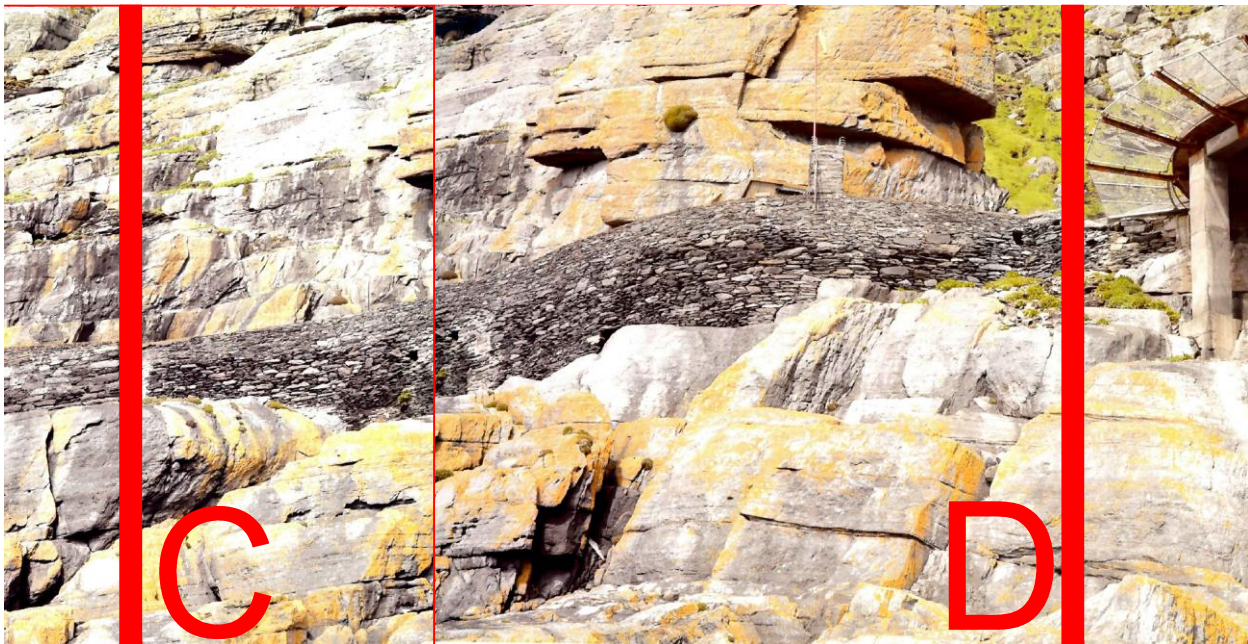
Retaining wall C-D. See plan, as this actual stretch runs up to the point E to the left. This section of walling (E-D) was completed in 2014.

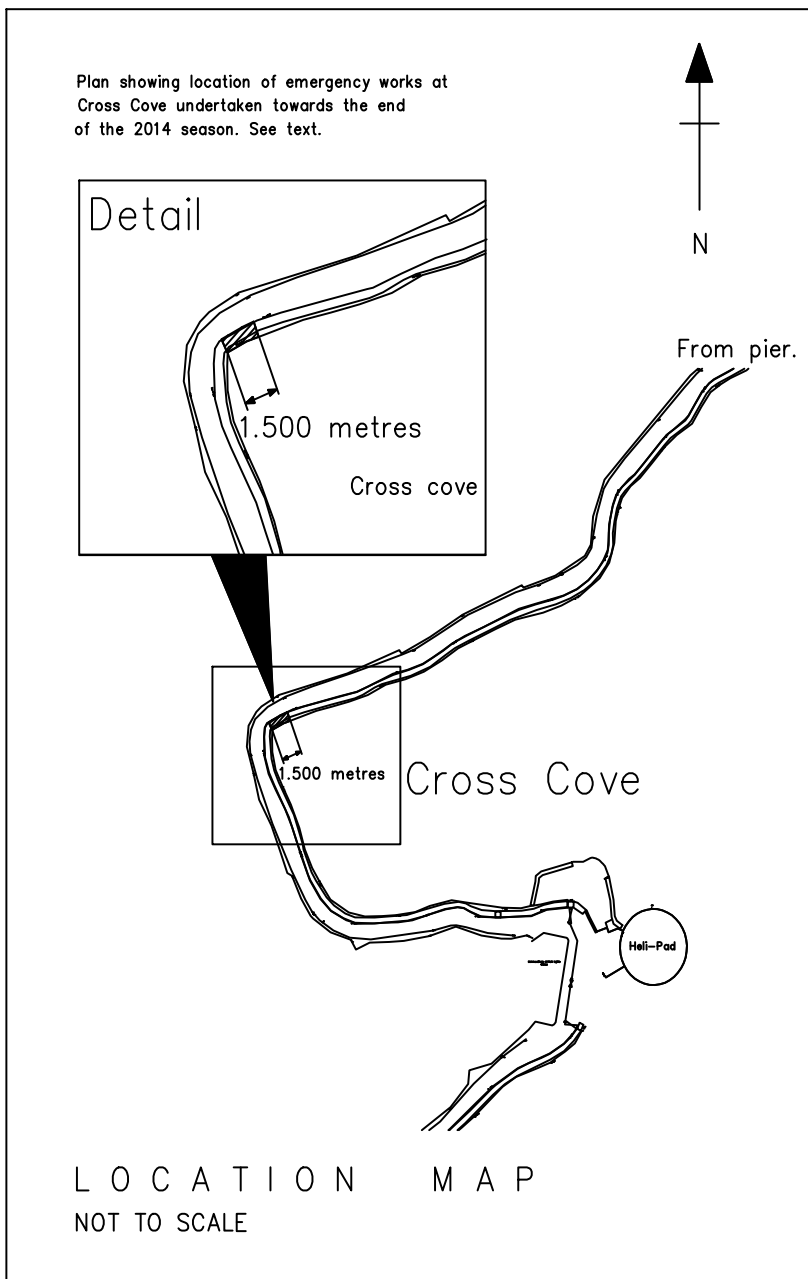
Conservation works had been completed in very recent years to the retaining wall around Cross Cove. However, over the winter considerable water had cascaded down in this corner causing the retaining wall (see plan for location on next page) to bulge outwards. This was examined by the project structural engineer and the immediate area was cordoned off to keep visitors back from the wall. As it was not deemed immediately urgent it was decided to undertake remedial work here later in the season when there would be fewer visitors, due to the requirement to open up the road. An extension of the consent for 2014 was granted.

The work was undertaken in early September and was supervised by an archaeologist with many years experience working on the island and the conservation architect/Site Manager. In the course of the opening up it was discovered there had been a water drain under the road which had been blocked on the retaining wall side with later cementitious repairs. This had probably been done by the lighthouse keepers. This intervention had effectively partially blocked the escape of water. In addition, lintols covering the drain had been broken, obstructing any water flow. Under the extreme pressure of the very heavy and persistent rainfalls over the winter the force of the water had pushed out the lower section of the wall so it presented a considerable bulge.

The remedial work was done during times visitors were not on the island. The roadway was opened up to reveal the drain which was cleaned out by the archaeologist. The side walls needed some minor repairs and a couple of broken lintols over the drain needed replacing. The cementitious repair was removed and the base of the wall repaired using a lime mortar forming an opening through the wall with a drain hole at the outer face. The detail was copied from other such drains along the road. See plan and photographs.

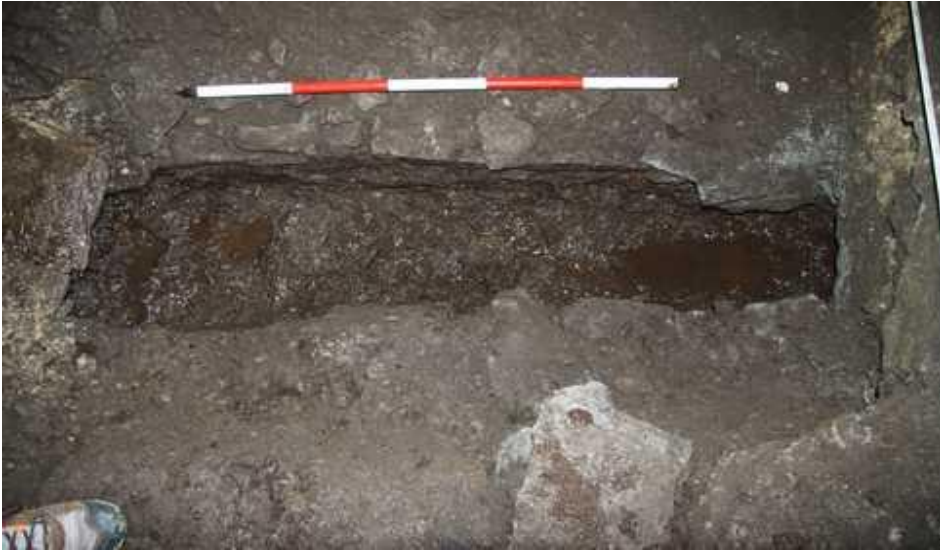
Drain after opening up.

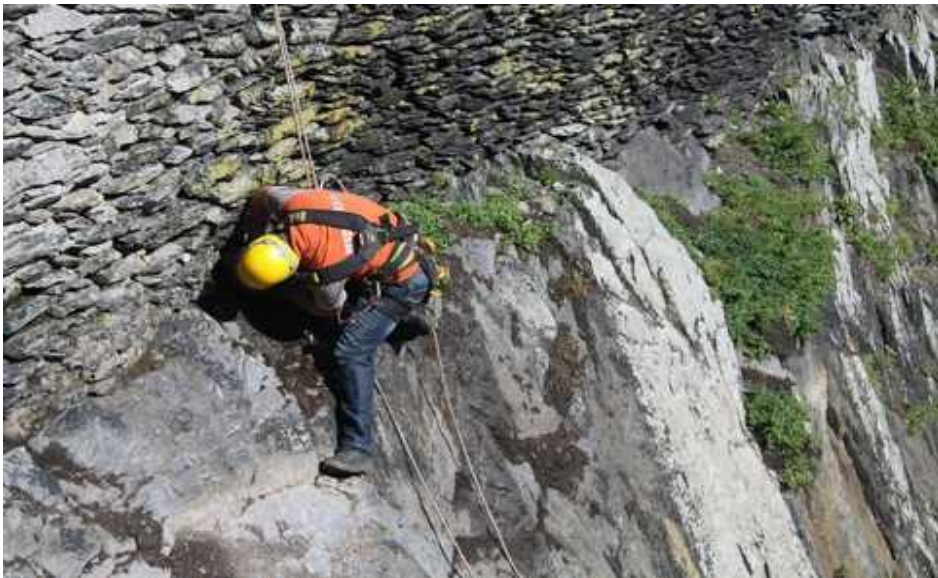
Working on the repair of the retaining wall after the removal of the cementitious repair.
