Archaeological Monitoring of Works

the Upper Lighthouse Road (Area E),

Skellig Michael, Co. Kerry,

**Archaeological Monitoring of Works
on the Upper Lighthouse Road (Area E), Skellig Michael, Co. Kerry, 2020.**
Ministerial Consent No. C000819, Excavation No. E004885, Detection device licence No. R00463
*Alan R. Hayden,
Archaeological Projects Ltd.,
October 2020.*

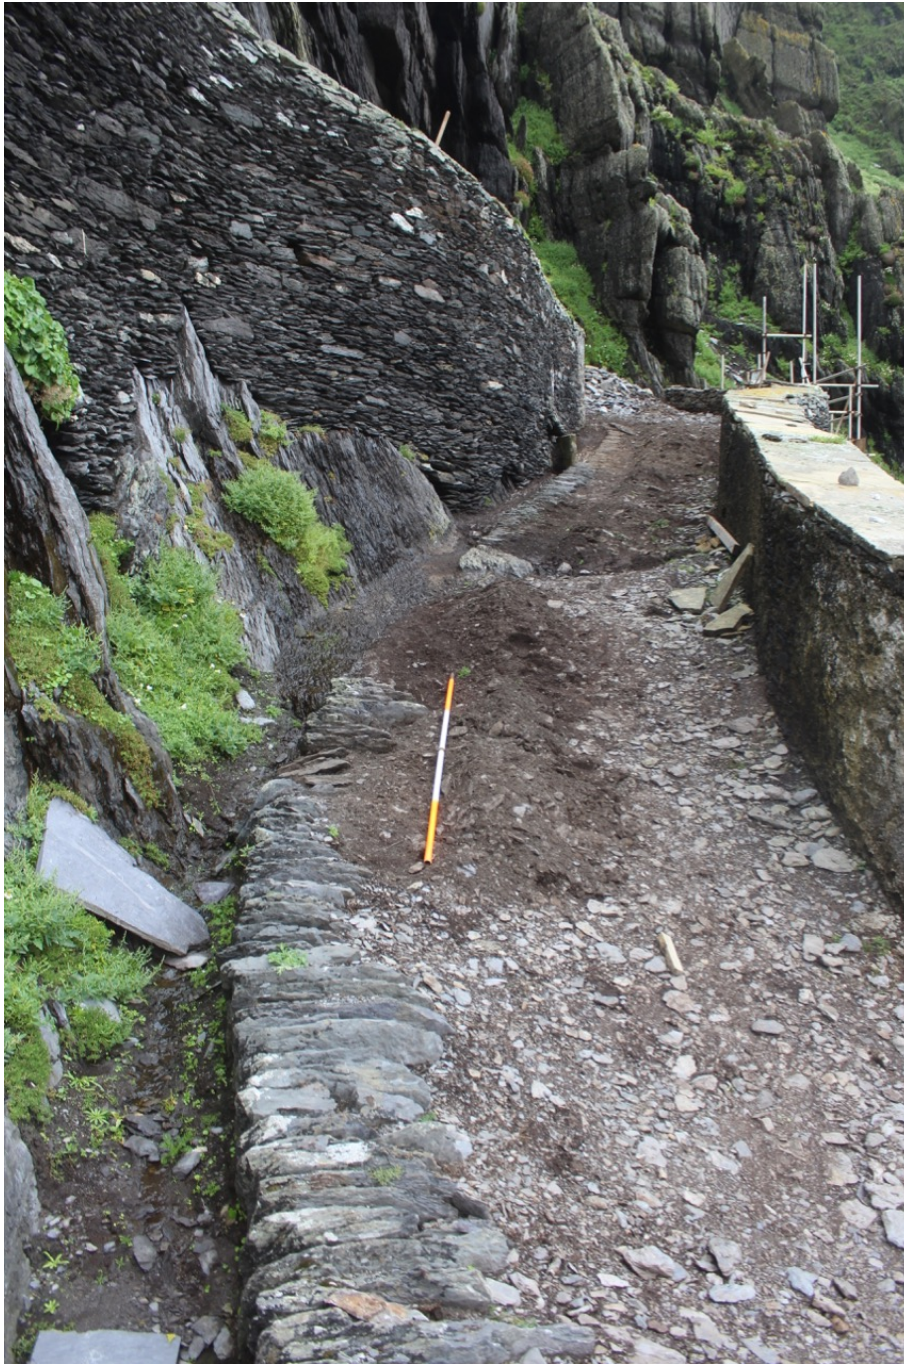
The lowest section of Area E extends upwards to the east. At its start, the road edging and lateral drain on its inner side are both damaged in a few places with stones missing (photo 1). 6m from the west end of the Section, the lateral drain is completely rock cut and the underlying bedrock also forms the base of the inner edge of the roadway for a length of 5m or so (photo 2). Above this point the lateral drain is intact but the road edging appears to have been replaced as it lies at a slightly different level and is composed of fresher looking and less oxidised stone than usual (photo 3). The rebuilding may have coincided with alterations made to the opening of a large drain leading down from the Section 2 (photos 4 & 5). The base of the outer face of the parapet wall of Section 2, which formed the inner side of the Section 1 roadway here has cracked and moved outwards around the opening of

Photograph 1. Section E, looking east. Intact road edging with damaged section by ranging rod and damaged lateral drain base at left. Surviving surface of roadway below original level.

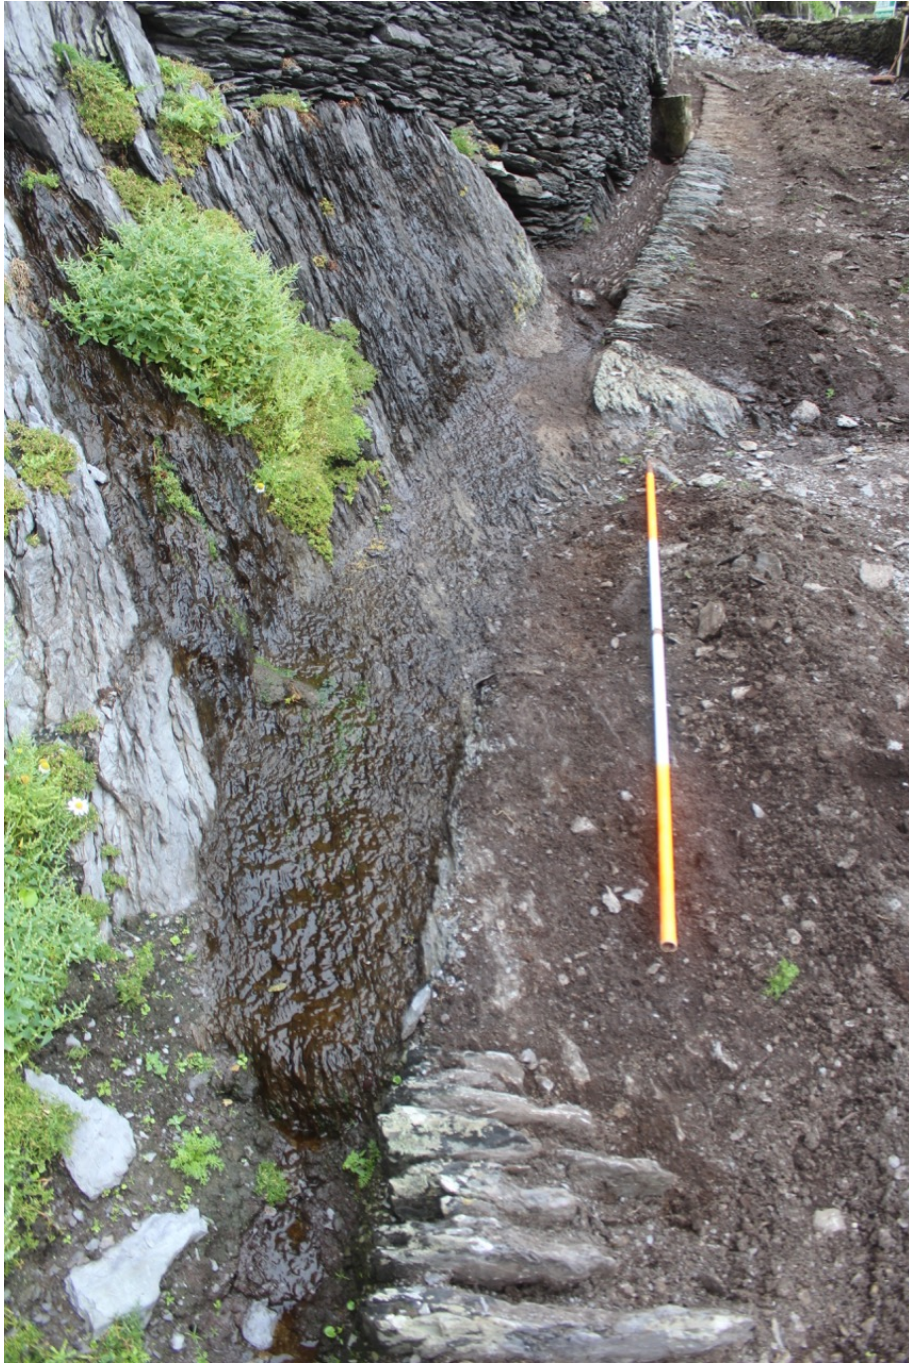
Photograph 2. Section E1 looking east. Rock cut lateral drain, with replaced road edging beyond ranging rod.

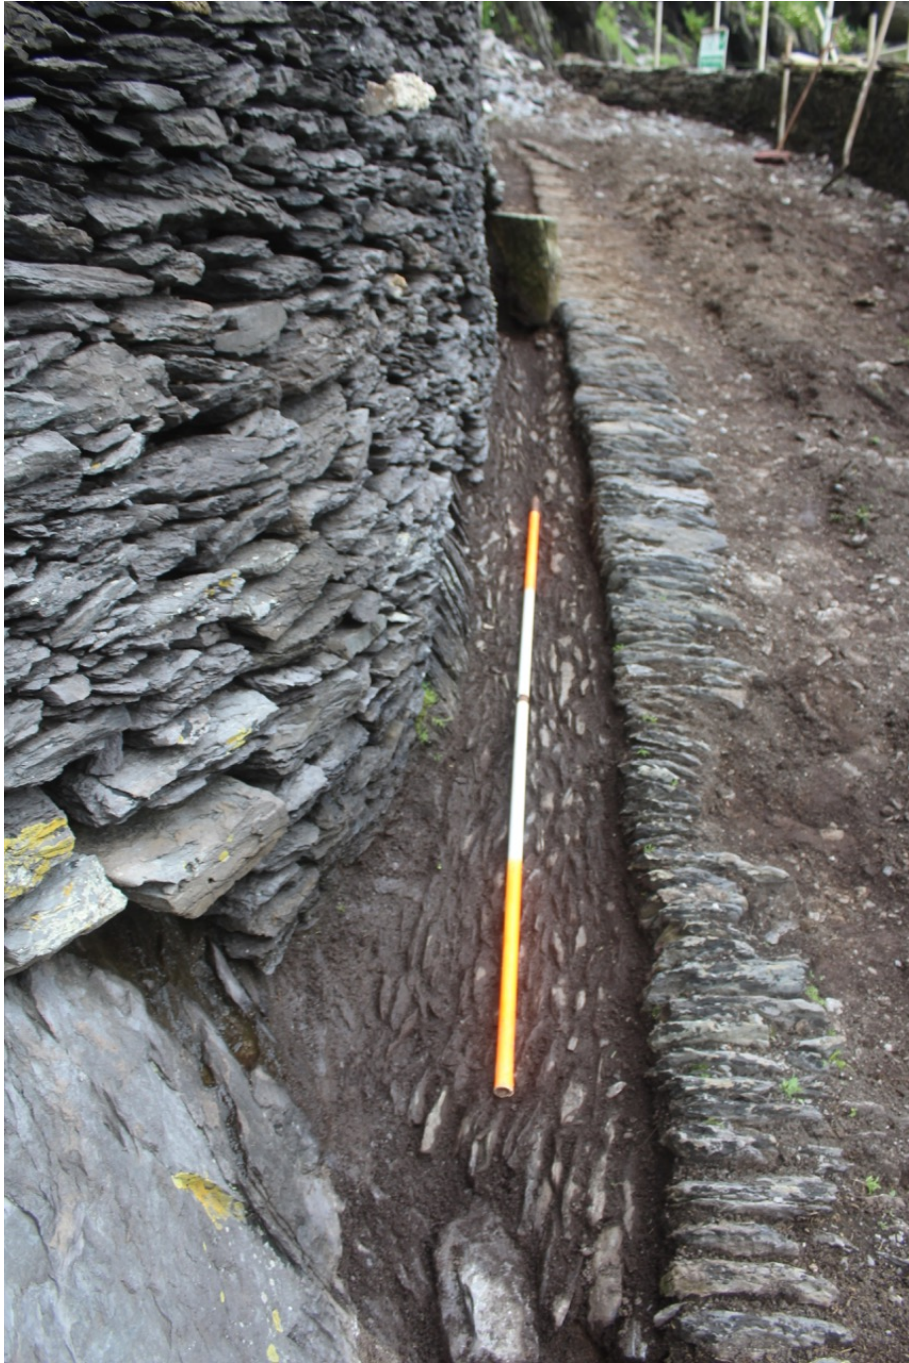
Photograph 3, section E1 looking east. Replaced road edging and intact lateral drain base. Surviving road surface below original level.

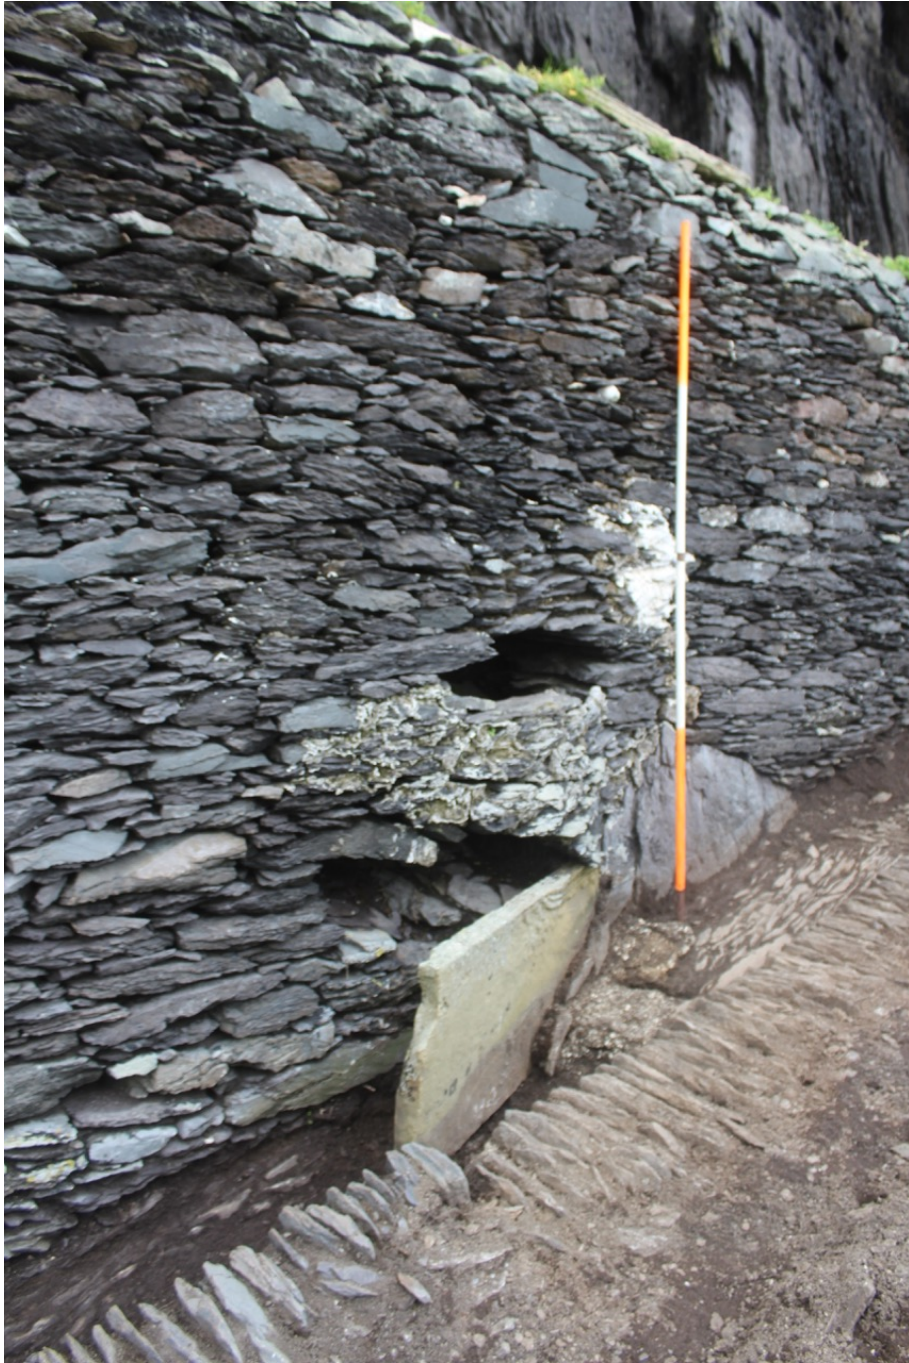
the drain, probably due to the blockage of the drain forcing water through the wall. A sandstone flag (of the type used to cap the parapet walls) was set upright and secured in place with cementitious mortar to divert water coming through the wall back into the lateral drain. Beyond the drain the road edging is intact and in good condition and curves around the east end of the parapet wall of Section 2 (photos 5 & 6). The lateral drain here is in excellent condition and after a length where the basal stones are conventionally set parallel to the line of the drain, there is a short length where they are set at right angles to their normal line before again changing to conventionally set stones where the drain narrows and extends around the corner of the parapet wall (photos 5 and 6).

Photograph 4, section E1 looking north. Partly collapsed base of parapet wall with drain exit and inserted vertical stone secured with cementitious mortar. Rebuilt road edging at left, original at right.

The parapet wall on the outer side of Section 1 was in excellent condition apart from its extreme east end which had been almost totally demolished by falling rocks and had to be largely rebuilt after the fallen rocks were removed. This east end of this part of the wall contained a square drain opening leading away water from the lateral drain of Section 2. Some of the stone at the base of the opening of the drain was missing and will have to be repaired.

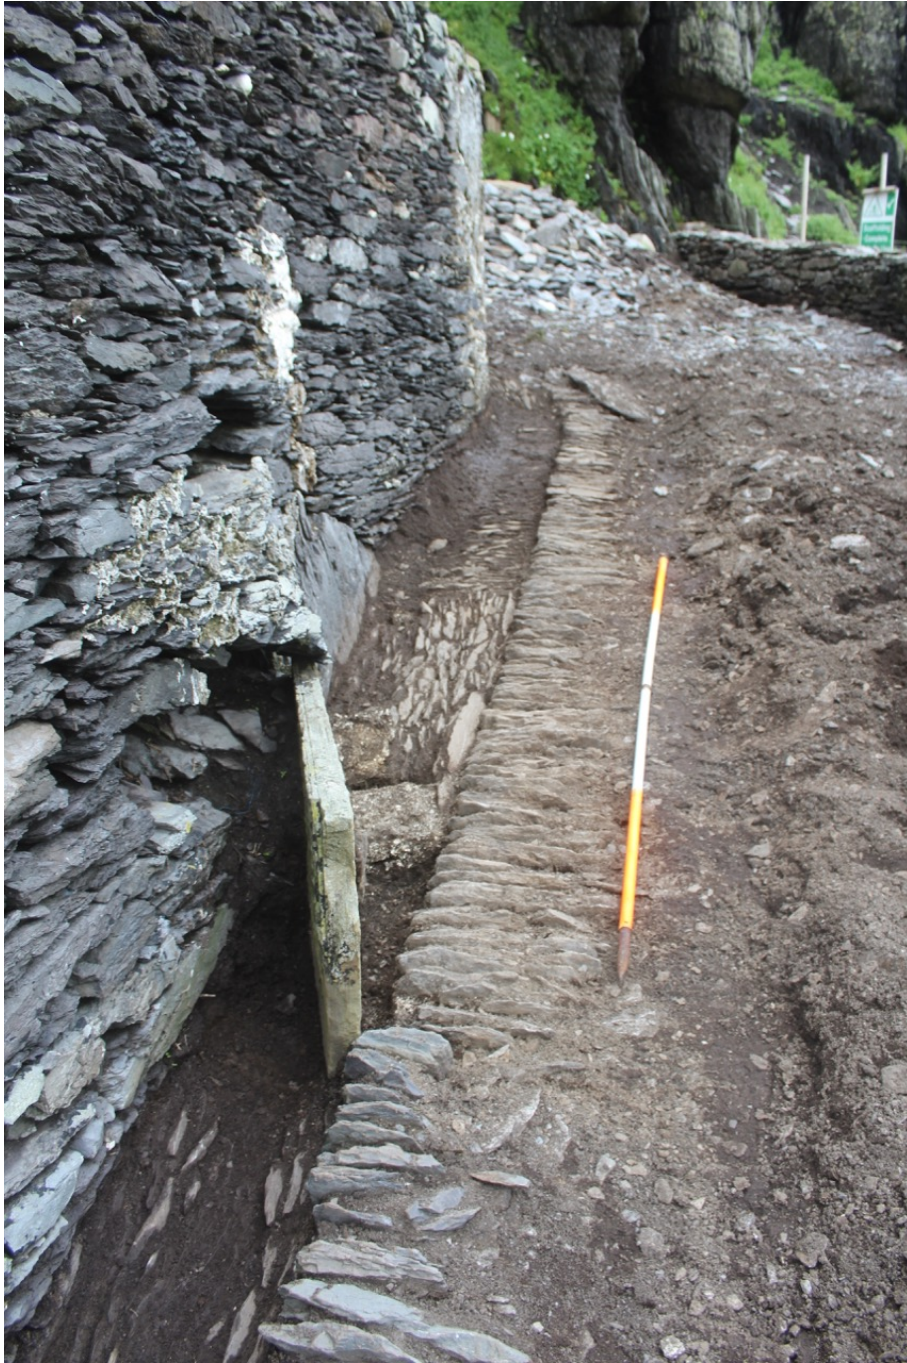
Photograph 5, section E1 looking east. Replaced road. Edging at front, partly collapsed base of parapet wall and inserted vertical stone with original road edging and intact lateral drain behind, note stones in base of lateral drain laid at right angles to its line at back.

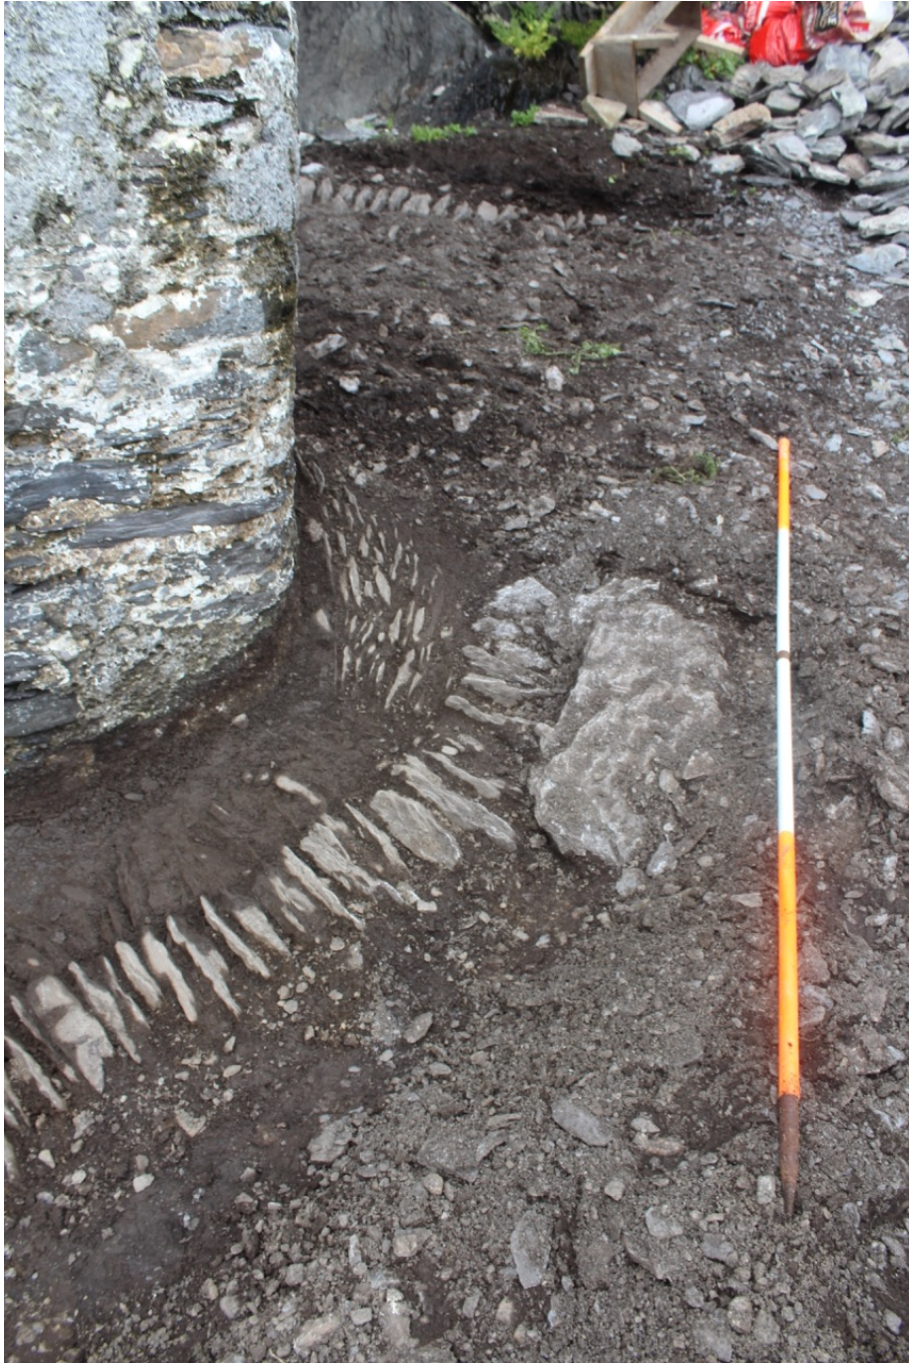
Photograph 6, section E1 looking north. End of parapet wall with lateral drain curving around it. Note change in alignment of stones in lateral drain.

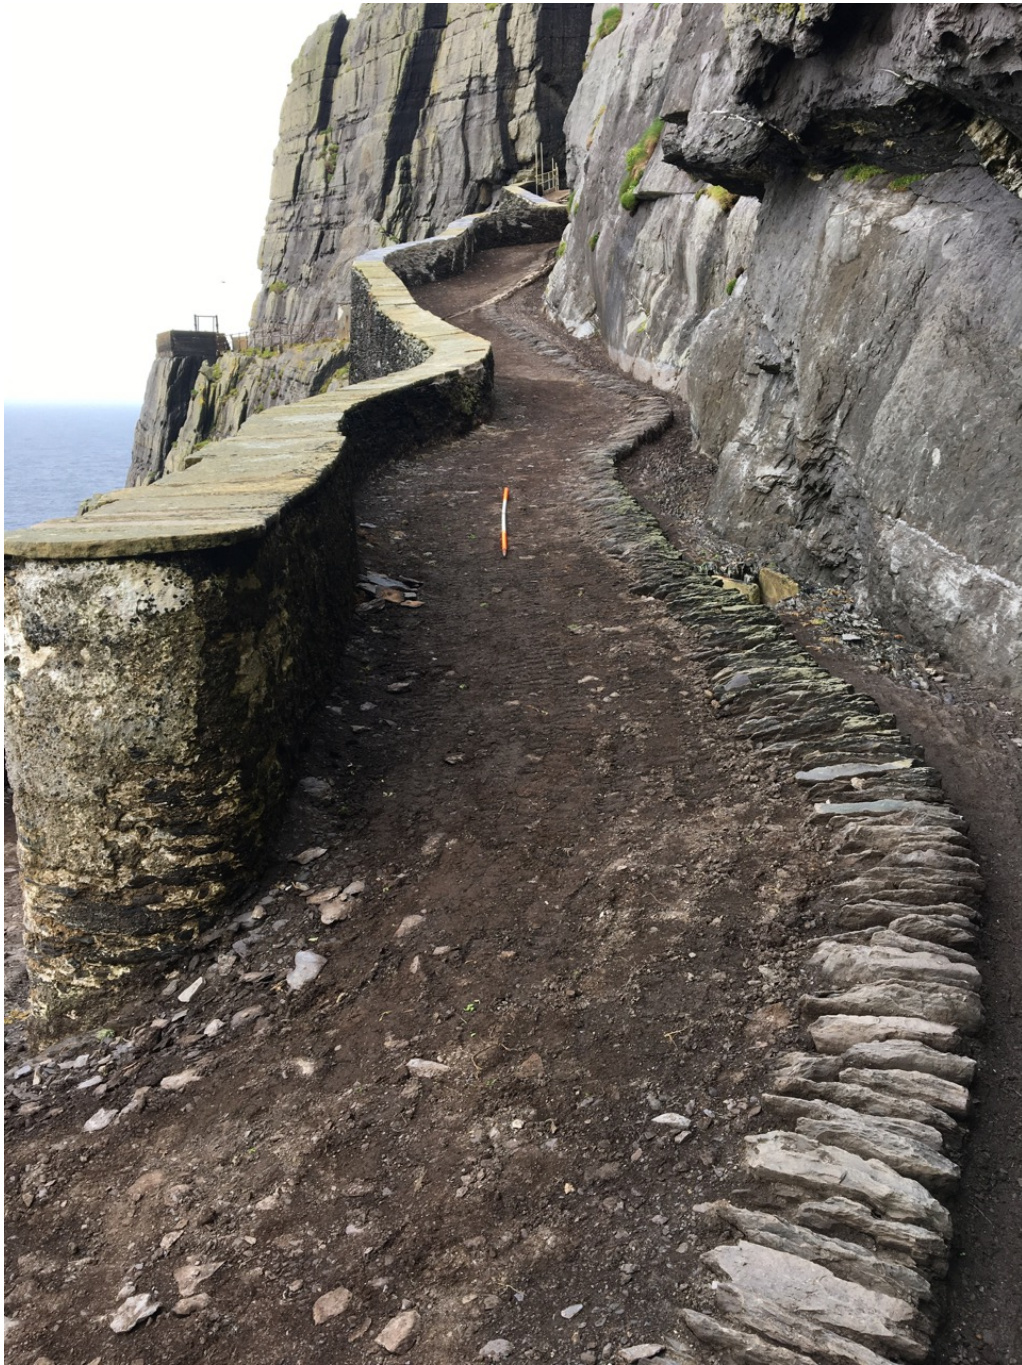
Both the lateral drain and road edging were in excellent condition at the lower end of Section 2 (fig. 3, photo 7) but the road surface itself again lay below its original level. A disturbed stone shore led water from the lateral drain into a subsurface drain extending across the roadway and through the parapet wall (photos 7 & 8). This is the drain the lower end of which opens onto the inner side of Section 1 (photo 4). The stone shore (photo 8) is of similar construction to one previously revealed on Area A in 2017. Only two of the original four or five vertically set sandstone flags survived. The missing stones will have to be replaced to secure the surviving stones.

Photograph 7, section E2 looking west. Well preserved road edging and lateral drain. Road surface below original level. Shore (see photograph 8) in lateral drain at right.

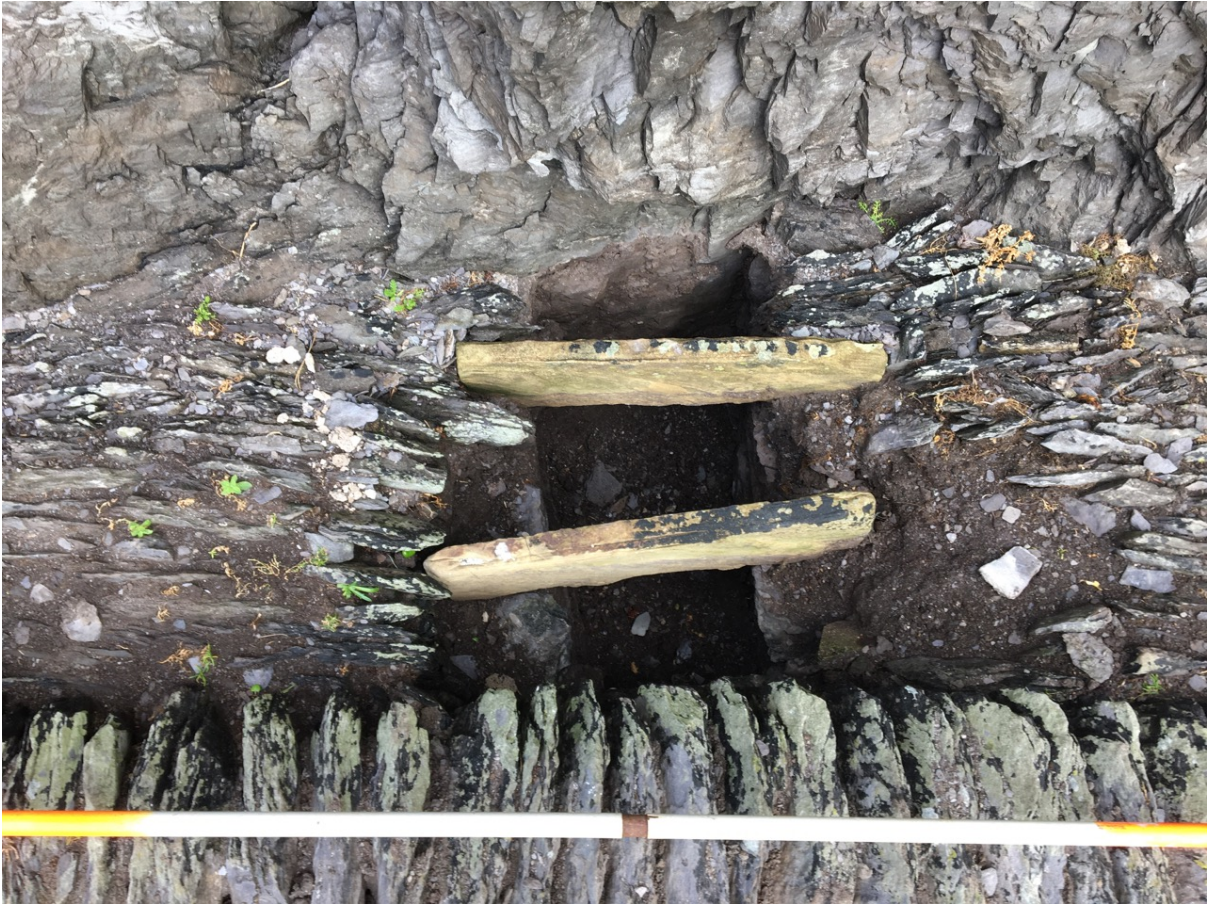
Photograph 8, section E2 looking north. Stone shore (several stones missing) in lateral drain, overlying subsurface drain.

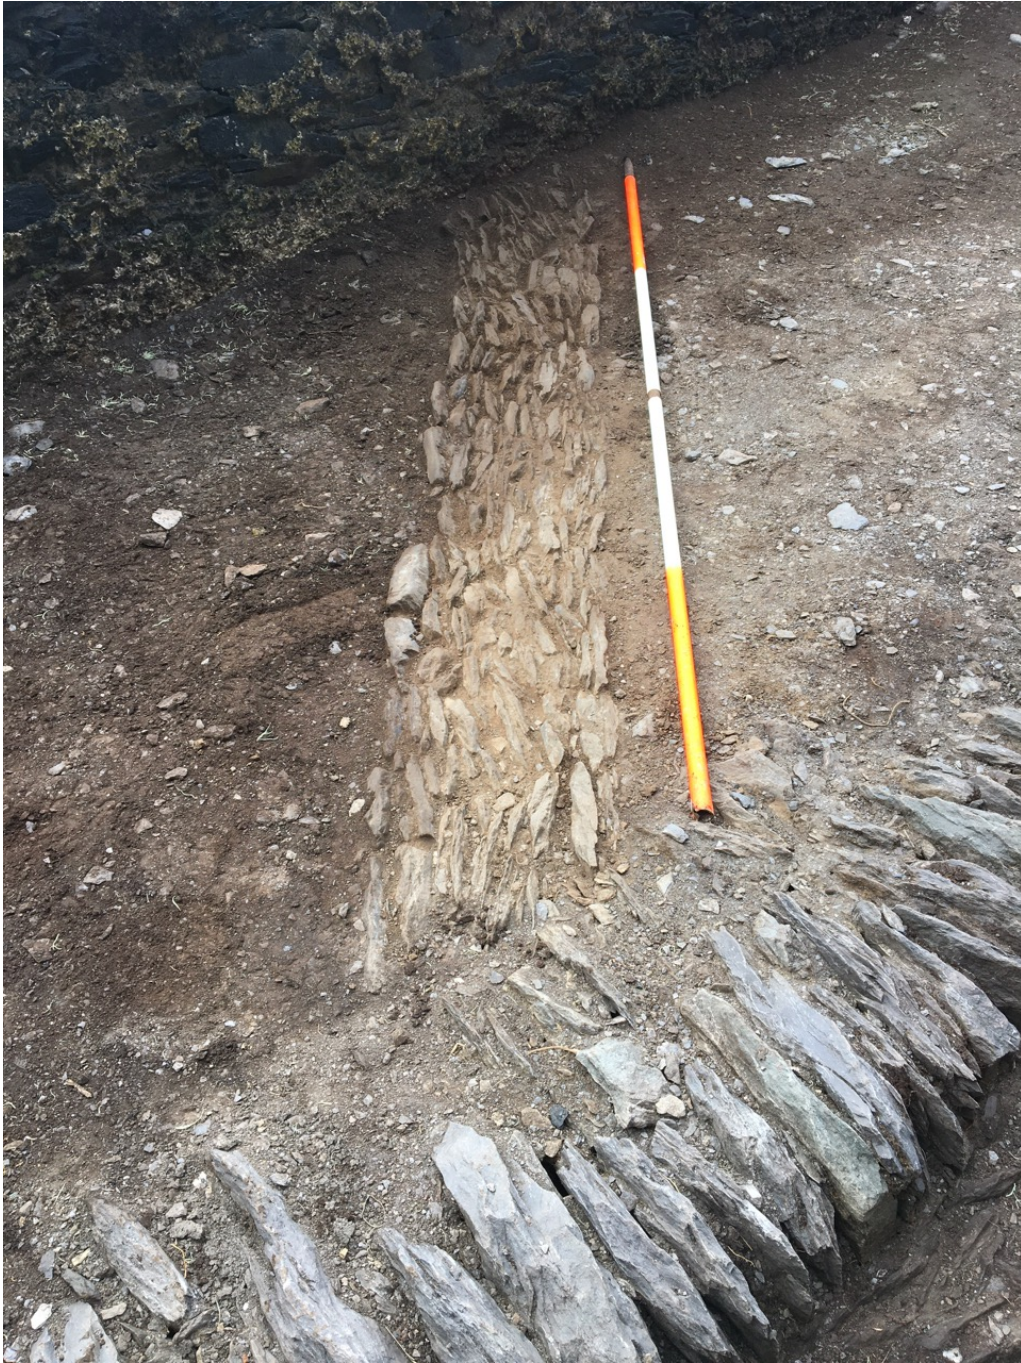
A surface water deflector composed of a narrow diagonally aligned band of vertically set stones survived intact further up Section 2 (photo 9). It diverted water flowing down the road surface into the lateral drain. Similar structures were previously revealed on Areas A and D of the roadway and it is possible that more of these structures may have originally existed on the roadway but were removed by the erosion of the road surface. The construction of more of these features on the steeper sections of the roadway might be considered as a method to hold the fill of the roadway in place.

Photograph 9, section E2 looking south. Surface water diverter.

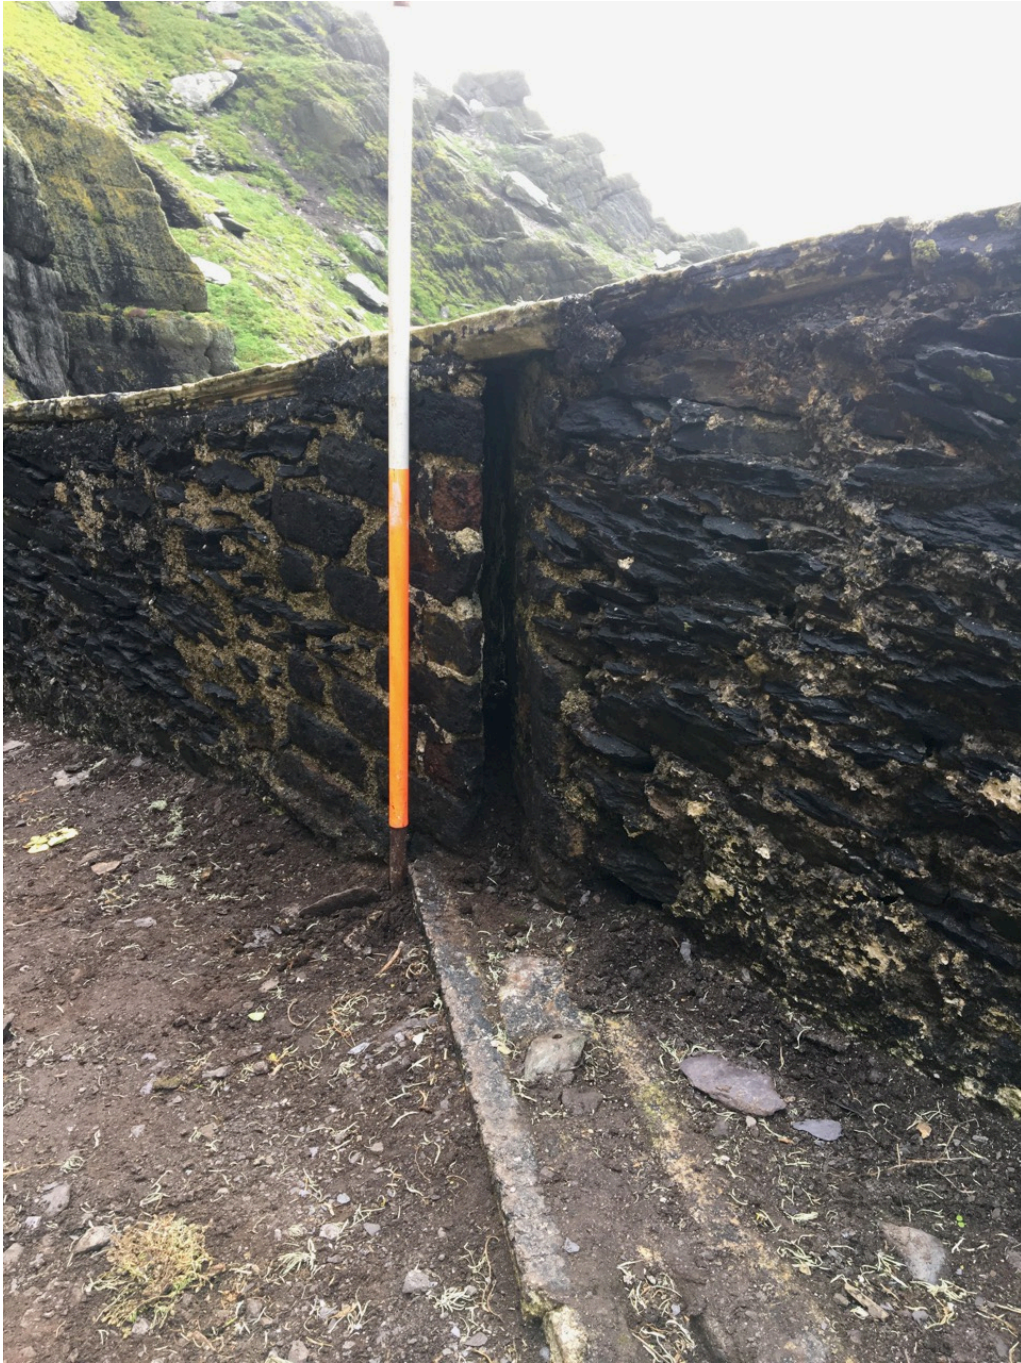
The early twentieth-century cable channel ran down along the upper half of Section 2 in the lateral drain (figs. 3 & 4, photos 11 & 12) and at its lower end crossed the roadway and exited through a stone and brick-lined slot constructed in the parapet wall, about halfway up Section 2 (fig. 3, photo 10). As in other Areas where the cable channel was constructed, it was laid in a trench cut into the base of the lateral drain loosening the basal stones of the drain around the edges of the trench leading to further disturbance due to erosion of the base of the drain. (fig. 4 & photo 10). The construction of the cable channel in Section 2 also resulted in the removal of lengths of the original road edging (fig. 4 & photos 11 & 12).

Photograph 10, section E2 looking southeast. Slot in parapet wall for cable with cable channel in foreground.

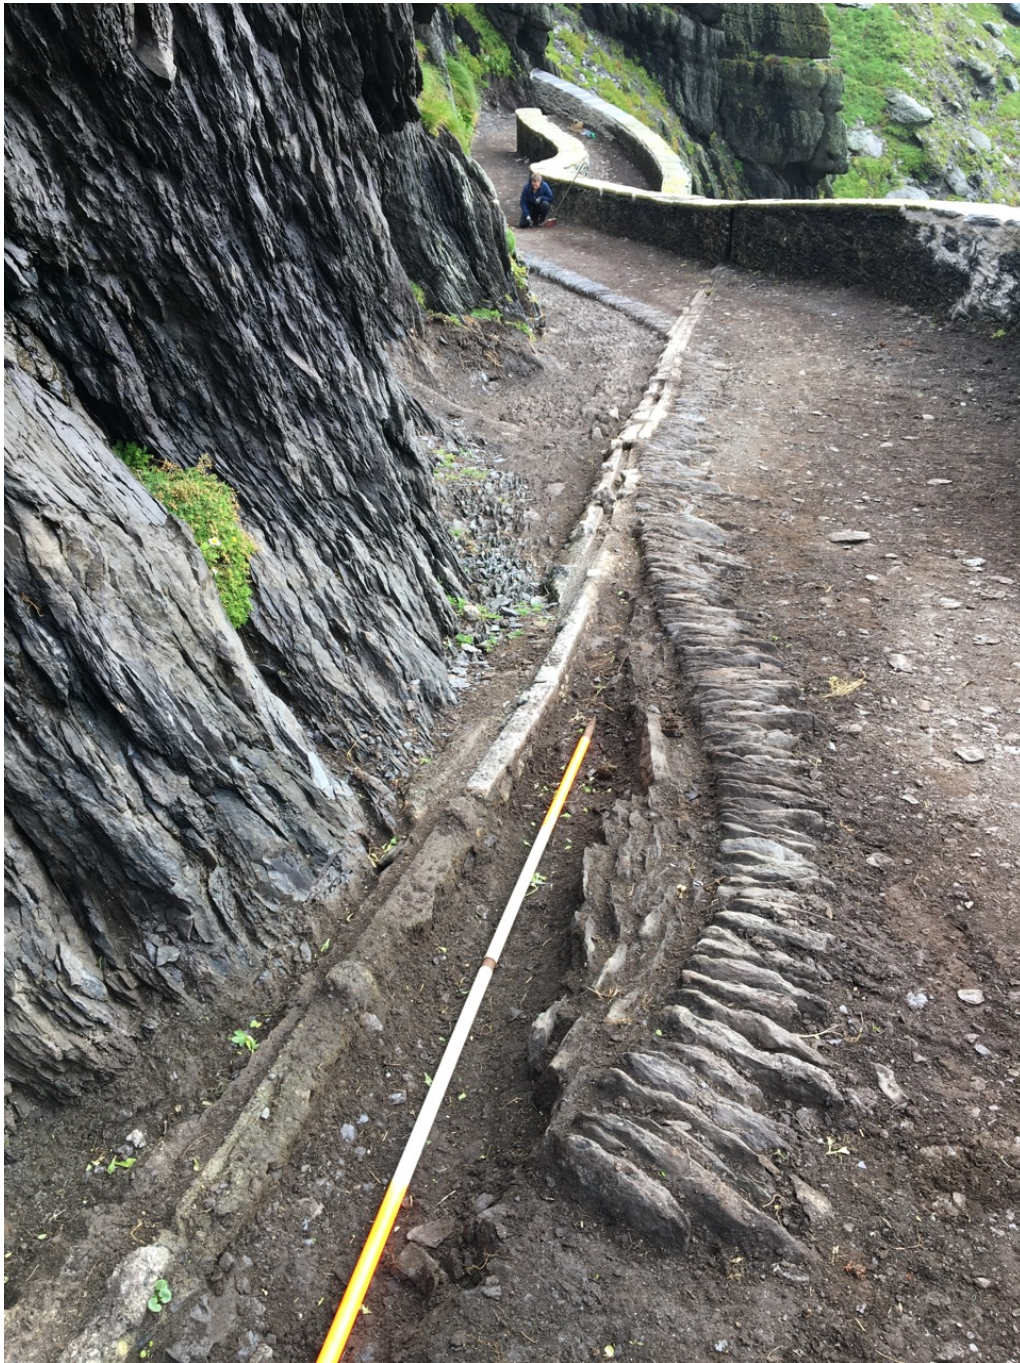
Photograph 11, section E2 looking east. Cable channel cut through base of lateral drain, gaps in base of lateral drain and road edging removed in foreground.

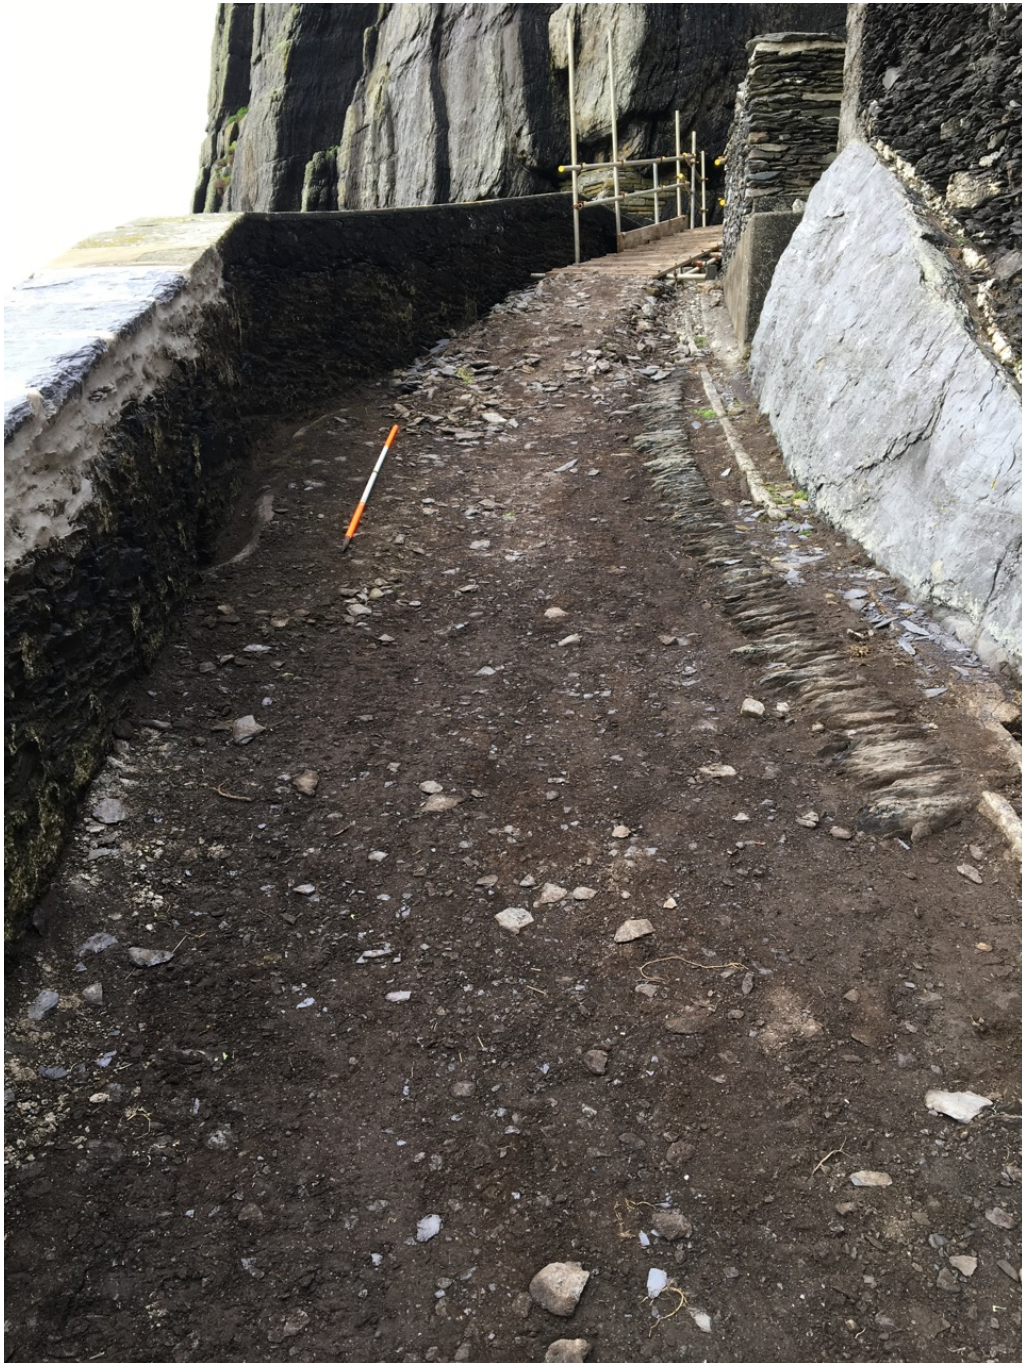
Photograph 12, section E2 looking west. Removed and intact road edging with lateral drain cut by cable channel at right and surface drain (to left of ranging rod). Mass concrete wall and modern bird-nesting wall in background.

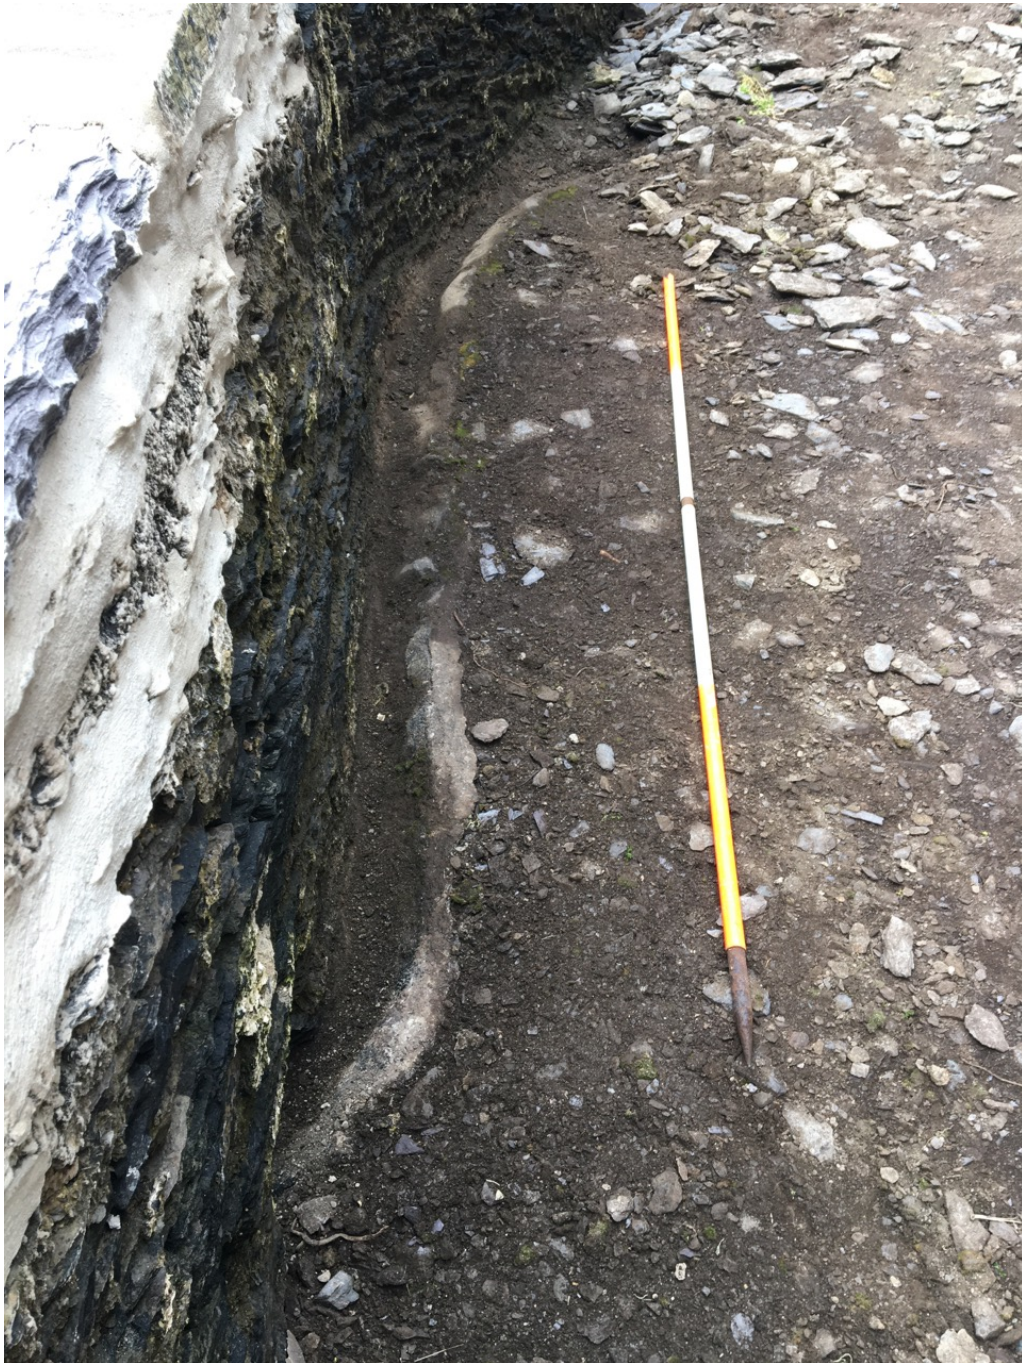
Near the top end of Section 2 a sinuous and narrow cement-lined surface drain extended along the inside of the parapet wall before exiting through it via a rectangular outlet (fig. 4, photo 13). This drain appears to be of later date than the original construction of the roadway and may replace an earlier one.

Photograph 13, section E2 looking west. Surface drain inside parapet wall.

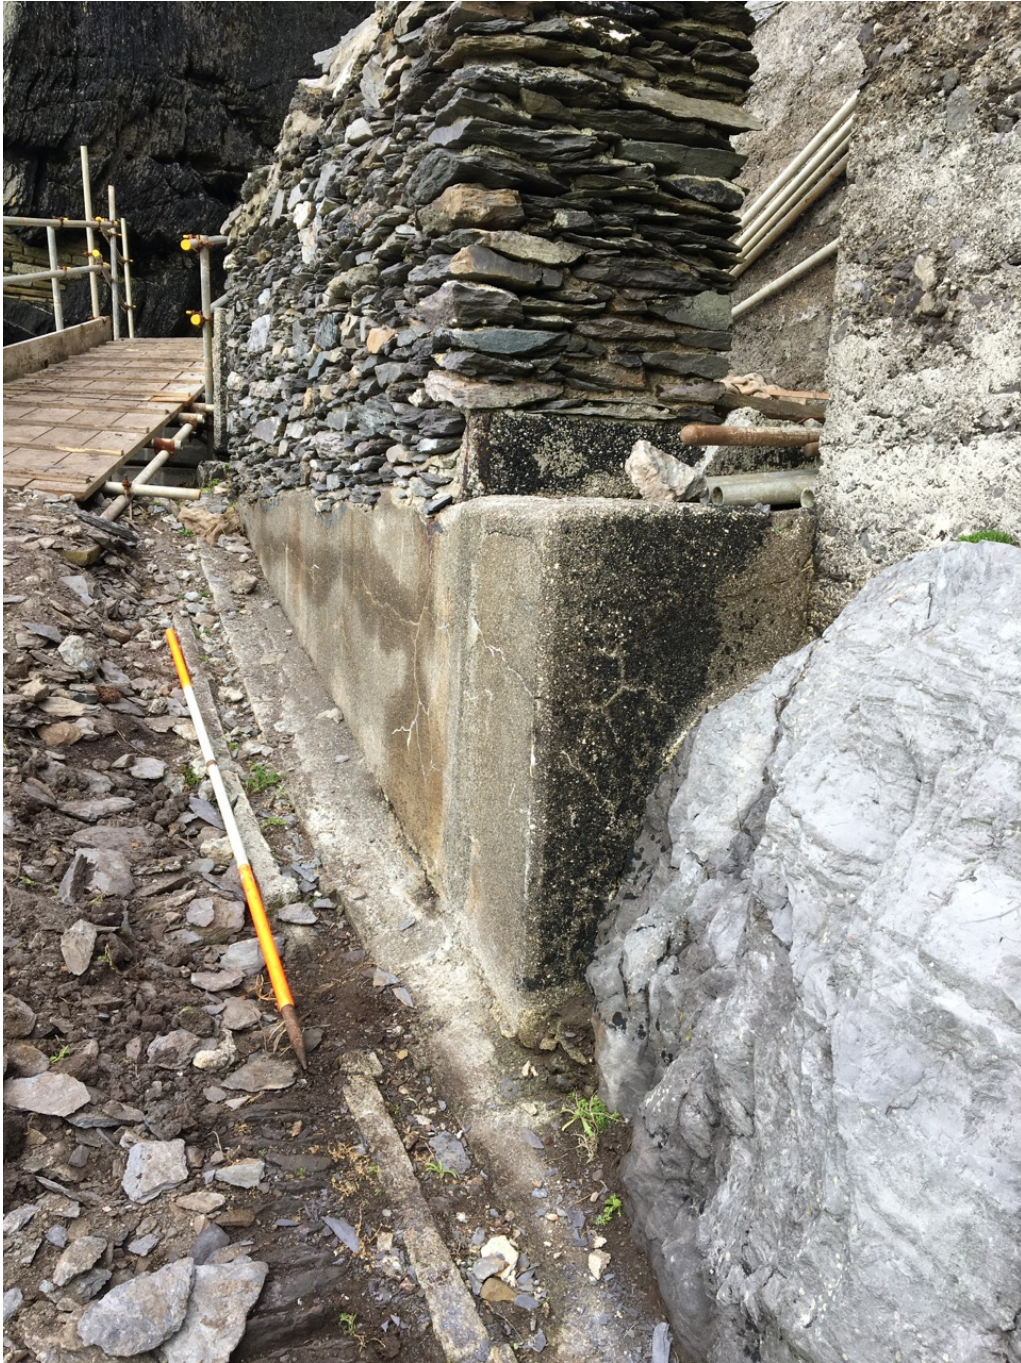
At the upper end of Section 2 the mass concrete walls of a building and steps erected in the twentieth century (probably when the fog station was built or extensively rebuilt) replaced the parapet wall along the inner side of Section 2 -the outer side of Section 3 (photos 14 & 15). The surface of the roadway here in Section 2 was not cleared nor exposed, as a ramp had to be constructed on its surface to facilitate the passage of the motorised dumper used to transport materials during the works.

Photograph 14, section E2 looking west. Cable channel at base of mass concrete wall topped by modern bird-nesting wall.

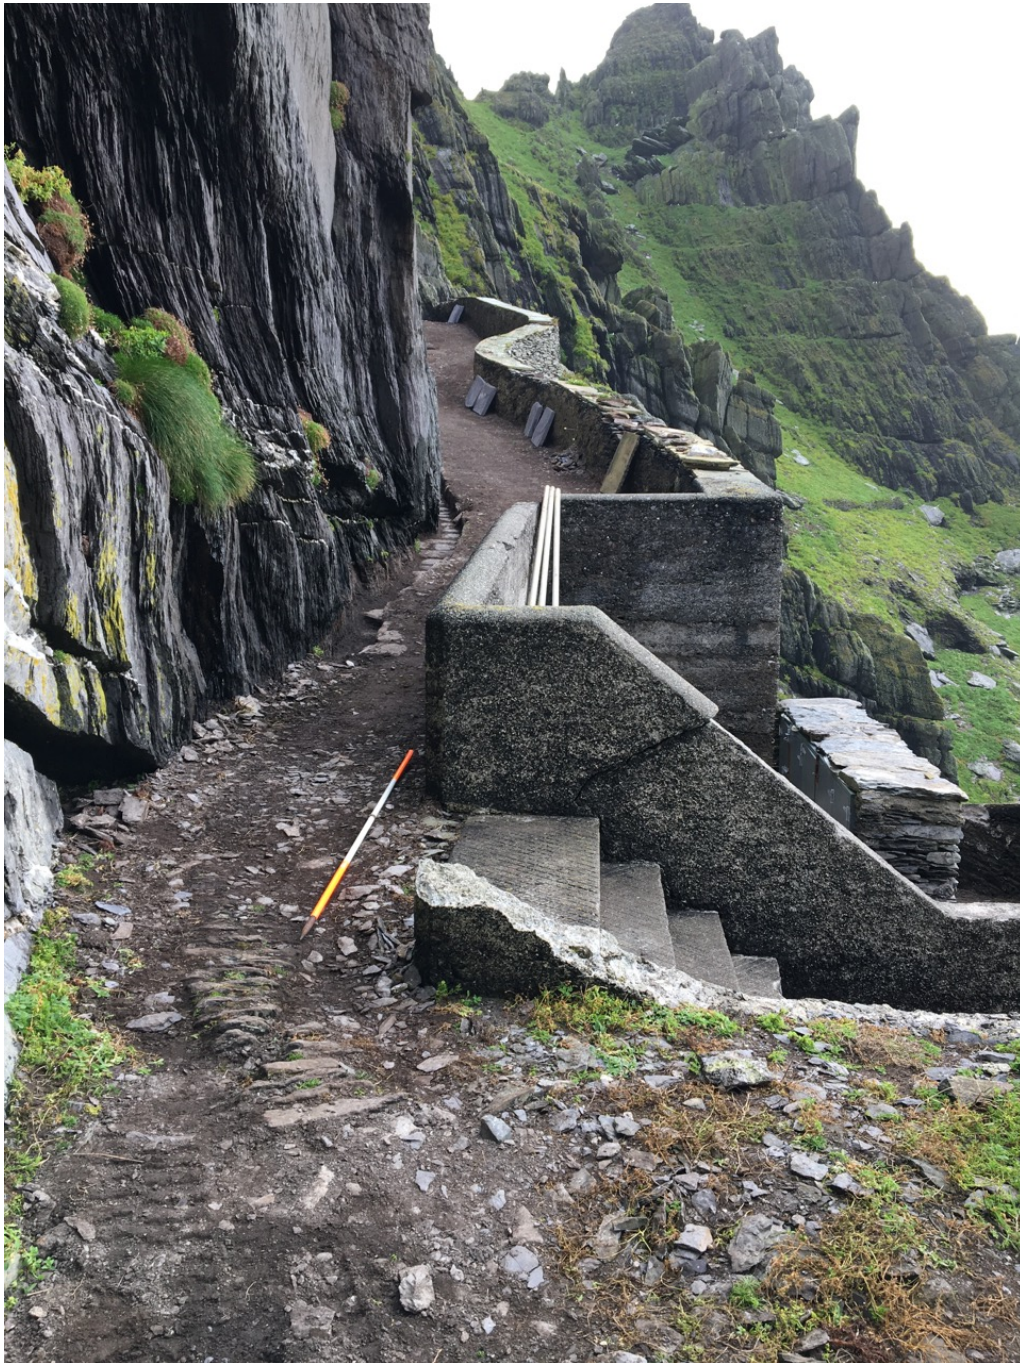
The western end of Section 3 was also not cleared for the aforementioned reason. A short length of the original road edging was visible at the start of this Section (photo 15) but over the majority it had been removed (probably when the mass concrete structures were erected). The edging was replaced by vertically set flagstones defining the side of a 300-400mm deep drain with either a bedrock or stone flagged base (photos 16, 17 & 19). The vertically set flags were not well anchored and a few fell over when the drain was cleared out, while others were loose. The poor construction of the side of the drain and its depth means that it will be vulnerable to erosion and also presents a clear trip hazard. Its partial infilling with gravel or stone is likely to be required.

Photograph 15, section E3 looking east. Short length of intact road edging in foreground. Mass concrete walls with road edging replaced by vertically set flags at back left.
