Archaeological Monitoring of Works

the Upper Lighthouse Road (Area E),

Skellig Michael, Co. Kerry,

**Archaeological Monitoring of Works
on the Upper Lighthouse Road (Area E), Skellig Michael, Co. Kerry, 2020.**
Ministerial Consent No. C000819, Excavation No. E004885, Detection device licence No. R00463
*Alan R. Hayden,
Archaeological Projects Ltd.,
October 2020.*

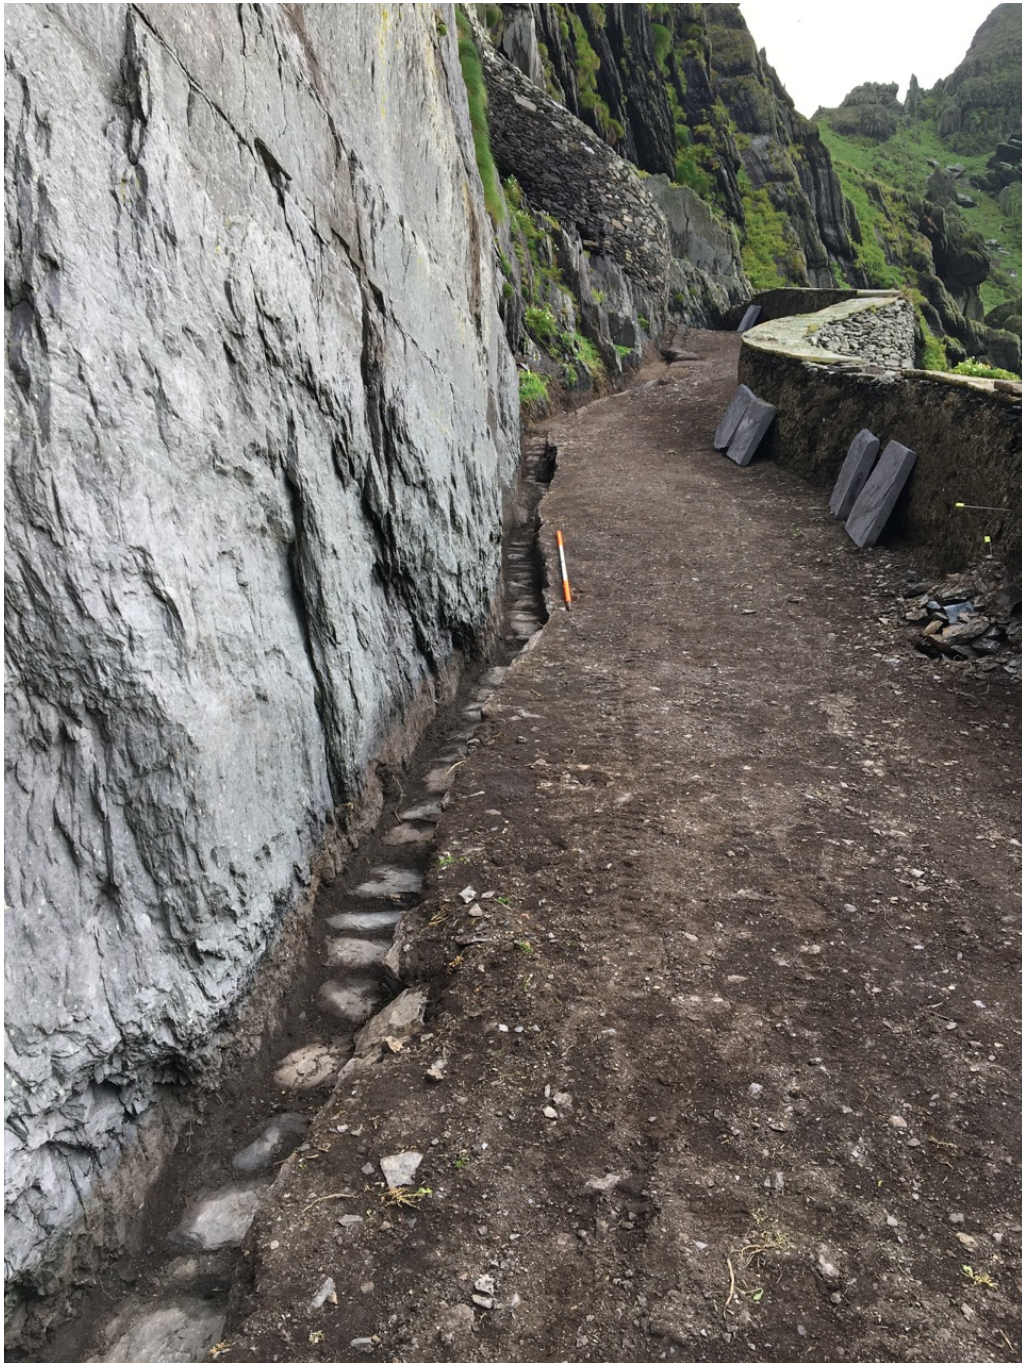
The western end of Section 3 was also not cleared for the aforementioned reason. A short length of the original road edging was visible at the start of this Section (photo 15) but over the majority it had been removed (probably when the mass concrete structures were erected). The edging was replaced by vertically set flagstones defining the side of a 300-400mm deep drain with either a bedrock or stone flagged base (photos 16, 17 & 19). The vertically set flags were not well anchored and a few fell over when the drain was cleared out, while others were loose. The poor construction of the side of the drain and its depth means that it will be vulnerable to erosion and also presents a clear trip hazard. Its partial infilling with gravel or stone is likely to be required.

Photograph 16, section E3 looking east. Original road edging replaced by vertically set flags and flagstone base of lateral drain.

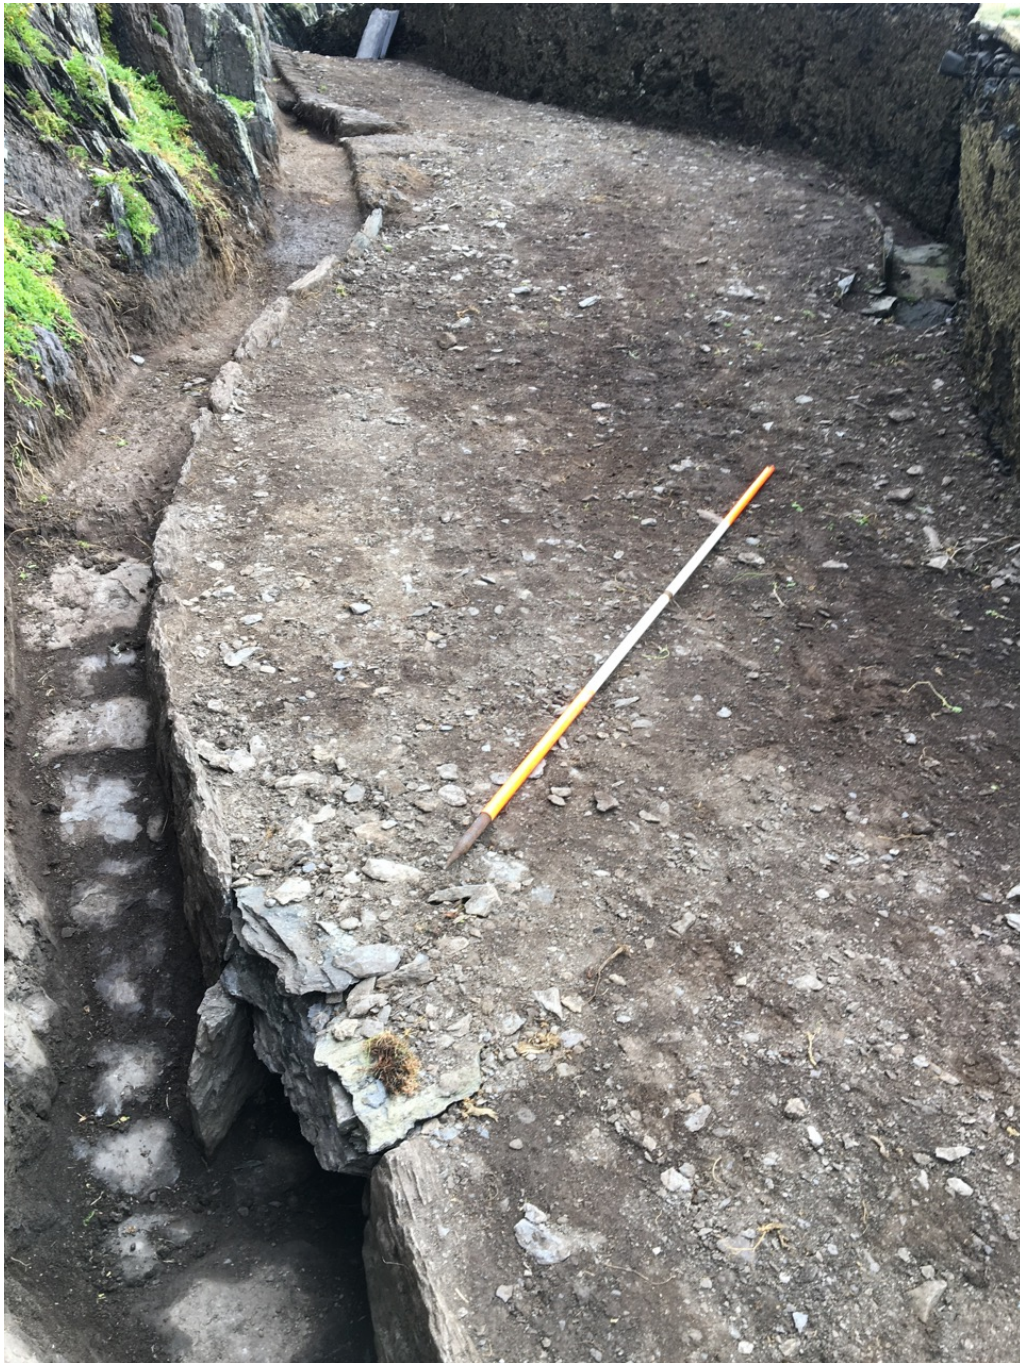
A subsurface, stone-walled and capped drain led water from a stone flagged surface drain inside the parapet wall into the later lateral drain about halfway up this section (photos 17 & 18). One of the capstones beneath the centre of the roadway was lifted so the drain could be cleaned out and was then replaced and re-covered. There was a wide and deep crack in the parapet wall where this drain began (fig. 4 & photo 18) and which will have to be repaired.

Photograph 17, section E3 looking east. Opening of subsurface drain into lateral drain at left and surface drain at right (see photograph 18). Replaced road edging in foreground with rock cut lateral drain and original road edging in background.

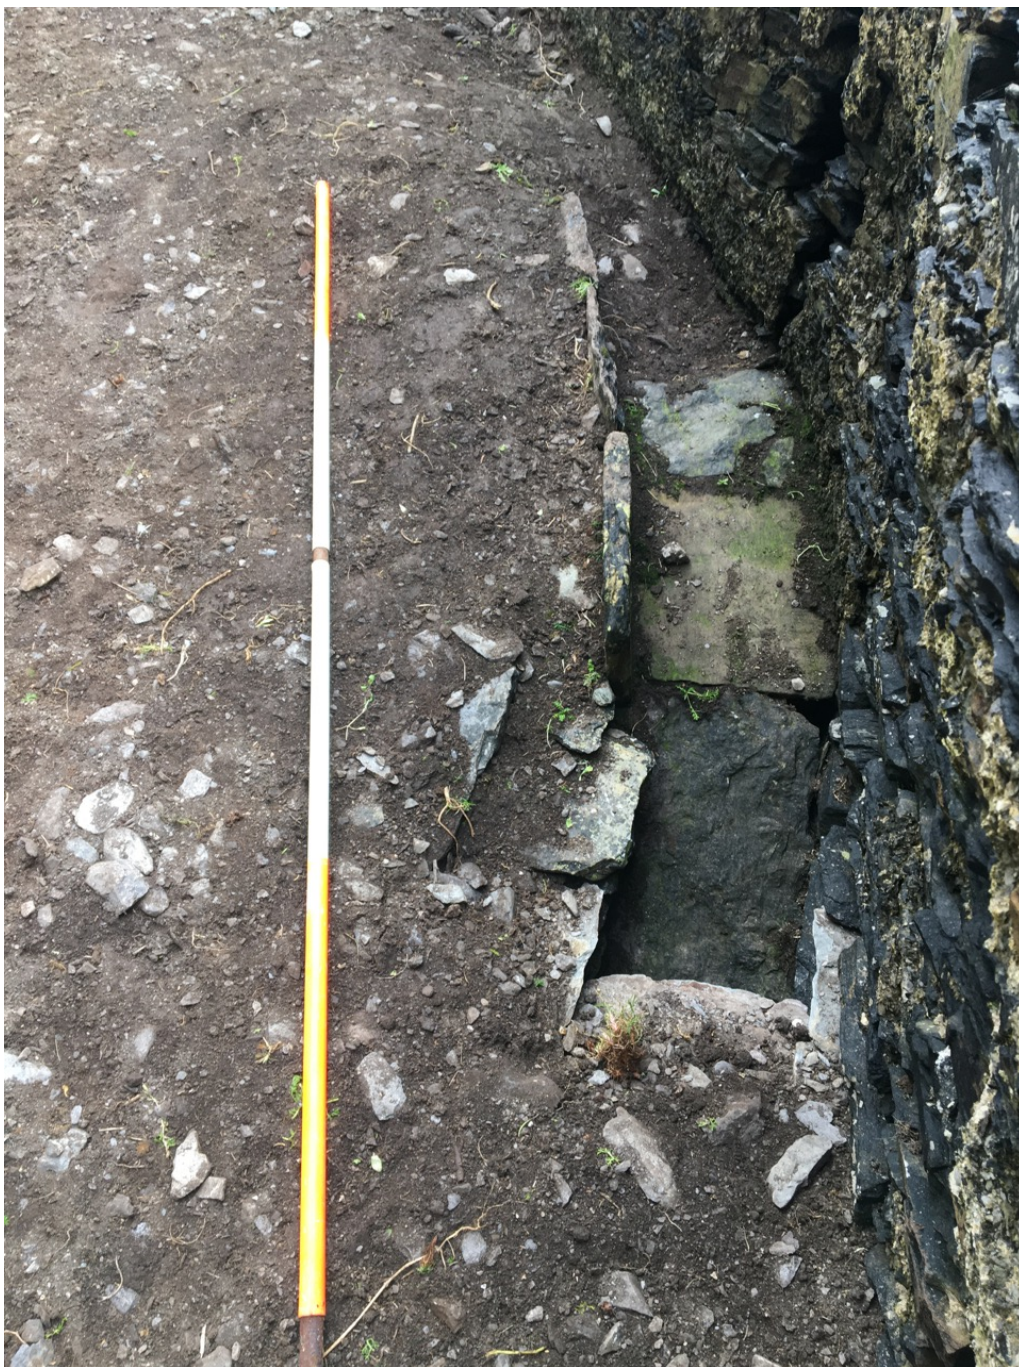
Photograph 18, section E3 looking east. Surface drain inside parapet wall. Note large crack in parapet wall.

- the collapsed outer face of the parapet wall where the drain exits through it at the top of Section 1,
- the partial infill of the deep and rebuilt lateral drain on the lower half of Section 3,
- the wide crack in the wall on Section 3.

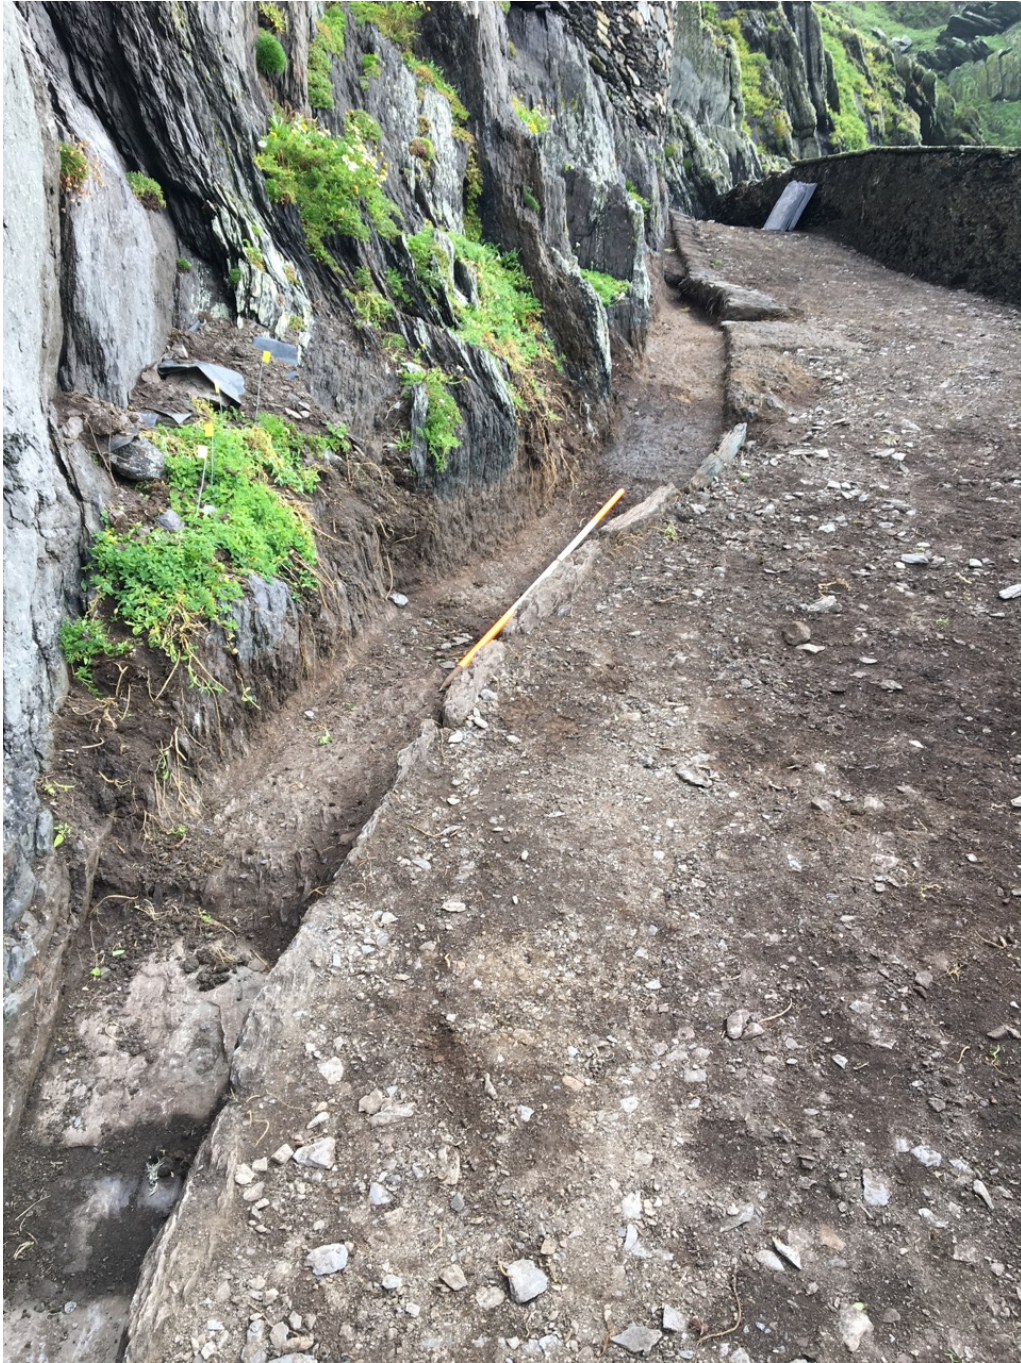
Beyond the reconstructed drain there was 3m-long section where the lateral drain was entirely rock cut and the exposed (and clearly quarried back) rock also formed the surface of the inner side of the roadway for a short length (photos 19 & 20). Here again it is clear that the surviving infilled surface of the roadway lies below its original finished level.

Photograph 19, section E3 looking east. Original road edging replaced with vertically set flags, rock cut base of lateral drain, original road edging in background.

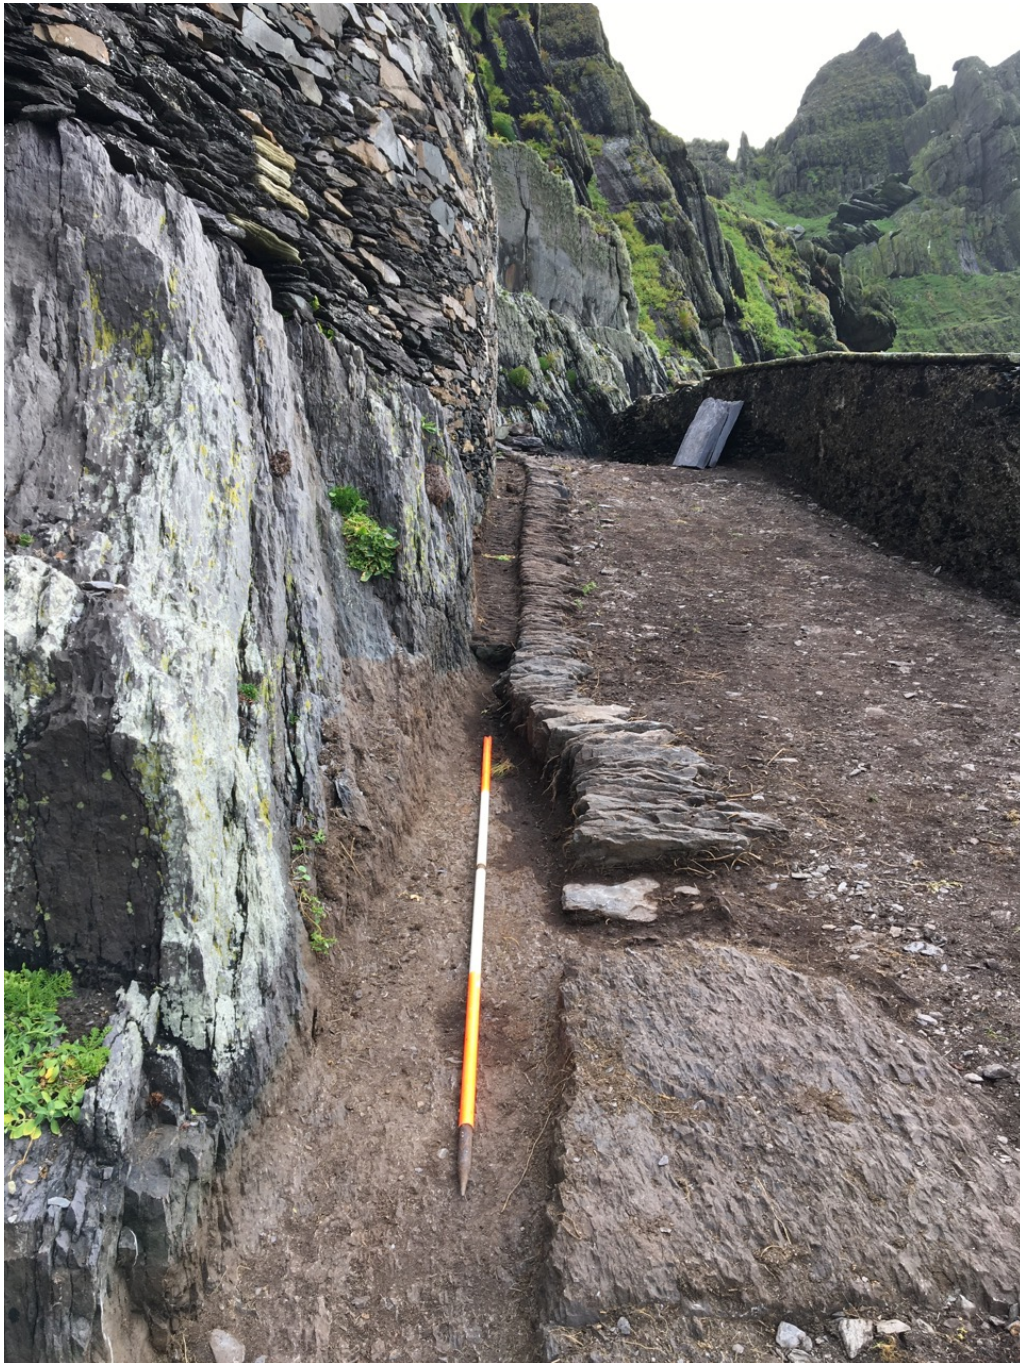
Photograph 20, section E3 looking east. Rock cut lateral drain in foreground, original road edging and intact set stone base of lateral drain behind.

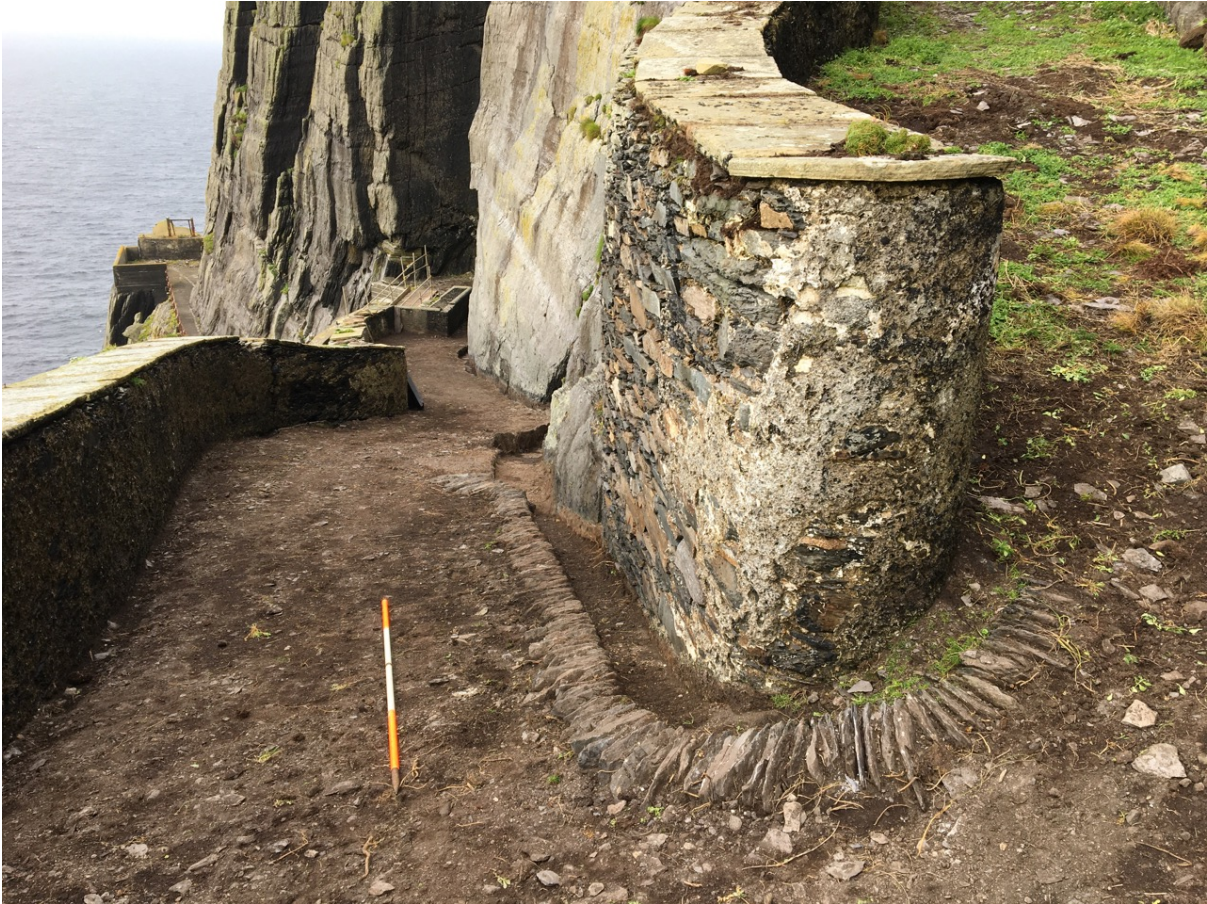
Photograph 21, section E3 looking west. Road edging and lateral drain curving around parapet wall, road surface slightly below original level.

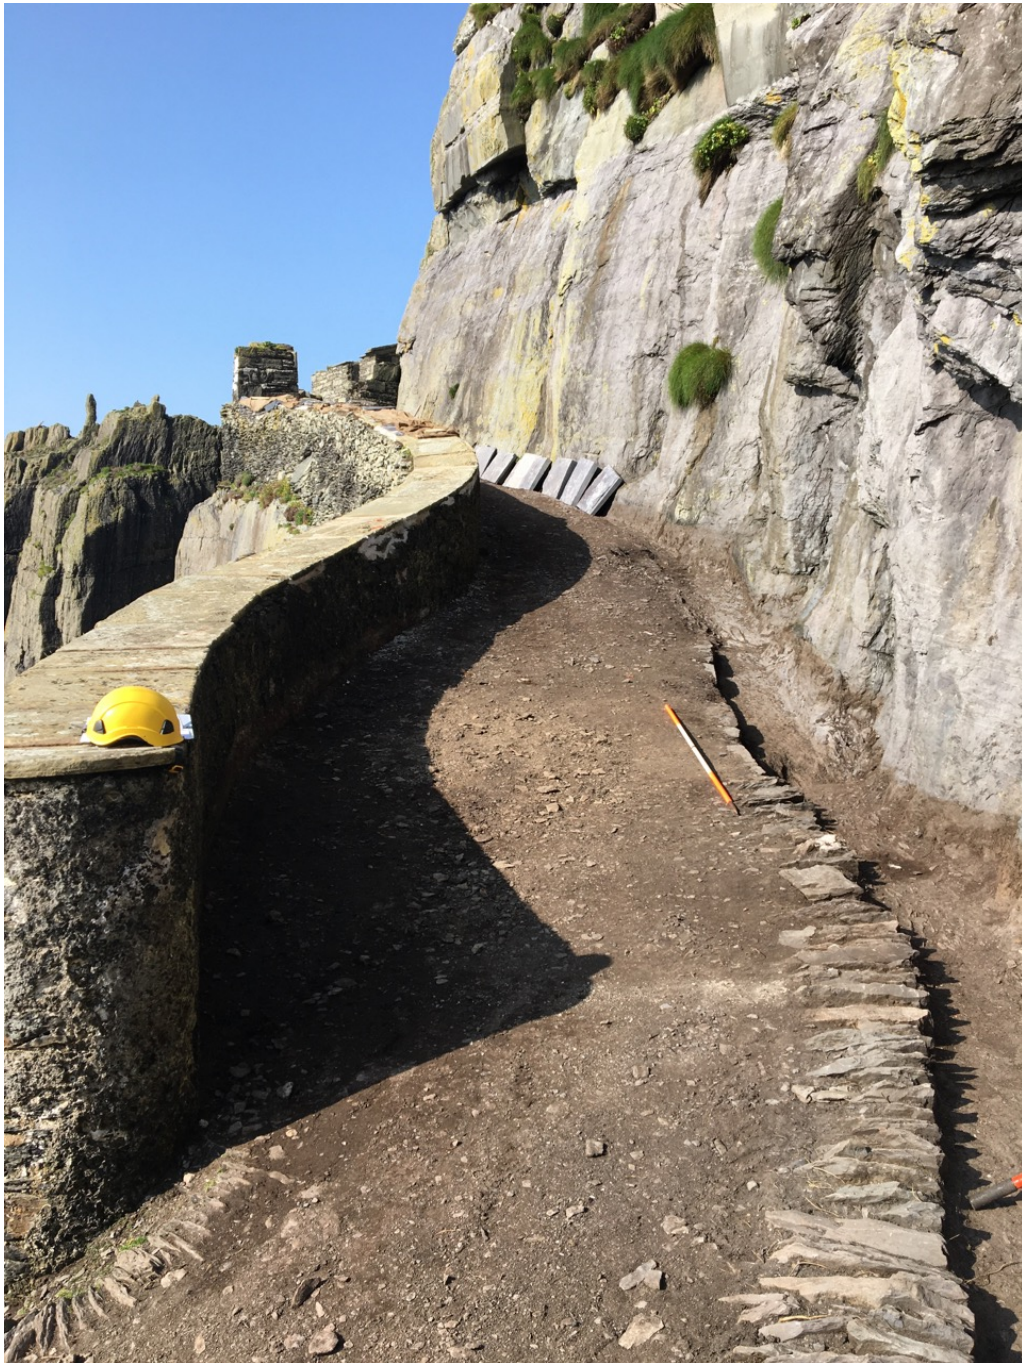
Both the road edging and vertically set stone base of the lateral drain survived in excellent condition at the lower end of Section 4 of the roadway (photo 22). A subsurface stone-lined and capped drain led water under the road from the lateral drain to the rock cut channel mentioned above at the upper end of Section 3. There was an unlined and rough hole in the base of the lateral drain where the subsurface drain began (photo 23). Judging by the size of this hole it is possible that it originally held a stone shore similar to that revealed at the east end of Section 2 (photo 8). In the vicinity of the shore the road edging may either have been built originally as horizontal masonry or may have been replaced by the surviving stonework; it is not clear which.

Photograph 22, section E4 looking west. Intact road edging and lateral drain, with disturbed shore / drain open by ranging rod (see photograph 23).

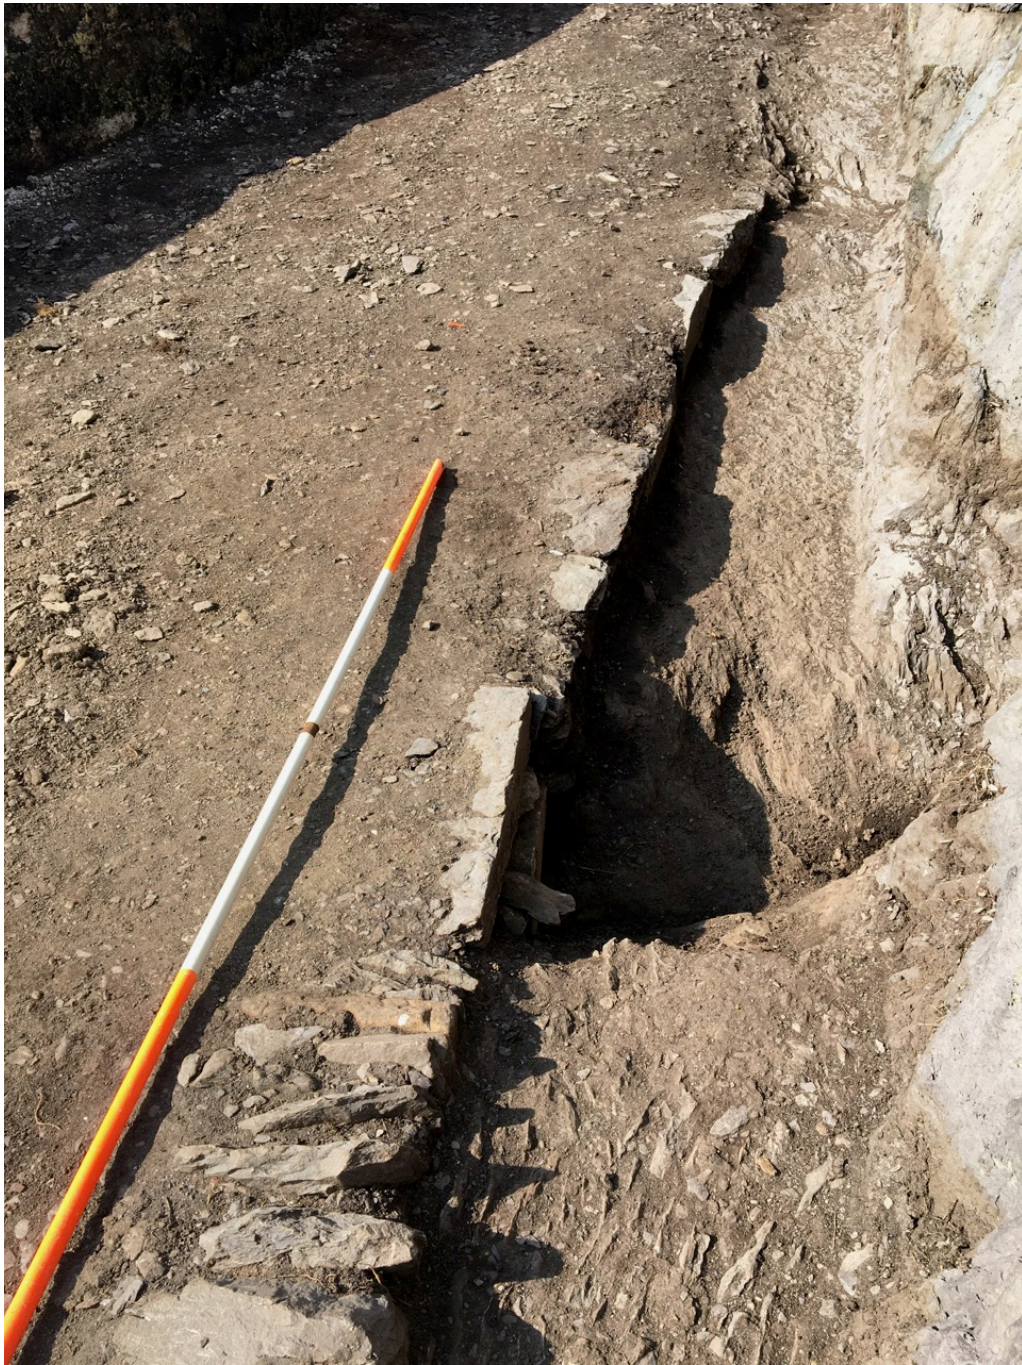
Photograph 23, section E4 looking west. Subsurface drain opening, possibly originally holding stone shore and intact set stone base of lateral drain, rock cut base in background. Note possibly rebuilt road edging.

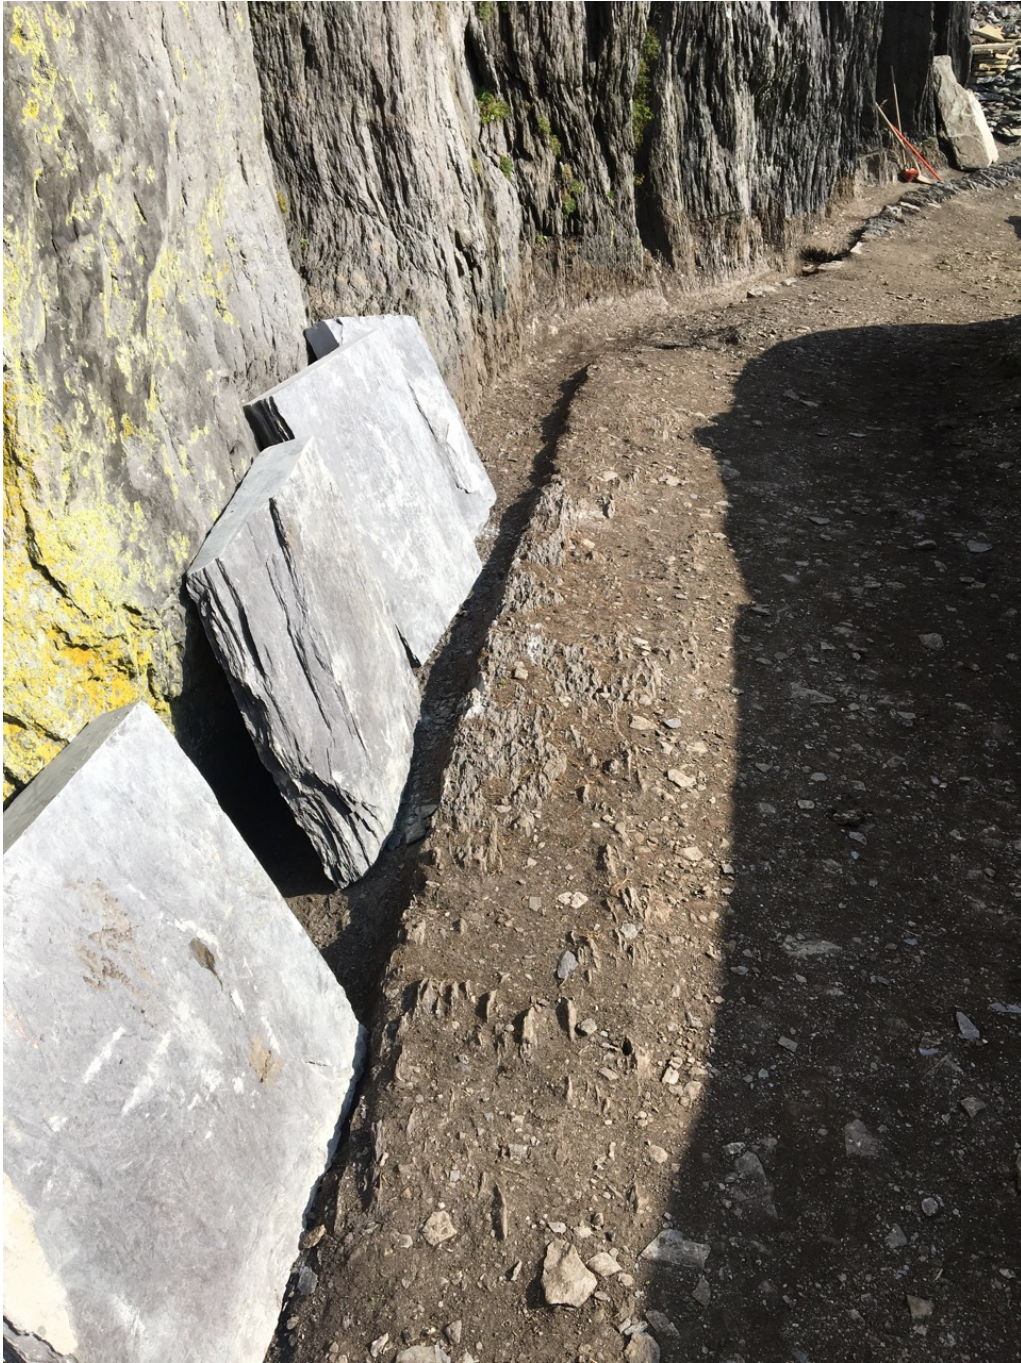
Above this point the road edging and lateral drain were generally rock cut with the quarried back rock also forming sections of the road surface (photo 24). There were short lengths of vertically set stone edging inserted where there would originally have been gullies in the rock, deeper than the finished road surface (fig. 4).

Photograph 24, section E4 looking east. Exposed rock at road surface and rick cut lateral drain.

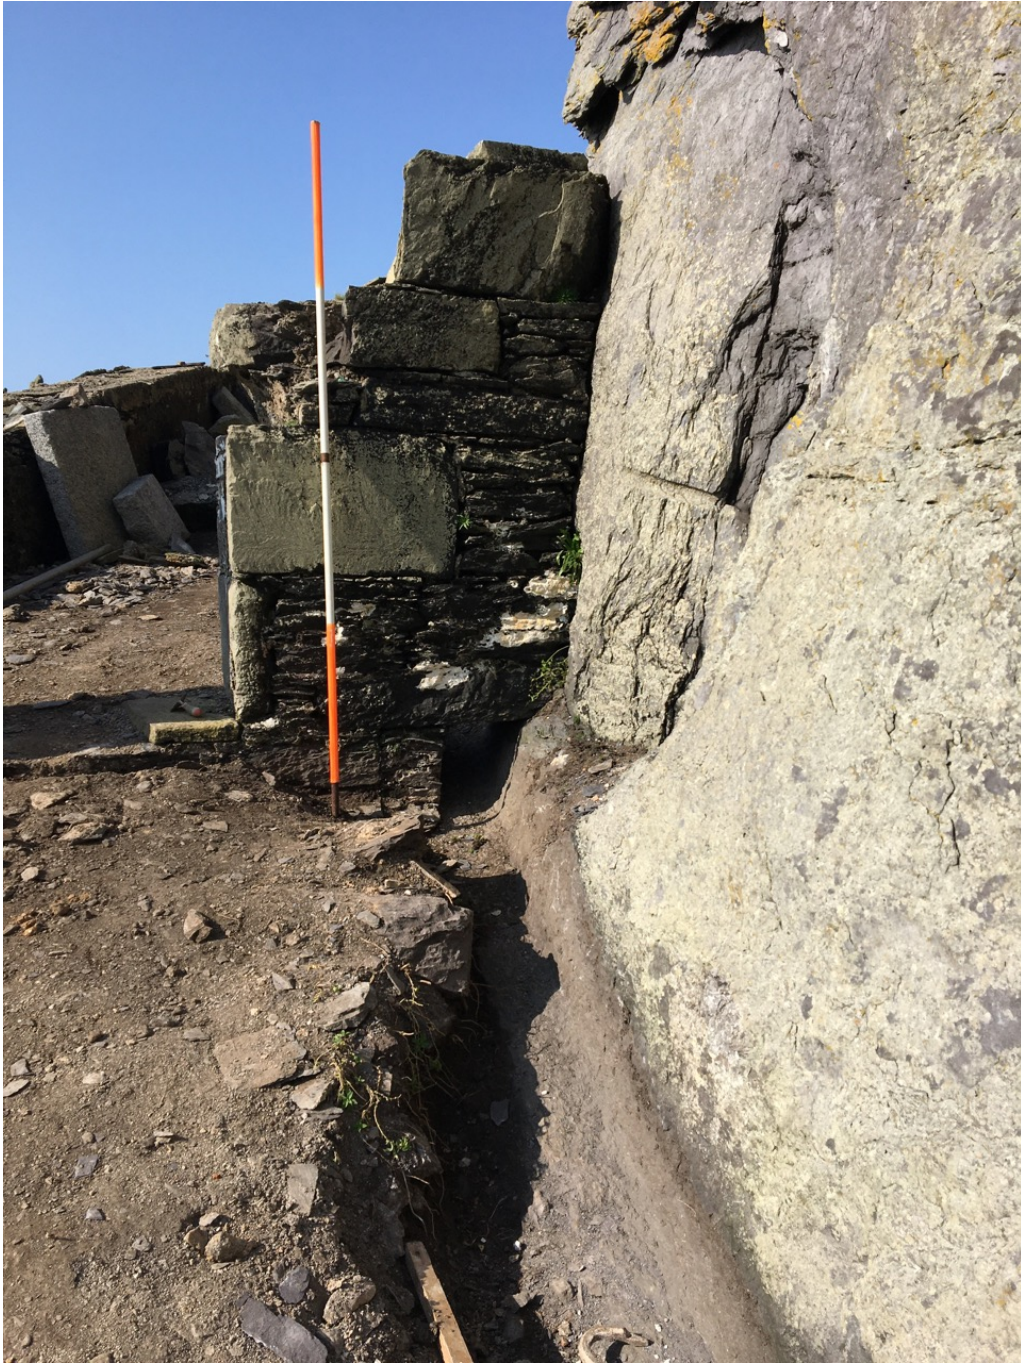
At the upper end of this Section the rock cut lateral drain narrowed and extended beneath the walling of the gate into the Upper Lighthouse. The gateway is in very poor condition having largely collapsed due to the movement of its outer side. It is to be repaired in the future.

Photograph 24, section E4 looking west. Rock cut lateral drain narrowing and extending beneath gate of Upper Lighthouse.
