**Reconnaissance Report  
Geological Context of Rockfall  
Monday 13th June 2022  
Lower Lighthouse Road,  
Skellig Michael**

on behalf of  
the Office of Public Works

June 2022

### **Lower Lighthouse Road, Skellig Michael**

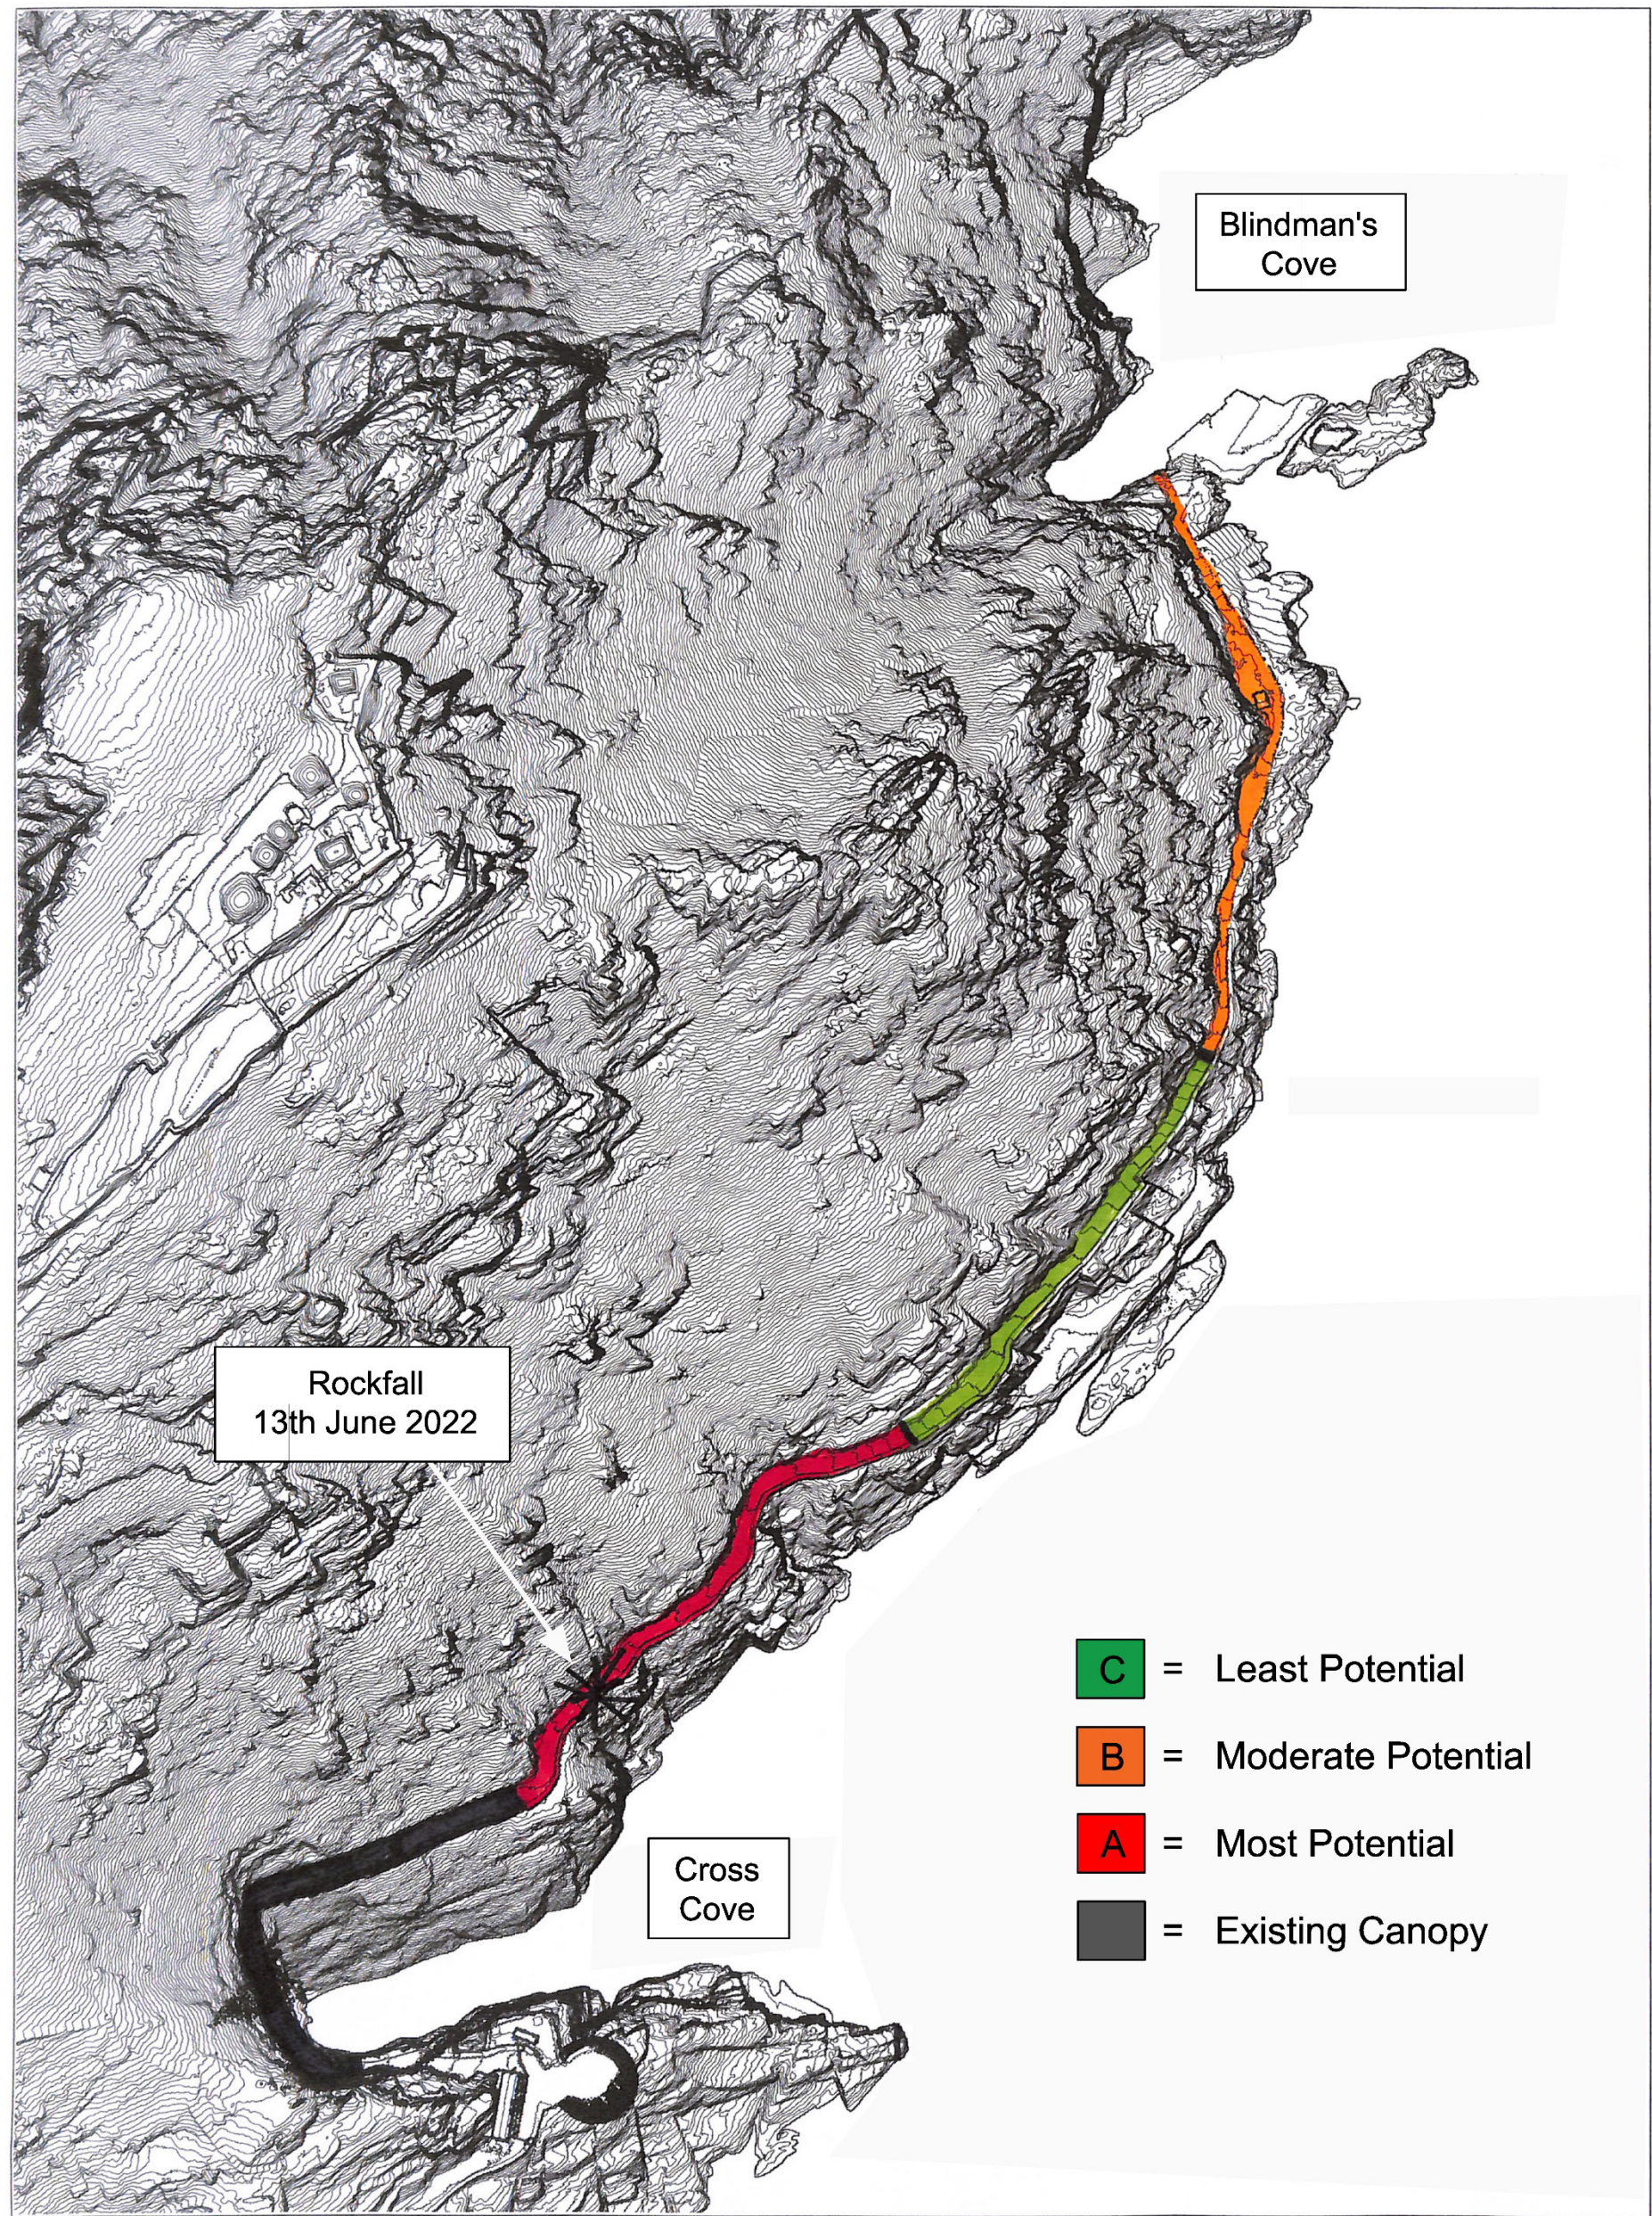
Figure 1. Potential for Rockfall: Lower Lighthouse Road – “Relative” Assessment.

With regard to the potential for rockfall in the narrow and very specific area between the pier at Blindman's Cove and the rock canopy at Cross Cove, the reconnaissance inspection allowed for the identification of most, moderate and least rockfall potential zones (see Figure 1), viz:

- A. Most Potential: Joint plane exposed zone with associated scree slopes.
- B. Moderate Potential: Narrow road zone adjacent to the landing at Blindman's Cove with cleavage rock faces above.
- C. Least Potential: Nineteenth century rock blasted zone between Zones A and B.

For clarity and avoidance of doubt this is a relative and not absolute assessment. Equally, a least potential assessment does not connote the absence of the potential for a rockfall. The nature and timing of prospective interventions to protect these areas are not considered in this geological report.

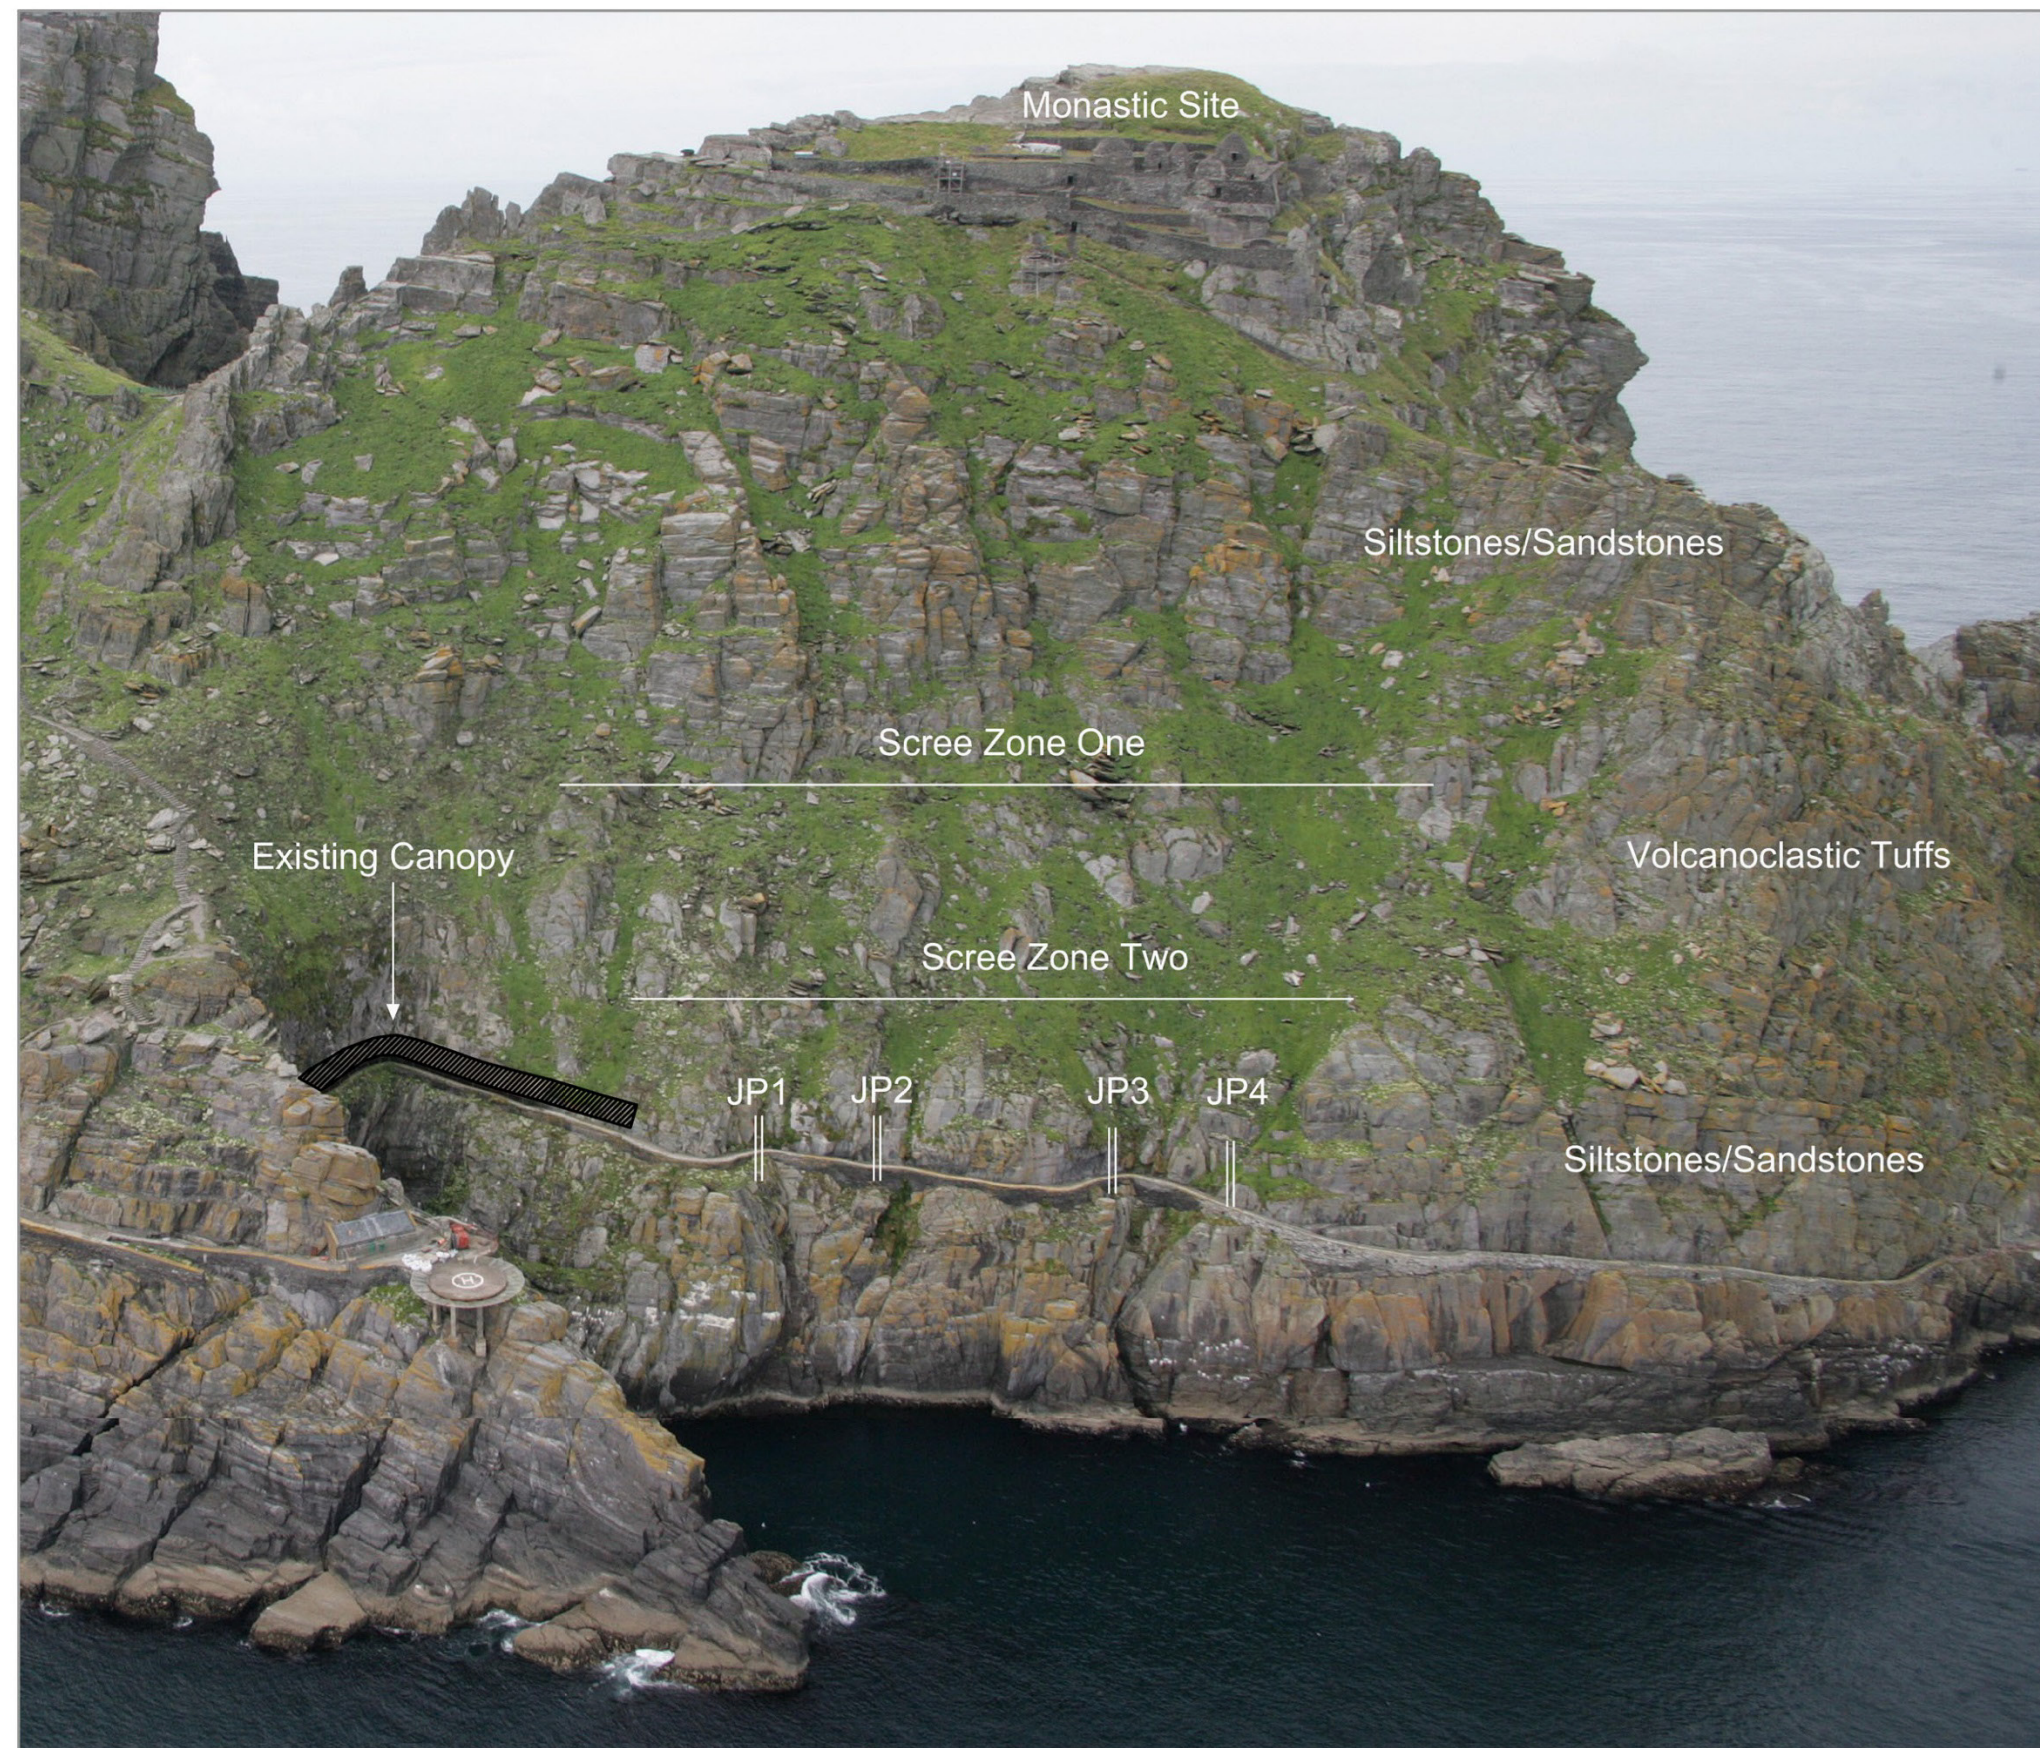
The geology at the fall site comprises a thick sequence of interbedded sandstones and siltstones, lithostratigraphically correlated with the onshore St. Finan's Sandstone Formation. A thick (>50m) volcanic sequence of pyroclastic lithic and welded tuffs interrupt the exposure midway on the rock slope between Cross Cove and the monastic site on the north peak (see Photograph 1).

High above the fall site (c. 50-100m) two distinct rock scree zones may be identified (see Photograph 1). An upper scree zone comprising "cleavage slabs" upwards of 5m x 5m (estimate) in size approximately aligned on the upper boundary of the exposed tuffs, and a lower zone also comprising "cleavage slabs" up to c. 2m x 2m (estimate) in size (see Photograph 1). The dominant superficial

**Photograph 1. Geological Context of Rockfall Site.**

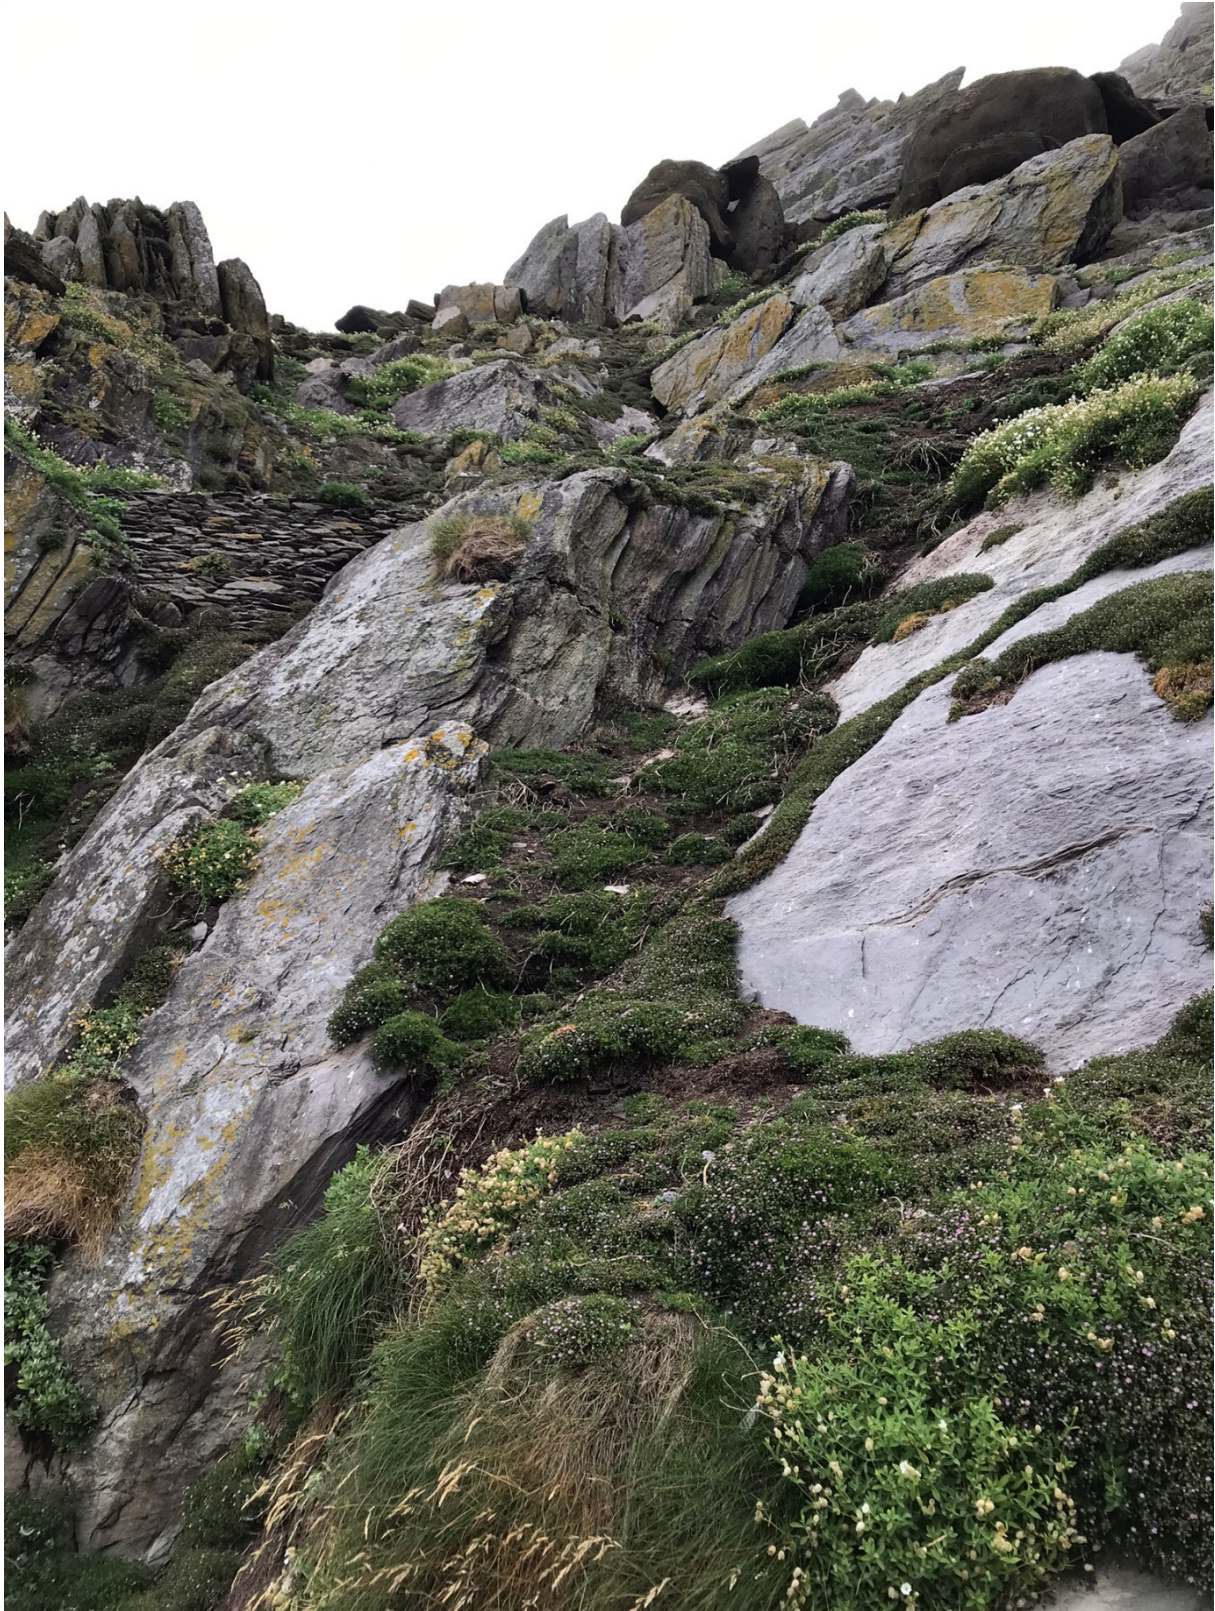
feature immediately above the fall site (<50m) is that of a number of cross cutting joint planes, striking 130°-140° and dipping 65°-80° to the east. At least four such joint plane zones are identifiable as vegetation filled gullies immediately adjacent to the lower lighthouse road to the east of the protective canopy at Cross Cove (see Photographs 1 to 5). The gullies at this location allow for rockfalls directly on to the lower lighthouse road.

**Photograph 2. Joint Plane Zone 1 (for location see Photograph 1).**

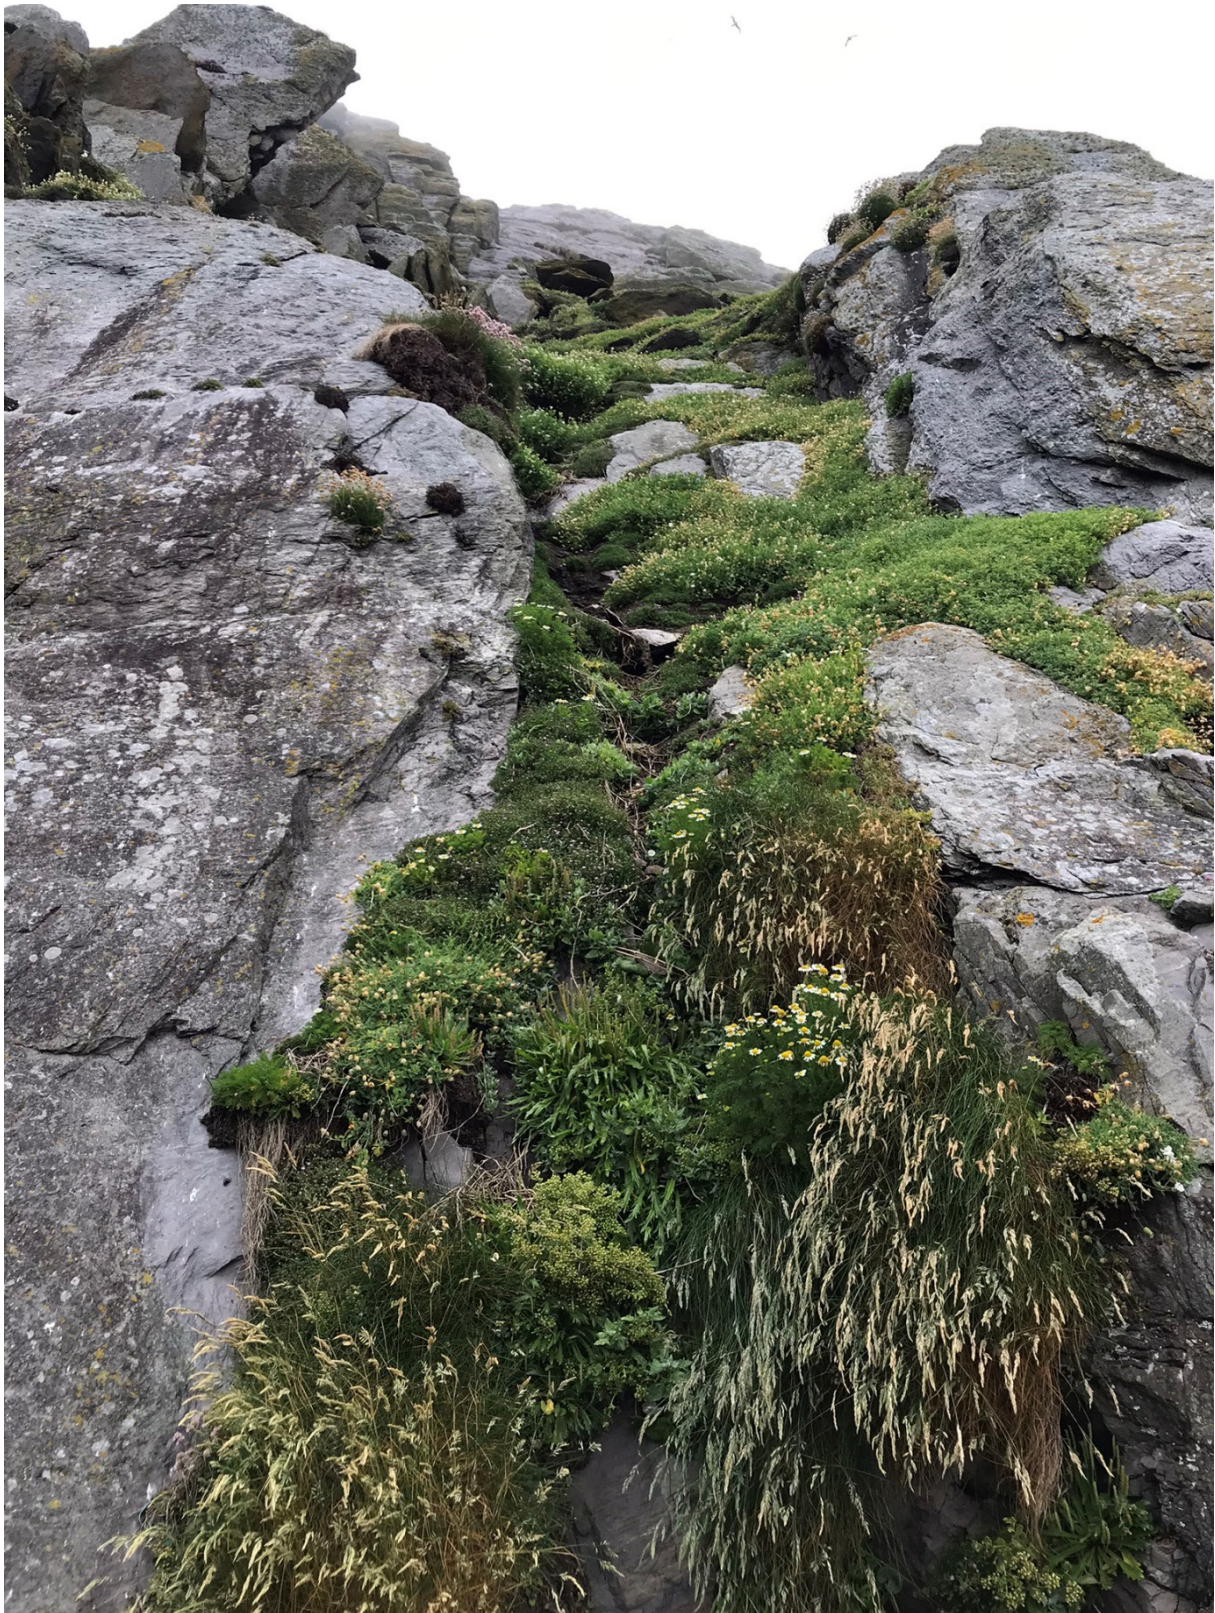
**Photograph 3. Joint Plane Zone 2 c. 20m east of Joint Plane Zone 1. The rockfall of 13<sup>th</sup> June occurred c. 7m to the west of this location (for location see Photograph 1).**

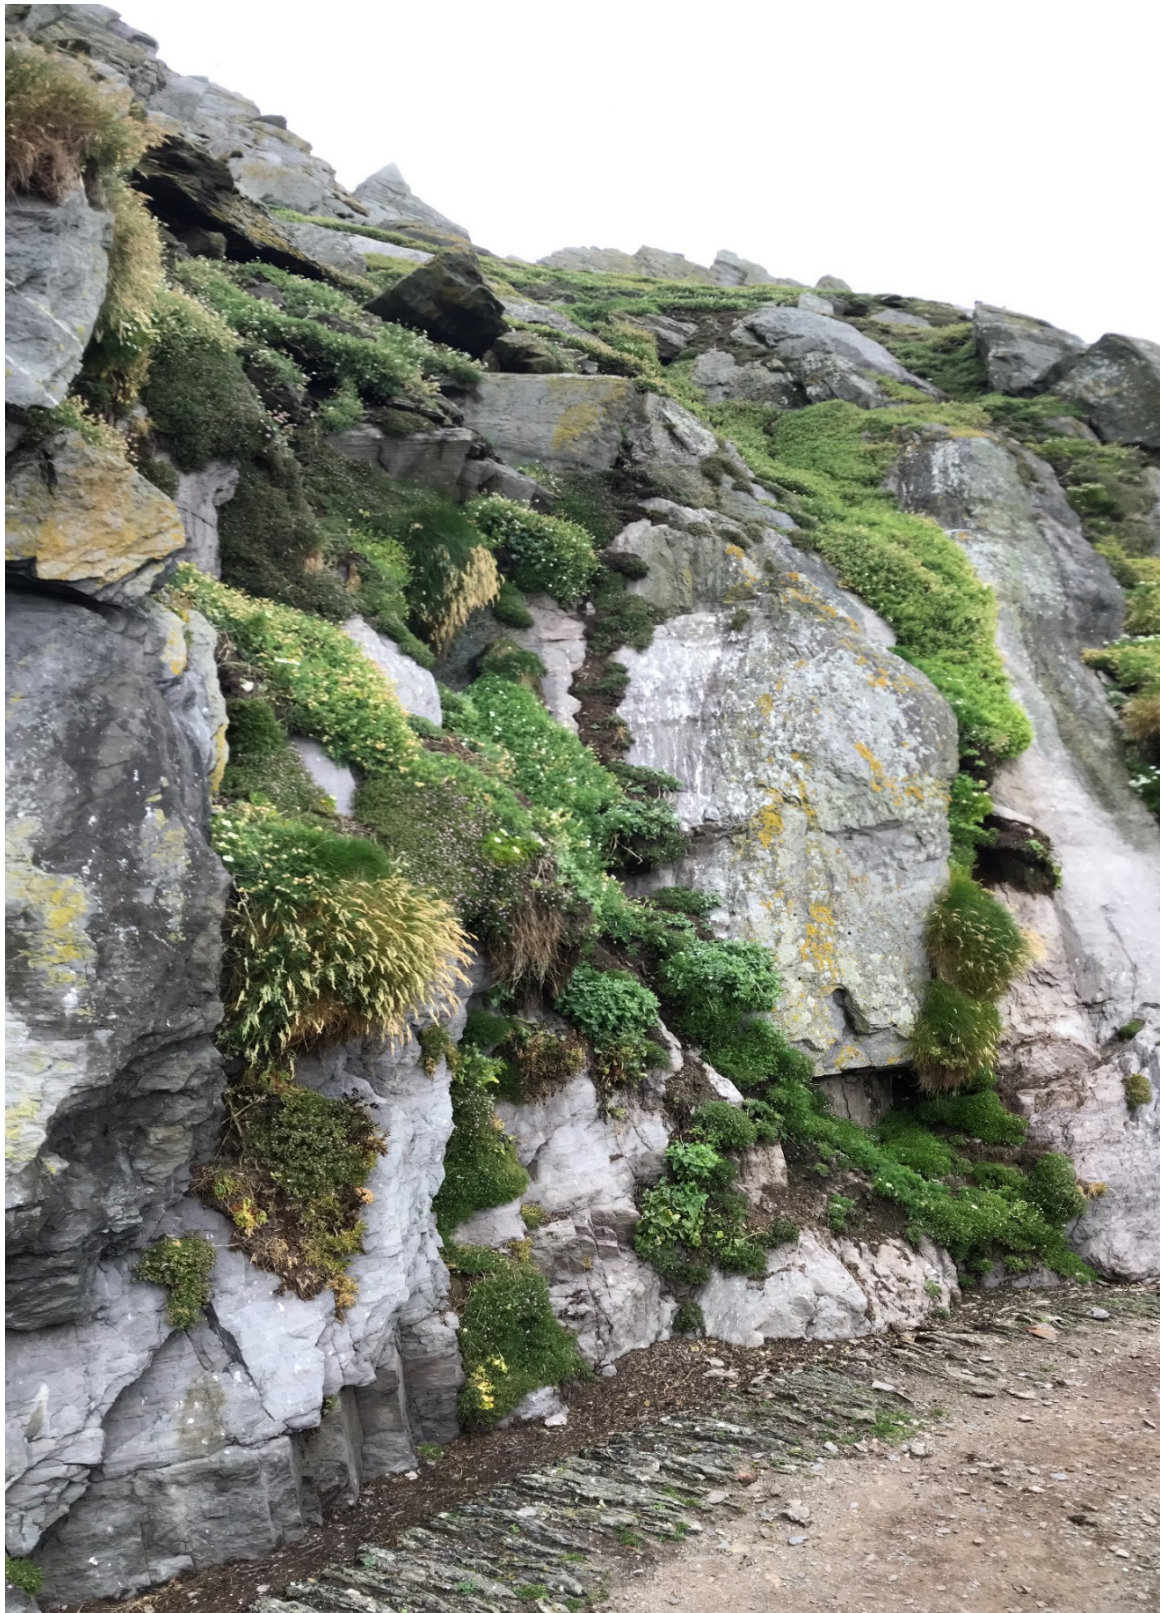
**Photograph 4. Joint Plane Zone 3 (for location see Photograph 1). This zone c. 40m from Joint Plane Zone 2.**

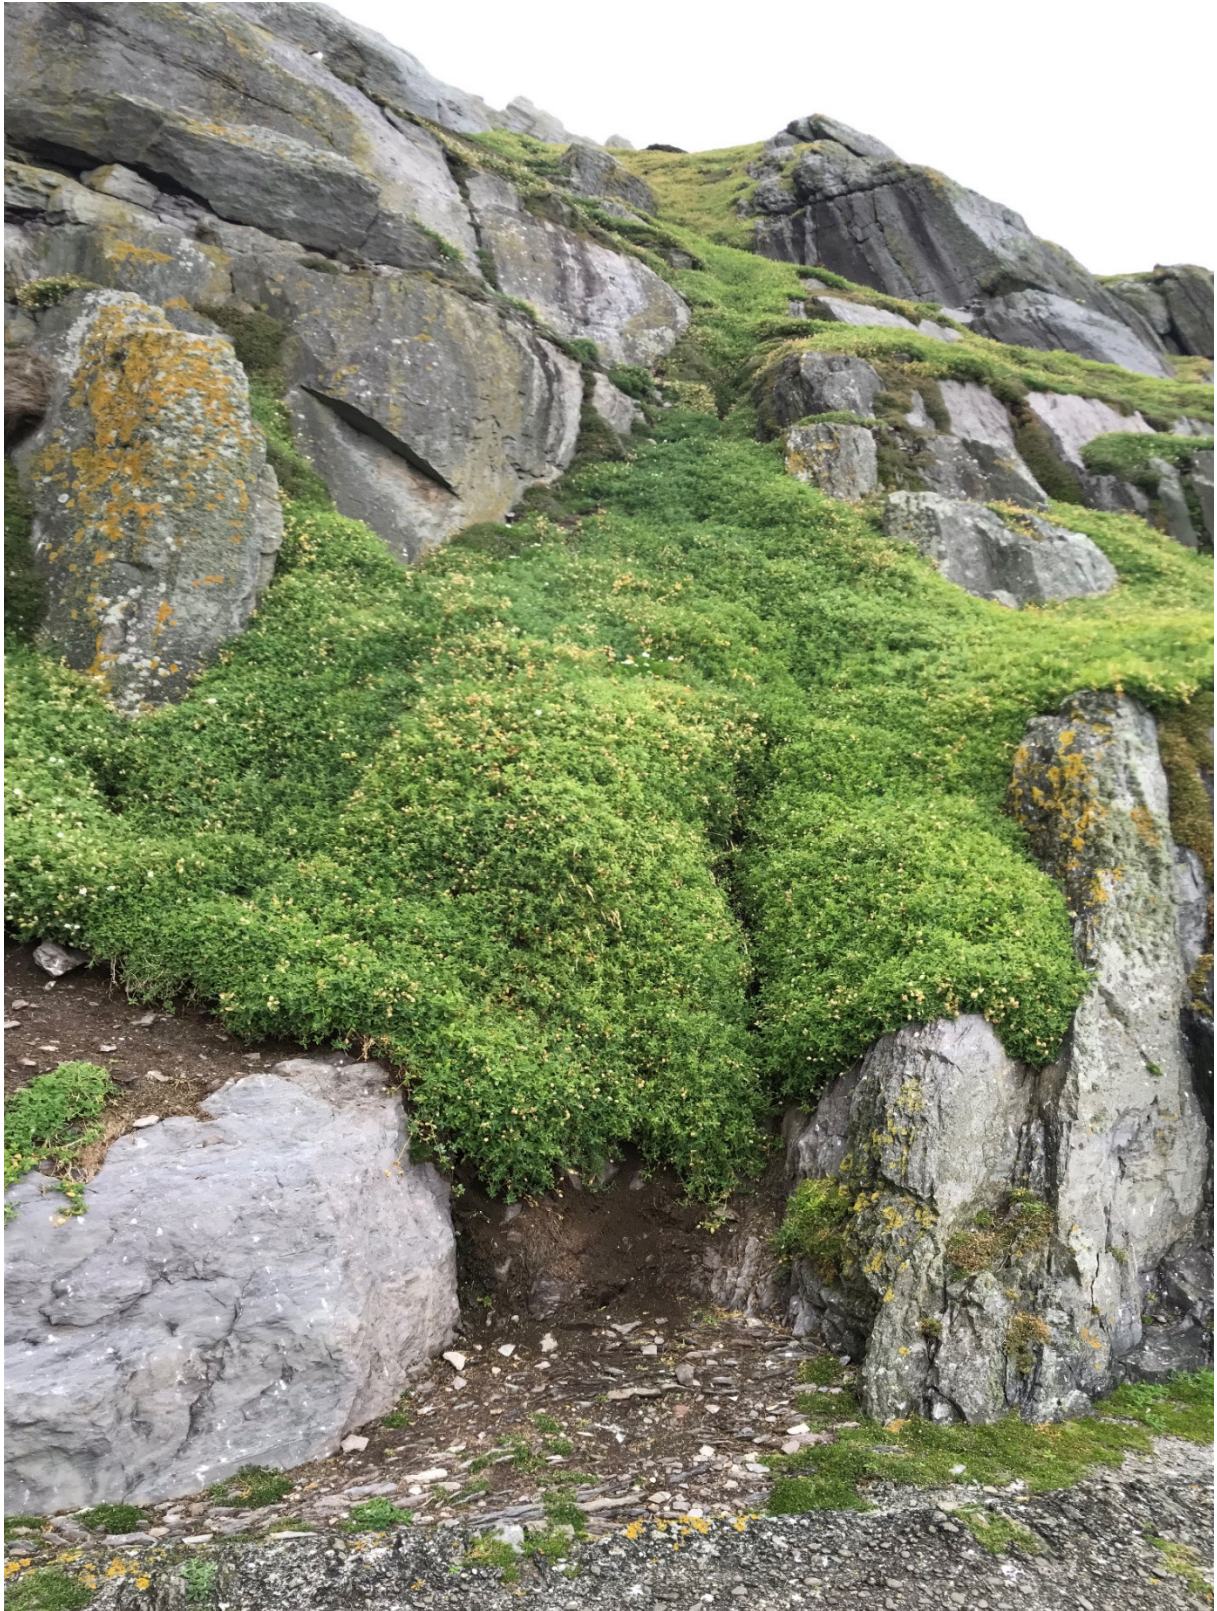
**Photograph 5. Joint Plane Zone 4 (for location see Photograph 1). This zone c. 10m from Joint Plane Zone 3.**

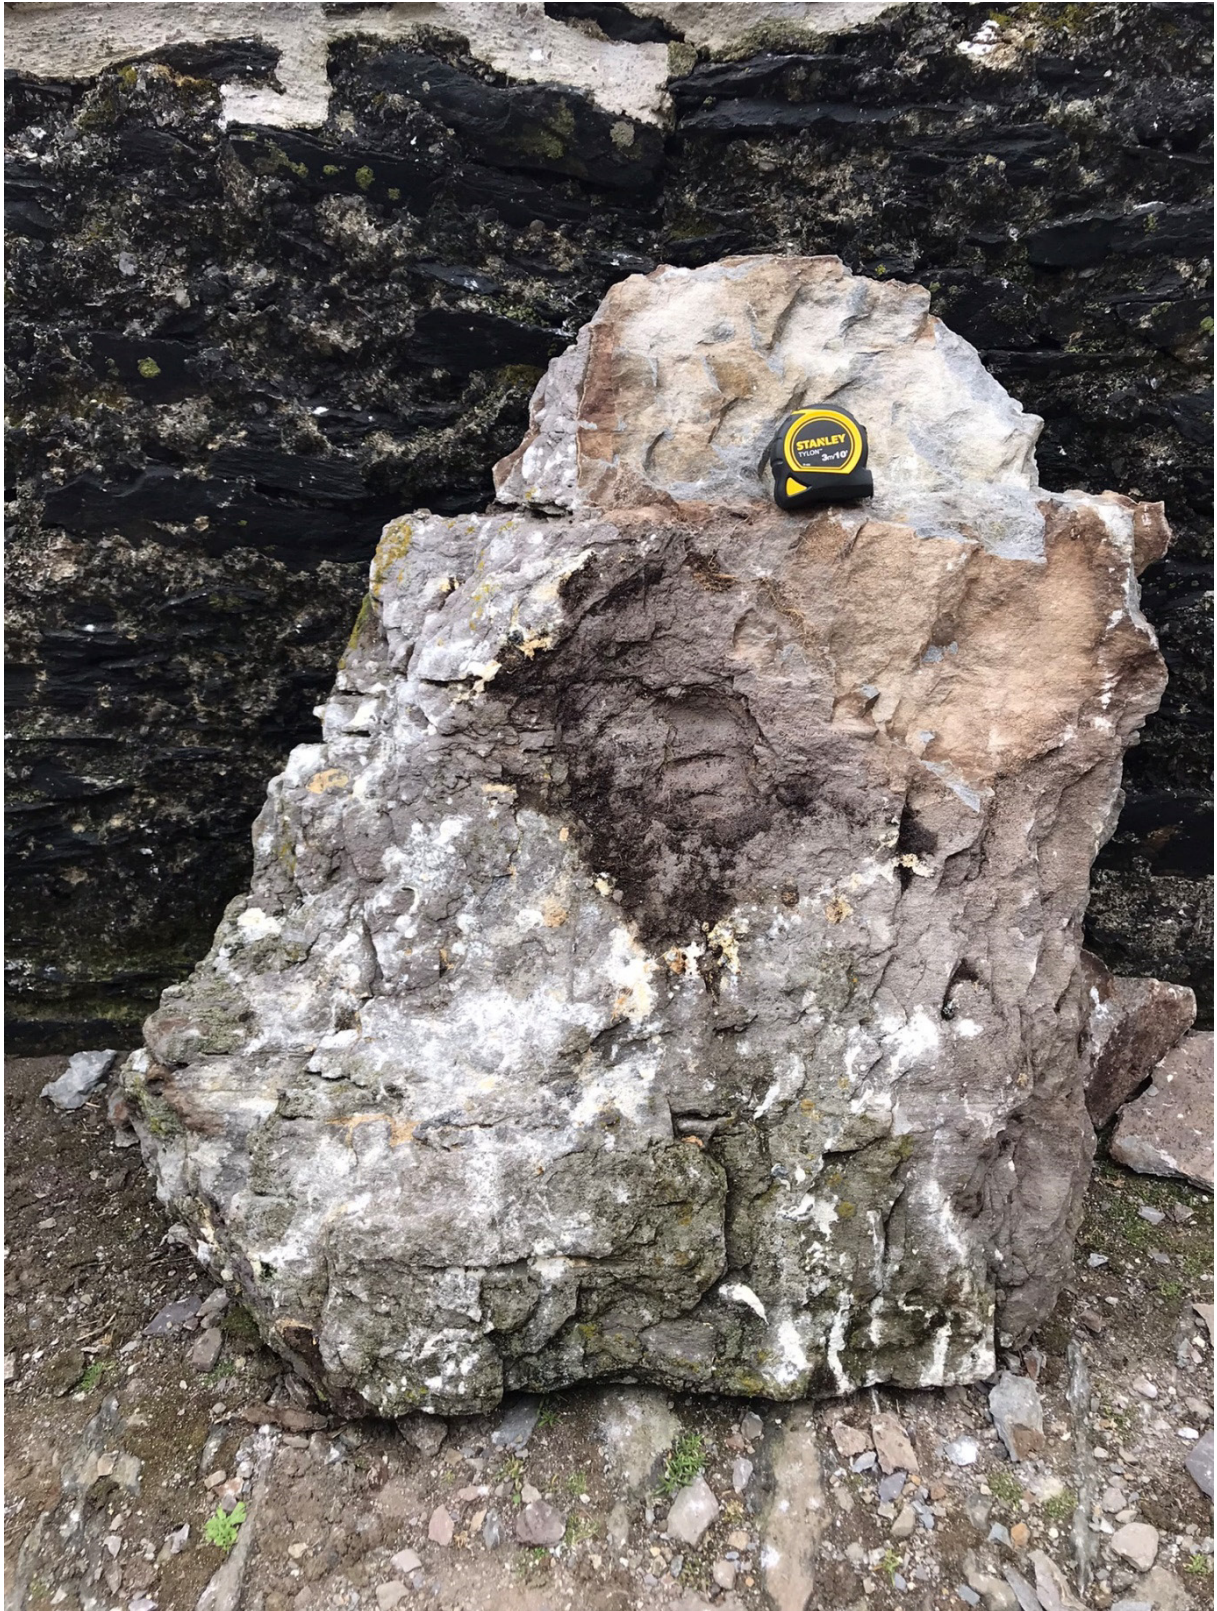
The particular rockfall of Monday, 13<sup>th</sup> June at this site largely comprised a single rock 0.5m x 0.5m x 0.2m of interbedded sandy siltstone. The rock displayed conspicuous weathering on both its principal faces (see Photographs 6 and 7). From observation it appears that the rock originated c. 20m above the lower lighthouse road and was dislodged by bird action (burrowing/perching).

**Photograph 6. Rockfall – Face 1.**

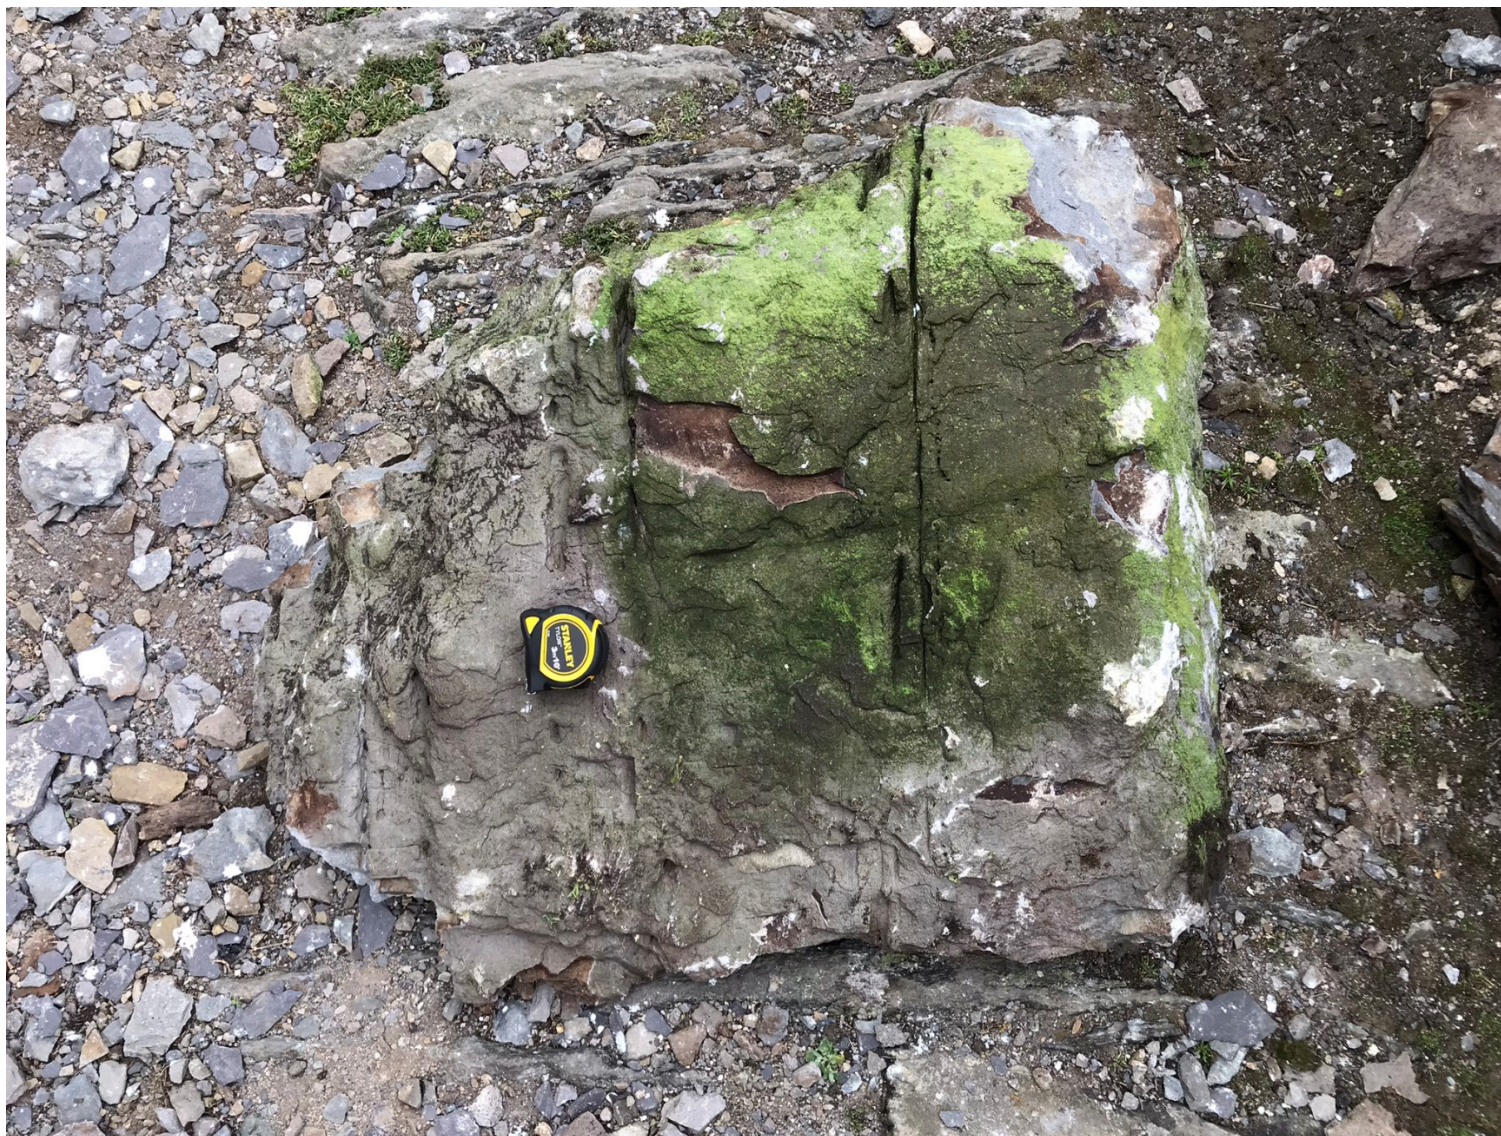
**Photograph 7. Rockfall – Face 2.**
