# SKELLIG MICHAEL ECOLOGICAL CLERK OF WORKS REPORT

Sweep of Rockfall Area  
Prepared on behalf of the Office of Public Works  
by  
Maurice O'Connor BSc (Hons), MSc.  
Senior Environmental Project Manager

JULY 4, 2022  
ENVIRICO LTD  
5A Courthouse Lane, Tralee, Co. Kerry

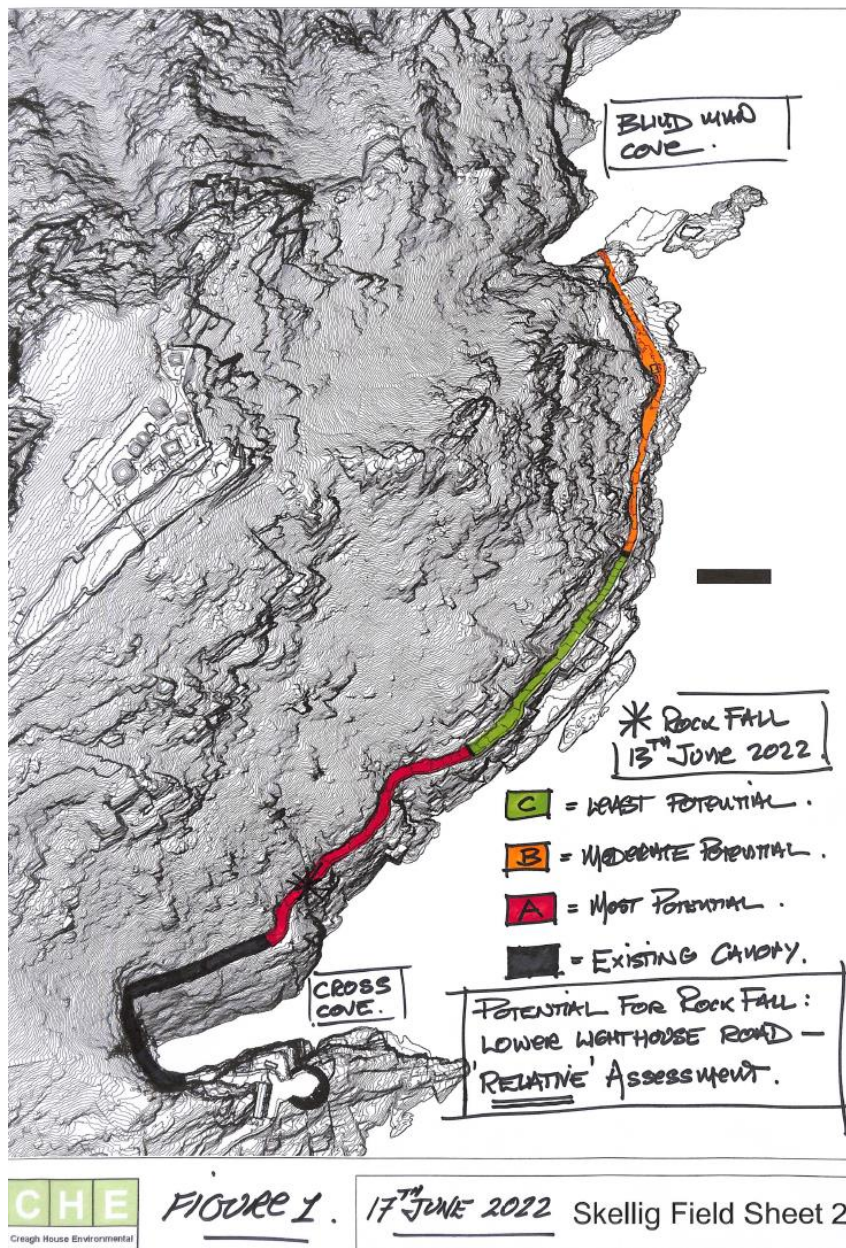
Figure 1 Potential for Rockfall: Lower Lighthouse Road – “Relative” Assessment (O’Sullivan, M. 2022)

Following a Geological Reconnaissance Report (O’Sullivan 2022) “with regard to the potential for rockfall in the narrow and very specific area between the pier at Blindman’s Cove and the rock canopy at Cross Cove, the reconnaissance inspection allowed for the identification of most, moderate and least rockfall potential zones (see Figure 1), viz:

- Most Potential: Joint plane exposed zone with associated scree slopes.
- Moderate Potential: Narrow Road zone adjacent to the landing at Blindman’s Cove with cleavage rock faces above.

- Least Potential: Nineteenth century rock blasted zone between Zones A and B”.

Following on from this report the areas highlighted in Figure 1 were swept, (the inspection and removal of debris over an area), along with an area where a rockfall had previously occurred north of the lower lighthouse but limited to a vertical slope of compacted soil type.

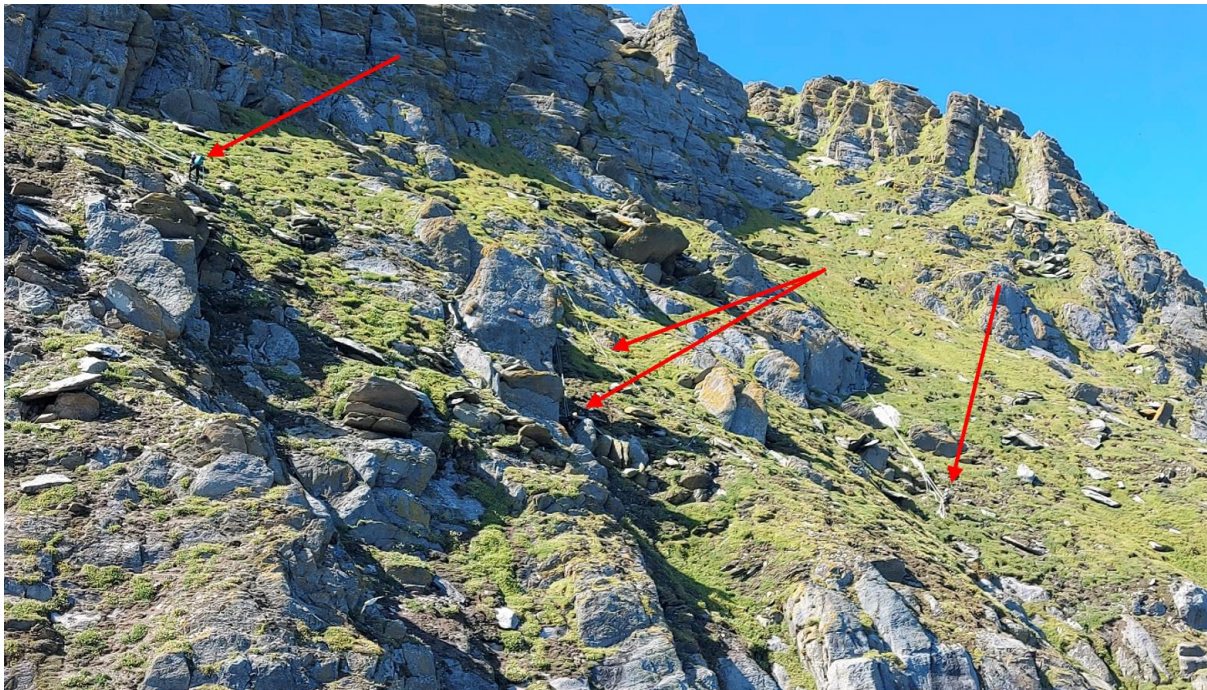
*Image 3 Sweeping above Cross Cove as viewed from Heliport (climbers and rope highlighted by red arrows)*

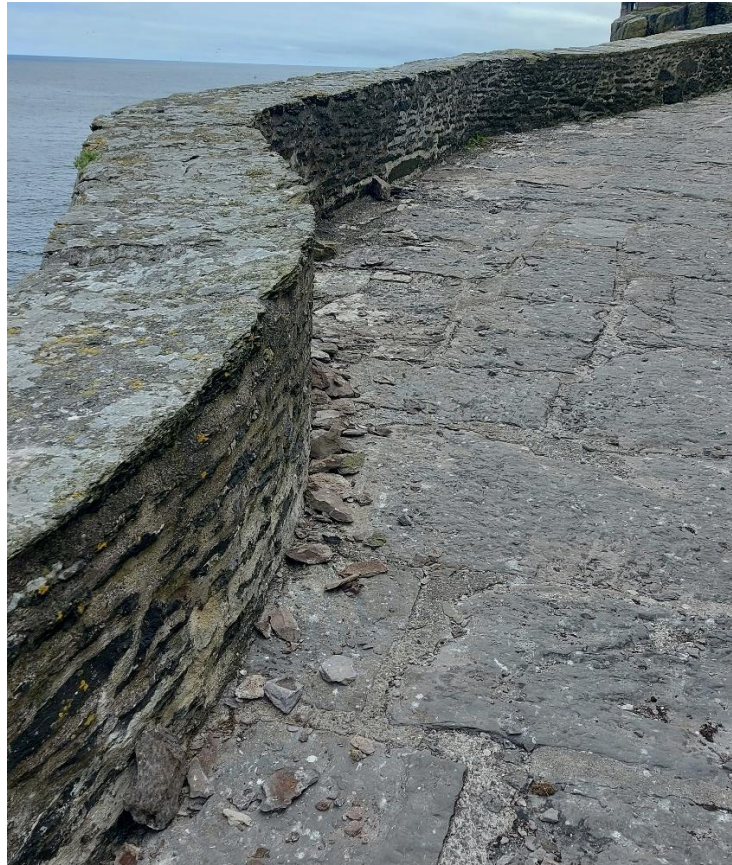
Two small stones "bounced" from the pathway and fell over the cliff face without impacting the bird colonies on the cliff face. ECoW informed the sweepers regarding the fall and adjustments were made to prevent stone falling directly onto pathway. Where necessary, loose stone was "slid" from lower rocks onto the path that could not be placed in a safe location further up the slope edge.

Some smaller stone was removed and dropped to the pathway without interfering with the ground surface during descent, i.e. it dropped onto lower rocks and then onto pathway below.

*Image 4 Debris on pathway below area 01 some from rockfall and some from sweep*

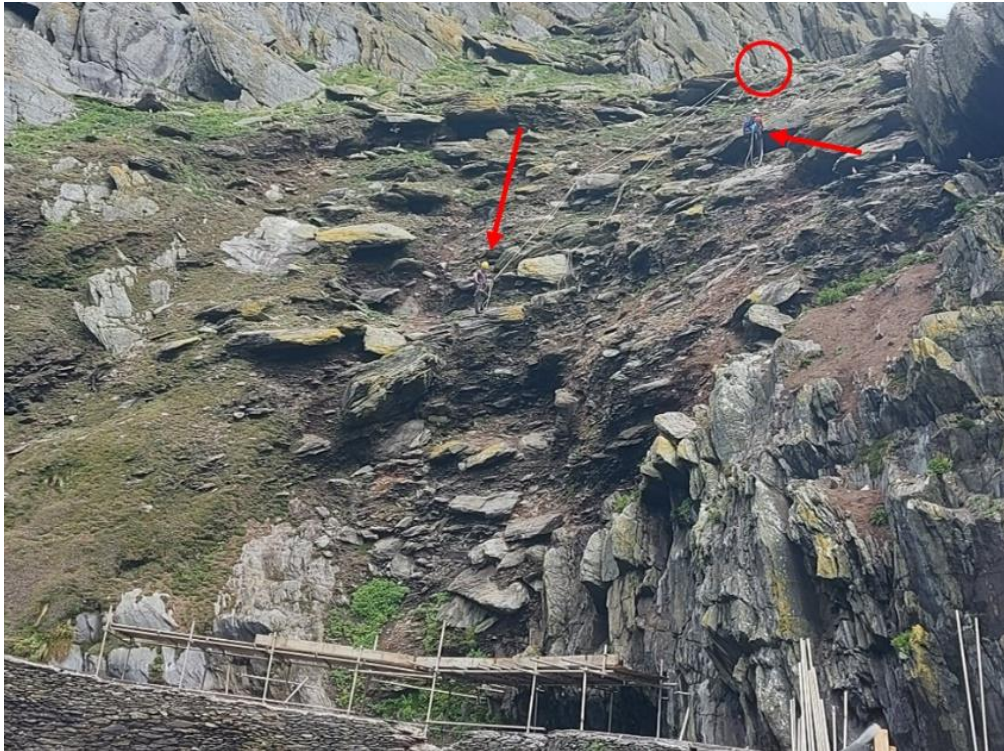
**12.00:** Installation of ropes observed by ECoW from overhead and then ECoW returned to lower lighthouse road to observe sweep through binoculars. At approx. 12.30 two sweepers (Brendan and Sean) descending at vertical and near vertical areas as agreed prior to drop, greener area to NW and rocky outcrops to the east are avoided due to nesting birds, third rope person on safety (Arthur). (See photo 5) Vertical slopes is principally compact soil and rock. Principally Puffin, herring gull and some Black Backed Gulls in the area but at verges and appear more curious than disturbed. Works did not approach greener areas or rock ledges to the east. The total sweep time was approximately 35 mins. Some loose rock was removed with little or no major disturbance and a small rock did strike pathway below, but noise was drowned out by bird calls and sea.

*Image 6 Two sweepers (highlighted by red arrow) at area 2 north of lower lighthouse, third sweeper circled on safety top of photo*
