Preliminary Visual Assessment of Building Stone at the Upper and Lower Lighthouses Skellig Michael

on behalf of
the Office of Public Works

September 2021

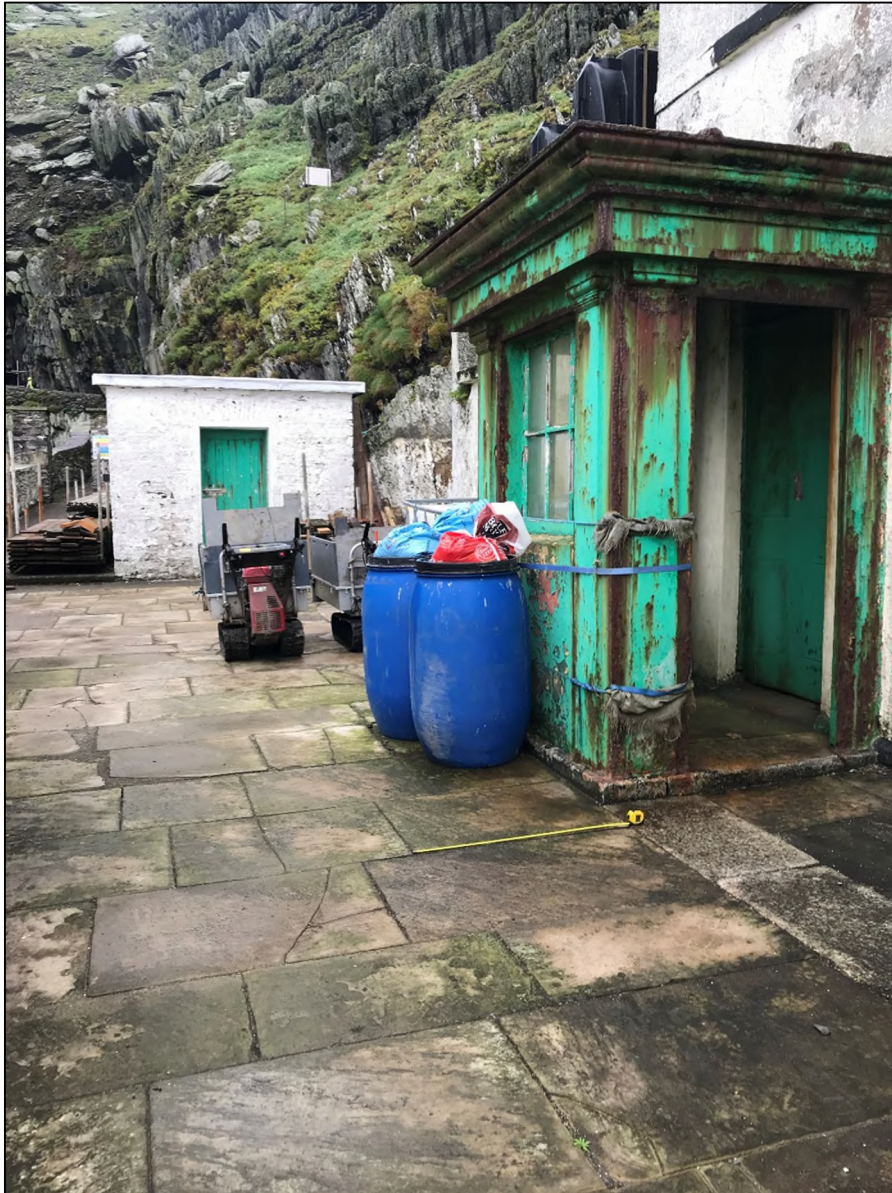
Photograph 1: Lower Lighthouse View to Northeast Showing Main Cast Iron Doorway. Note Yorkshire Flagstones (left) and Wicklow Granite Setts (right).

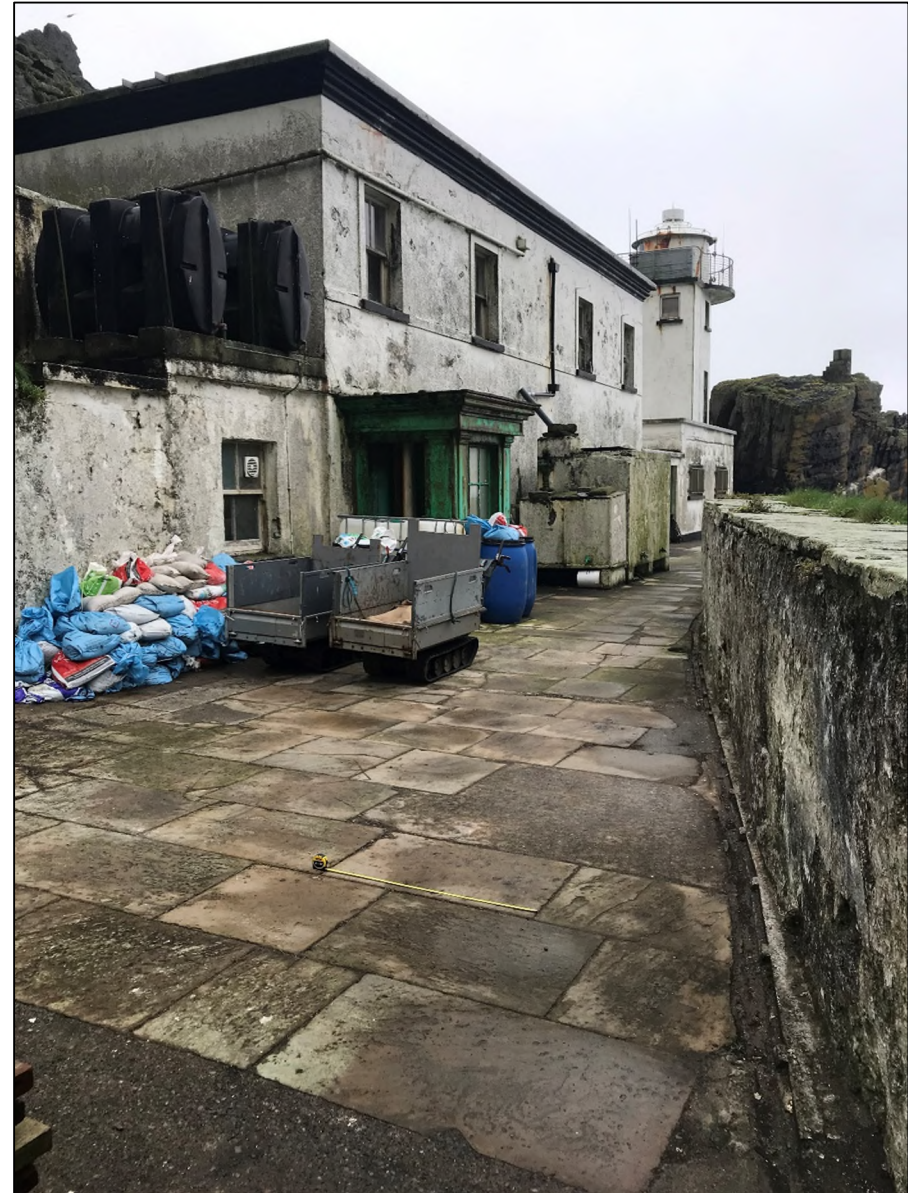
Photograph 2: Lower Lighthouse View to Southwest. Note Yorkshire Flagstones and Flagstone Caps to Safety Wall.

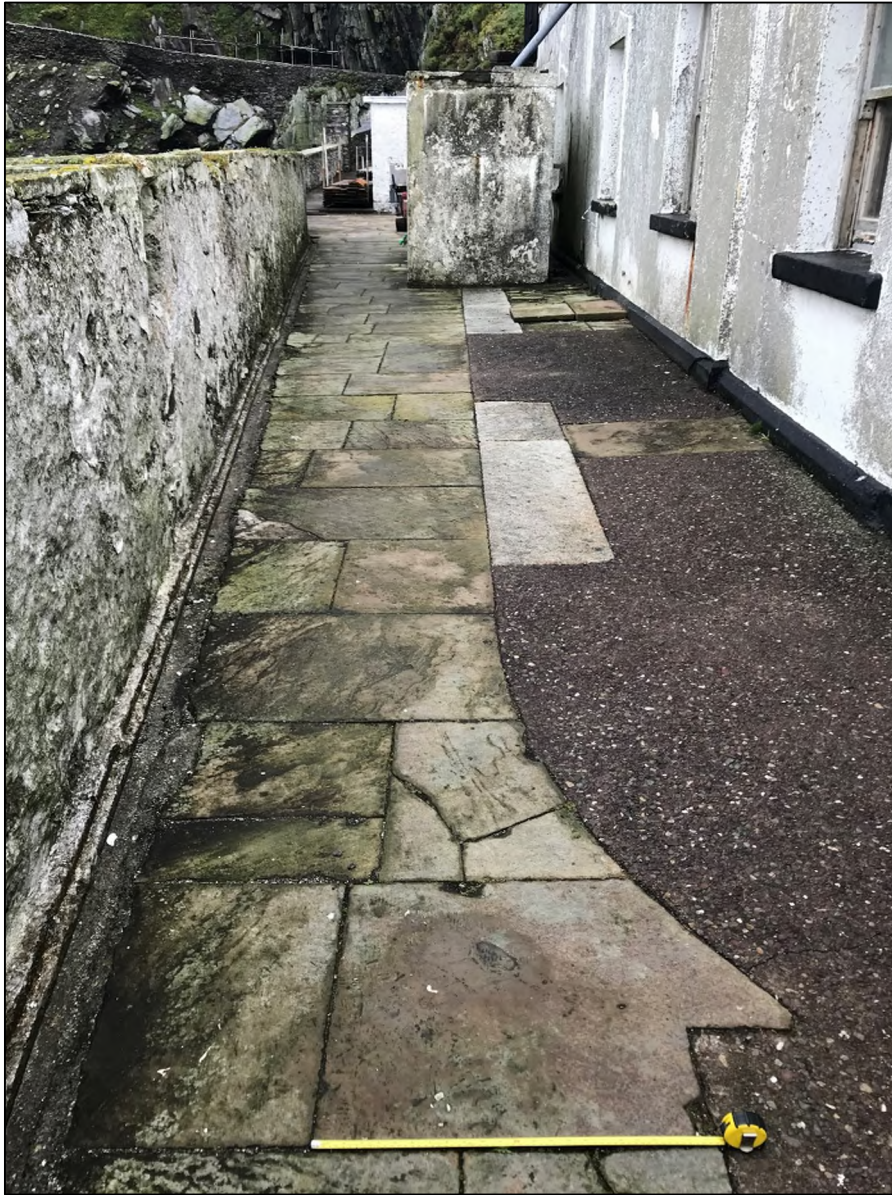
Photograph 3: Lower Lighthouse View to Northeast. Note Yorkshire Flagstones (left) and Wicklow Granite Setts (right).

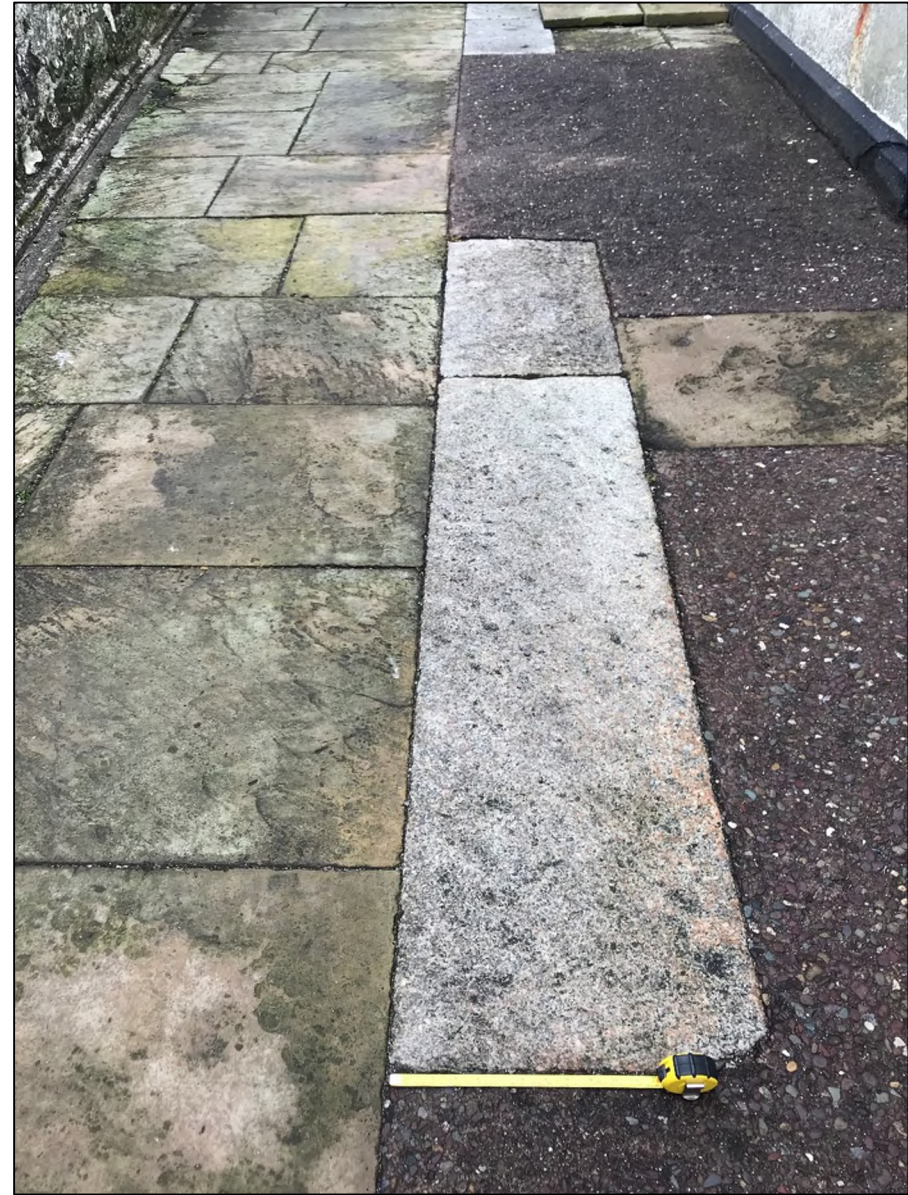
Photograph 4: Lower Lighthouse View to Northeast. Detail of Relationship Between Yorkshire Flagstone (left) and Wicklow Granite Setts (right).

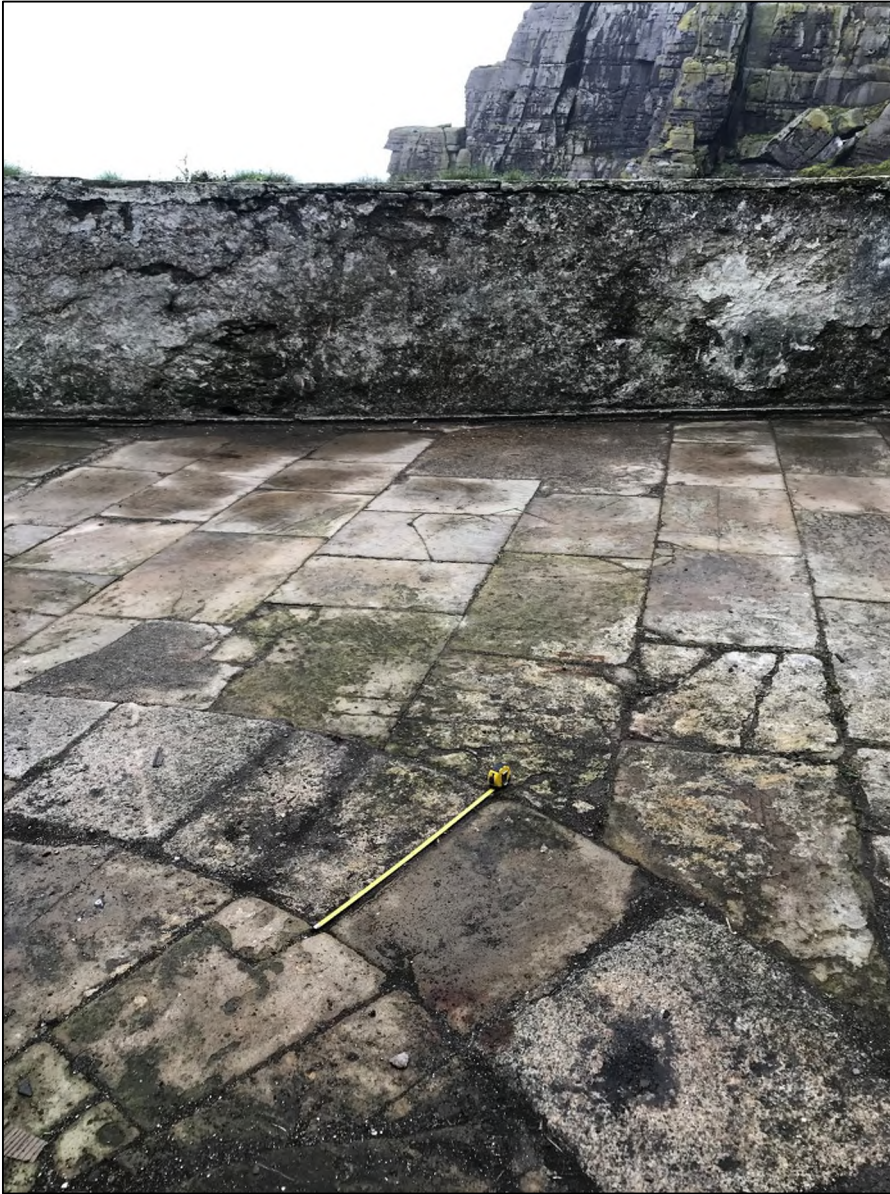
Photograph 5: Lower Lighthouse View to Northwest. Yorkshire Flagstones and Wicklow Granite Setts (curved with tape).

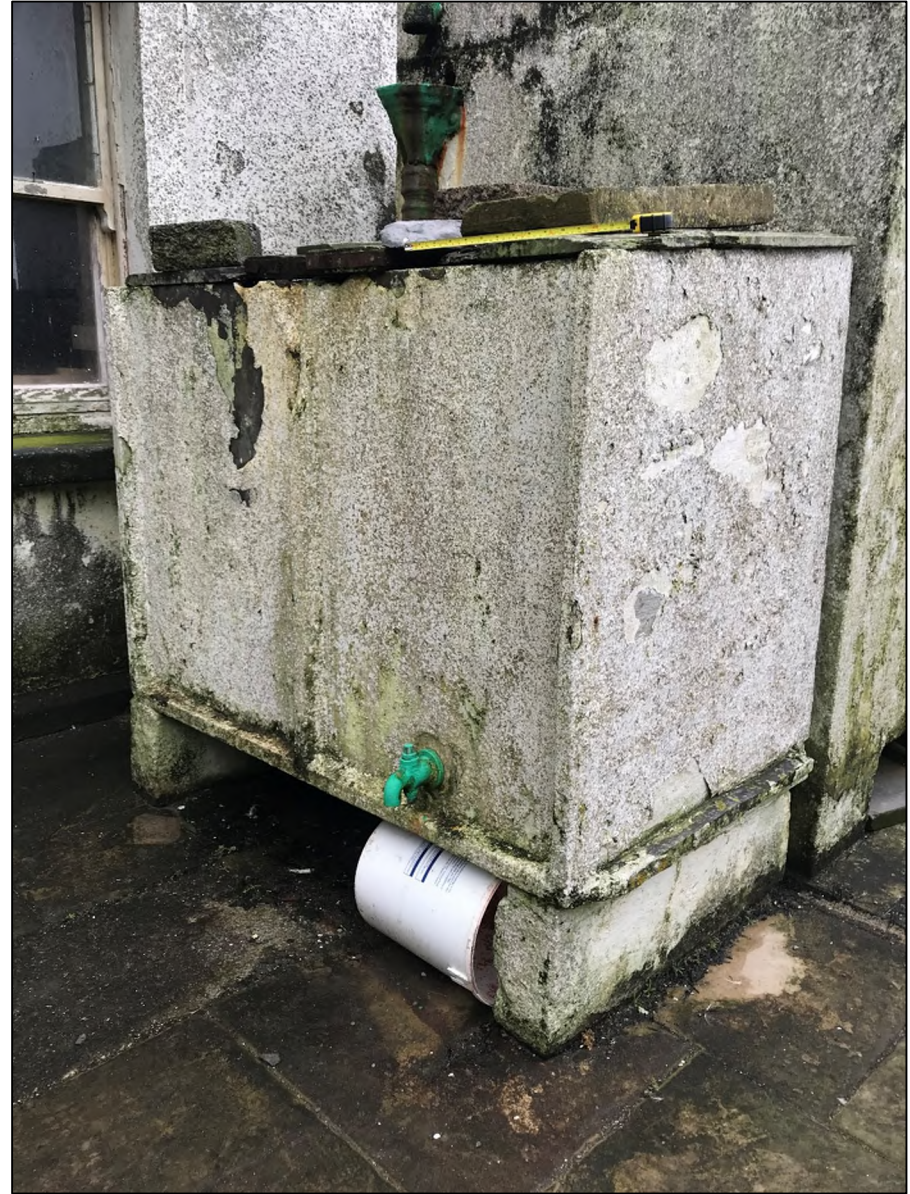
Photograph 6: Lower Lighthouse. Water Cistern Constructed From Valentia Slate.

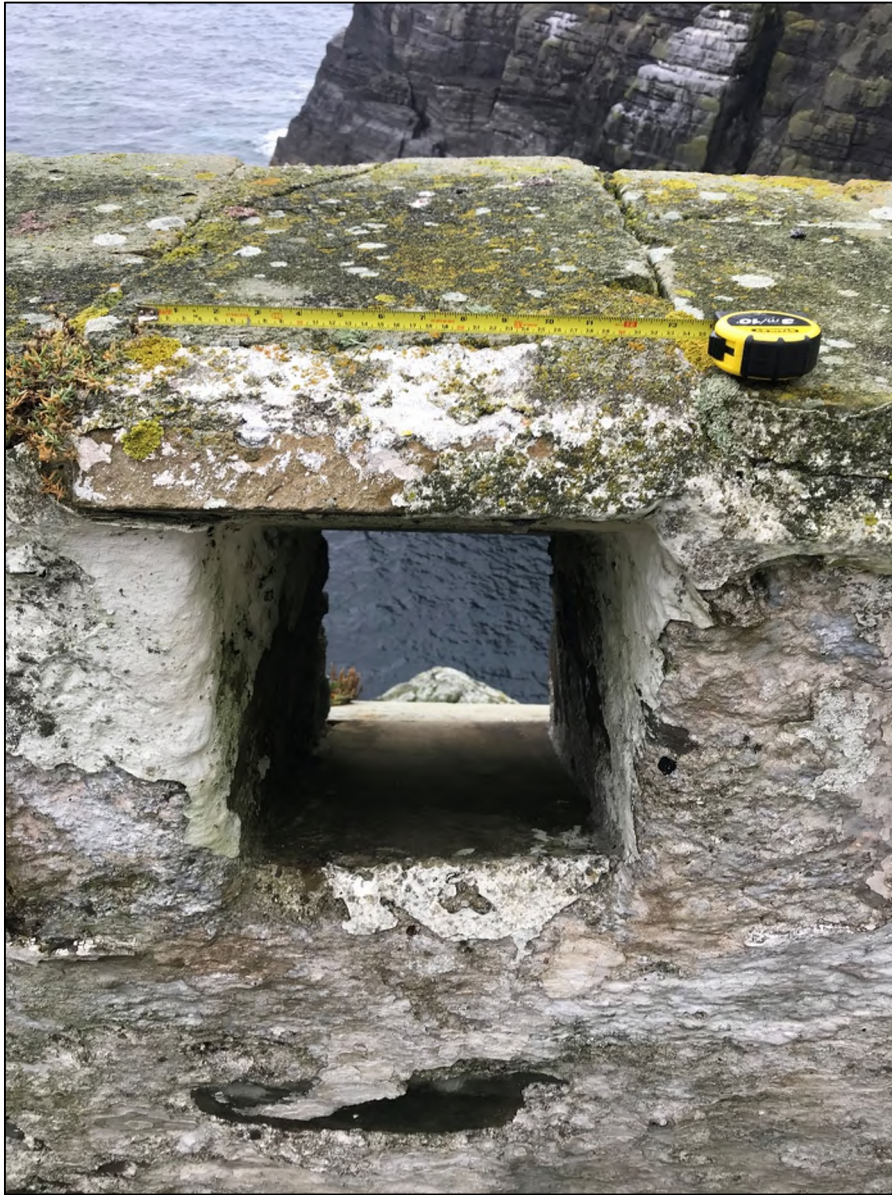
Photograph 7: Lower Lighthouse. Waste Chute to Seaward With Thick Yorkshire Flagstone Cap.

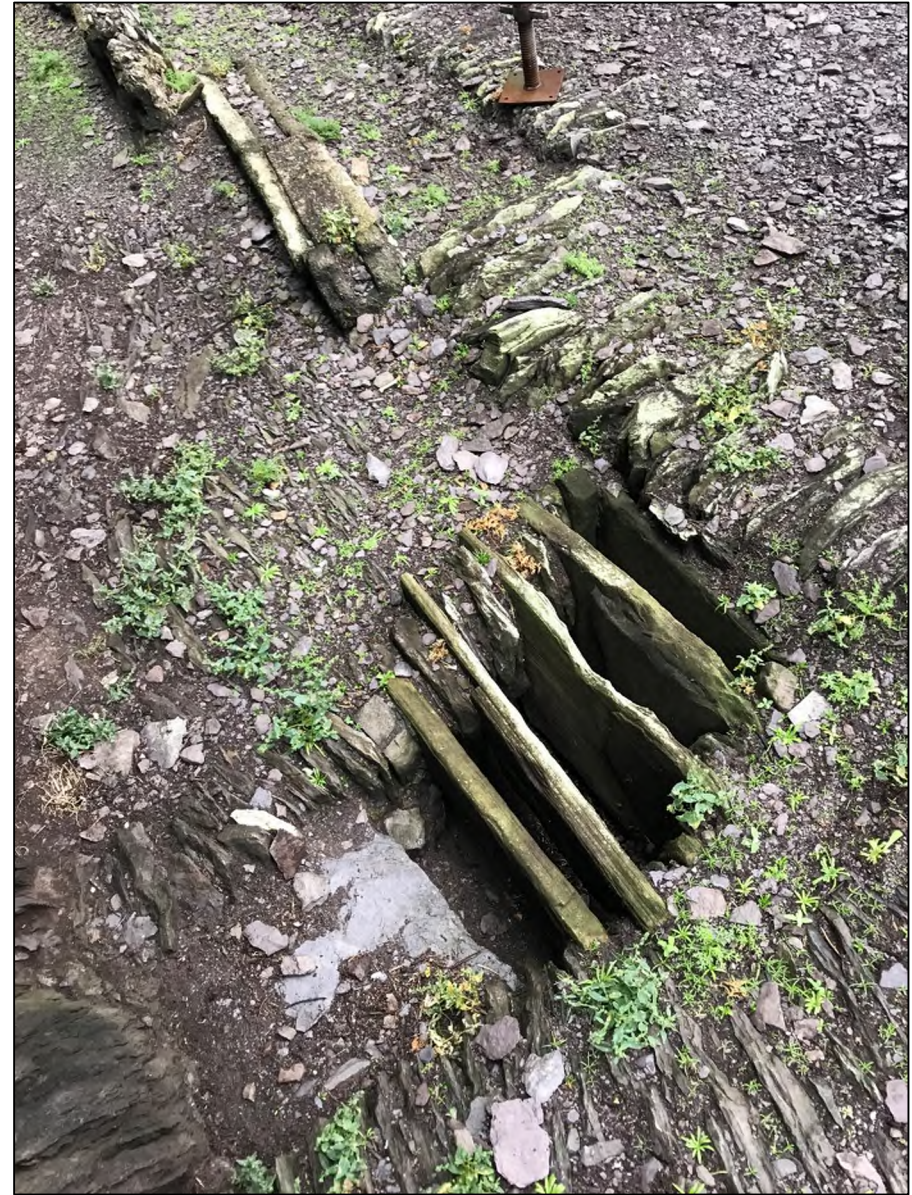
Photograph 8: Lower Lighthouse. Yorkshire Flagstone "Grill" at Surface Water Drainage Outlet.

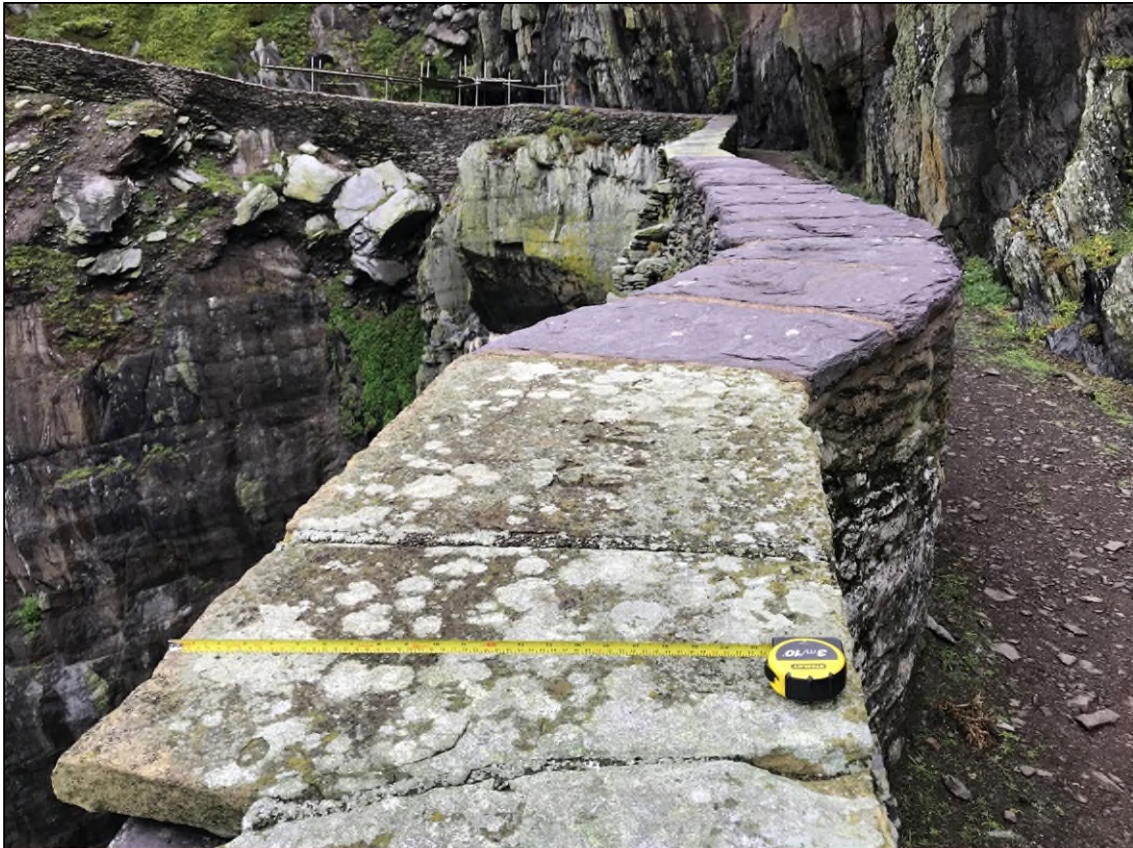
Photograph 9: Lighthouse Road Lower Section. Yorkshire Flagstone Cap in Foreground, "New" Valentia Slate Caps in Background.

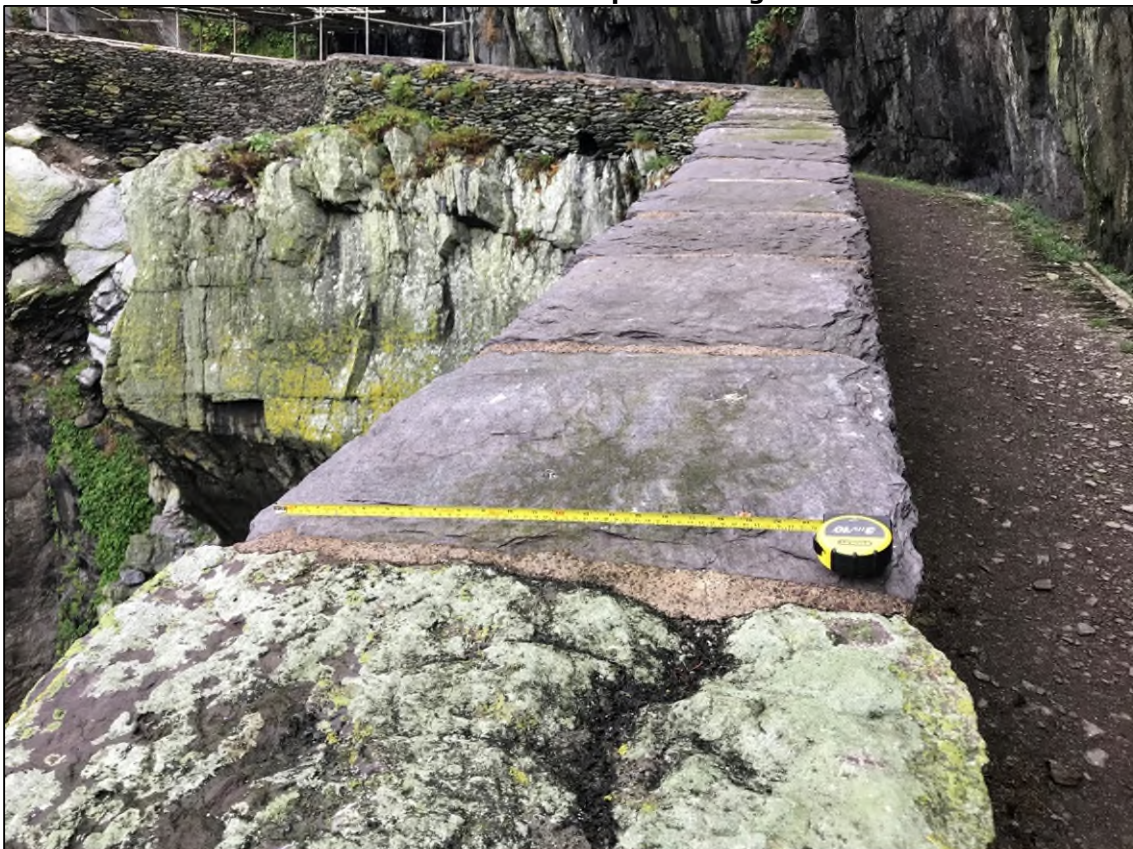
Photograph 10: Lighthouse Road Lower Section. "Old" Skellig Sandstone Cap in Foreground, "New" Valentia Slate Caps in Background.

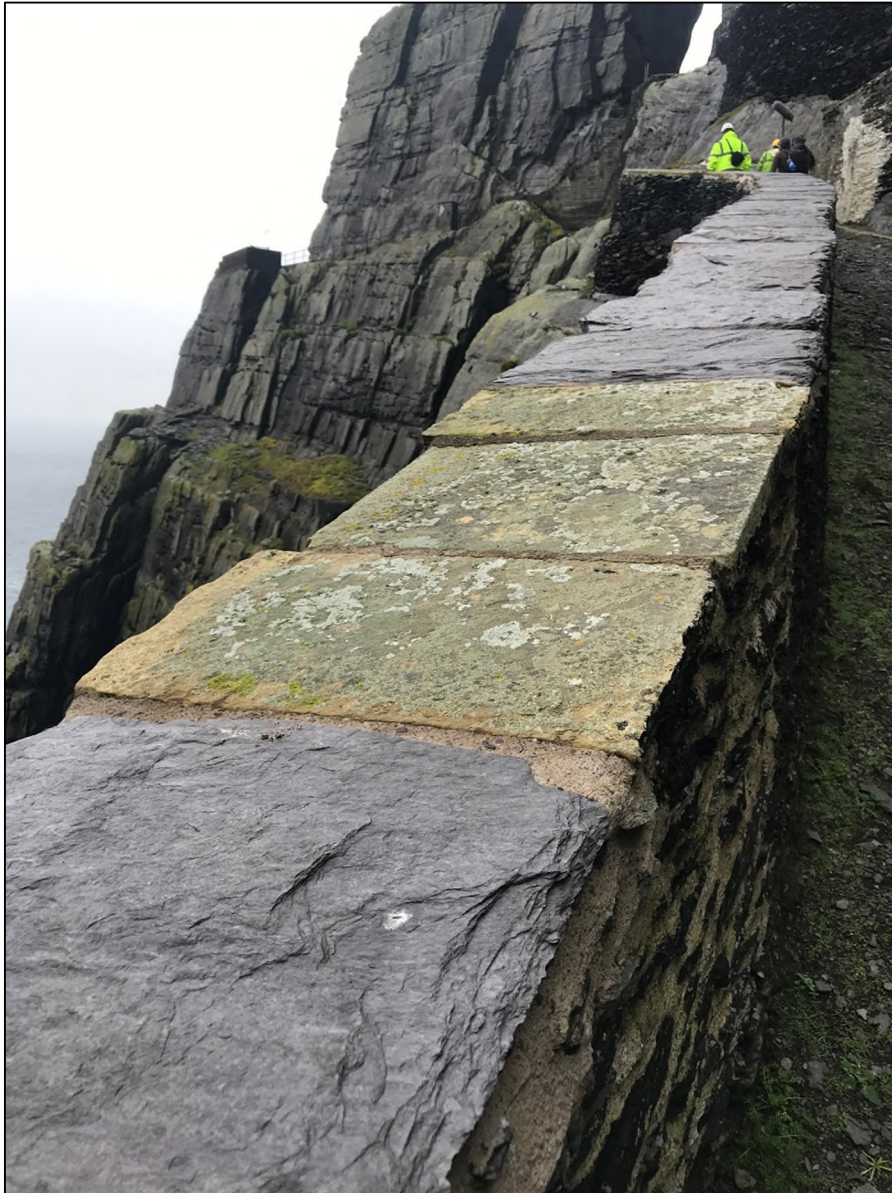
Photograph 11: Lighthouse Road Upper Section. Mix of "New" Valentia Slate and Yorkshire Flagstone Caps on Skellig Sandstone Rubble Wall.

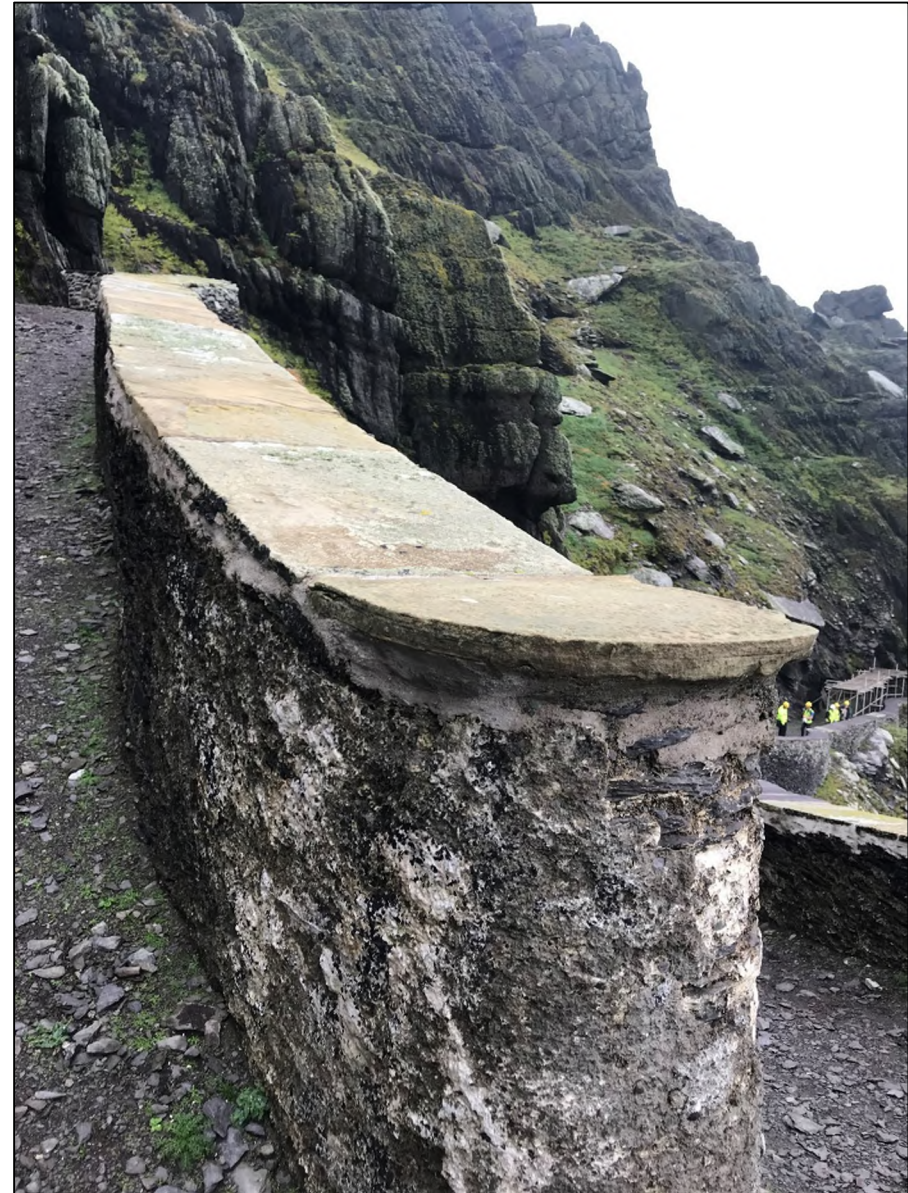
Photograph 12: Lighthouse Road Upper Section Dog-leg. Yorkshire Flagstone Caps on Skellig Sandstone Rubble Wall.

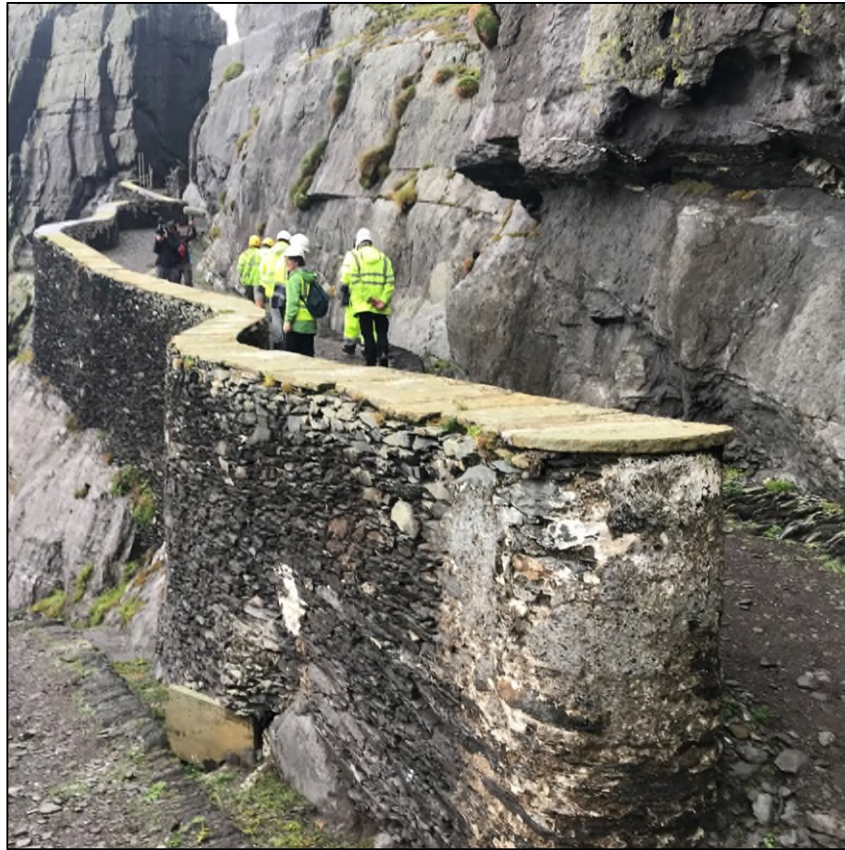
Photograph 13: Lighthouse Road Upper Section Dog-leg. Yorkshire Flagstone Caps on Skellig Sandstone Rubble Wall.

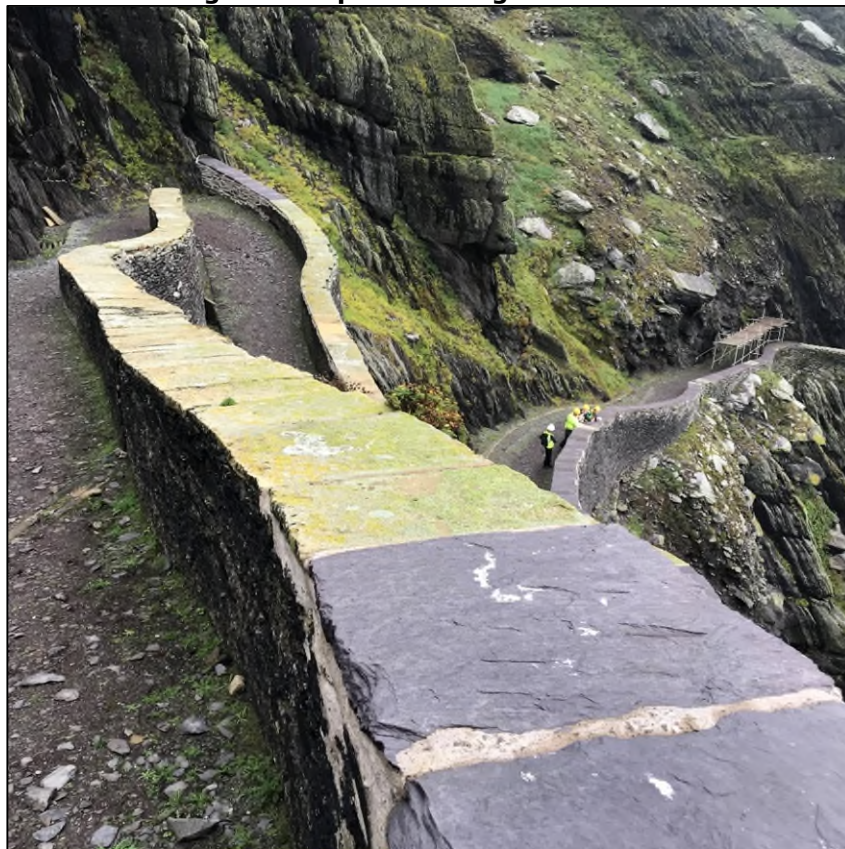
Photograph 14: Lighthouse Road Upper. Mix of Yorkshire Flagstone and "New" Valentia Slate Caps on Skellig Sandstone Rubble Wall.

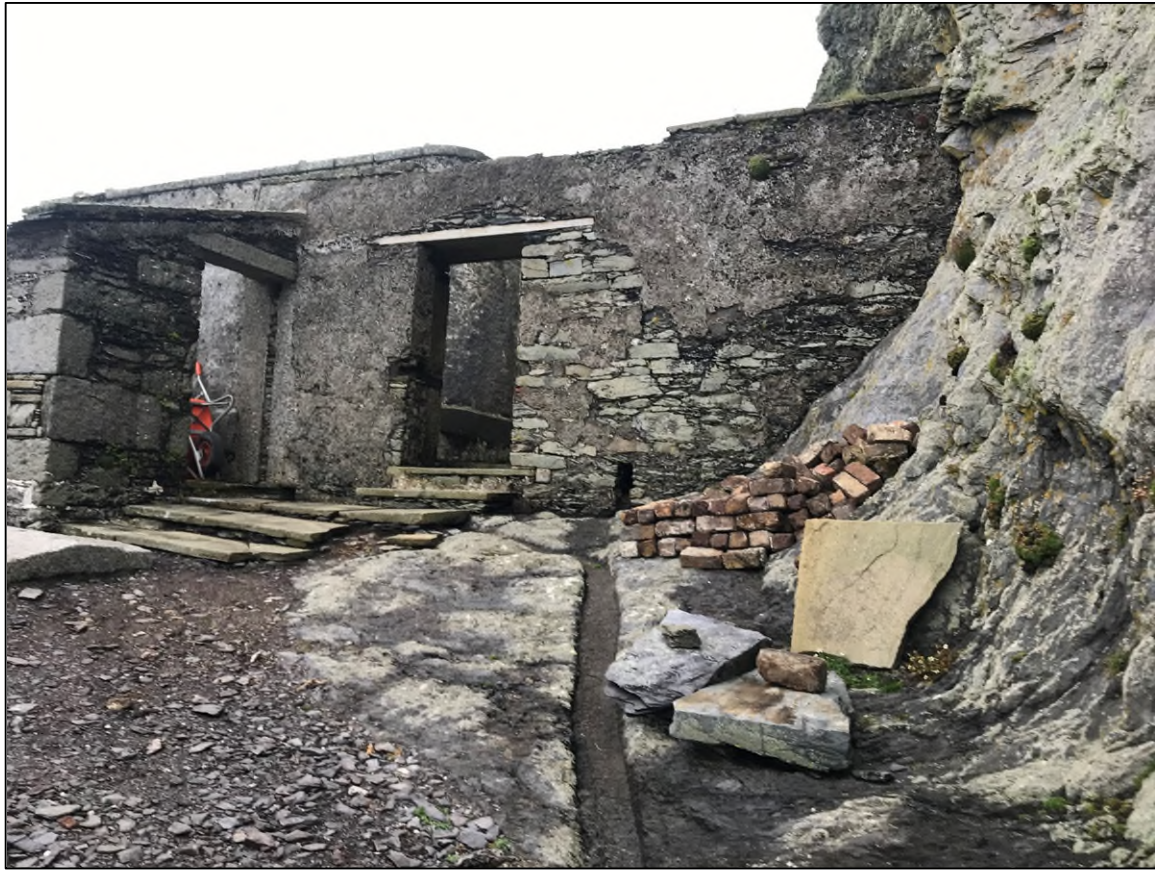
Photograph 15: Upper Lighthouse Entrance With Bedrock Surface Water Drainage Channel.

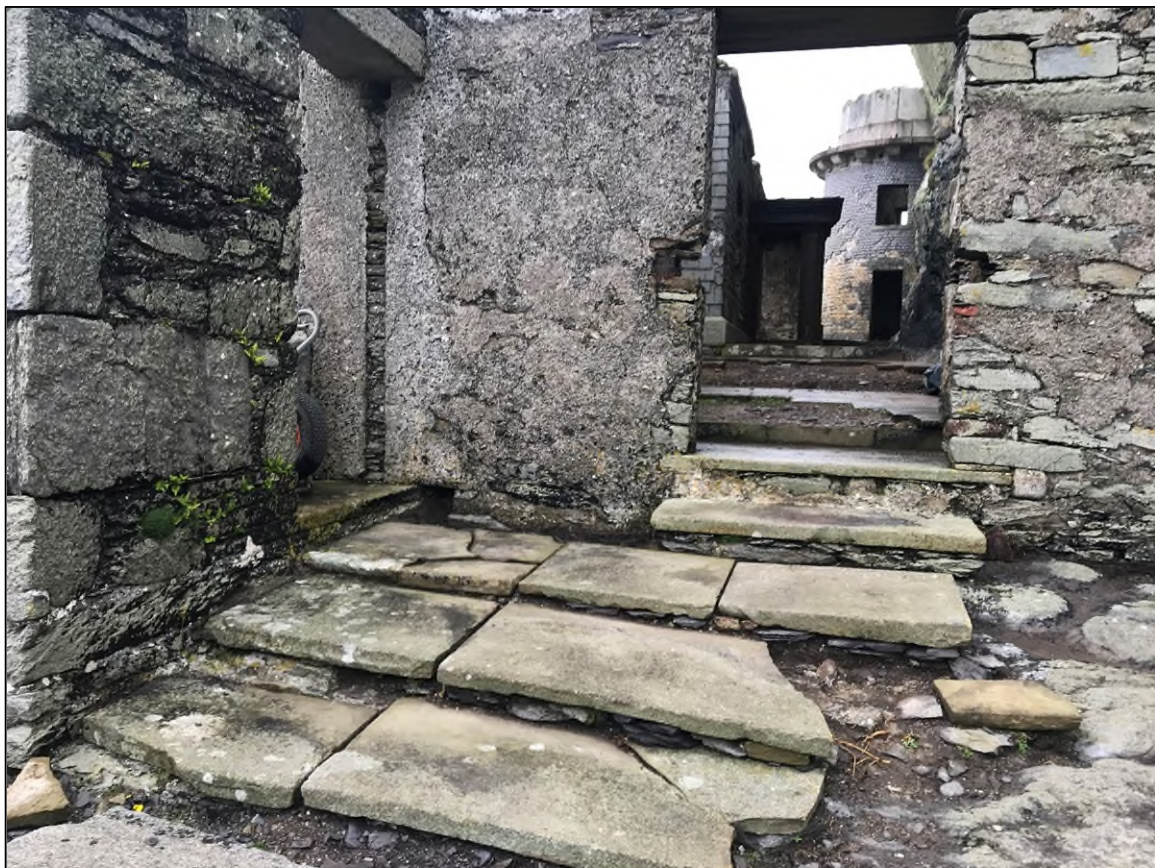
Photograph 16: Upper Lighthouse Entrance With Yorkshire Flagstone Steps.

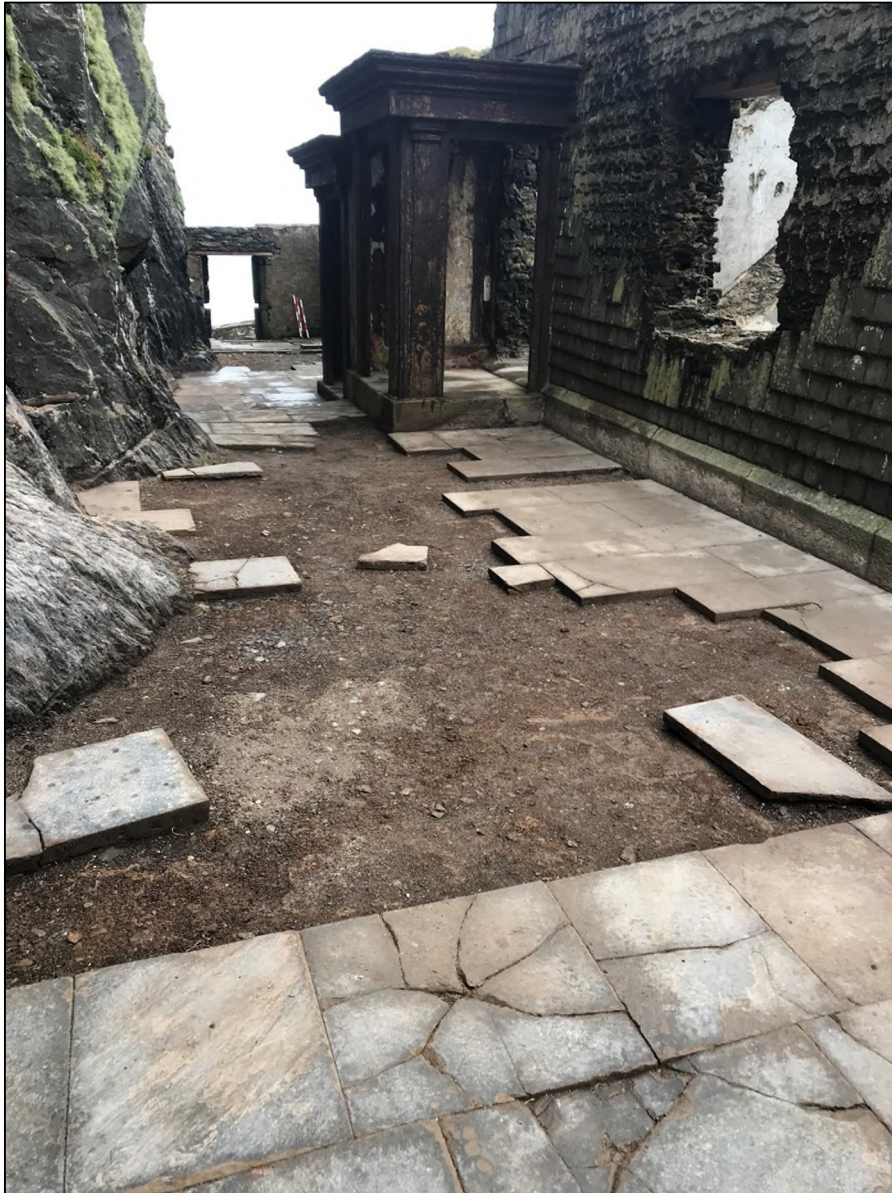
Photograph 17: Upper Lighthouse View to Southeast. Yorkshire Flagstone Setts in Front of Lighthouse Keepers' Cottages.

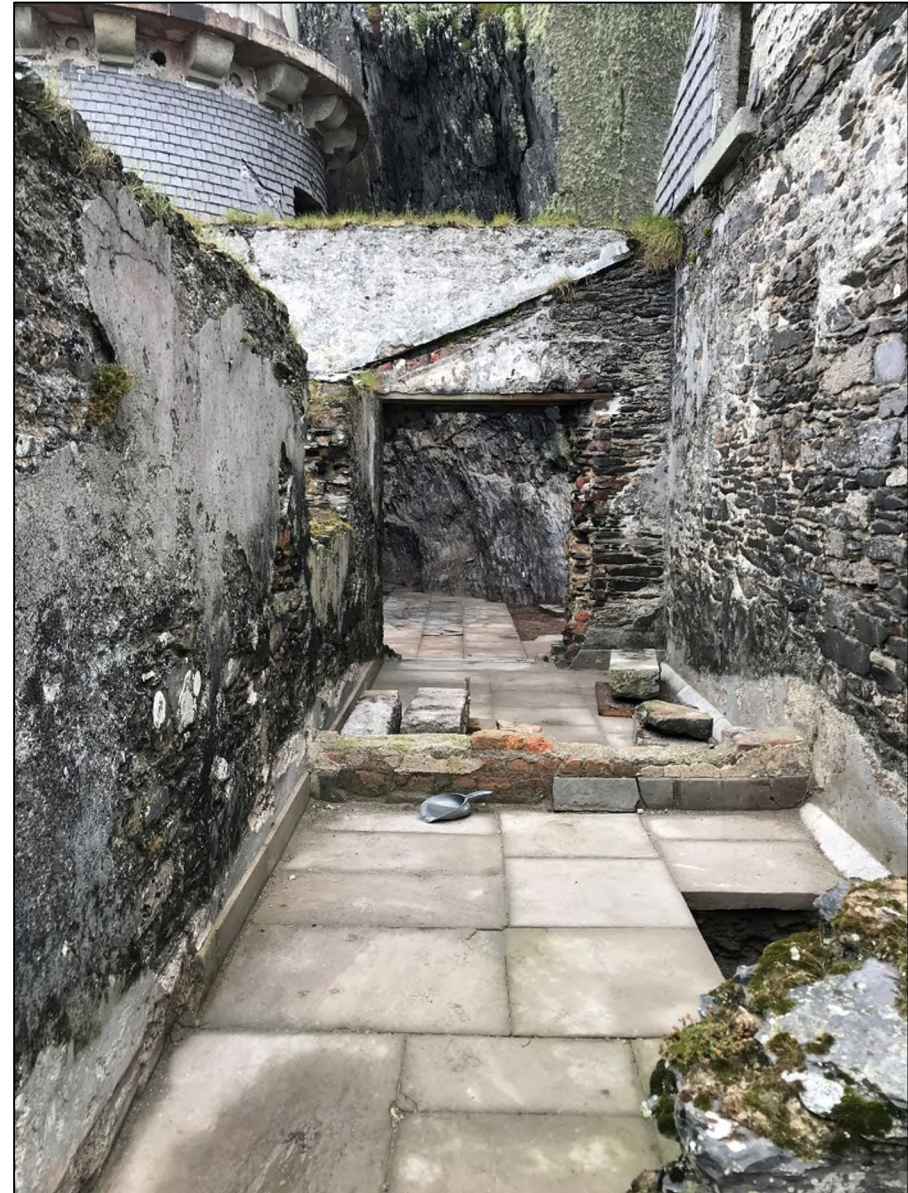
Photograph 18: Upper Lighthouse View to Northeast. Yorkshire Flagstone Setts in Extension to Lighthouse Keepers' Cottages.

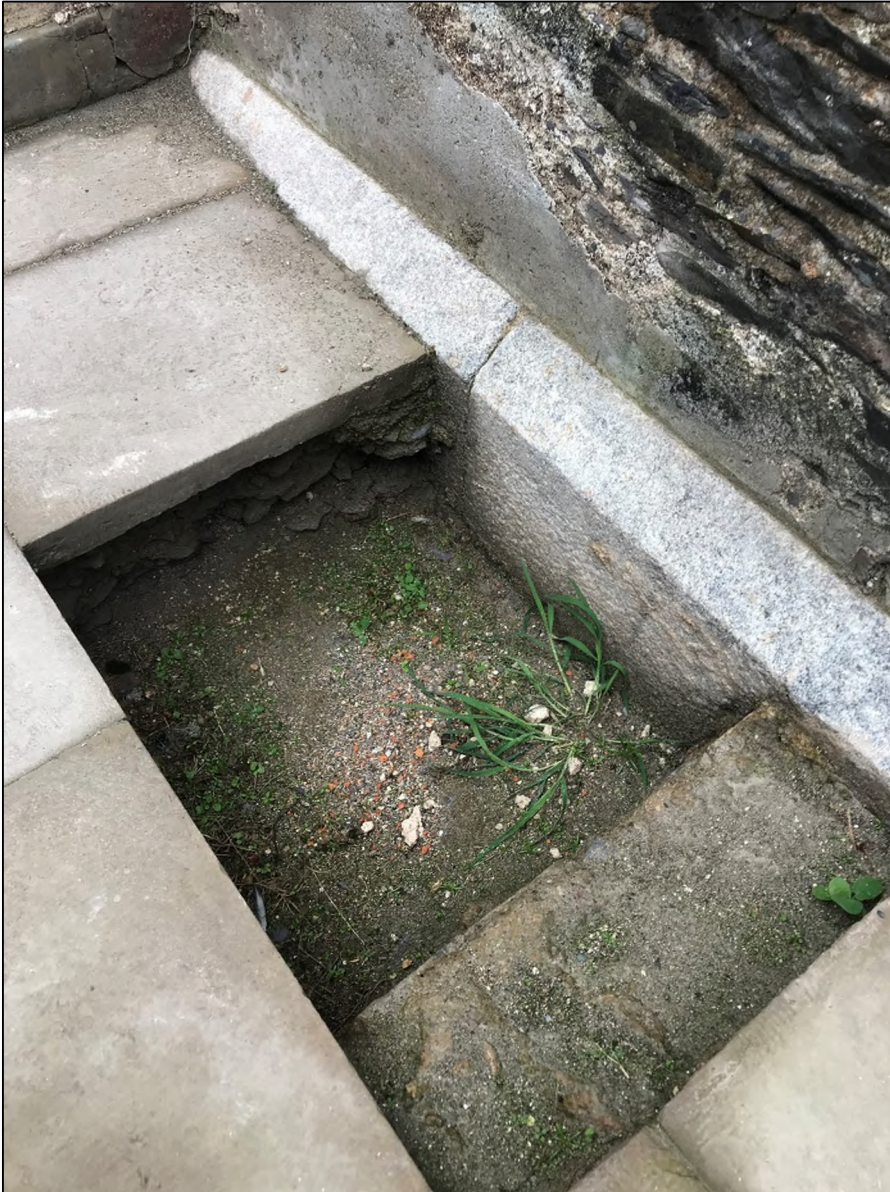
Photograph 19: Detail of Wicklow Granite Base Plinth to Lighthouse Keepers' Cottages.

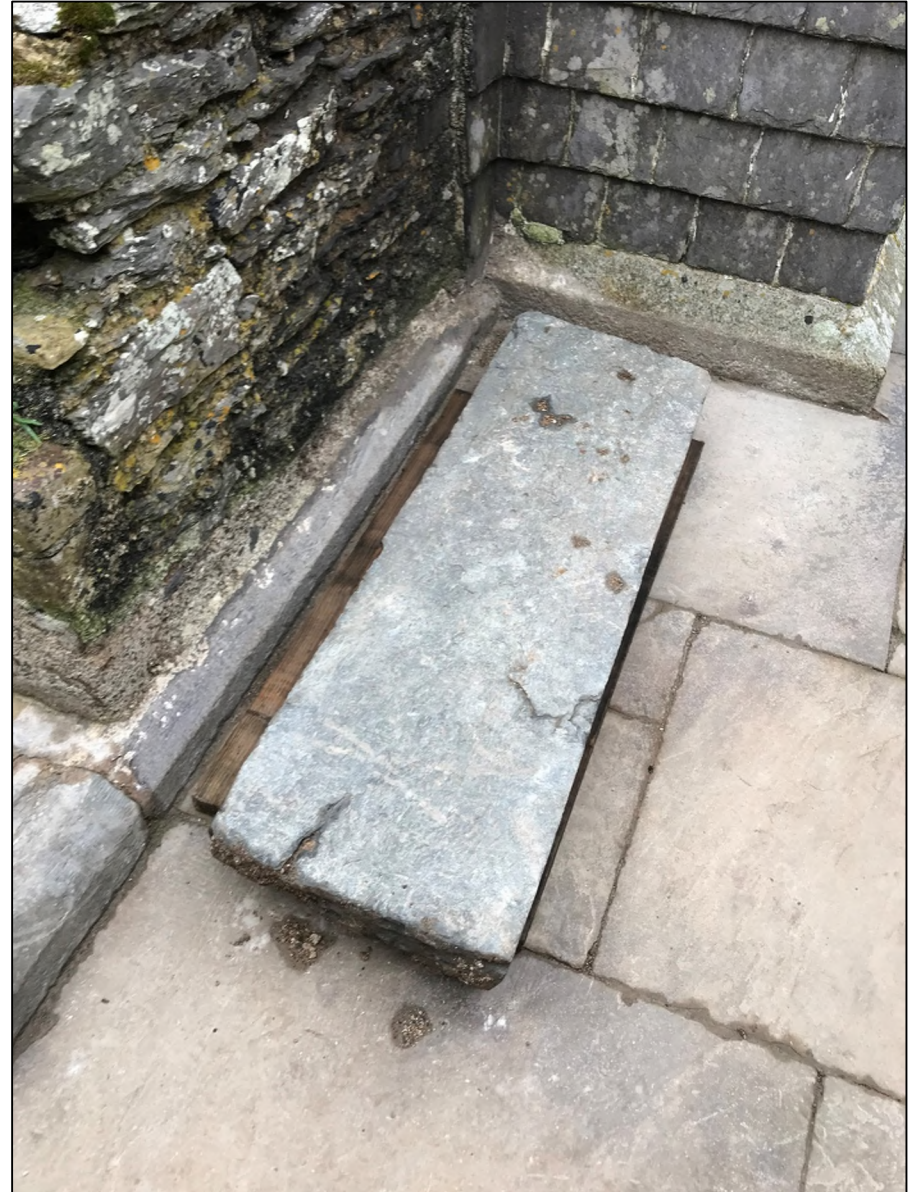
Photograph 20: Detail of Valentia Slate Base Plinth to Lighthouse Keepers' Cottages. Note Valentia Slate Plug.

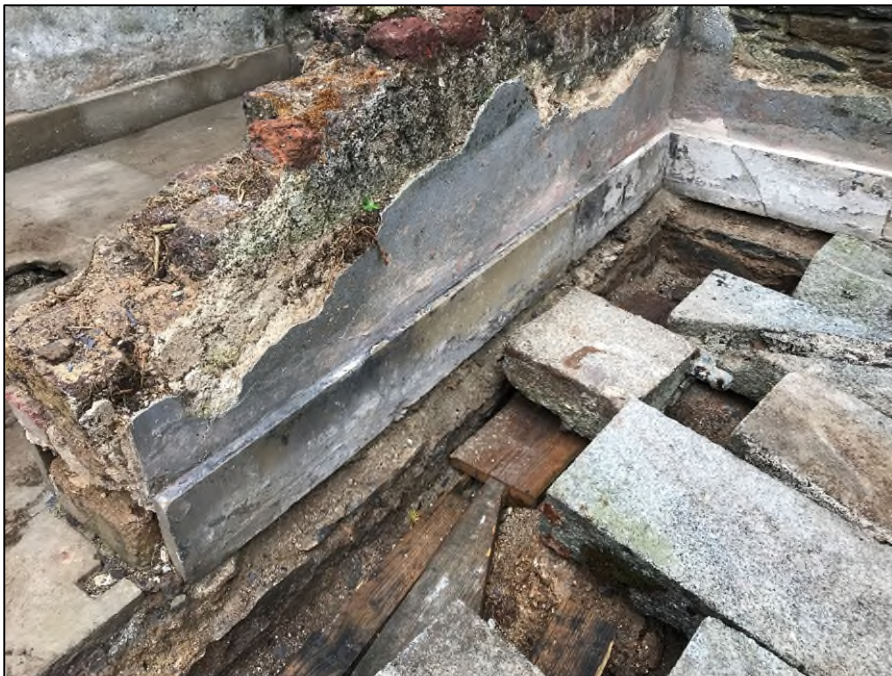
Photograph 21: Yorkshire Flagstone "Skirting Board" in Lighthouse Keepers' Cottages.

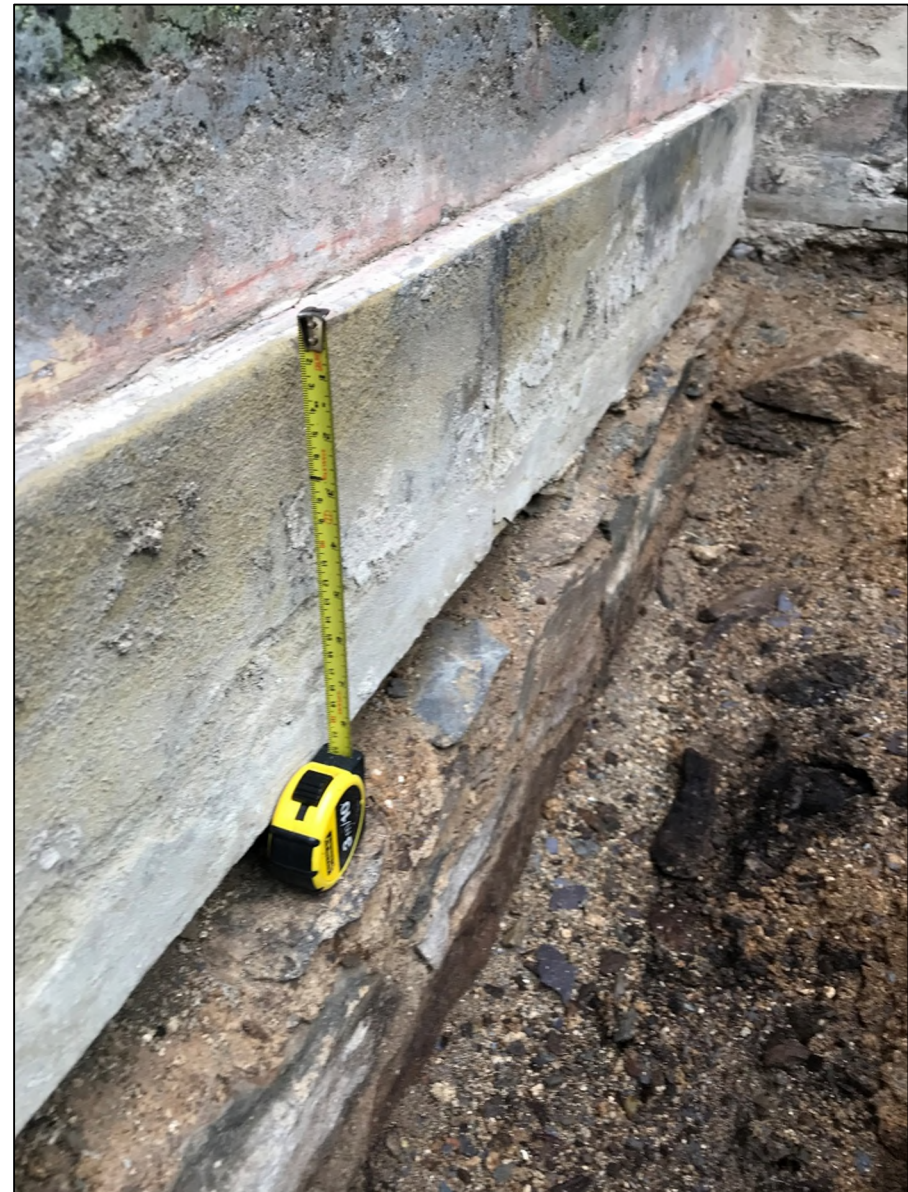
Photograph 22: Detail of Yorkshire Flagstone "Skirting Board" in Lighthouse Keepers' Cottages.
