Preliminary Visual Assessment of Building Stone at the Upper and Lower Lighthouses Skellig Michael

on behalf of
the Office of Public Works

September 2021

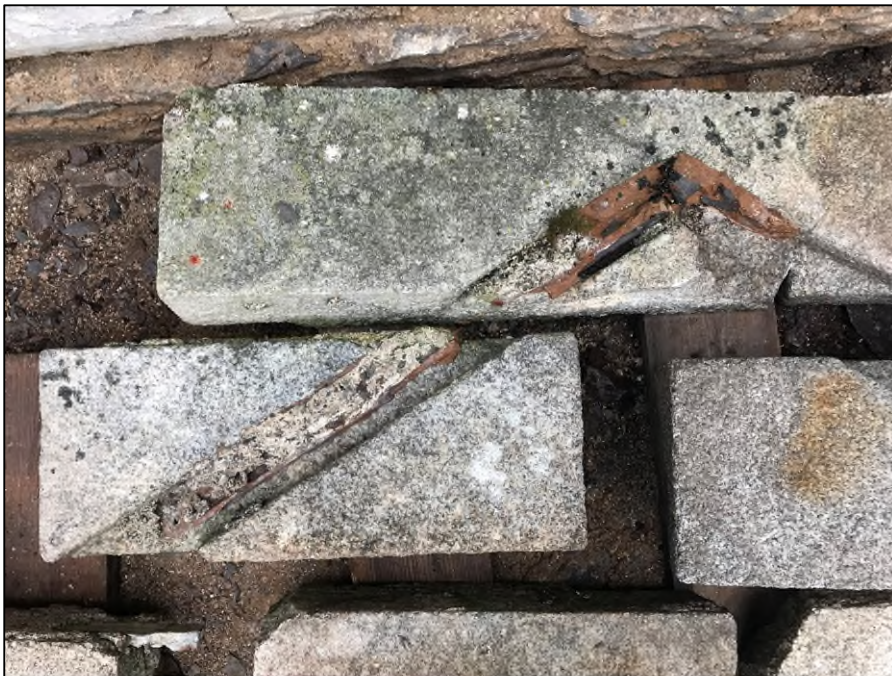
Photograph 23: Lighthouse Keepers' Cottages Roof Barge in Wicklow Granite Showing Outline of Roof Apex.

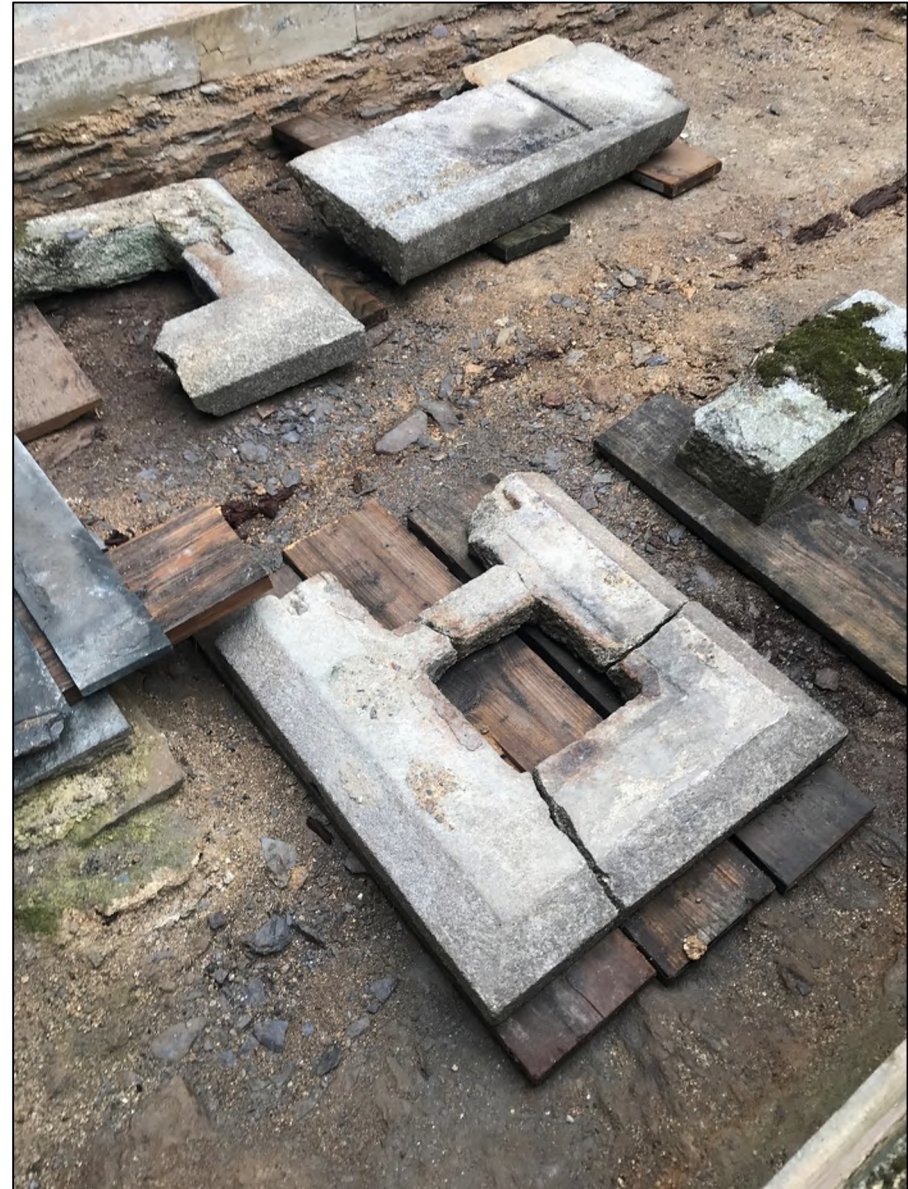
Photograph 24: Lighthouse Keepers' Cottages Chimney Basal Plinth in Wicklow Granite.

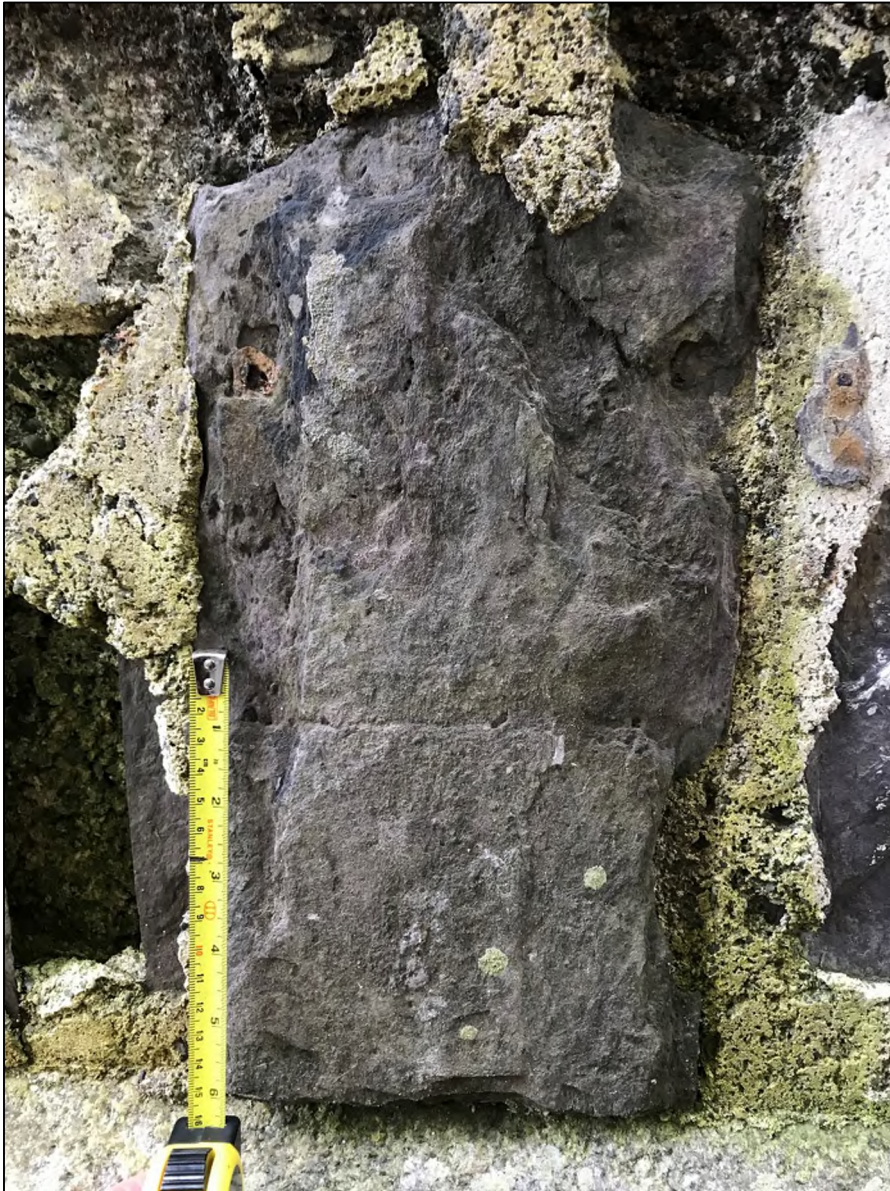
Photograph 25: Lighthouse Keepers' Cottages Cladded in Skellig (Silty) Sandstone.

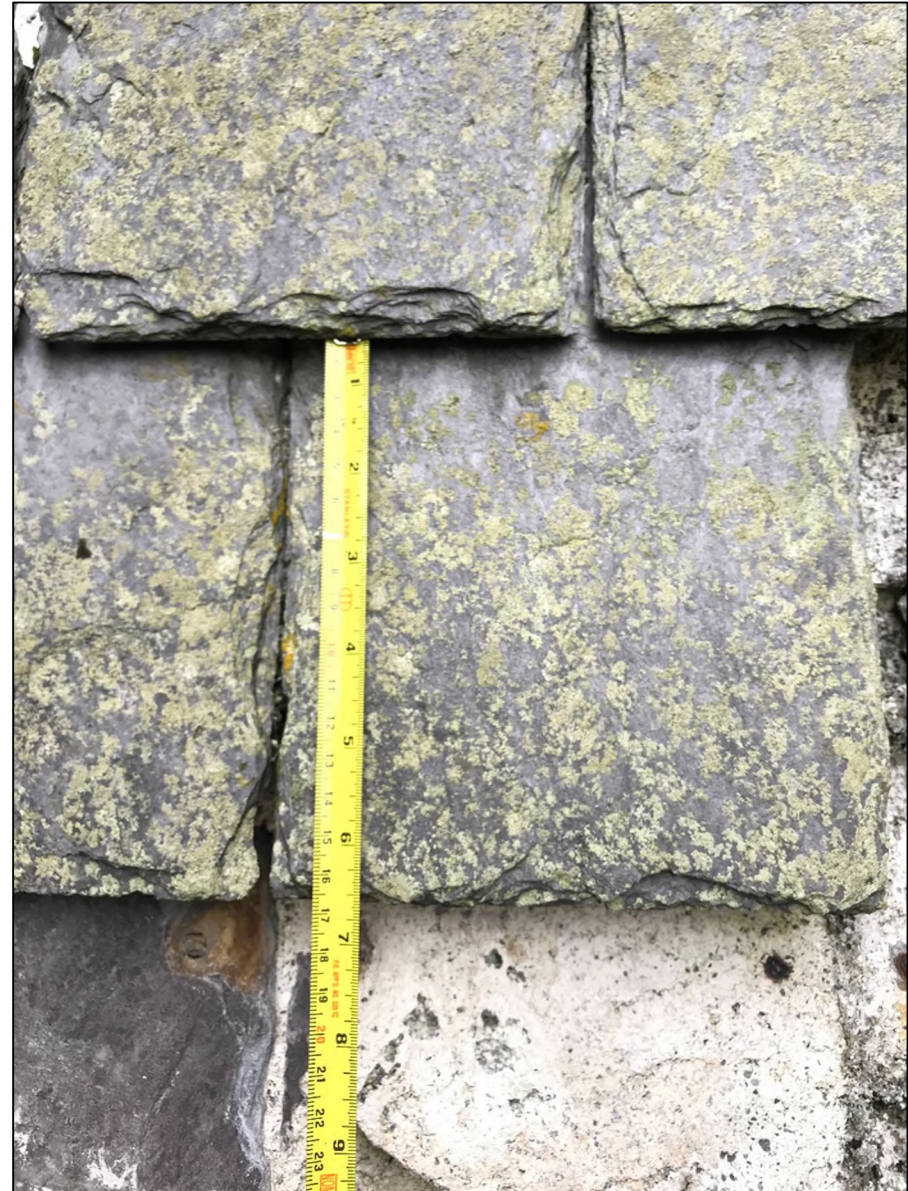
Photograph 26: Lighthouse Keepers' Cottages Cladded in Valentia Slate.

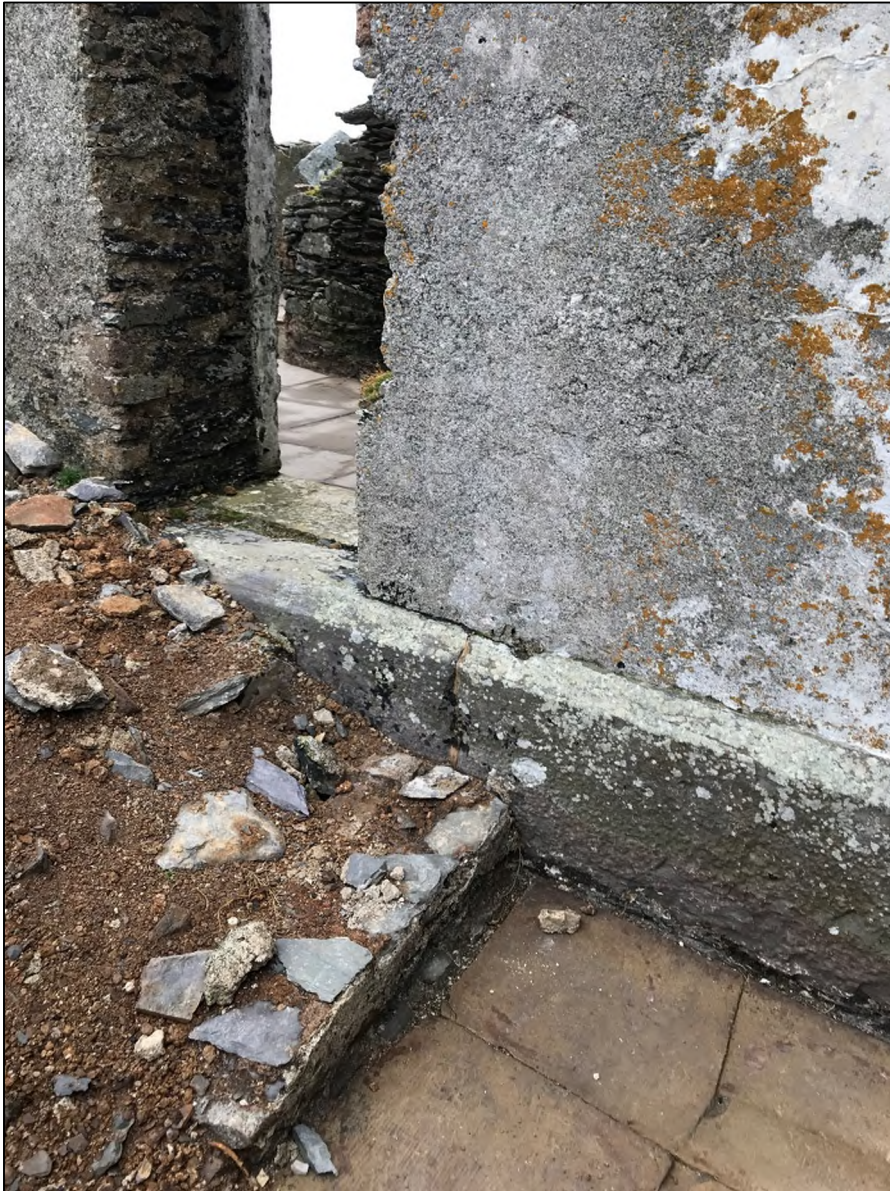
Photograph 27: Lighthouse Keepers' Cottages Base Plinth in Valentia Slate.

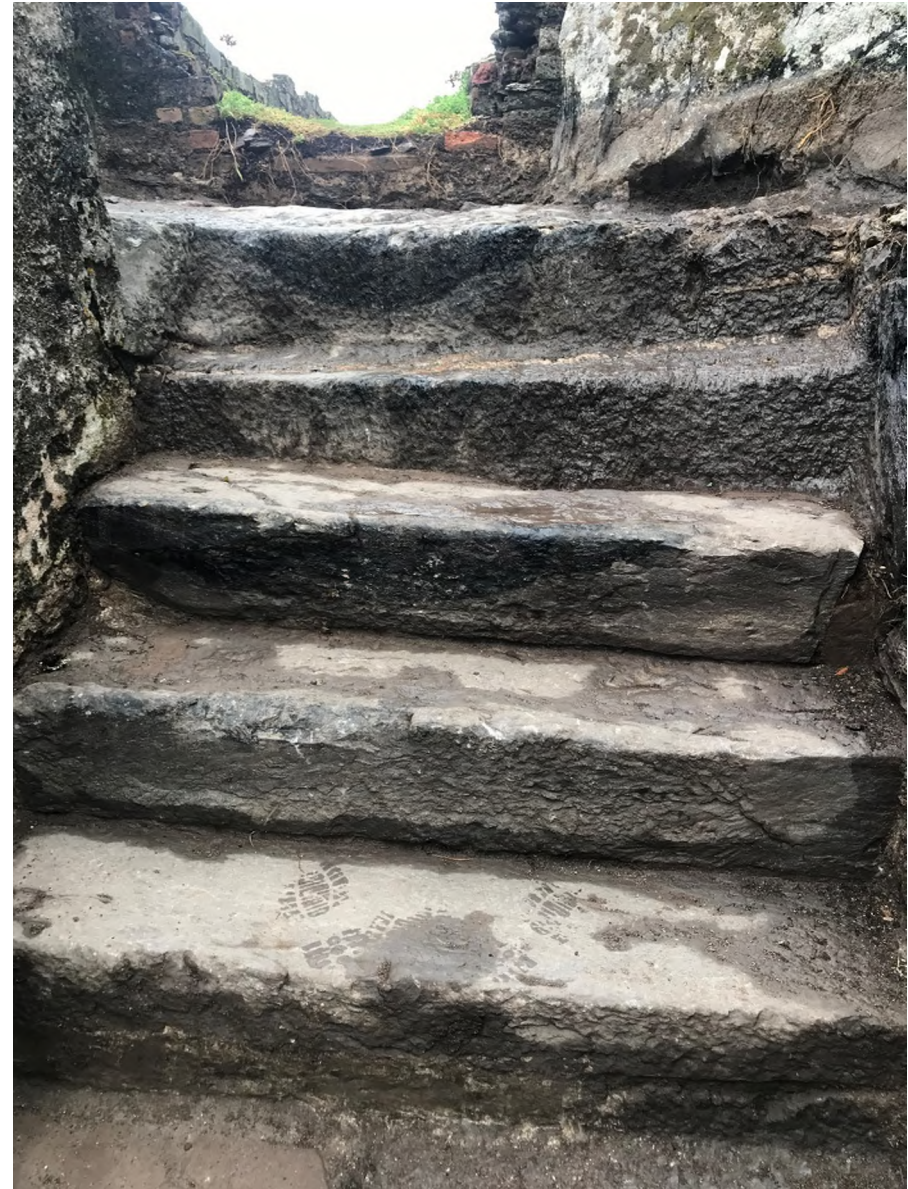
Photograph 28: Mix of Bedrock Cut Steps and Valentia Slate (?) Stone Steps to Northeast of Upper Lighthouse.

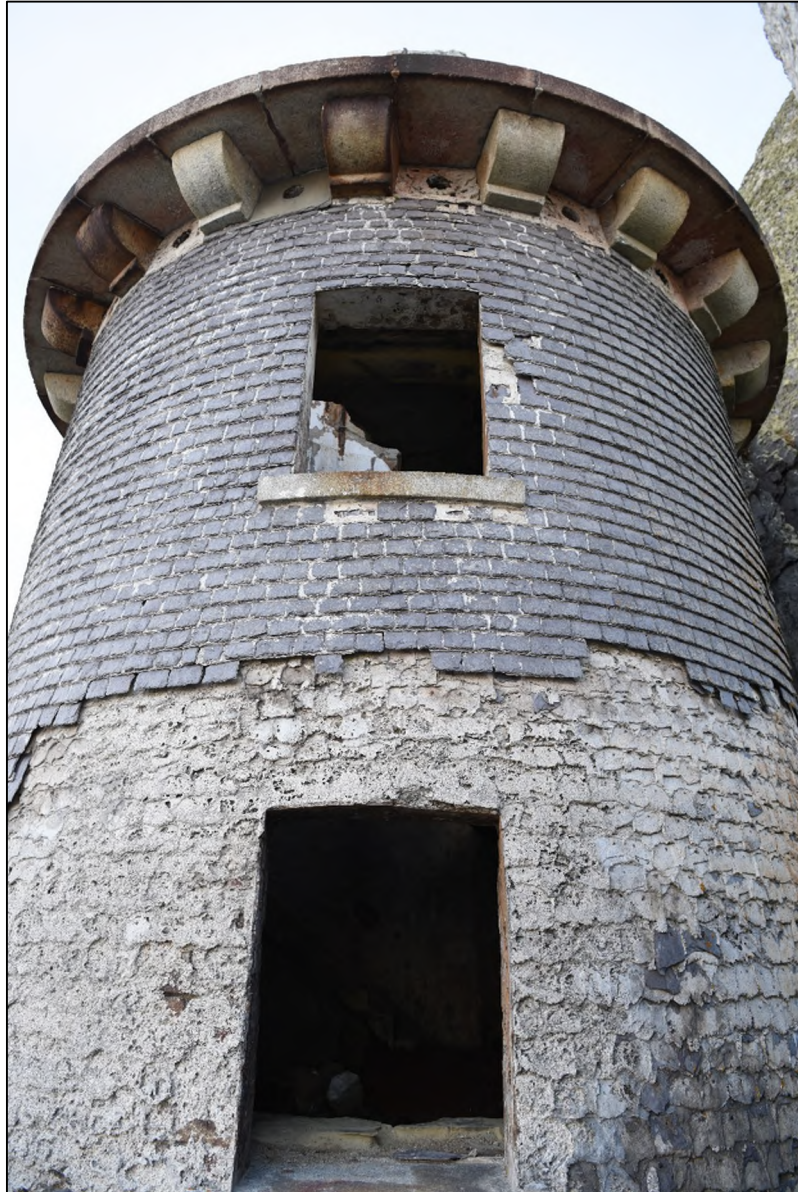
Photograph 29: Valentia Slate Cladding to Upper Lighthouse With Wicklow Granite Detailing to Sill and Upper Corbel Plinth.

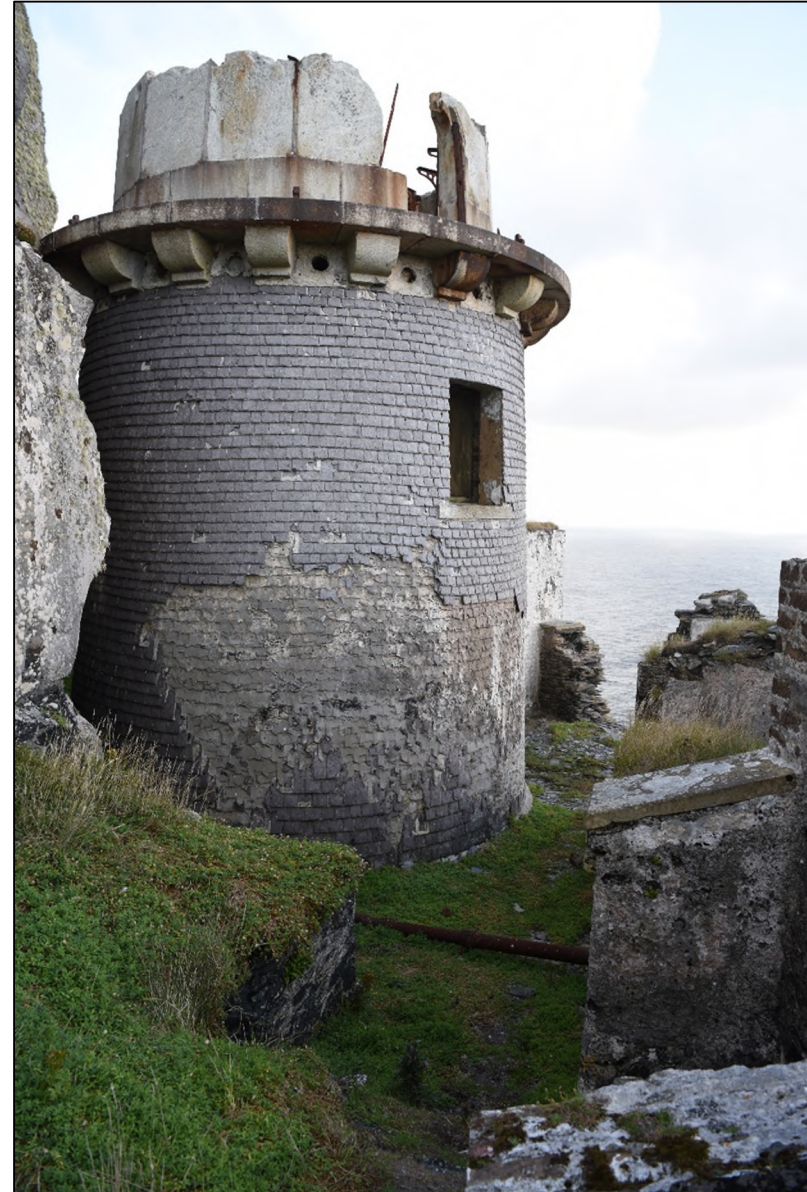
Photograph 30: Valentia Slate Cladding to Upper Lighthouse With Wicklow Granite Detailing to Sill and Upper Corbel Plinth.

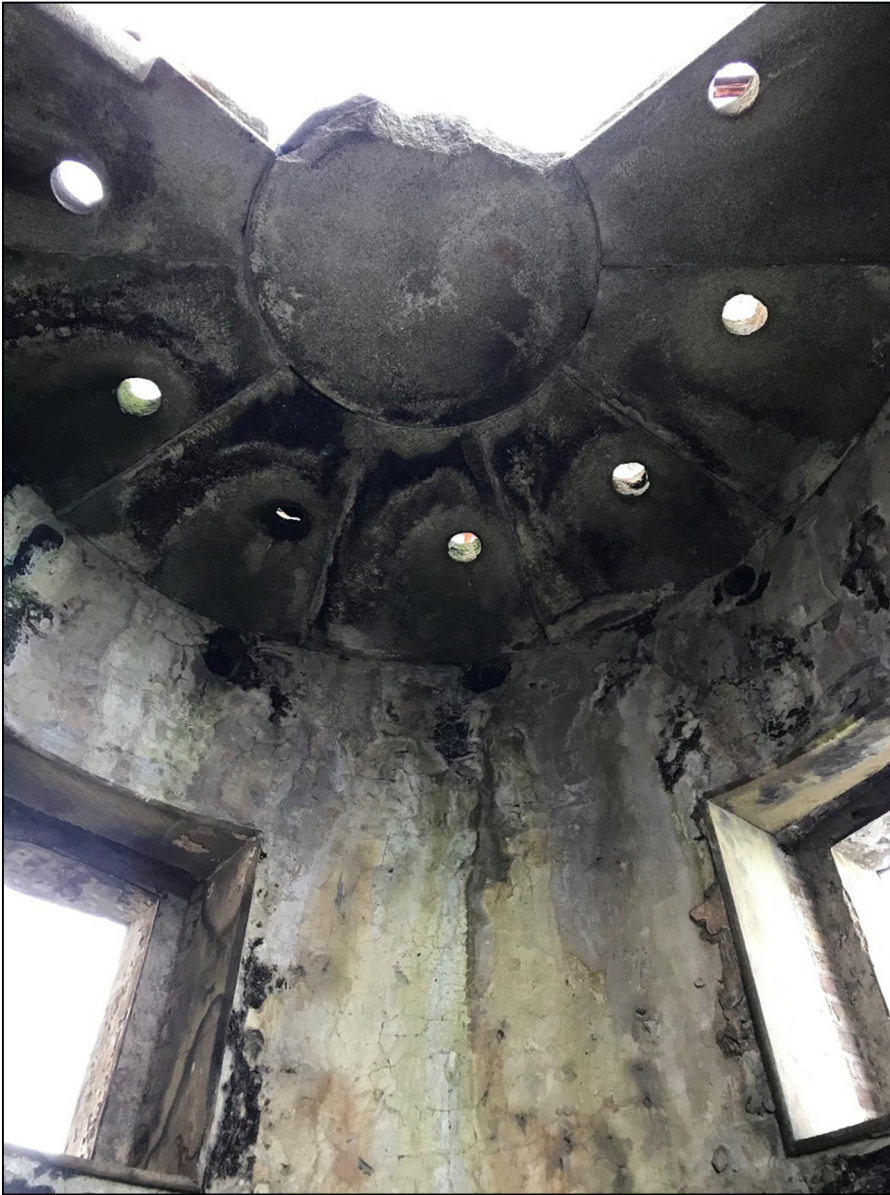
Photograph 31: Upper Lighthouse Wicklow Granite Corbel Plinth Roof with Yorkshire Flagstone Surrounds to Window Openings.

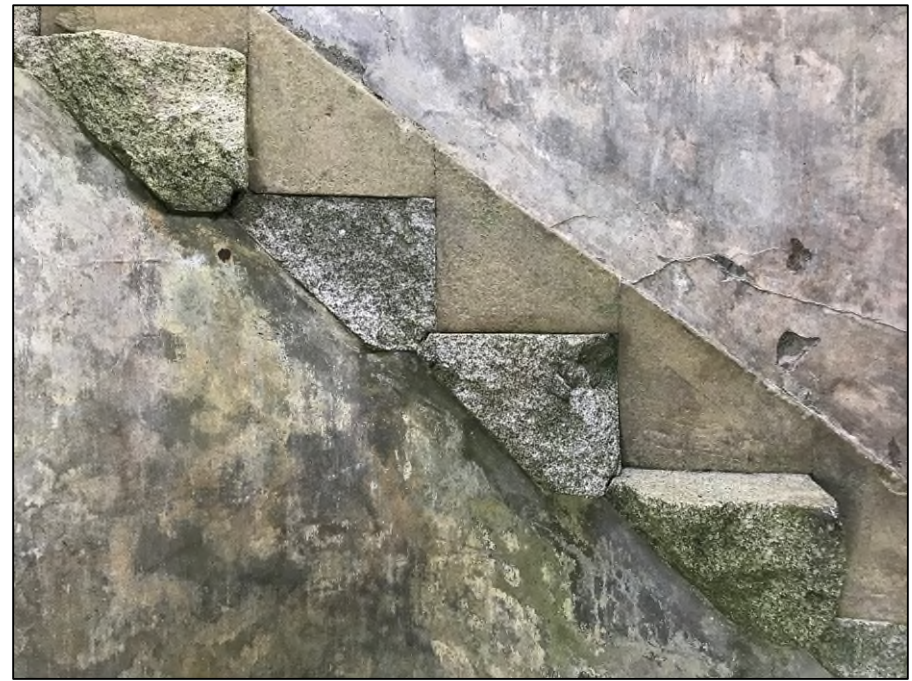
Photograph 32: Upper Lighthouse Wicklow Granite Cantilevered Steps.
