**Skellig Michael Co. Kerry- Archaeological Monitoring of Construction of 3 No. Crash
Decks on the Lighthouse Roadway.
(Ministerial Consent No. C0001053; Excavation Licence No. E005336; Detection Device
Licence No. R000560)**

*Alan R. Hayden
December 2022*

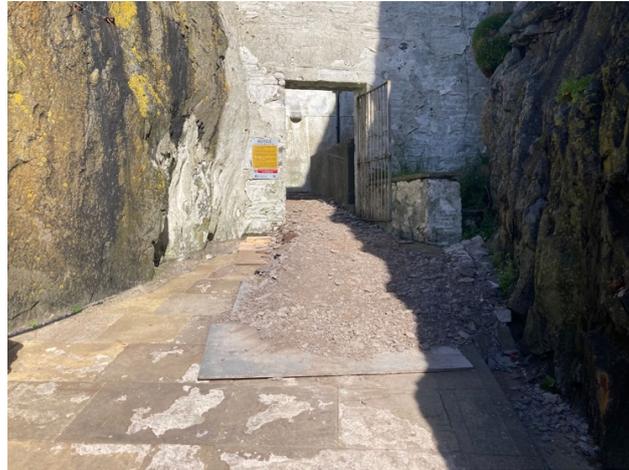
- the covering with plywood sheets of all the exposed yellow Yorkshire sandstone paving slabs before the entrance to and within the lower lighthouse station (figs 1 & 3) in order to protect them from damage by traffic. This will need to be done again next year,

Fig1. Protection of the area of the entrance into lower lighthouse station.

These construction works should not require archaeological monitoring, however the same restrictions and precautions undertaken in 2022 to avoid damage to the yellow sandstone flags and the cable channel by traffic etc. (figs 1-4) will need to be taken in 2023 and supervised to ensure they are adhered to.

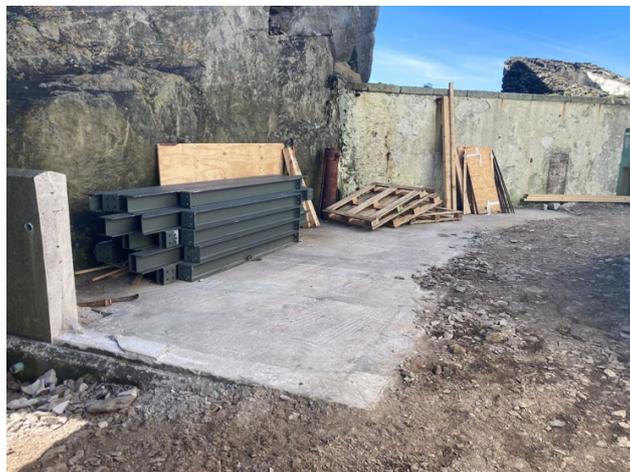
- The removal of the concrete block bund walls around the former, green plastic diesel tanks in the lower lighthouse station (see separate report). The lower part of the western bunded area consisted of the chamfered plinth of one of the original 1820s stores so it was left in situ and the ground was raised around it with soil and rubble to facilitate transit (fig. 2),

Fig. 2. Ground raised after removal of bund walls, retaining original foundations of 1820s store.

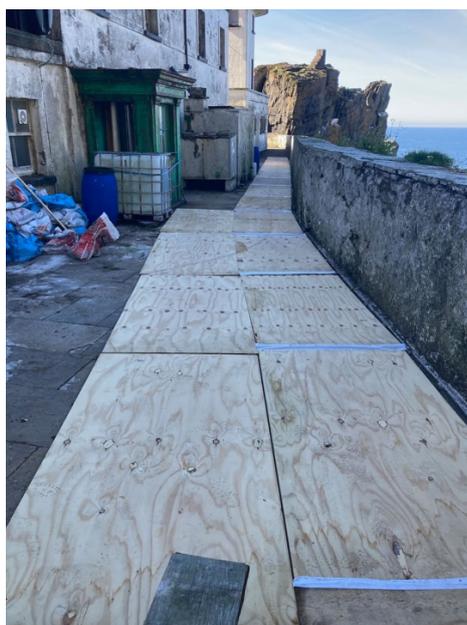
Fig. 3. Protection of Yorkshire paving slabs in front of lighthouse and dwellings.

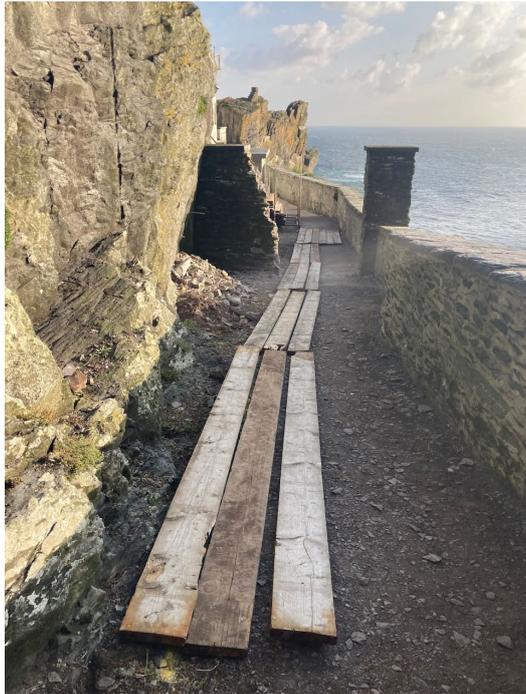
- the covering of the cable channel outside the north entrance of the lower lighthouse station (fig. 4), to protect it from damage by traffic. This will also need to be done again next year,

Fig. 4. Protection of cable channel outside north entrance to lower lighthouse station.

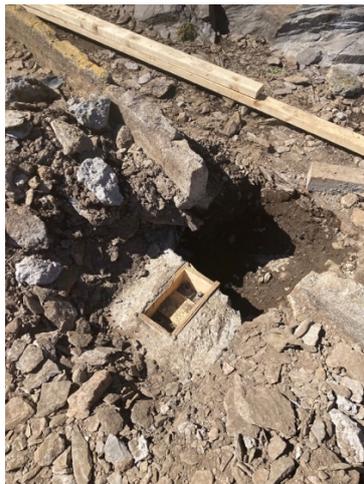
The rear beam of the eastern bay was laid too far towards the outer side of the roadway and so did not interfere with the concrete wall of the 'pond'. However, it had to be extended inwards and a slot had to be cut through the wall of the pond and the base of the lateral drain to hold extension beams supporting uprights (fig. 5).

Fig. 5. Crash Deck 1. Slot cut through 'pond' wall.

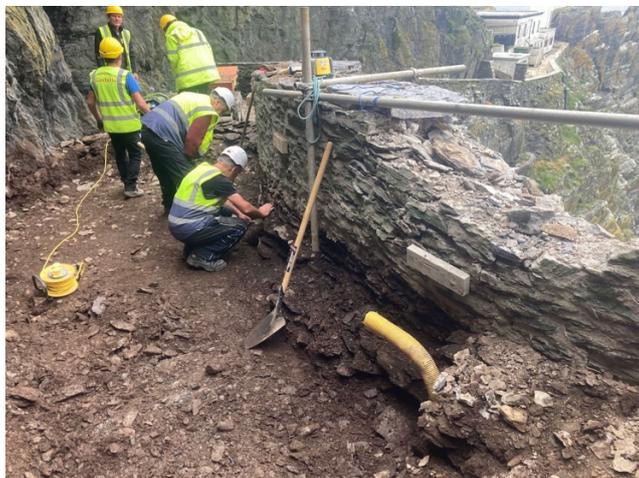
During the excavation of the trench for the front beam a ragged hole was revealed in the inner face of the base of the parapet wall and was repaired by the OPW mason using lime mortar and stone (fig. 6).

Fig.6. Cras Deck 1, repairing hole in parapet wall.

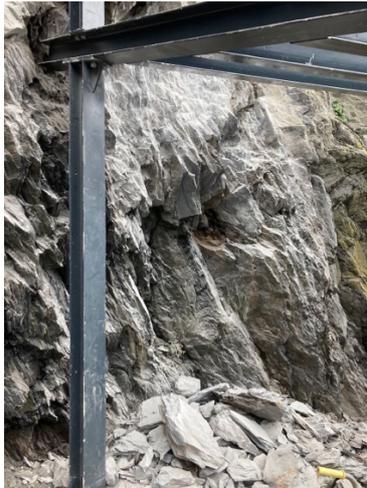
Parts of the rock higher up above the roadway had also to be removed to facilitate the construction of the substructure for the roof (fig. 7).

Fig.7. Crash Deck 1, rock removed to allow rood substructure to be erected.

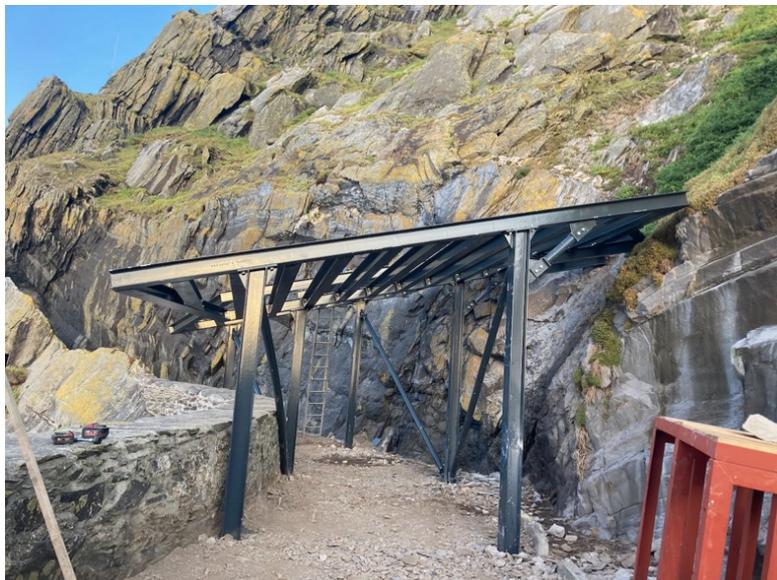
After the construction of the ground beams was completed on each crash deck the trenches were backfilled and compacted. Following construction of the superstructure the roadway was again made good and in each area a drain was created along the inner side of the roadway to replace the removed parts of the lateral drain to ensure drainage was maintained (figs. 8, 10 & 12).

Fig. 8. Crash Deck 1 after completion.

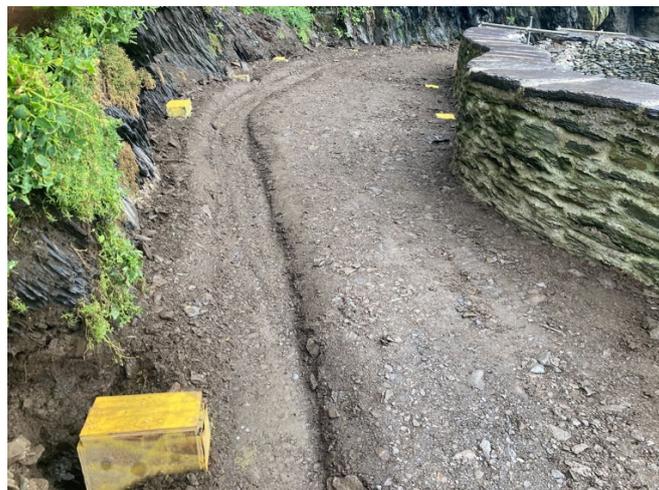
The location where Crash Deck 2 was built has been particularly prone to falling rocks due to the compacted glacial moraine rather than bedrock through which the roadway was cut at this point. Rockfalls in the 1950s severed access here and left only the inner 1-1.5m of the roadway intact. The roadway was excavated and the outer wall rebuilt and repaired in this area in recent years. Rockfalls again in the winter/spring of 2021/2022 broke through the wall in one place, knocked the wall out of plumb and cracked the wall for a length of over 20m. This will require substantial repairs in the future.

The line of the ground beams at the back of the structure coincided with the line of the road edging and cable channel which had to be completely removed to facilitate construction. Much of the surface of the lateral drain was also removed. The Cable channel was cut by consaw into metre long sections which were laid out in the order they were removed in the yard behind the northern dwelling of the lower light station. The stone removed from the road edging and lateral drain was stockpiled on the outer side of the roadway immediately above crash deck 2. The stones in the road edging here were much larger than elsewhere as the great depth of infill in the steep gully beneath the roadway allowed for the use of larger stones.

Fig. 9. Crash Deck 2, roadway made good after completion of construction of ground beams.

The extensive areas of the road edging, cable channel and lateral drain surface removed will have to be replaced under supervision at some stage. Whether or not this will be possible next year when the roofs of the crash decks are being constructed is not clear. The parapet wall of the roadway for a length of some 20m in the area of Crash Deck 2 will

also have to be taken down and rebuilt at some stage and the side of the northern gateway into the lower lighthouse station will also need to be made good.

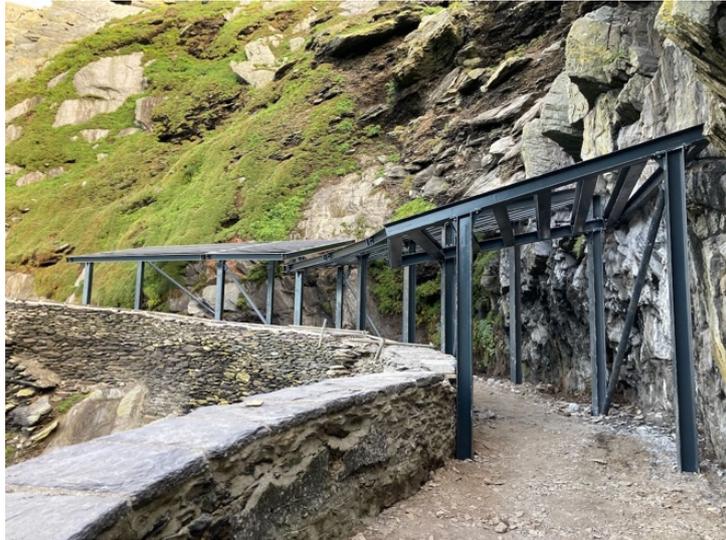
Fig. 10. Crash Deck 2 after completion.

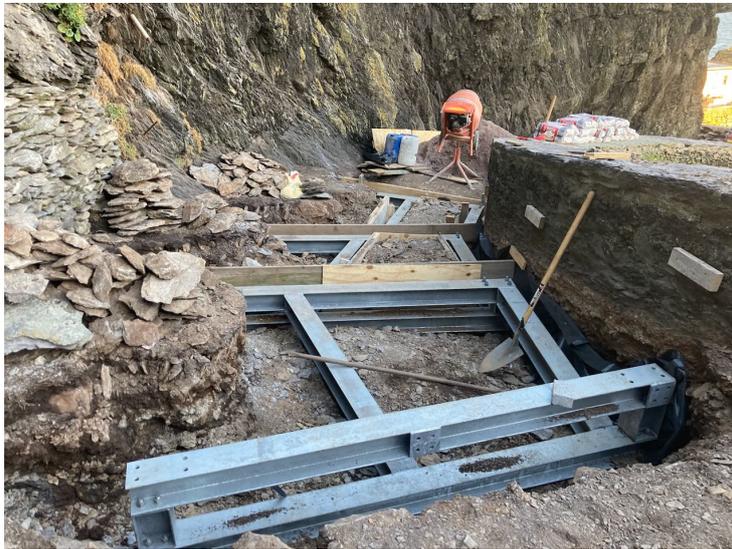
The rear beam in the redesigned crash deck was to be set roughly in the middle of the roadway and so did not interfere with the road edging etc. at the rear of the roadway. However the foundations for all the transverse beams would cut through it and the cable channel. In order to avoid damage to the cable channel it was cut into metre lengths by consaw before construction work began. The removed cable channel was placed on the inner side of the roadway further upslope and in the order in which the sections originally lay. As much as possible of the road edging and the surface of the lateral drain was retained in situ but sections had to be removed at the location of each of the transverse beams. The removed stone was stockpiled further upslope.

Fig. 11 Crash Deck 3 under construction. The rear beam being closer to the outer side of the wall allowed the retention in situ of sections of the road edging and lateral drain surface.

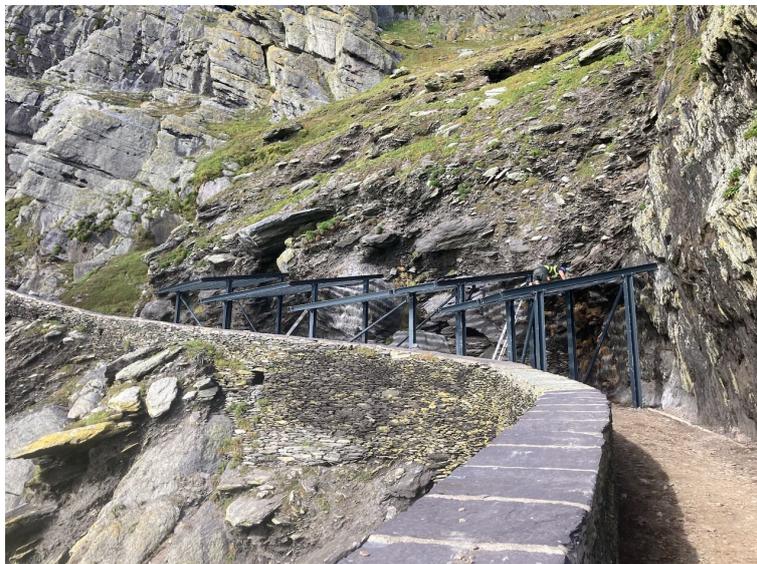
Fig. 12. Crash Deck 3 after completion or works
