**Skellig Michael Co. Kerry- Archaeological Monitoring of Extension of Cross Cove Canopy on the Lower Lighthouse Roadway.**

**(Ministerial Consent No. C001122; Works No. W000562**

*Alan R. Hayden*

*October 2022*

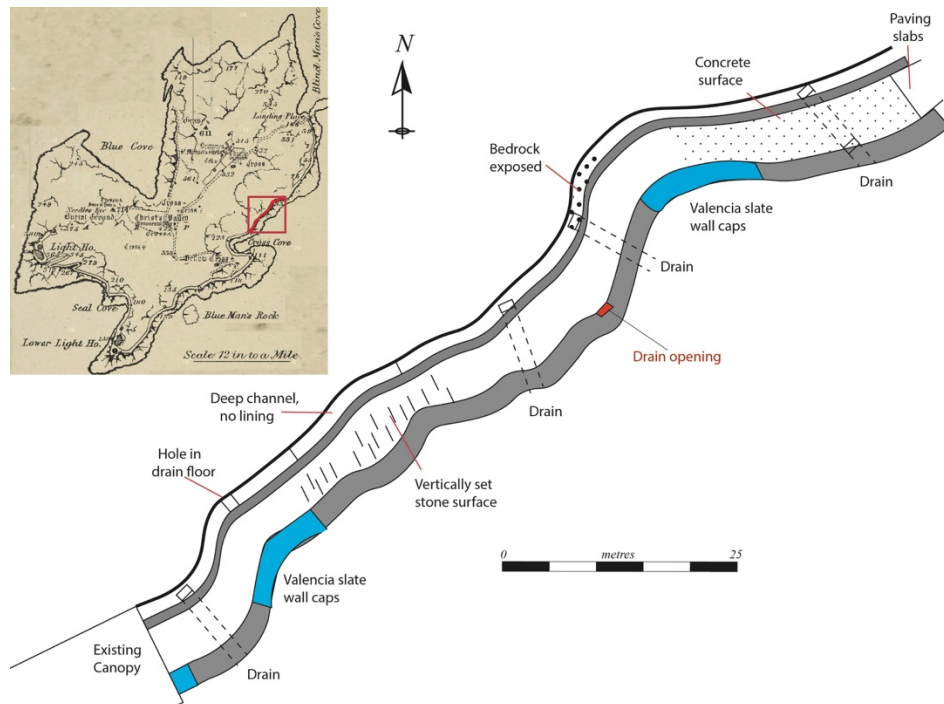
Fig. 1. Location of canopy extension and features on roadway with recently revealed drain opening highlighted.

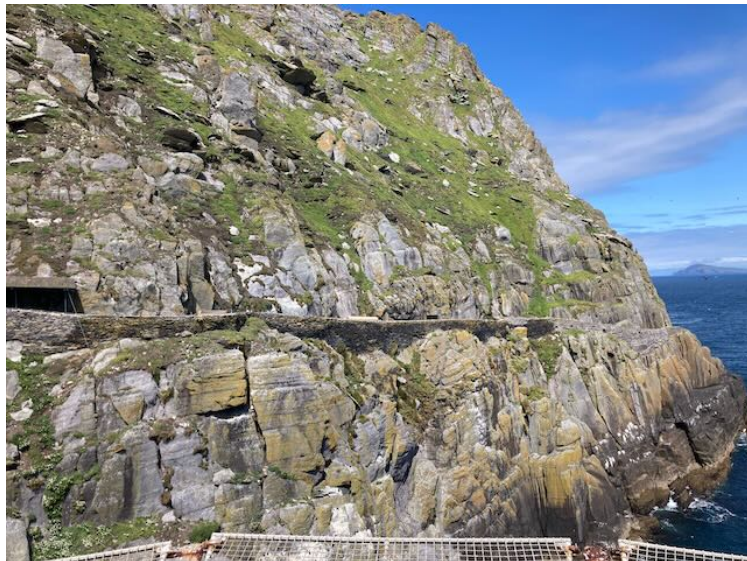
Fig. 2. Area of roadway before canopy constructed.

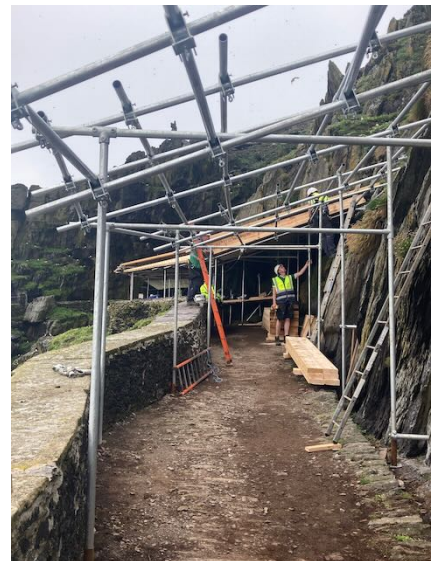
The new canopy was of similar construction to the original and the previous extension and consisted of a frame of scaffold poles supporting a roof composed of 100mm-thick larch planking (fig. 3).

Fig. 3. Canopy under construction.

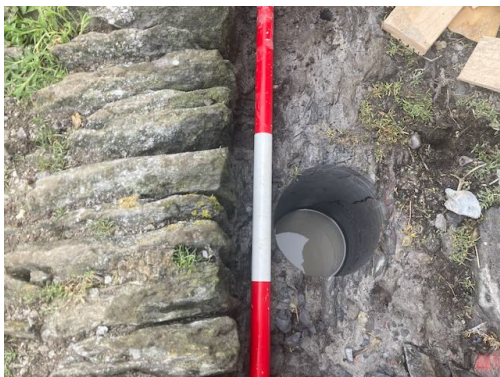
The base of the poles supporting the inner side of the canopy were set in holes either opened in the vertical stone surface of the base of the lateral drain or holes core drilled into rock (fig. 4) where the latter was exposed. The stones removed from the lateral drain were replaced after construction (fig. 5) as has been done previously.

Fig. 4. Cored hole, inner side of roadway.

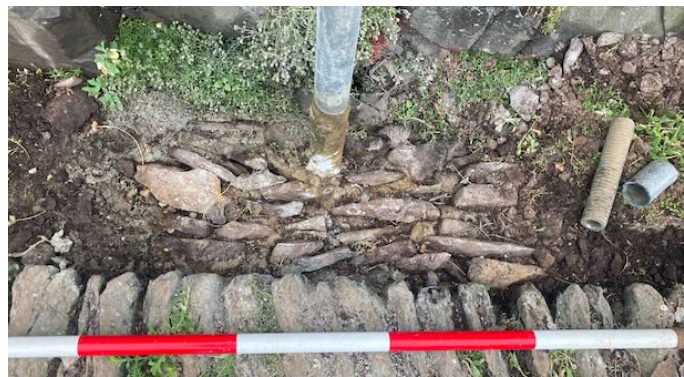
Fig. 5. Stones of lateral drain replaced after construction.

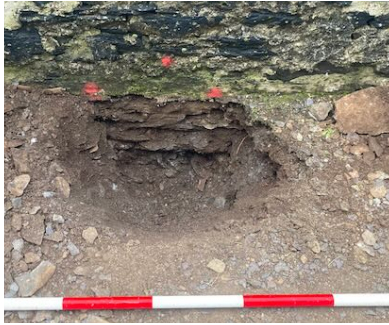
The frontal supports were set in holes typically about 300mm in depth and 400mm square excavated into the surface of the roadway immediately inside the parapet wall (fig. 6). The surface of the roadway varied in different areas from simple compacted clay and stones, to larger vertically set stones some with a thin covering of concrete. Care was taken to ensure the material used to backfill the holes did not enter holes or cracks in the wall. The use of a dry mix post cement also helped greatly in this regard. Where the vertically set stones were encountered these were replaced after construction.

*Fig. 6. Typical foundation for pole on outer side of canopy.*

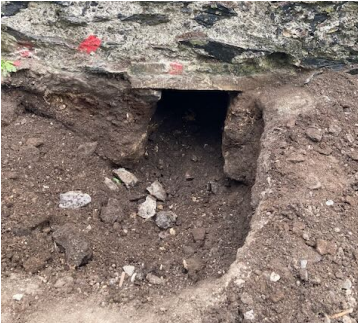
The only feature of interest noted was the 300mm high opening for a surface drain in the parapet wall immediately below the road surface level (fig. 7). The outer side of the wall there had been rebuilt at least once due to damage by falling rocks or storms and the outer side of the former drain was covered over, possibly as it was either not recognised or because the drain was no longer in use. The former drain lies between two closely spaced subsurface drains which remove water from the lateral drain on the inner side of the roadway and the disuse of the former surface drain has not affected drainage on the roadway. The opening of the drain was sealed with a sheet of tin and stones before the foundation hole was infilled to ensure it was not blocked (fig. 8).

*Fig. 7. Disused drain ope uncovered.*

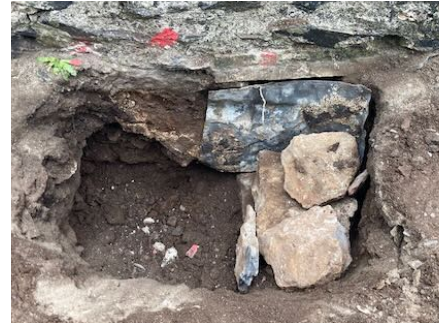
*Fig 8. Drain ope sealed before backfilling.*

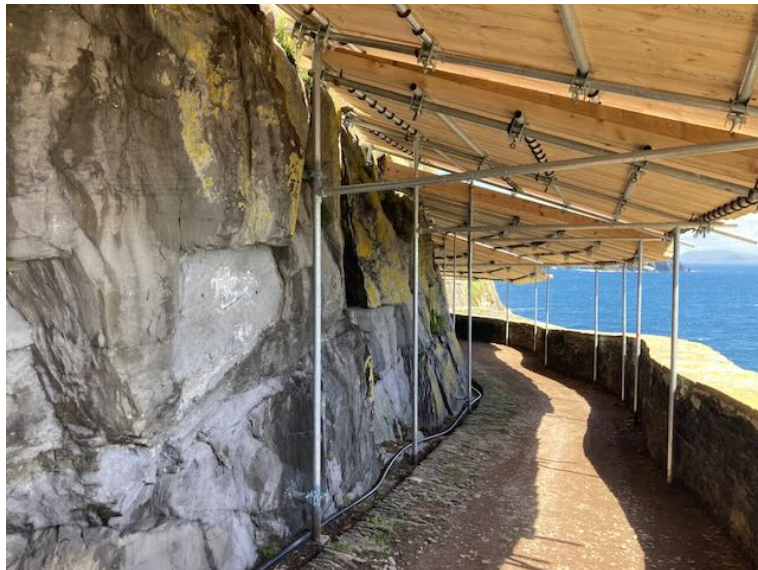
In the morning to mid-afternoon when visitors come to the island, the area of the new length of canopy benefits from direct sunlight (fig. 9), which means it is nowhere as dark beneath it as beneath the canopy in the more shaded Cross Cove. As there is nothing to see above the canopy from the road level and as the external side of the canopy frame is but a line of well-spaced scaffold poles it also does not obstruct the view and detract from the visitors experience.

*Fig. 9. The sunlight beneath the completed canopy.*

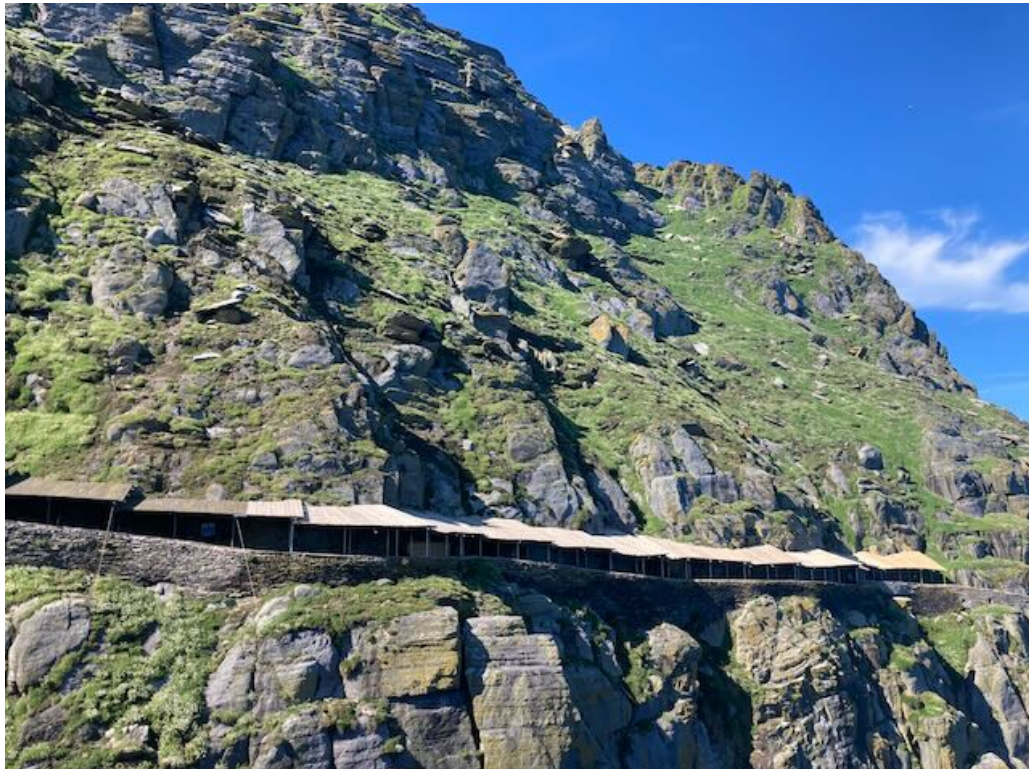
Where the roof or outer face of the canopy is visible from a distance it represents such a small area compared to the height of the cliffs below and above that it is not visually intrusive (fig. 10).

*Fig. 10. The completed canopy viewed from the helipad.*
