Geological Context of Rockfall Potential

Skellig Michael

on behalf of
the Office of Public Works

January 2023

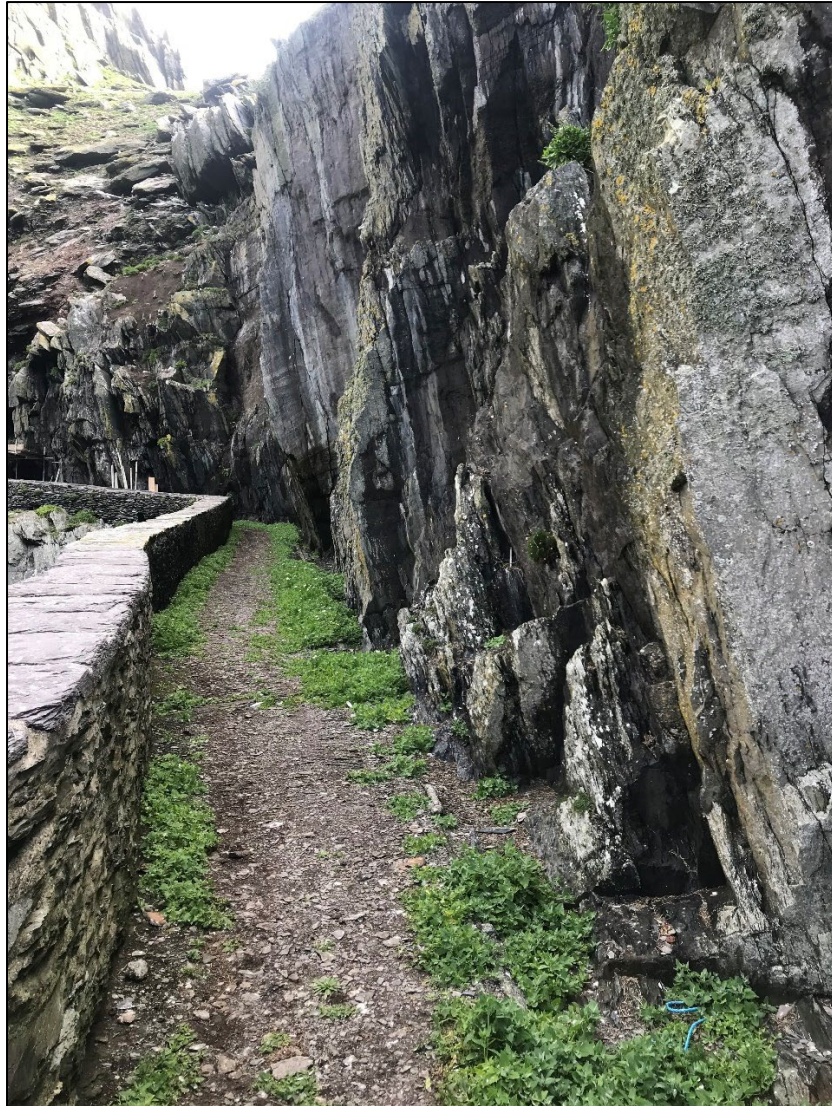
Photograph 01. Upper Lighthouse Road – Section 1.

Feature	Description	Score
Nature	Thick Siltstone/Purple – little exposure as running along strike.	3
Bedding	Clean/blasted. 090/23, 100/18.	1
Cleavage	Blasted/wavy/clean – dominant exposure. 060/78S.	1
Joints	Blasted up to 10m – clean. “Exposed” 150/80E, 120/78E, 148/82E; dominant.	1

Nature of Source	Description	Score
Source - Bedrock	No weathered loose material.	0
Type - Overburden	N/A	-
Height Above Receiver	Clean – adjacent to 10m. <50m (blasted faces).	2
Nature of Pathway	Direct.	3
Protection of Receiver	Dipping of cleavage plane to southeast allows added local protection – up to 10m wall protection.	1

TOTAL **11**

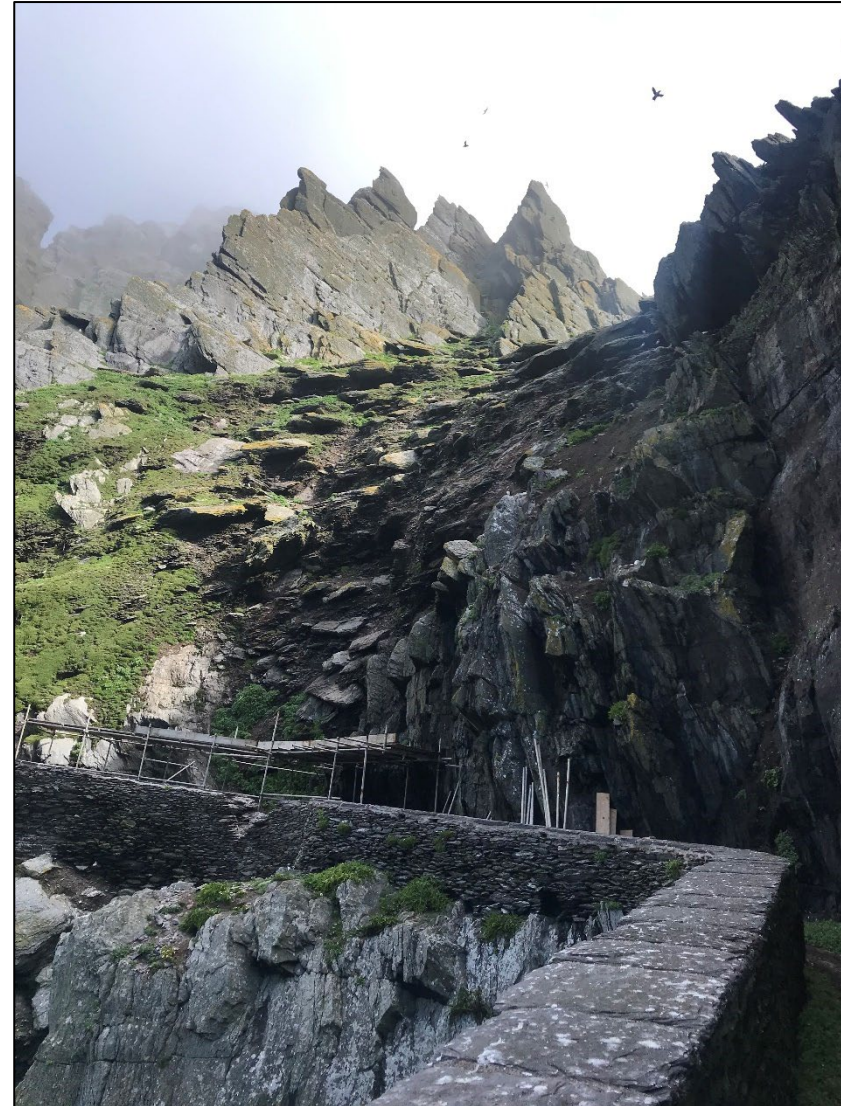
Photograph 02. Upper Lighthouse Road – Section 2.

Feature	Description	Score
Nature	Siltstone – below and above scree slope.	3
Bedding	Moderate at high level, cleavage slabs on top of scree slope from upper. 085/22E.	2
Cleavage	Deep weathering on high exposure – cleavage “edges”. 060/80SE.	3
Joints	Very little exposure – only at blast level. 140/73W.	1

Feature	Description	Score
Soil	Thin cover on top of thick.	1
Scree	Thick soliflucted glacial scree/moderated Siltstone chips to large cleavage slabs.	3
Weathered Rock	Blasted below – highly weathered above scree.	3

Nature of Source	Description	Score
Source - Bedrock	Extreme mix on island.	3
Type - Overburden	Extreme mix on island.	3
Height Above Receiver	Scree up to col. Bedrock up to lesser South Peak.	3
Nature of Pathway	Direct – vertical rockfall and scree fall protection.	3
Protection of Receiver	None – scree slope direct to receiver.	3

TOTAL **31**

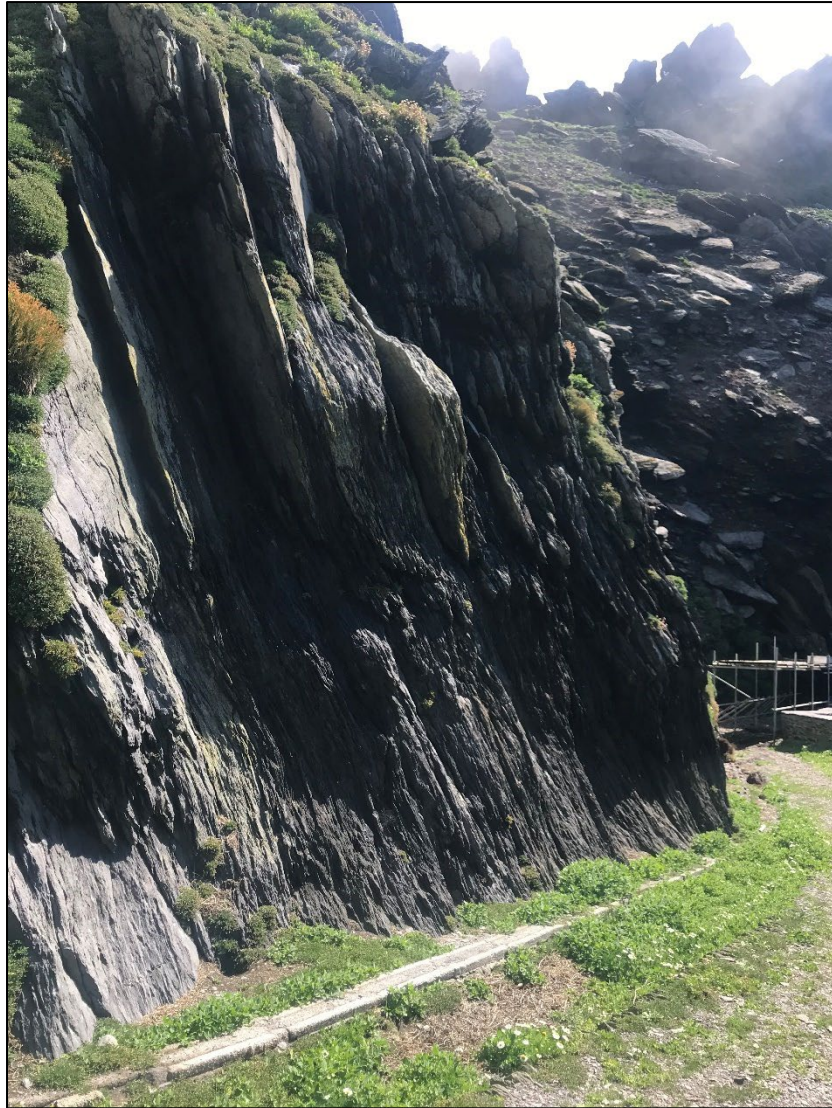
Photograph 03. Upper Lighthouse Road – Section 3.

Feature	Description	Score
Nature	Siltstone.	3
Bedding	Little exposure. 160/10E.	1
Cleavage	Blasted surfaces to 5m. Clean – higher exposures weathered. 058/72S.	3
Joints	Little exposure.	1

Nature of Source	Description	Score
Source - Bedrock	Siltstone bedrock.	3
Type - Overburden	N/A	-
Height Above Receiver	Up to little South Peak, however cleavage slabs will fall to scree zone 1 or 2.	3
Nature of Pathway	No direct pathway cleavage spine.	0
Protection of Receiver	Moderate blast zone c. 5m.	2

TOTAL 17

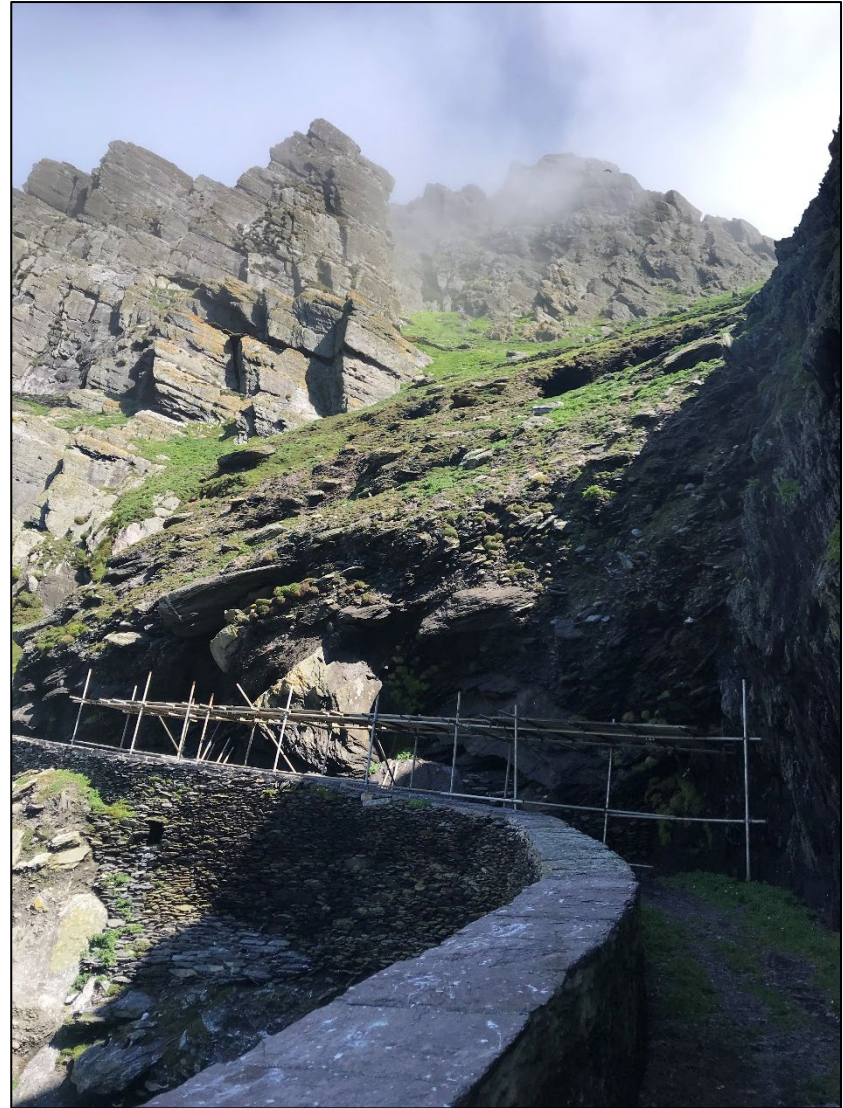
Photograph 04. Upper Lighthouse Road – Section 4.

Feature	Description	Score
Nature	Siltstone.	3
Bedding	No low exposure – high on South Peak and Lesser Peak.	2
Cleavage	No exposure at low scree level. High on South peak and Lesser Peak.	2
Joints	No exposure at low scree level. High on South Peak and Lesser Peak.	2

Feature	Description	Score
Soil	Cover of soil on top of scree/better than sheet no. 2 of 6; past agriculture here.	1
Scree	Heavy glacial – soliflucted zone – large cleavage slabs in base of scree.	3
Weathered Rock	On top of soil level at height.	3

Nature of Source	Description	Score
Source - Bedrock	Extreme mix on island.	3
Type - Overburden	Extreme mix on island.	3
Height Above Receiver	Scree up to South Peak col. Bedrock on South Peak and Lesser Peak.	3
Nature of Pathway	Direct – vertical rockfall and scree fall potential.	3
Protection of Receiver	None – scree slope direct to receiver.	3

TOTAL **31**

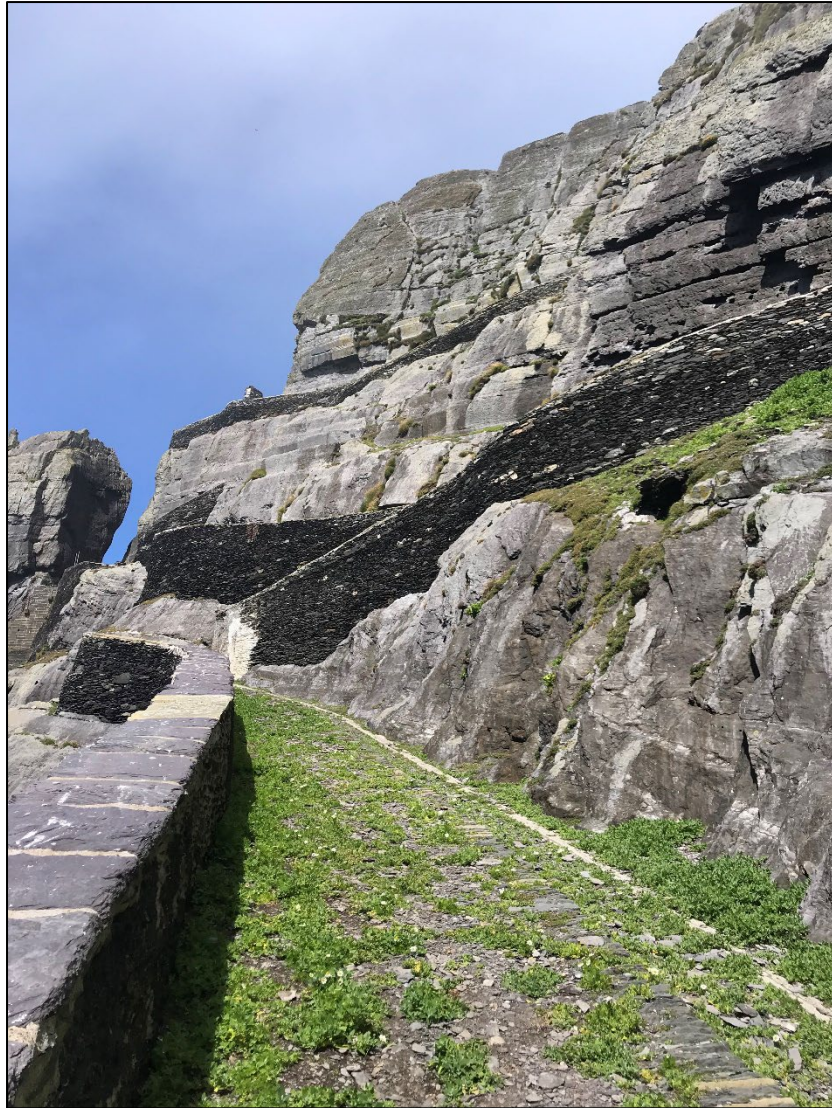
Photograph 04. Upper Lighthouse Road – Section 5.

Feature	Description	Score
Nature	Siltstone.	3
Bedding	Little exposed at road level. 040/26S.	1
Cleavage	Blasted surfaces up to 5m at higher exposures weathered cleavage ends. 063/81S.	3
Joints	No material exposure hackly cleavage blast.	1

Nature of Source	Description	Score
Source - Bedrock	N/A	-
Type - Overburden	N/A	-
Height Above Receiver	Up to 5m blasted. Up to high South Peak.	3
Nature of Pathway	Direct pathway. Cleavage spine.	3
Protection of Receiver	None.	3

TOTAL **18**

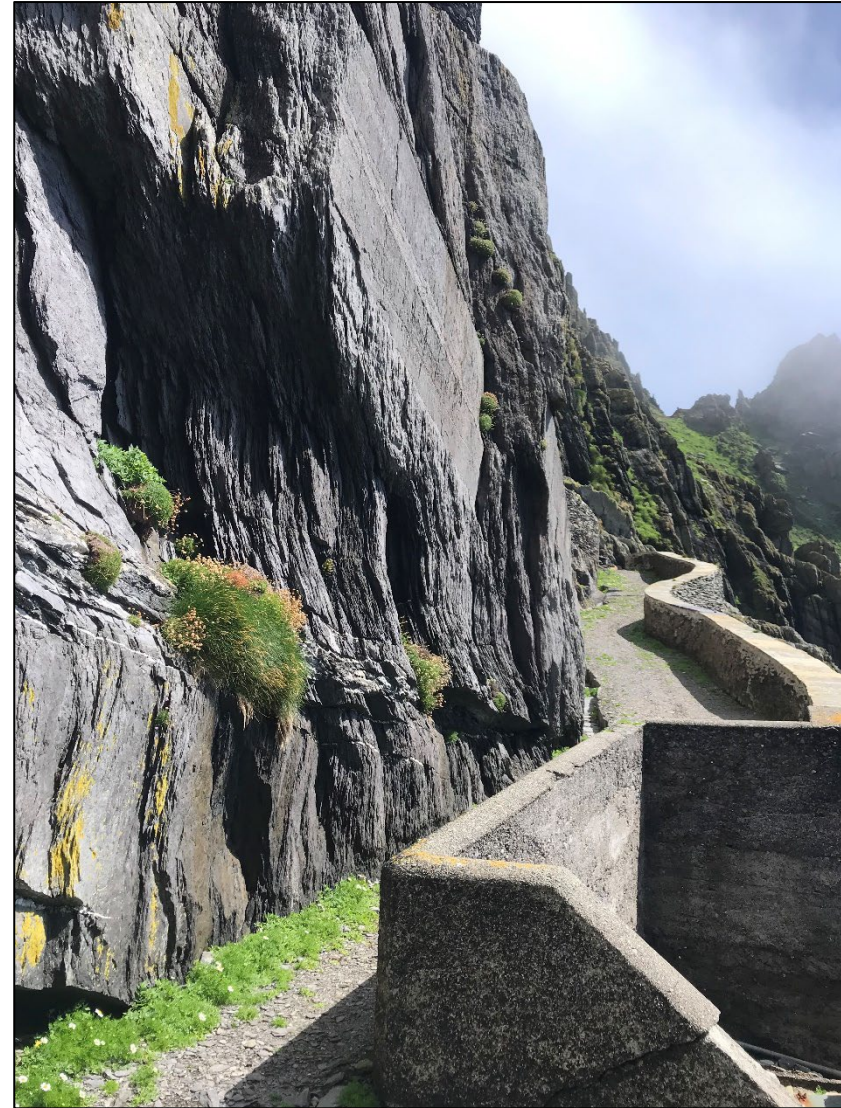
Photograph 05. Upper Lighthouse Road – Section 6.

Feature	Description	Score
Nature	Siltstone.	3
Bedding	Clean in blast zone – little exposure – above as dominant. Cleavage face. 095/22NE.	1
Cleavage	Clean in blast zone – clean/semi-weathered above. 057/75S.	2
Joints	Little exposure of clean surfaces, except at lighthouse. The dominant joint plane at the old lighthouse runs 130/65E. This overhangs the building also. 147/75E, 170/73W.	1

Nature of Source	Description	Score
Source - Bedrock	No material source.	-
Type - Overburden	No material source.	-
Height Above Receiver	Blasted clean faces and adjacent. <50m at top. Height advantage.	2
Nature of Pathway	Direct.	3
Protection of Receiver	>10m rock wall. Each level protected by one above and short clean cleavage face.	1

TOTAL **14**

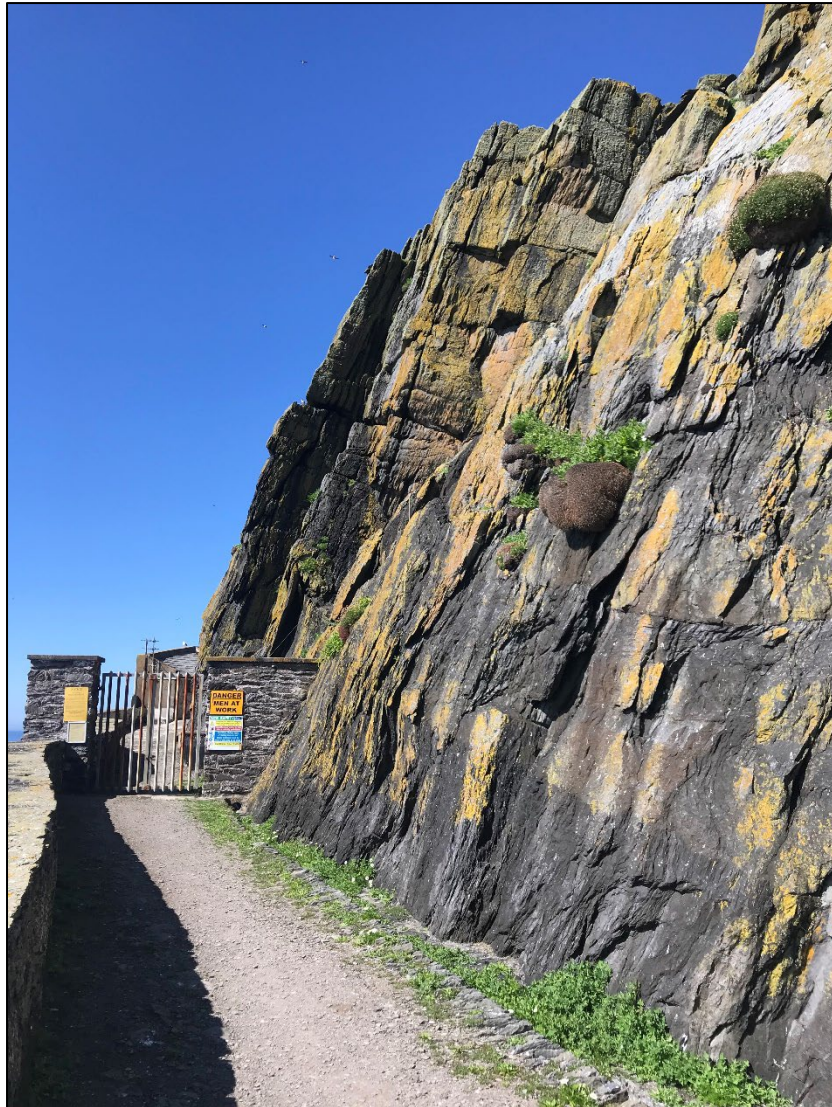
Photograph 06. Lower Lighthouse Road – Section 1.

Feature	Description	Score
Nature	Siltstone.	3
Bedding	100/17E. Low exposure.	1
Cleavage	060/70°. Strong south sloping feature – 70° – set back from road – clean fare.	3
Joints	165/85°	1

Nature of Source	Description	Score
Source - Bedrock	Clean siltstone – level faces.	1
Type - Overburden	N/A	-
Height Above Receiver	Adjacent and up to 50m above.	2
Nature of Pathway	Direct pathway – clean surfaces – joint places.	2
Protection of Receiver	Rock protection – blasted cleavage plane 070° to south >10m.	1

TOTAL **14**

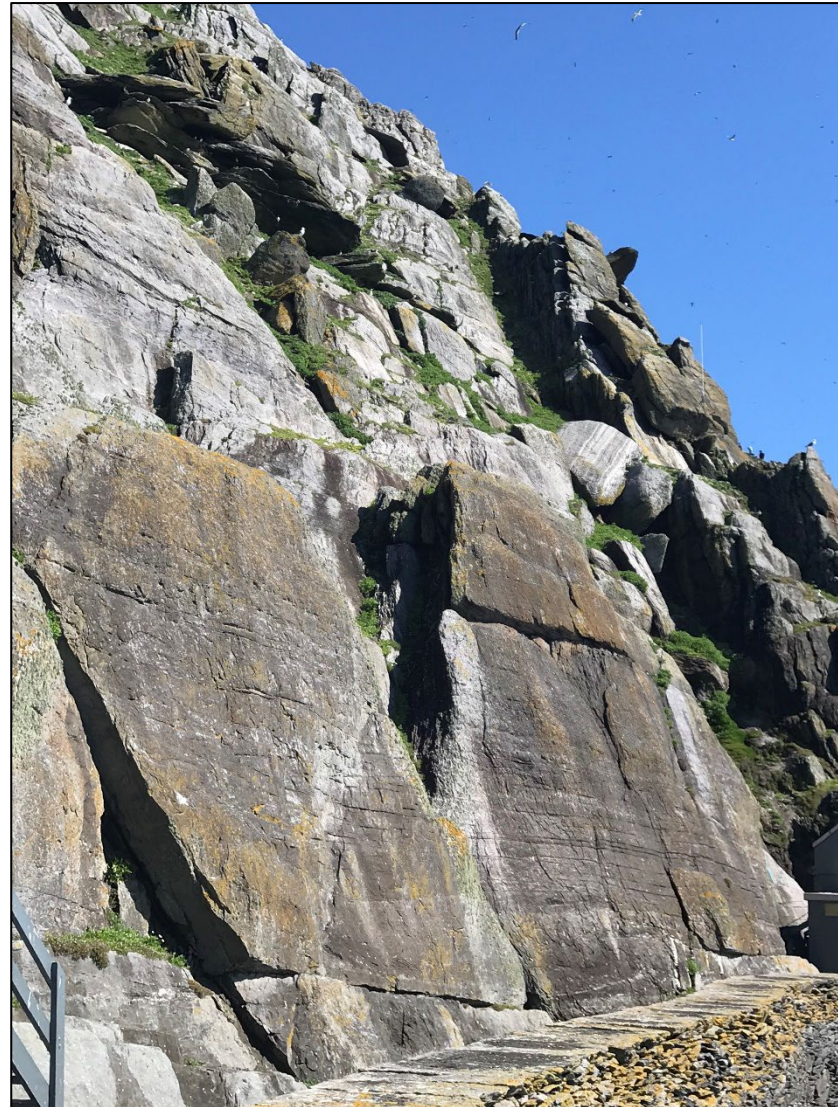
Photograph 07. Lower Lighthouse Road – Section 2.

Feature	Description	Score
Nature	Siltstone	3
Bedding	125/5°E. Moderate exposure.	2
Cleavage	063/76S. Moderate exposure.	2
Joints	135/65°E. Strong joint plane faces. Strong cleavage faces.	3

Feature	Description	Score
Soil	N/A	-
Scree	N/A	-
Weathered Rock	Cleavage slabs on ledges in joint plane zones.	2

Nature of Source	Description	Score
Source - Bedrock	Cleavage slabs. Moderate extent.	2
Type - Overburden	N/A	-
Height Above Receiver	<50m.	1
Nature of Pathway	Exposed joint planes.	3
Protection of Receiver	None.	3

TOTAL **21**

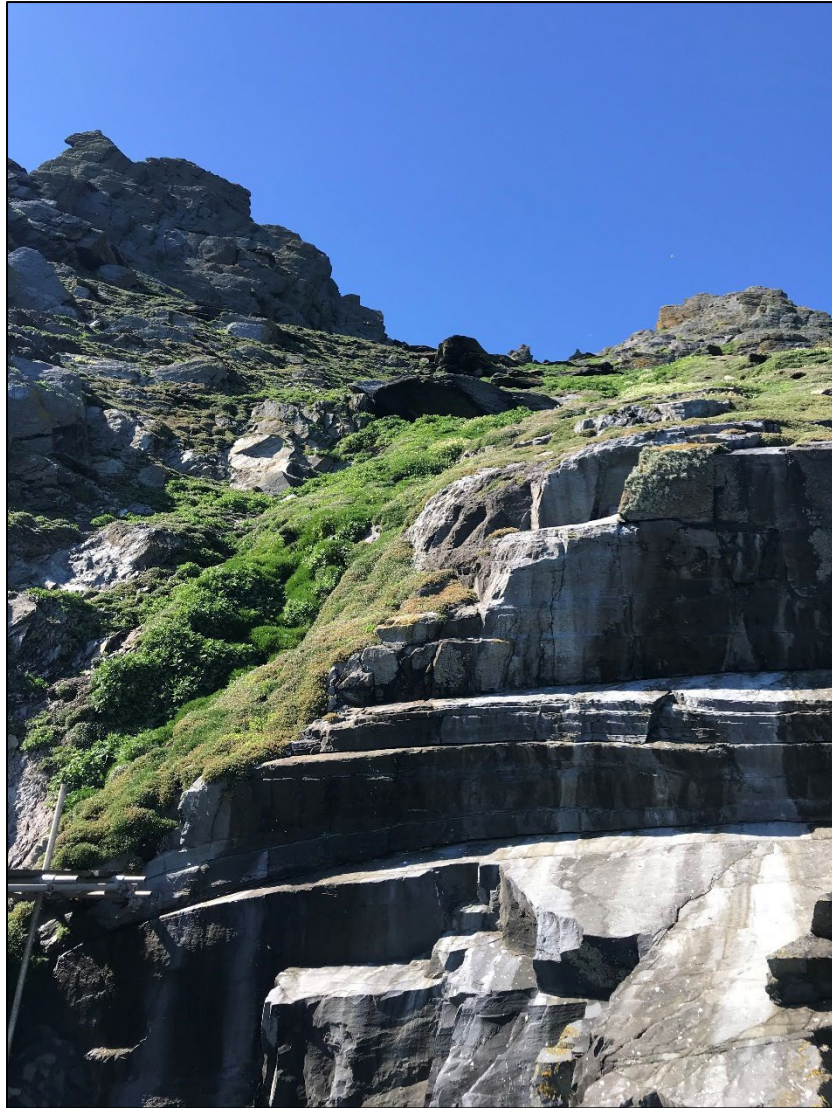
Photograph 08. Lower Lighthouse Road – Section 3.

Feature	Description	Score
Nature	Sandstone/Siltstone – 2m shoulder blast zone low.	2
Bedding	070/45S. At height – towards receiver.	3
Cleavage	070/76S. At height – towards receiver.	3
Joints	140/76E. At height.	3

Feature	Description	Score
Soil	Extensive in col zone/partial elsewhere.	3
Scree	Thin/beneath the soil.	1
Weathered Rock	Moderate distribution of large cleavage slabs especially at height.	2

Nature of Source	Description	Score
Source - Bedrock	High extent.	3
Type - Overburden	Scree/soil – moderate extent.	2
Height Above Receiver	Full. >50m.	3
Nature of Pathway	NB: Col “fault” zone (zone of fractal rock).	2
Protection of Receiver	None. Blast rock at 2m high.	3

TOTAL 30

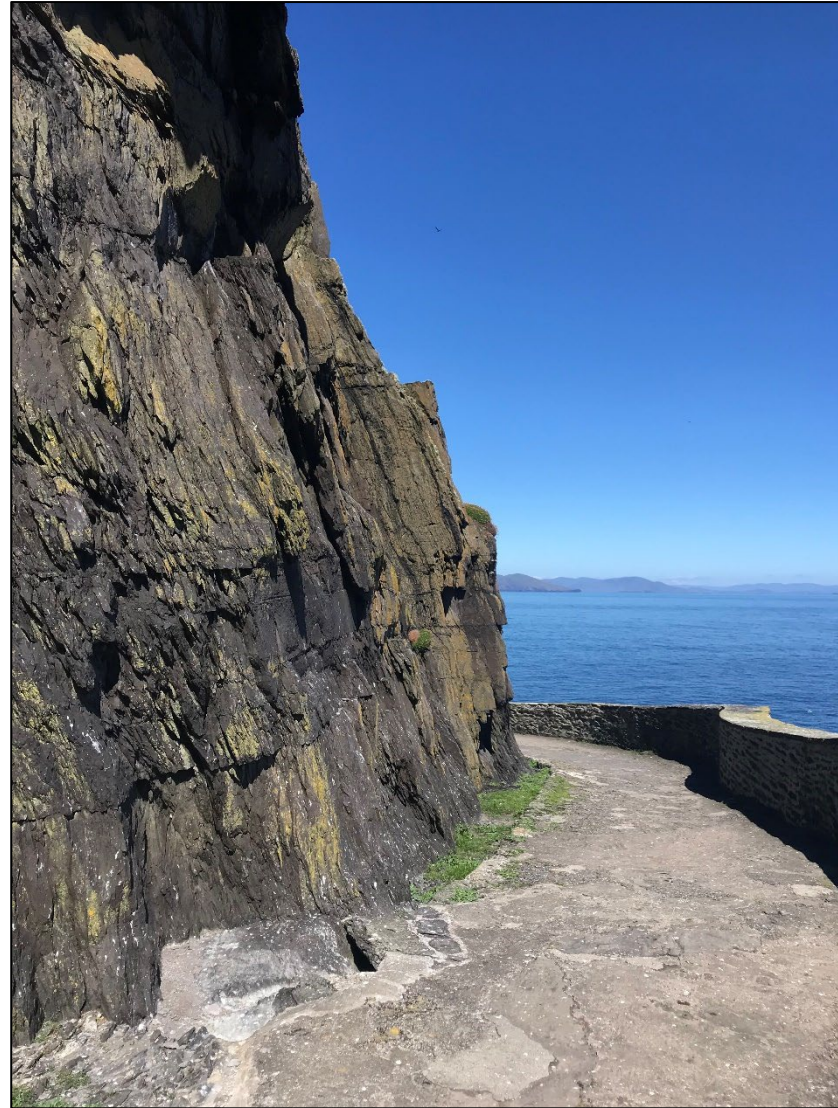
Photograph 09. Lower Lighthouse Road – Section 4.

Feature	Description	Score
Nature	Sandstone/Siltstone.	2
Bedding	Flat bed clean surfaces – low exposure.	1
Cleavage	068/68S. Clean, dipping to south – high exposure.	3
Joints	165/88°. Clean, surfaces – low exposure.	1

Nature of Source	Description	Score
Source - Bedrock	Clean section – no material loose.	-
Type - Overburden	N/A	-
Height Above Receiver	<25m.	2
Nature of Pathway	Direct – joint/cleavage plane.	2
Protection of Receiver	5m high blast wall protection.	2

TOTAL **13**

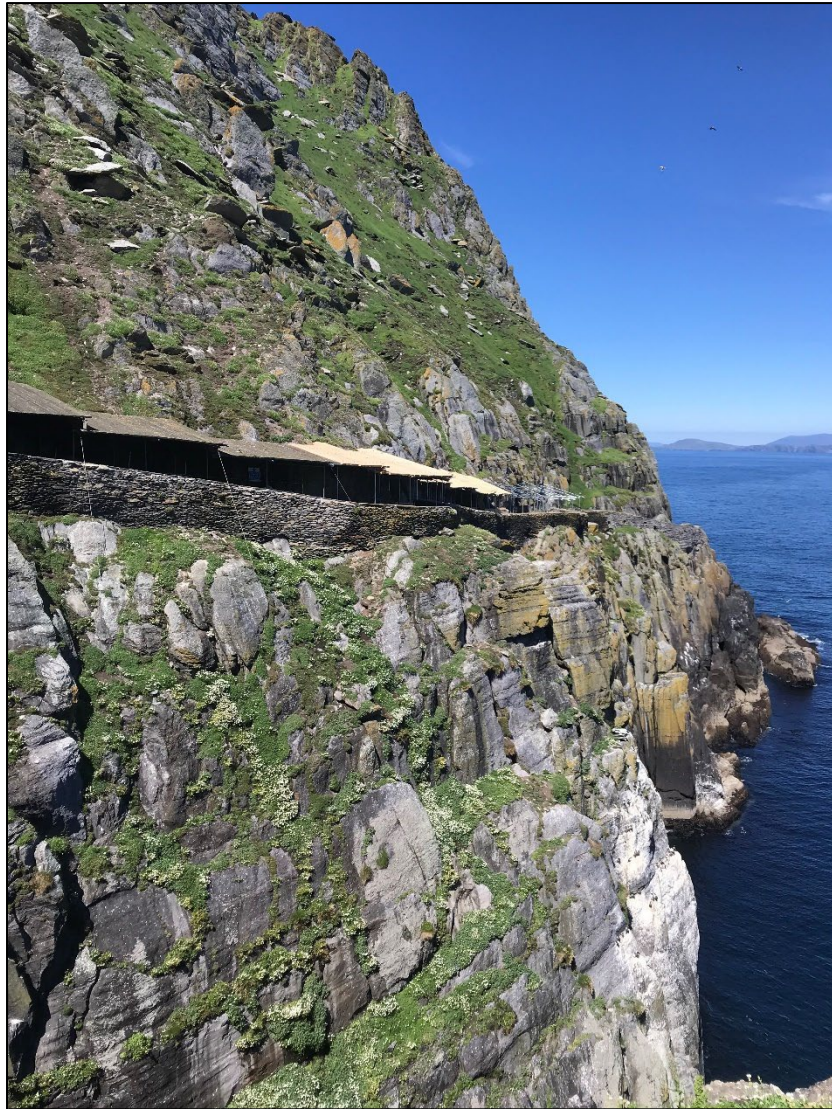
Photograph 10. Lower Lighthouse Road – Section 5.

Feature	Description	Score
Nature	Rhyolite. Volcanic in core of Cross Cove and halfway on face under monastery.	1
Bedding	040/29S. Clean low exposed high under monastery.	3
Cleavage	069/83S. Clean low – blast zone, exposed high under monastery.	3
Joints	157/79S. Clean low – blast zone exposed high under monastery.	3

Feature	Description	Score
Soil	Above Cross Cove and rhyolitic slope.	3
Scree	Two levels on top of rhyolitic slope (and Cross Cover) and lower Rhyolite.	3
Weathered Rock	Large cleavage slabs – multi-level.	3

Nature of Source	Description	Score
Source - Bedrock	High and extensive.	3
Type - Overburden	High and extensive.	3
Height Above Receiver	>50m.	3
Nature of Pathway	Scree slope and joint planes x 4.	3
Protection of Receiver	No natural protection. Assessment assumes no new canopy in place (July 2022).	3

TOTAL **34**

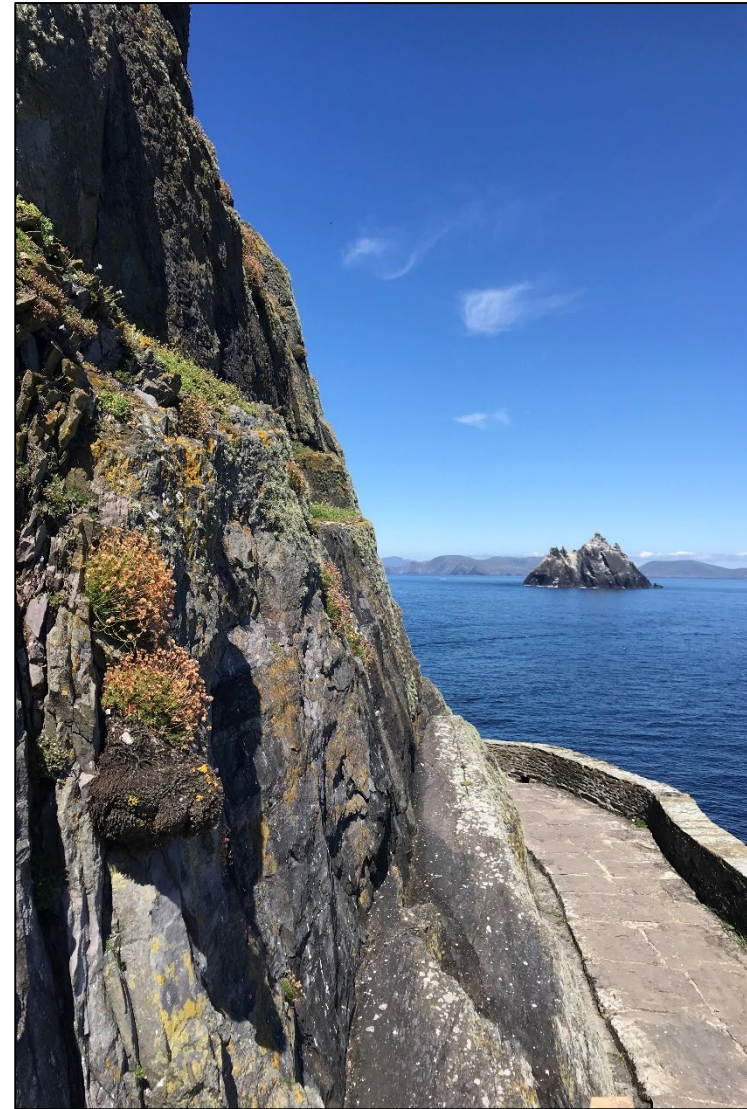
Photograph 11. Lower Lighthouse Road – Section 6.

Feature	Description	Score
Nature	Sandstone.	2
Bedding	Clean – Continues reasonably flat in the zone. Low exposure.	1
Cleavage	Clean. 068/85S. High exposure.	3
Joints	Clean strong. (1) 115/60S, (2) 135/68S – low exposure.	1

Nature of Source	Description	Score
Source - Bedrock	Moderate extent.	2
Type - Overburden	N/A	-
Height Above Receiver	<50m. Note shelf above this to provide protection.	1
Nature of Pathway	Joint/cleavage planes.	2
Protection of Receiver	15m+ protection of cleavage wall/clean/blasted.	1

TOTAL **14**

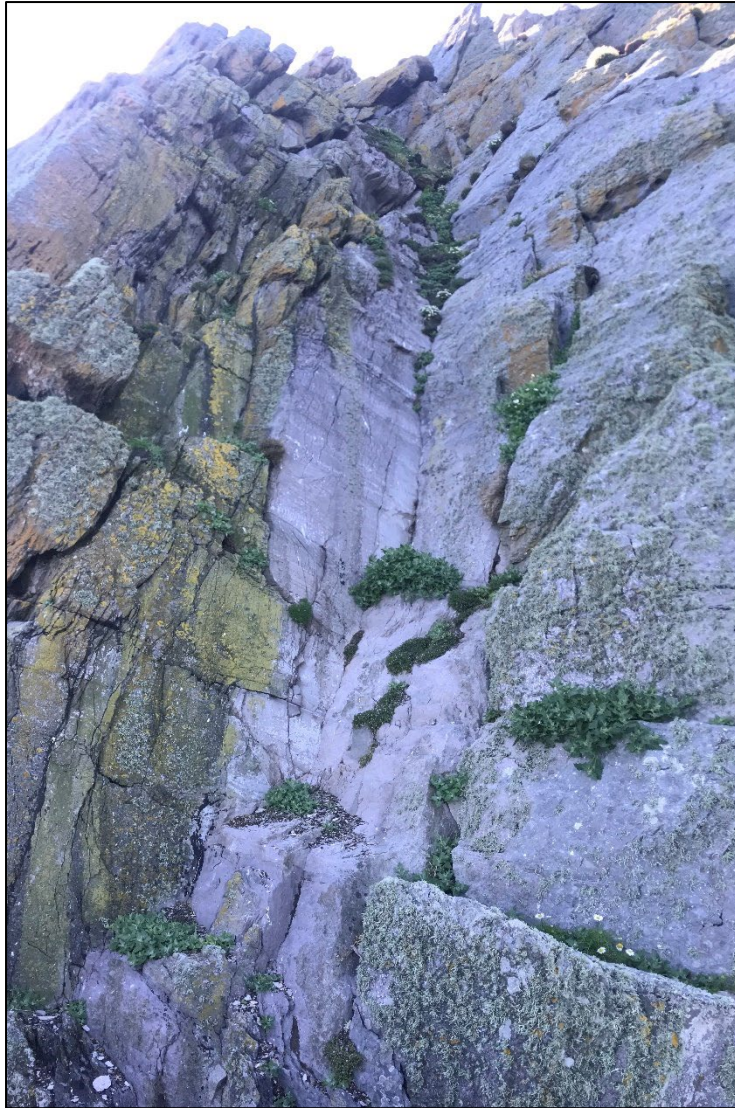
Photograph 12. Lower Lighthouse Road – Section 7.

Feature	Description	Score
Nature	Siltstone.	3
Bedding	071/35N. Clean below/moderate weathered exposure at height.	2
Cleavage	065/82S. Clean in blast zone, heavily weathered at height.	3
Joints	140/71E. Clean in blast zone, moderately weathered at height.	2

Feature	Description	Score
Soil	N/A	-
Scree	Cleavage slabs – ‘end of island’ at height.	2
Weathered Rock	At height – moderate extent.	2

Nature of Source	Description	Score
Source - Bedrock	Weathered bedrock up top; high extent.	3
Type - Overburden	N/A	-
Height Above Receiver	50m.	3
Nature of Pathway	Direct – joint planes.	2
Protection of Receiver	High blast walls locally.

TOTAL 22

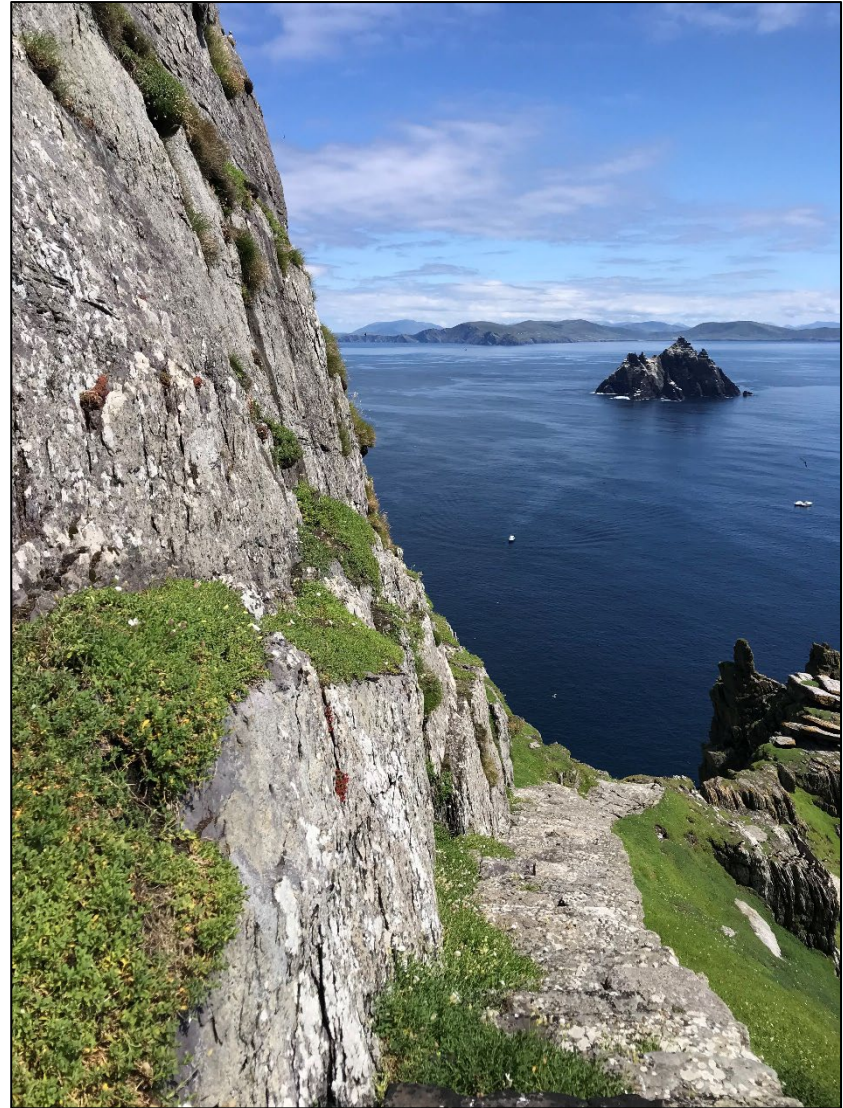
Photograph 13. East Steps – Section 1.

Feature	Description	Score
Nature	Siltstone.	3
Bedding	180/24E. Tight. Very little exposure.	1
Cleavage	062/82S. Tight. Clean cleavage.	1
Joints	Low exposure.	1

Nature of Source	Description	Score
Source - Bedrock	N/A	-
Type - Overburden	Cleavage slabs – few in number.	1
Height Above Receiver	<50m. This location 'under' high cleavage. Direct fall beneath.	1
Nature of Pathway	Direct vertical immediately adjacent. Mitigation: elevated position on island.	1
Protection of Receiver	None. However potential for overshoot, given the steep slope adjacent.	3

TOTAL **12**

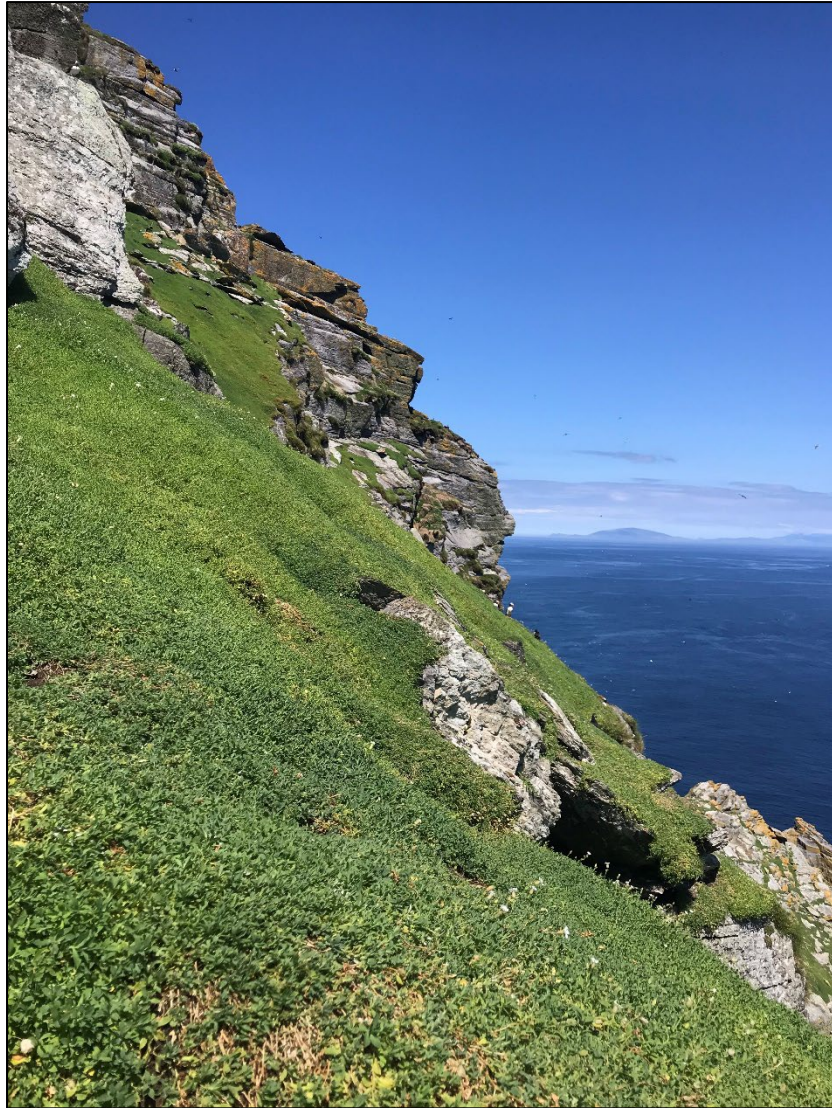
Photograph 14. East Steps – Section 2.

Feature	Description	Score
Nature	Dominant Rhyolite in mid-position. Note narrow footpath c. 1m. Small target – wide vegetative slope – c. 50m wide.	1
Bedding	Bedrock hard. Rhyolite to either side – wide “valley” feature. Little exposure until lower 30-40m.	1
Cleavage	No access – steep slope – at margins.	1
Joints	No access – steep slope – at margins.	1

Feature	Description	Score
Soil	High extent, moderately thick – extensive vegetation.	3
Scree	Low extent – very steep slope.	1
Weathered Rock	Low level of exposed weathered rock on vegetated slope. Moderate level on rock bluff to north – low level on bluff to south.	1

Nature of Source	Description	Score
Source - Bedrock	Bedrock from monastery zone.	2
Type - Overburden	Weathered cleavage slabs on vegetative slope.	2
Height Above Receiver	Extensive track from monastery to pier at c. 70% >50m.	3
Nature of Pathway	Direct on surface vegetation.	3
Protection of Receiver	None – narrow pathway c. 1m wide exposed for much of length to rockfall – save for cleavage bluffs at lower end which provide protection from upper falls – but source of rockfall in own right.	3

TOTAL **22**

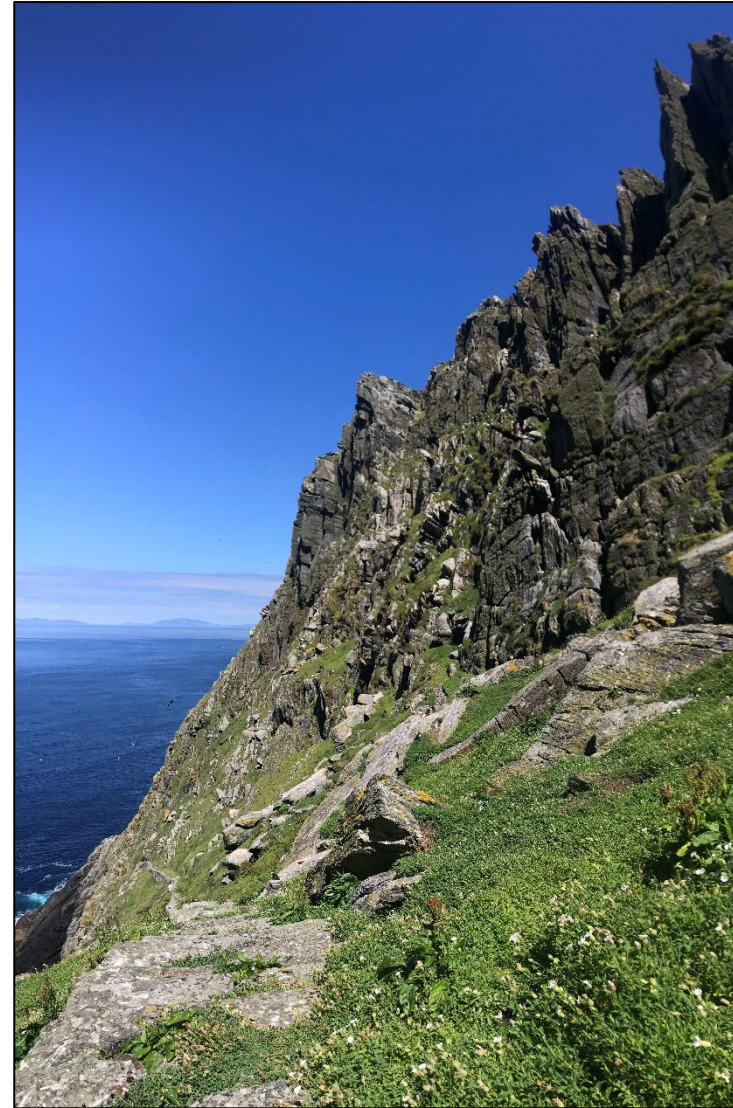
Photograph 15. North Steps.

TOTAL **32**
