Additional Method Statement for Archaeological Monitoring of Conservation of Upper Lighthouse Terrace Wall, Skellig Michael, Co. Kerry

*Alan R. Hayden
August 2023*

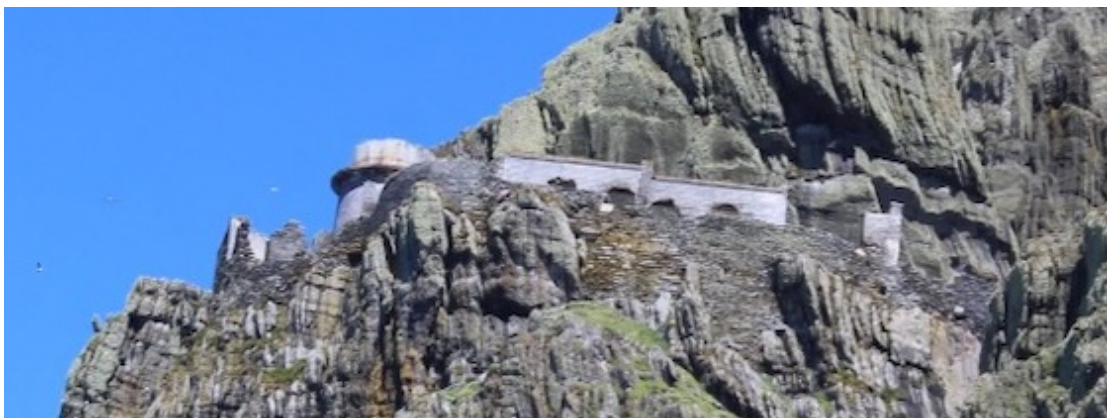
View of the parapet wall taken from the sea below.

While as usual there was little mortar remaining in the face of the wall and the joints are open, the wall was in remarkable good condition considering its age and its very exposed location. There were many loose stones which will have to be hammered back into place and many small gaps, many of which will need to be infilled with stone leaving nesting opportunities for birdlife but overall, the wall was secure.

The top of the wall will have to be rebuilt and capped with Valentia Slate slabs mortared in place. The amount of rebuilding of the upper part will vary considerably from little at the south end to the whole height above the finished terrace level immediately beyond the dwellings and west of the lighthouse tower, where the parapet wall was almost completely demolished, probably by the collapse of the lantern of the lighthouse sometime after the 1930s.

The conservation of the wall will be undertaken by the OPW masons and crew following the usual method used on the lighthouse walls on Skellig. Local stone, matching that in the wall in size and character will be used for repairs. Lime mortar will be used as bonding, as in the original work, but the face of the wall will not be pointed and gaps and small chambers will be left to allow birds utilise them for nesting. The finished level of the parapet wall is clear from the surviving sections and from scars on buildings which abutted the wall. The parapet wall will be capped with Valentia slate slabs, as again previously used on the lighthouse roadway walls on Skellig.
