**Archaeological Monitoring
of Conservation
of
Upper Lighthouse Terrace Wall,
Skellig Michael, Co. Kerry**

**Ministerial Consent C001045; Works No. W000428; Excavation No. E005321;
Detection Device No. R000551.**

*Alan R. Hayden
October 2023*

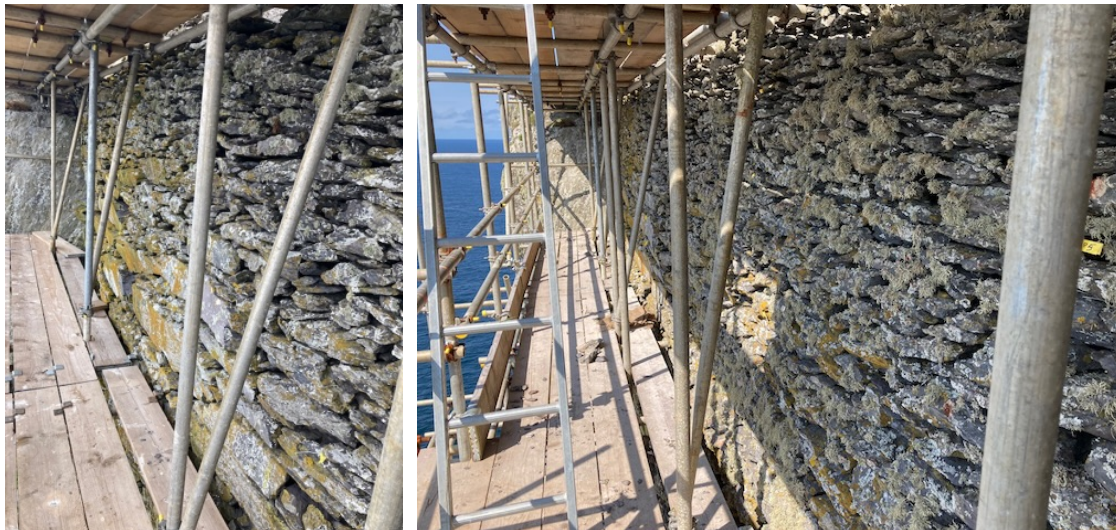
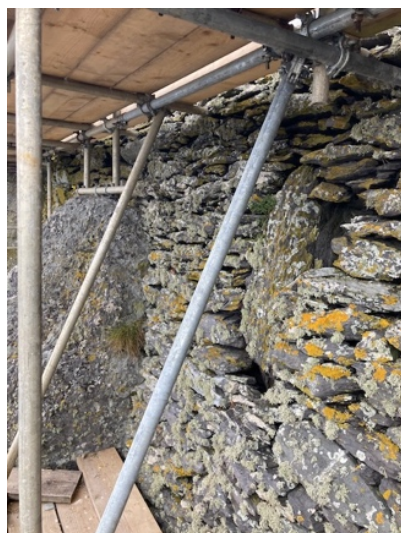
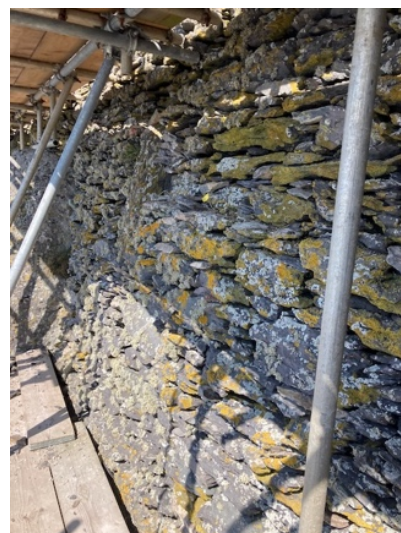
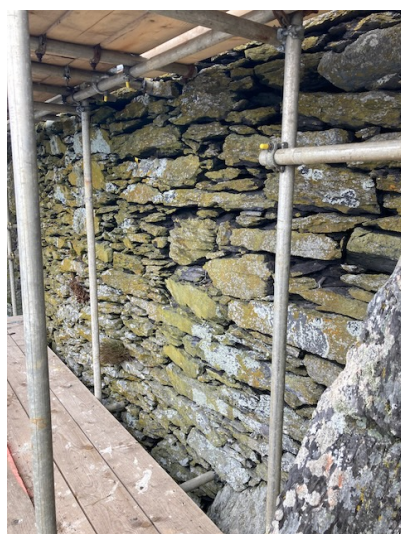
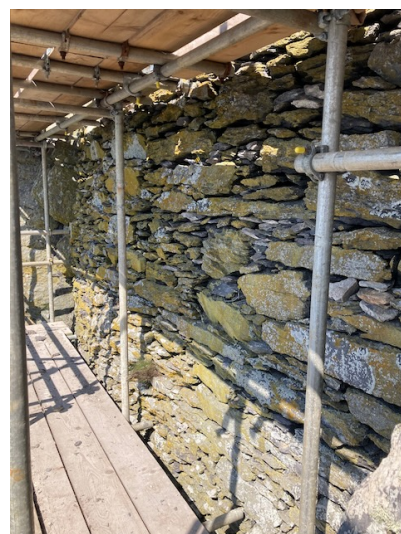
Contrary to expectations the base of the wall was in excellent condition (figs. 4, 8 & 13) and it did not require underpinning or any major intervention. It appeared that the movement evident in the upper part of the wall may have been no more than the result of the initial settling of the wall, which given its height could have caused all the movement evidenced there. The wall was also clearly rapidly built, as work did not start on the upper station until late 1825 at the earliest and the light was lit in December 1826.

While as usual there was little mortar remaining in the face of the wall and the joints were open, the wall was in remarkable good condition considering its age and exposed location. There were inevitably some loose stones, which were hammered back into place and some small gaps, which required infilling with stone leaving nesting opportunities for birdlife, but overall the wall was stable.

Fig. 4. Before (left) & after (right) photographs of central part of south wall of terrace from base (bottom) to top (top).

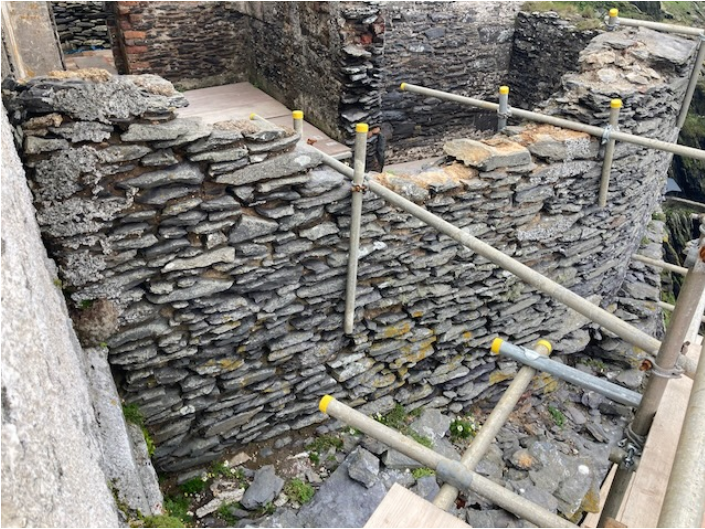
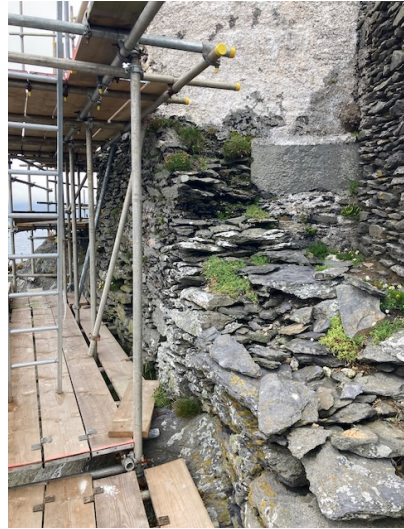
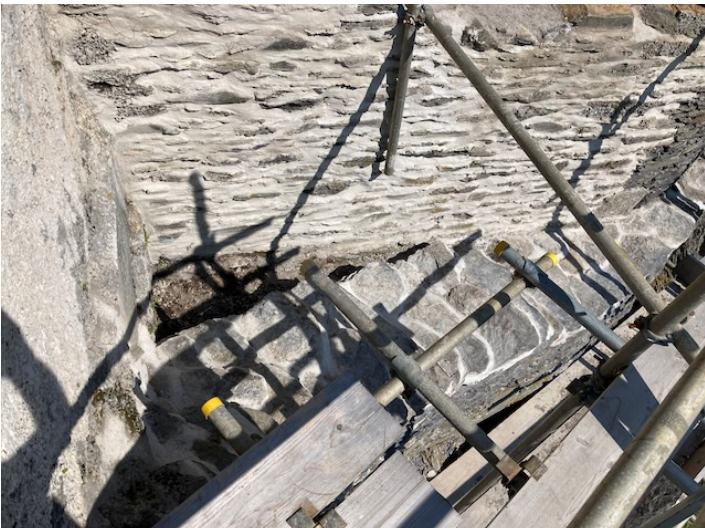
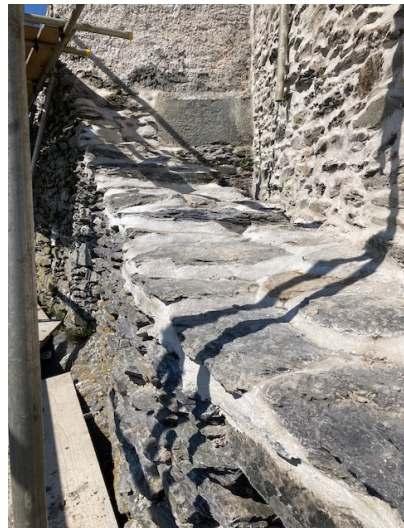
The top of a 5m long section of the parapet wall at the southeast end of the site (immediately south of the long drop toilet in the yard of House 1) was in poor condition (fig.

5). Here a shed (no. 21) had been built inside the line of the wall cutting off access to it from inside the complex. Perhaps as a result, the length of the parapet wall outside the shed was not maintained and the top of the line of the wall had unravelled and was loose. It required some rebuilding to secure it and knit it back into its former line. The external wall of the adjacent shed (No. 21) was also in poor condition and was repointed to secure it.

Fig. 5. Before (top) & after (bottom) photographs of top of terrace wall & wall of shed No. 21, to the south of the houses.

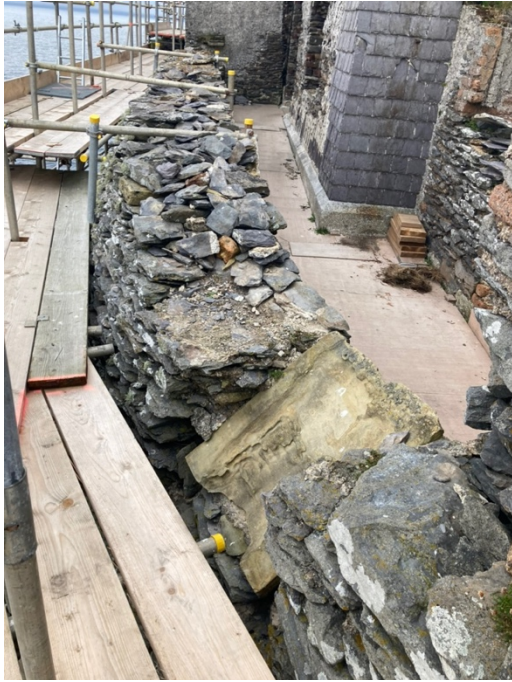
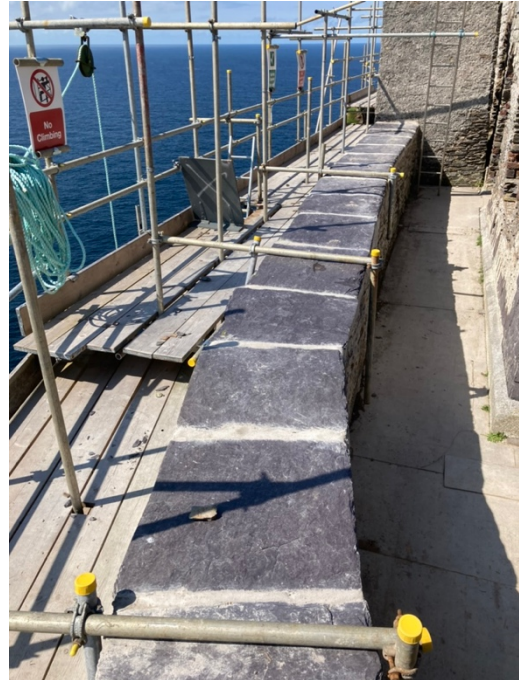
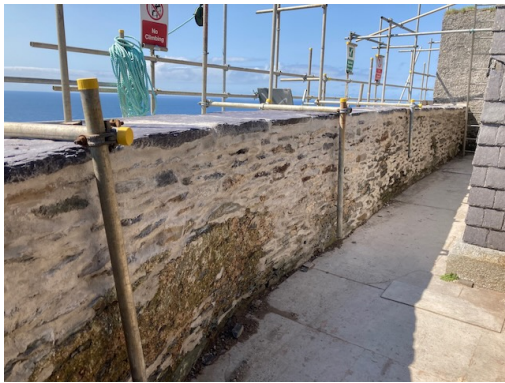
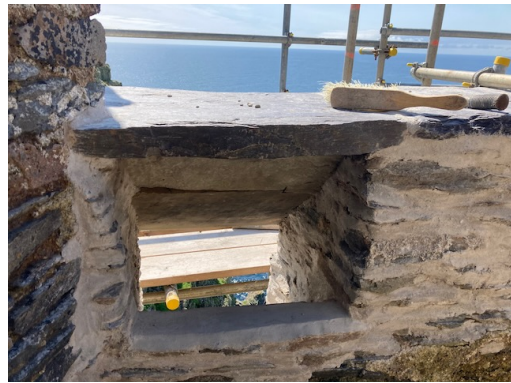
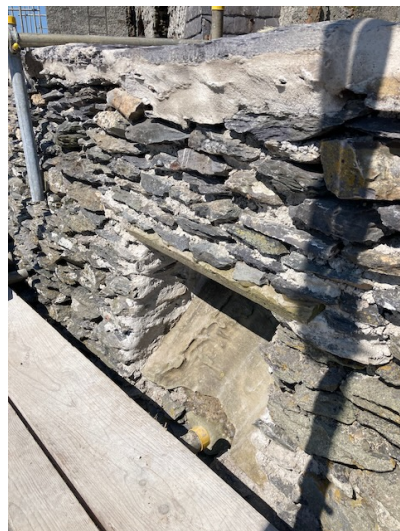
Fig. 6. Before & after photographs of parapet wall and details of rubbish chute behind House 1

The sandstone slab tops of the two rubbish chutes in the parapet wall behind the houses were missing and were replaced with Valentia Slate slabs (figs. 6 & 7).

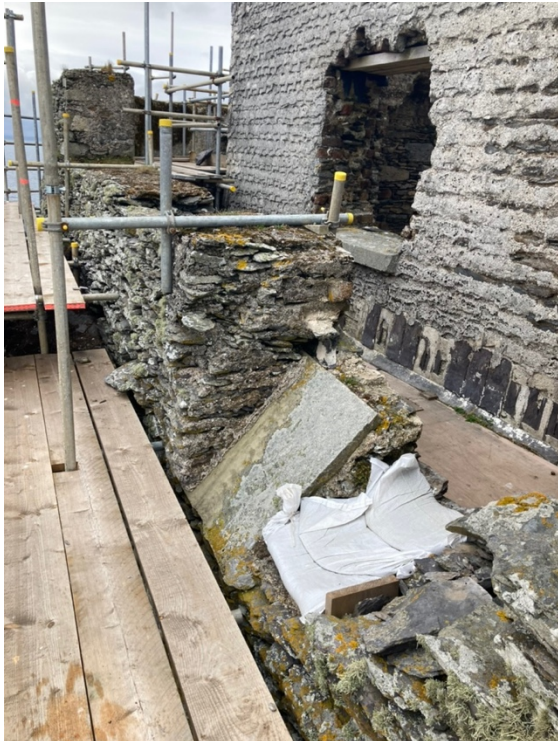
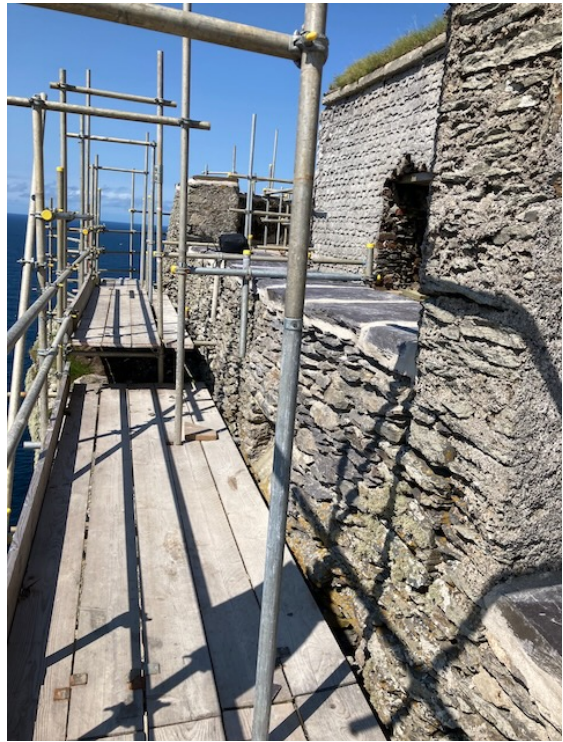
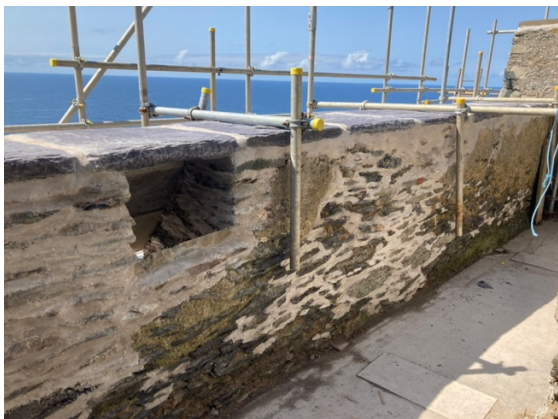
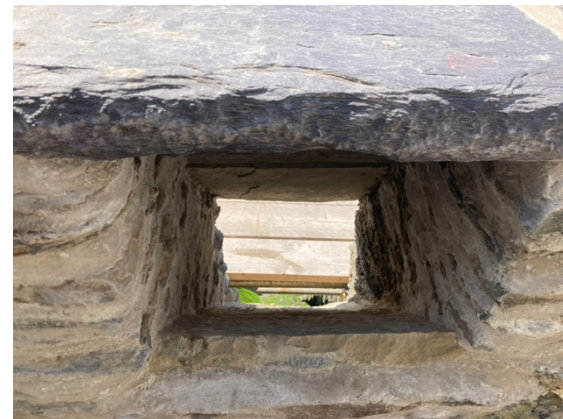
Fig. 7. Before & after photographs of parapet wall and details of rubbish chute behind House 2

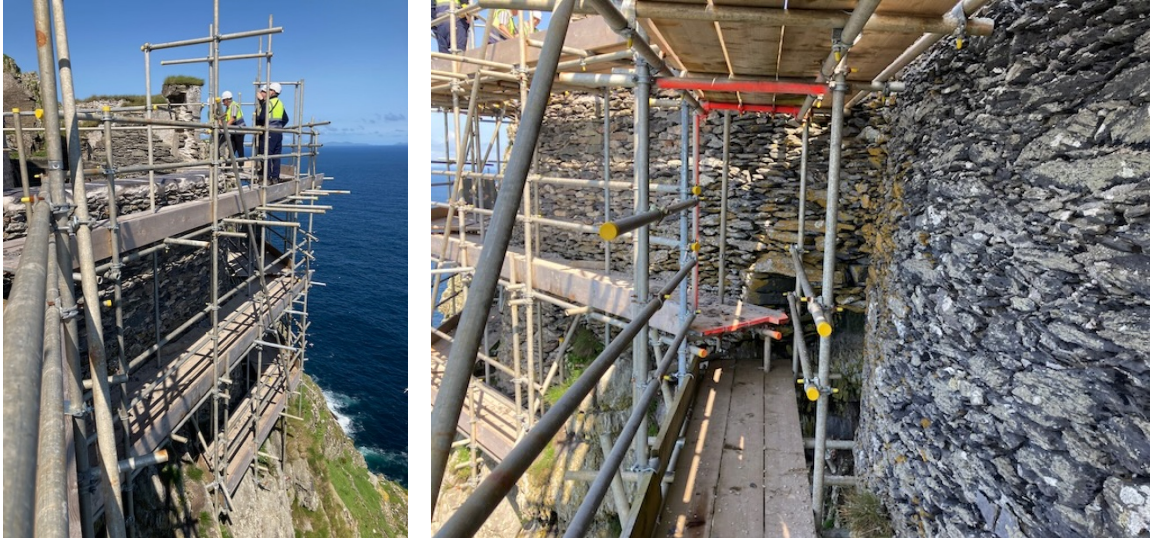
Fig. 8 North end of south wall, general views.

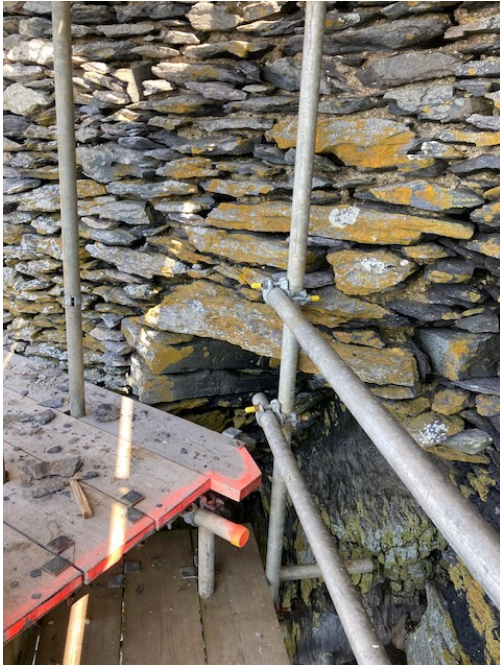
Fig. 9. Opening of drain from toilet House 2.

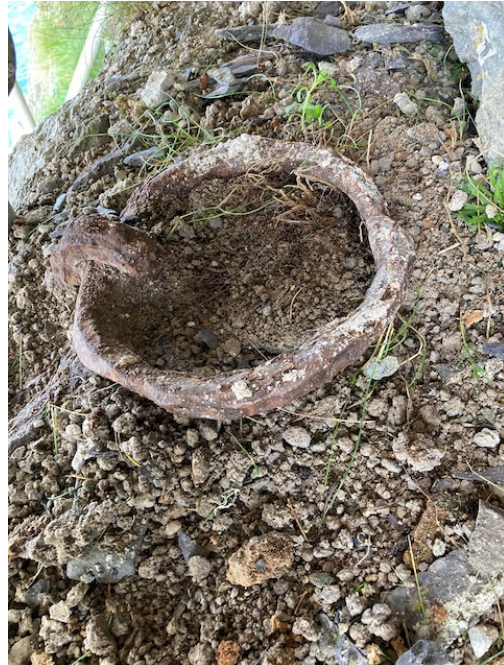
Secondly, an iron ring pinned by an iron bolt to the bedrock lay outside the base of the parapet wall opposite the lighthouse tower (fig. 10). This can only have had a use before the parapet wall was built and likely was used to secure the rigging for the lifting equipment used to construct the lighthouse tower.

Fig. 10. Iron ring fixed to rock at base of wall.

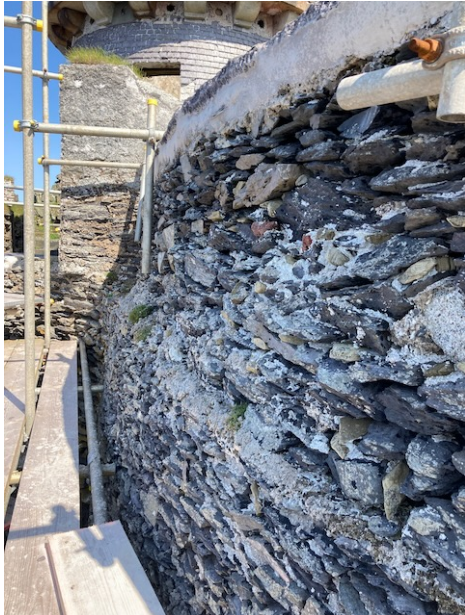
Firstly, the higher wall at the north end of the yard around the House 2 had evidently been first built to the same height as the parapet wall at the rear of the dwellings but was later raised in height, no doubt because of the wind coming from the northwest. The flat bed of mortar which underlay the original capstones was visible on the outer face of the wall beneath the later rebuilding (fig. 11). It was not visible on the internal face of the wall which was rendered.

Fig. 11. Raised top of north end of south wall.

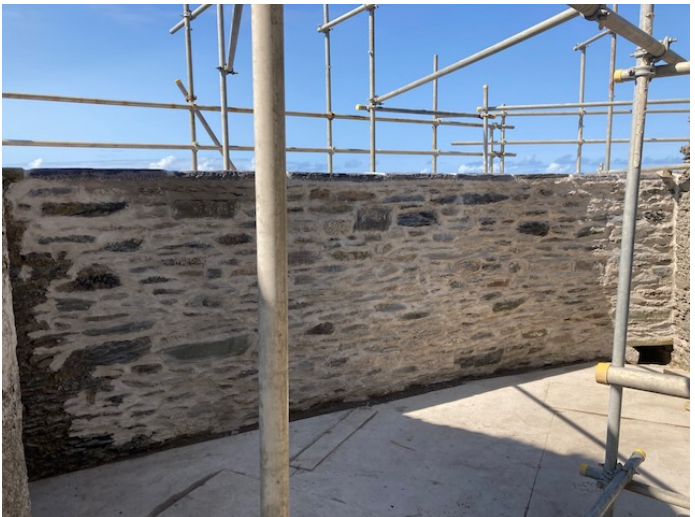
Fig. 12. Rebuilt parapet of north wall.

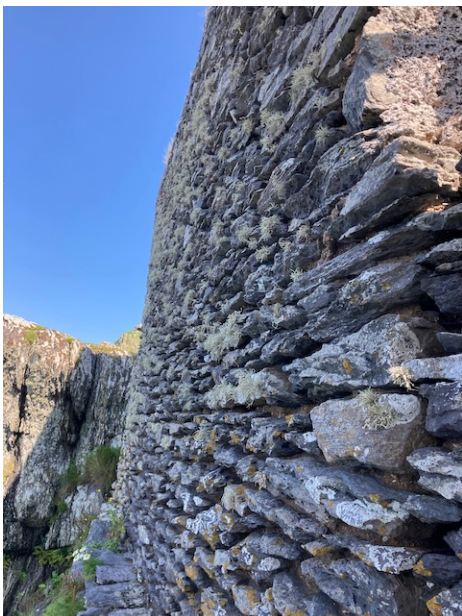
Fig. 13. North wall exterior.

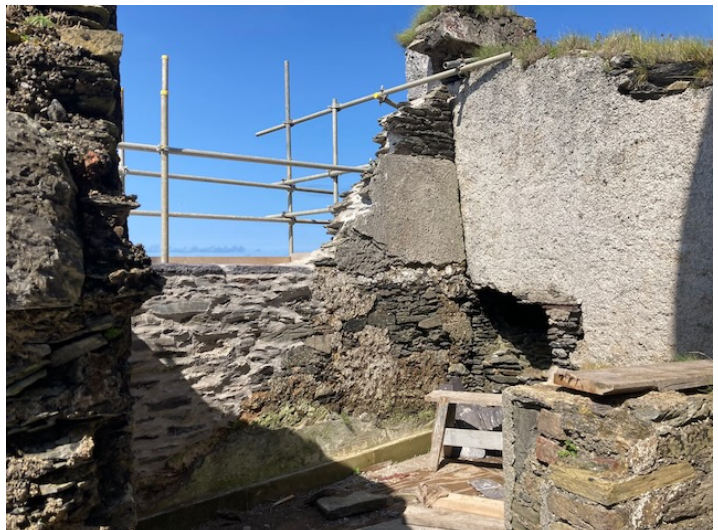
Fig. 14. Rebuilt section of wall in 'Teacher's House'.
