**Examination of a broken timber board fabric from the
Crash Deck Structure
at Cross Cove, Sceilg Mhichíl.**

TO: Office of Public Works, Attn: Mr Fergus Mc Cormick, Senior Architect

REPORT REF: 002413

REPORT BY: Gordon Knaggs F.I.W.Sc.

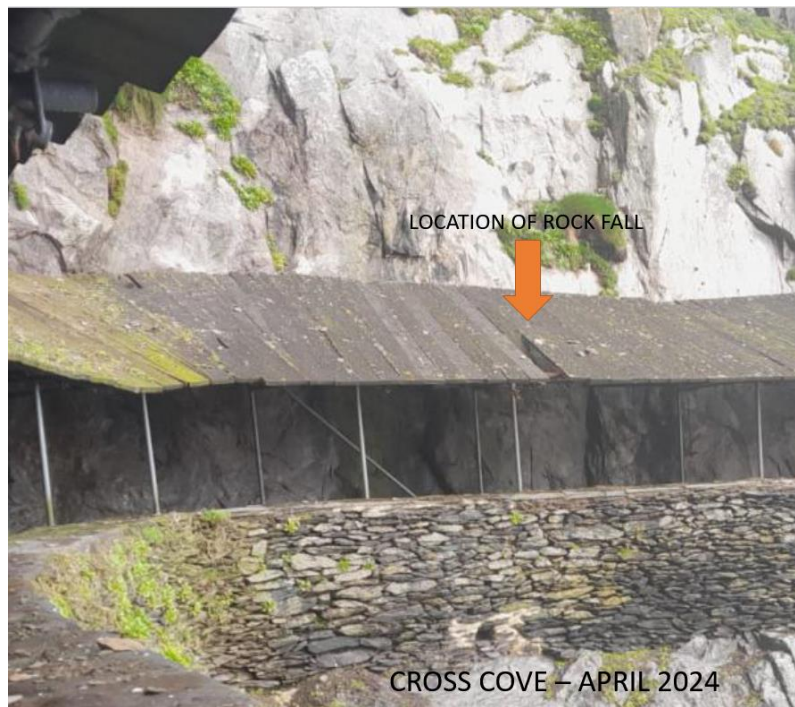
Image: Cross Cove Crash Deck – Location of board damaged by rockfall.

In relation to the sample of boarding provided by OPW, I understand that its location is within the first phase of construction from 2000 and that these crash deck boards were originally specified and described as being of Larch.

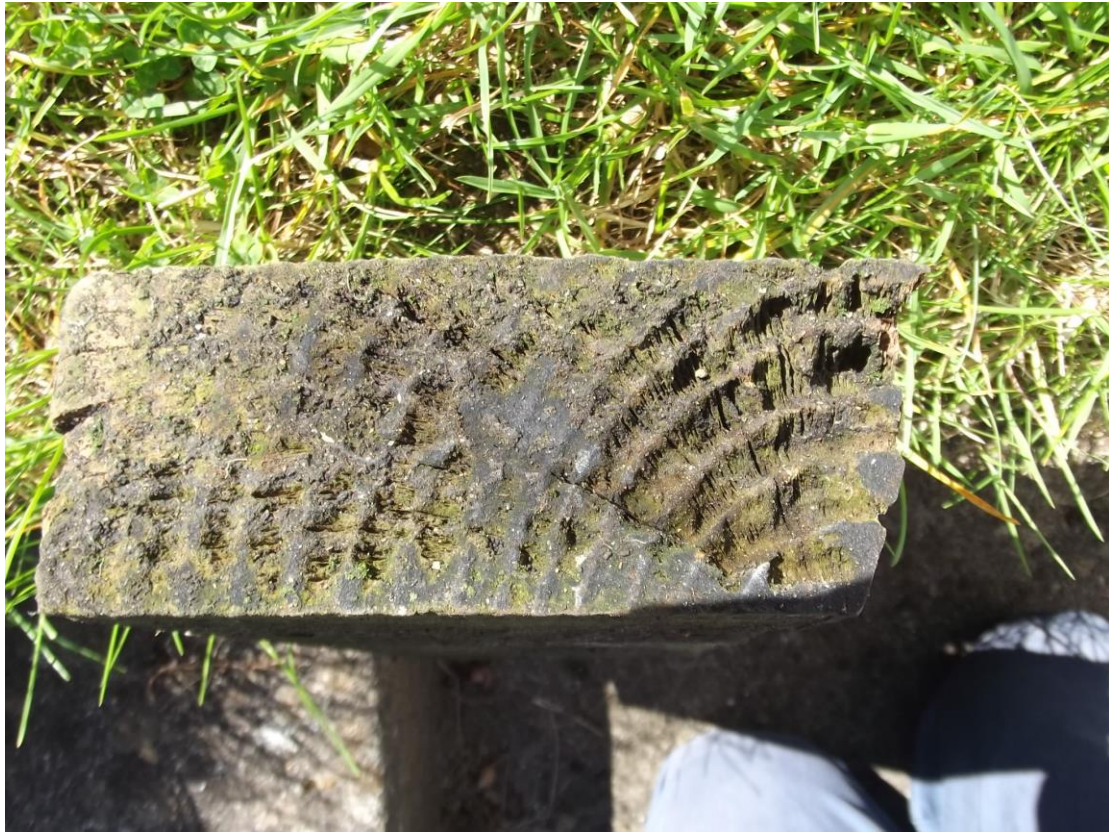
The sample of board, 350mm long with a broken end, and a nominal 125x50mm in section, was received on 2nd. May 2024. This was extremely weathered in appearance, with erosion of the earlywood of the wide annual rings – see Figure 1. Extensive algal and lichen growth was present on the original surfaces – see Figure 2. The core of the section was extensively decayed, with a relatively intact surface skin – see Figure 3. Samples of the strands on the decayed surface were microscopically examined and identified as fungal hyphae rather than being of plant roots. Thin sections were prepared from the relatively sound skin and also microscopically examined. The species present was identified as Douglas fir, *Pseudotsuga menziesii*.

The considerable erosion of the less dense earlywood portion of the growth rings at the end grain, and the extensive algal and lichen growth, suggests that this sample of board has been in service for a considerable time, possibly since the construction of the first phase of the Crash Deck during 2000, but this cannot be determined with any certainty.

Figure 1. End-grain, showing wide rings and erosion of the early wood.

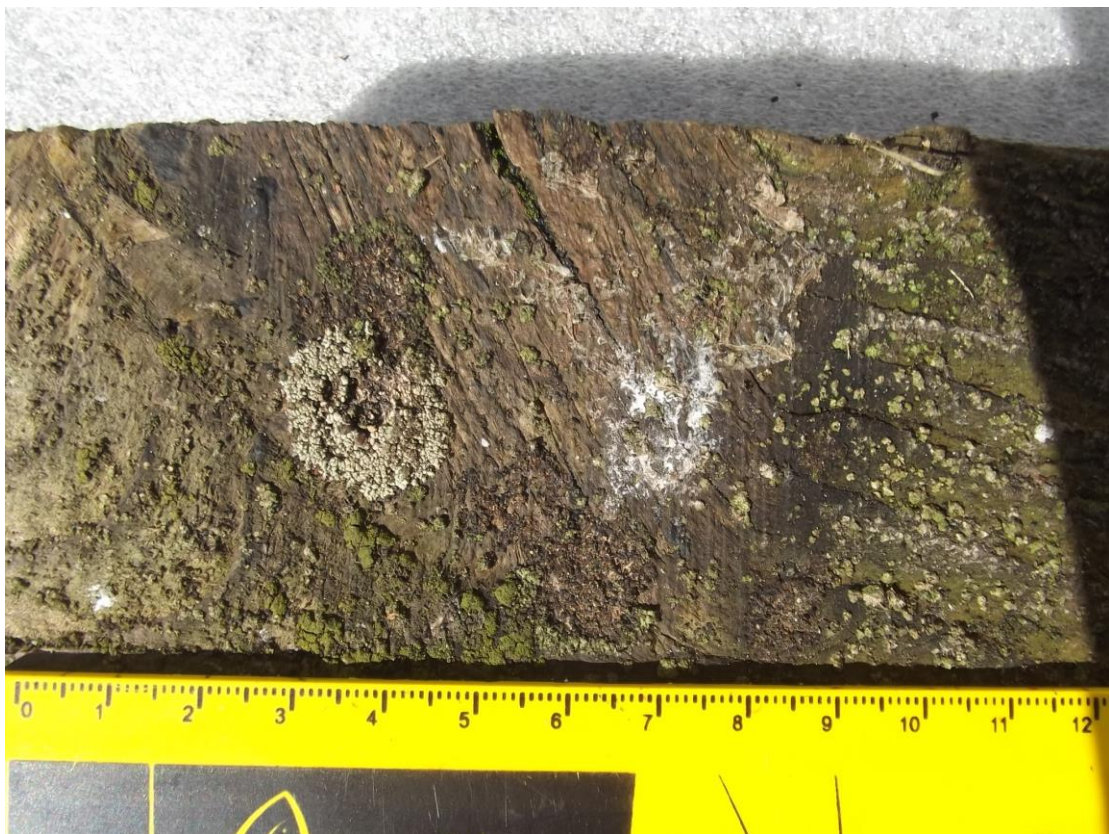
Figure 2. Surface growth of algae and lichen.

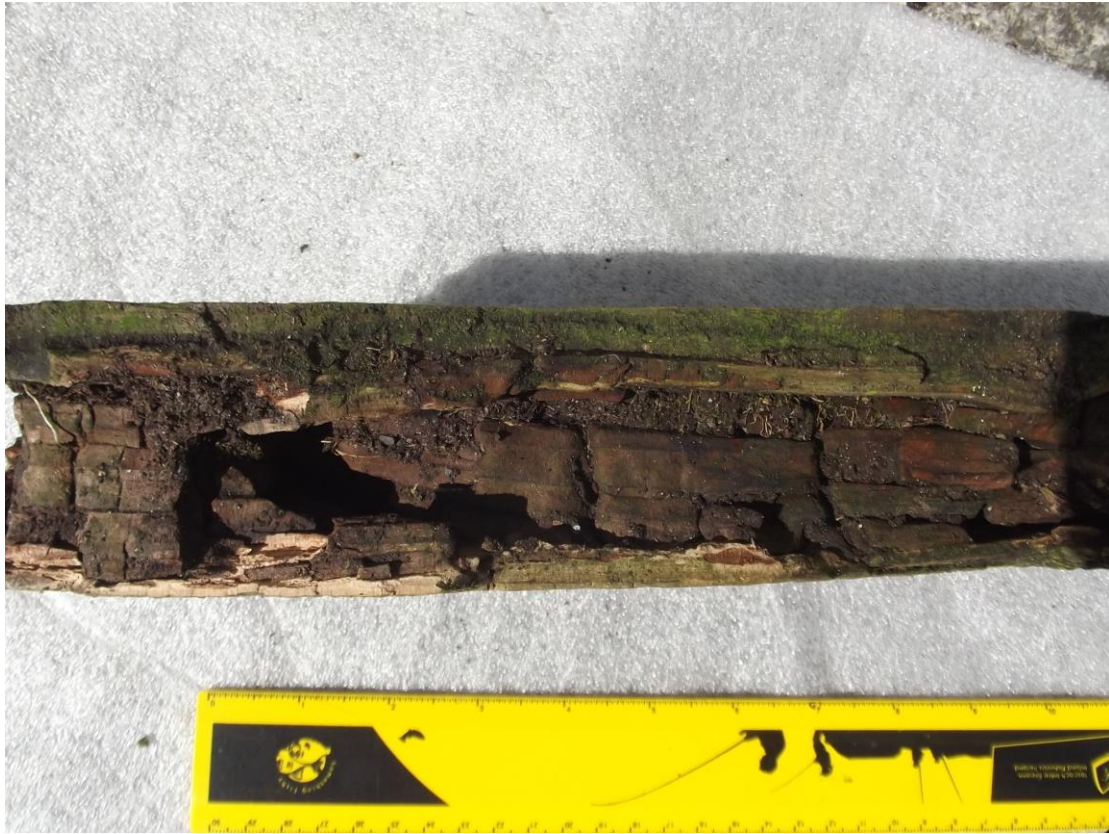
This board has suffered considerable decay and weathering, has lost most of its strength, and is unfit for continued use.

The pattern of decay, with a relatively sound surface skin which in service would have concealed the decayed core on a visual examination, is most unusual. Such a pattern can sometimes be seen in timber which has received a surface treatment with preservative, but I understand that no such treatment was applied.

Figure 3. Severe decay in core of board, with relatively intact surface layer.

An examination should be carried out to determine the extent of decay in the other boards in the structure, and to identify if other species are present.

1. The boards should receive pressure treatment with a water-borne copper-based preservative. (boards should be dried before treatment)
2. Any cut ends or drill holes should be re-treated.
3. A space of 4-6mm should be left between adjacent boards to minimise the lodging of rainwater.
4. All top ends of boards should be kept clear of the rock face.
