**Examination of timber boarding at  
the Crash Deck Structure,  
(Phases 1, 2 and 3)  
at Cross Cove, Sceilg Mhichíl.**

**TO: Office of Public Works, Attn: Mr Fergus Mc Cormick, Senior Architect**

**REPORT REF: 002414**

**REPORT BY: Gordon Knaggs F.I.W.Sc.**

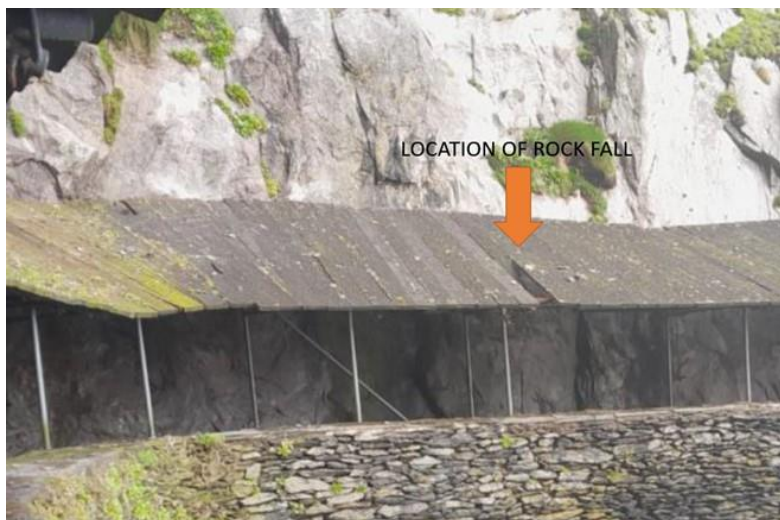
**Image: Location of April 2024 Rockfall - Cross Cove Crash Deck**

Subsequently, this Crash Deck was extended at the lower end towards the pier, as part of Phase 2 works in 2016 and further in 2022 as part of Phase 3 works. Recently a large rock fell and broke through one of the boards in the Phase 1 section of the Crash Deck between Bays 15 and 16 – refer to OPW Site Layout Plan on page 6.

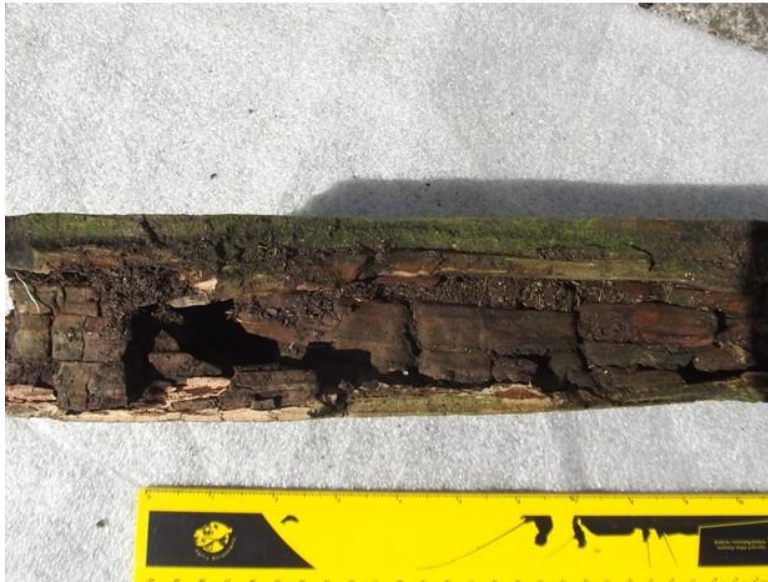
**Image: Photo of board sample from Report 002413 - severe decay in core**

I received a sample of this board, examined this and prepared a separate report (my number 002413), which concluded that the board has suffered considerable decay and had lost much of its strength, leading to fears that other boards in the Crash Deck were similarly affected. I was therefore requested to carry out an in-situ examination of the boarding.

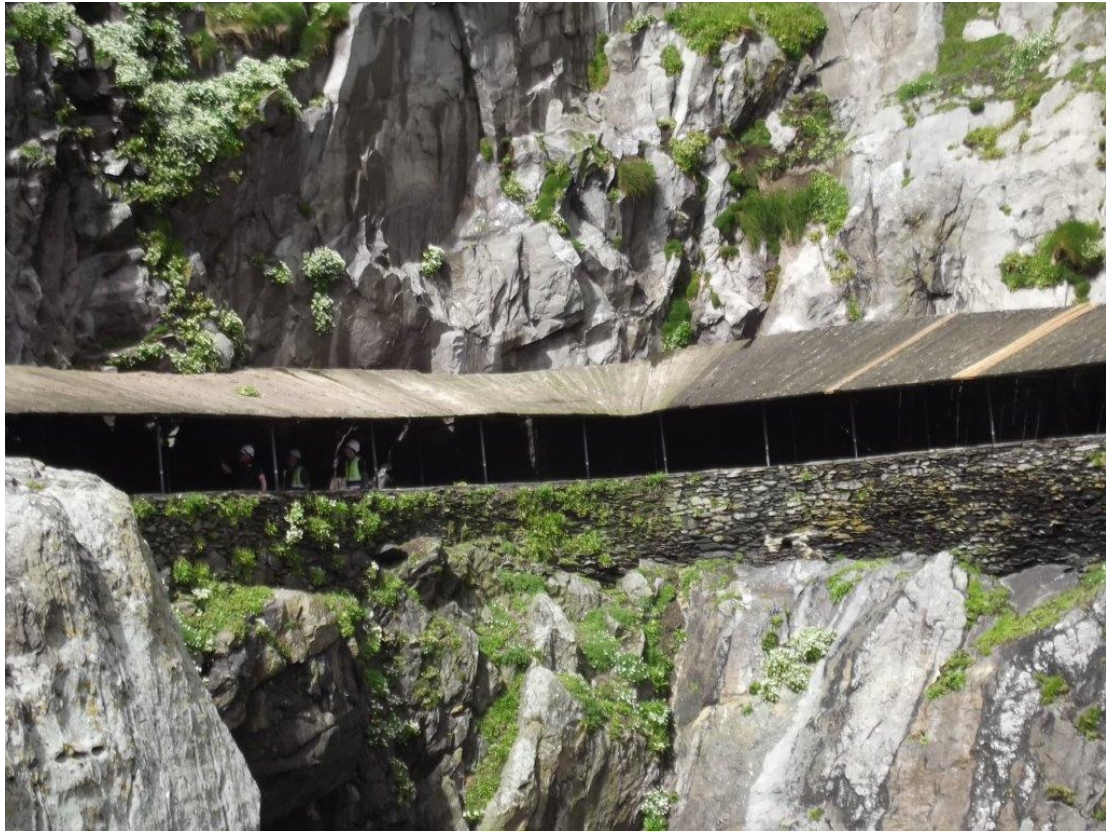
Initially the top surface of the boarding of the Crash Deck was scanned with a telescopic lens at a distance from the helipad area. This area was utilised as it provides a relatively clear line of sight of the overall structure, in particular the Phase 1 section and subsequent repairs. Four newer (ie replacement) boards were visible near the sharp curve in the boarding under a gully – see Figure 1.

Figure 1. Upper end of walkway, showing replaced boards at right.

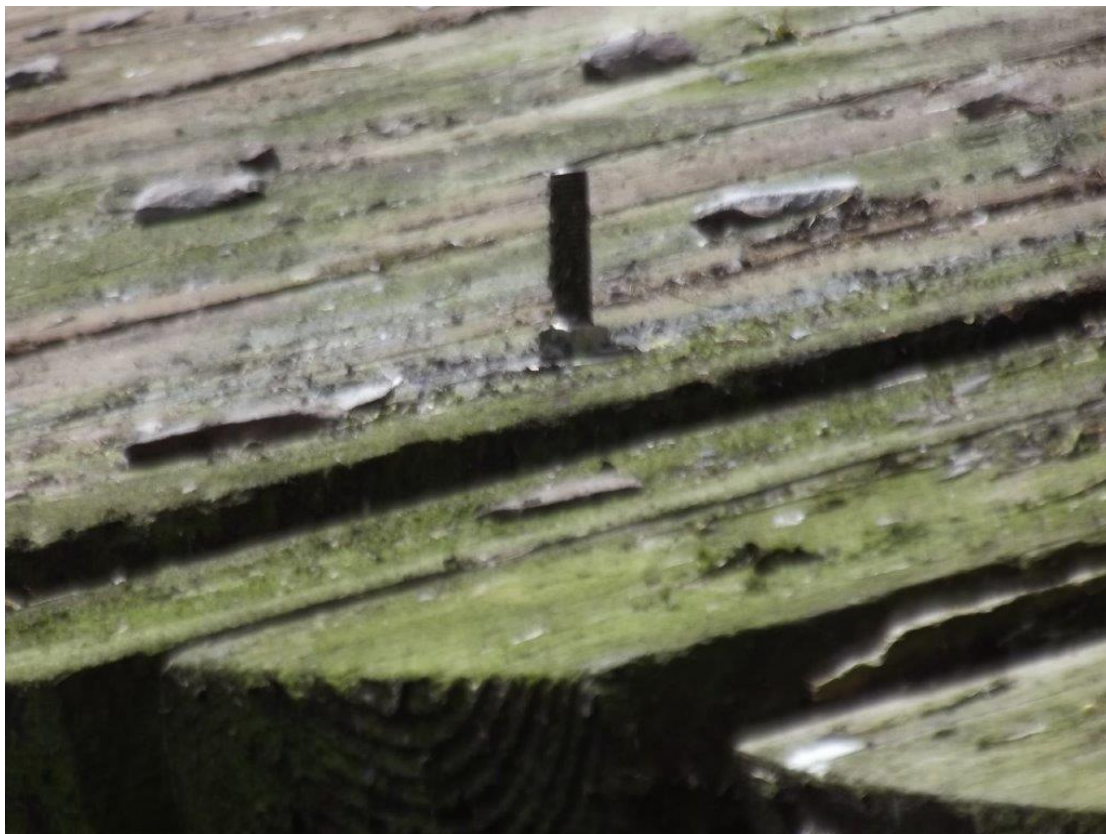
'J' bolts holding the boards to the supporting structure (scaffolding poles) were fixed through the boards and held by washers and nuts. A number of small stones, and some vegetation, were visible on top – see Figure 2.

Figure 2. J bolt through boards. Note loose stones from above.

- Where holes are drilled for 'J' bolts these should be flooded with preservative before installation, and compressible washers fitted under the washers on top to minimise intake of water. 4-6mm gaps should be left between adjacent boards to facilitate drainage.

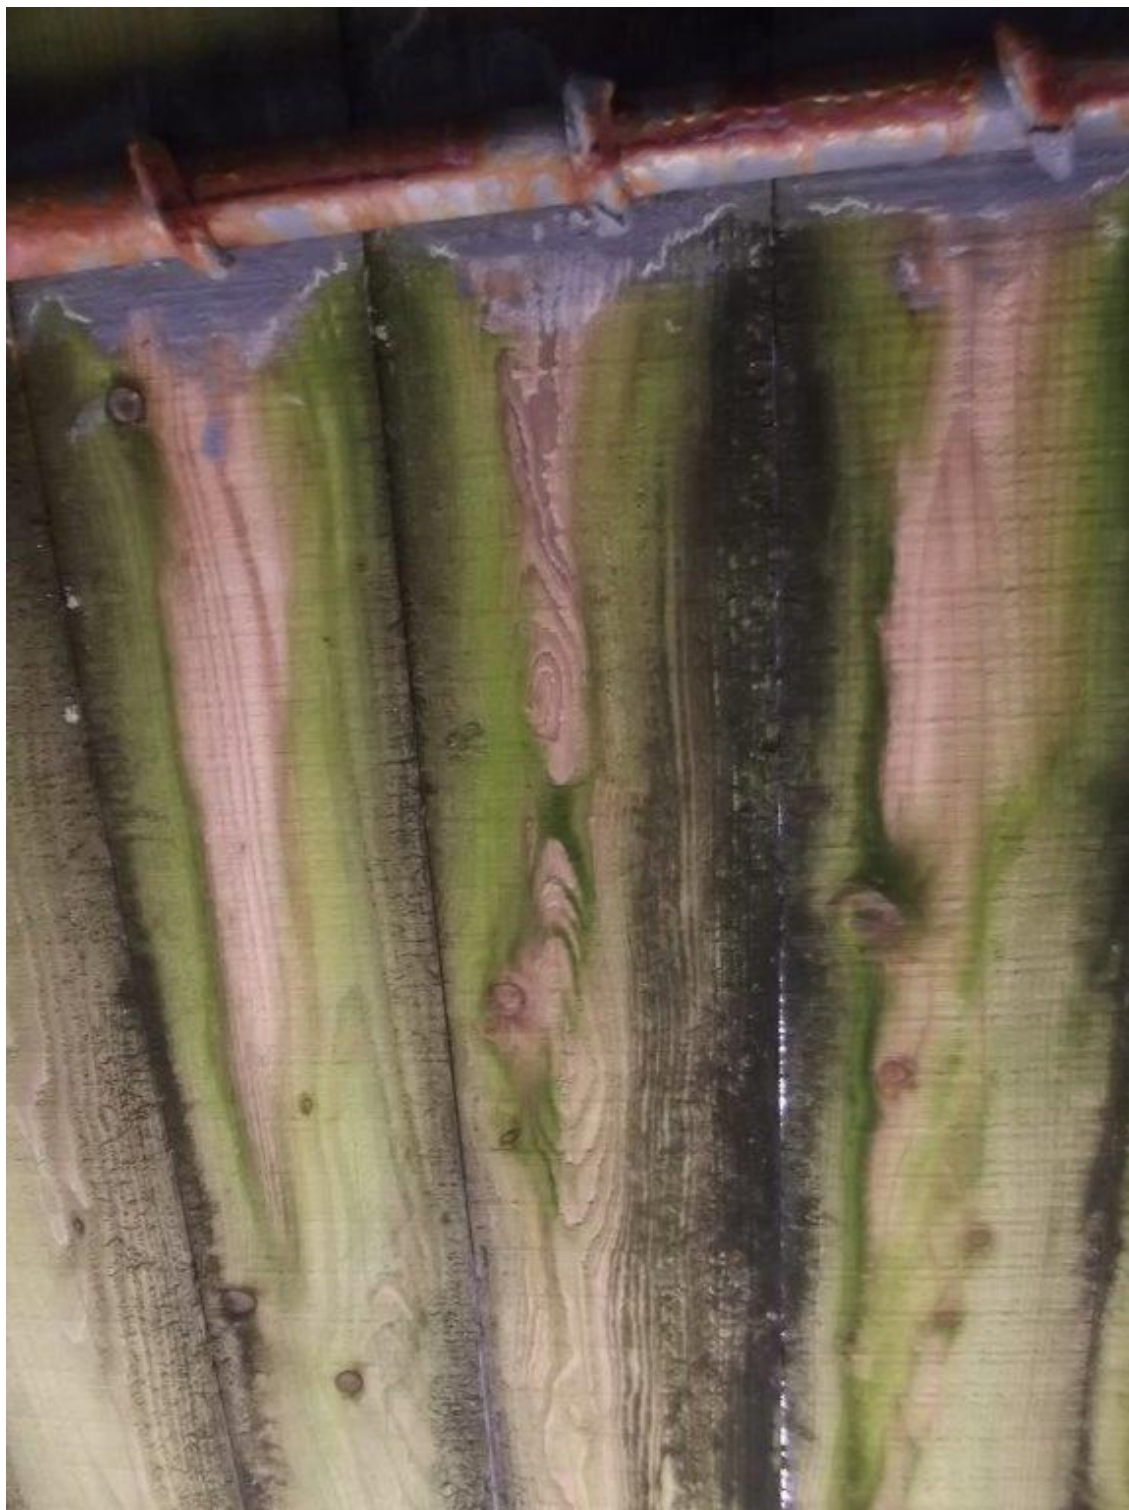
Boards to Phase 2 (2016) and Phase 3 (2022) sections of the overall Crash Deck at Cross Cove are still sound and a further useful service life can be expected, probably of the order of at least five years. Those boards of larch are inherently more durable than the spruce within the Phase 3 (2022) section and it is likely that the spruce boards will need to be replaced after a shorter total service period than the larch. Periodic inspections should be made to assess the condition of the spruce boards.

Figure 3. Underside of boards installed in 2016.

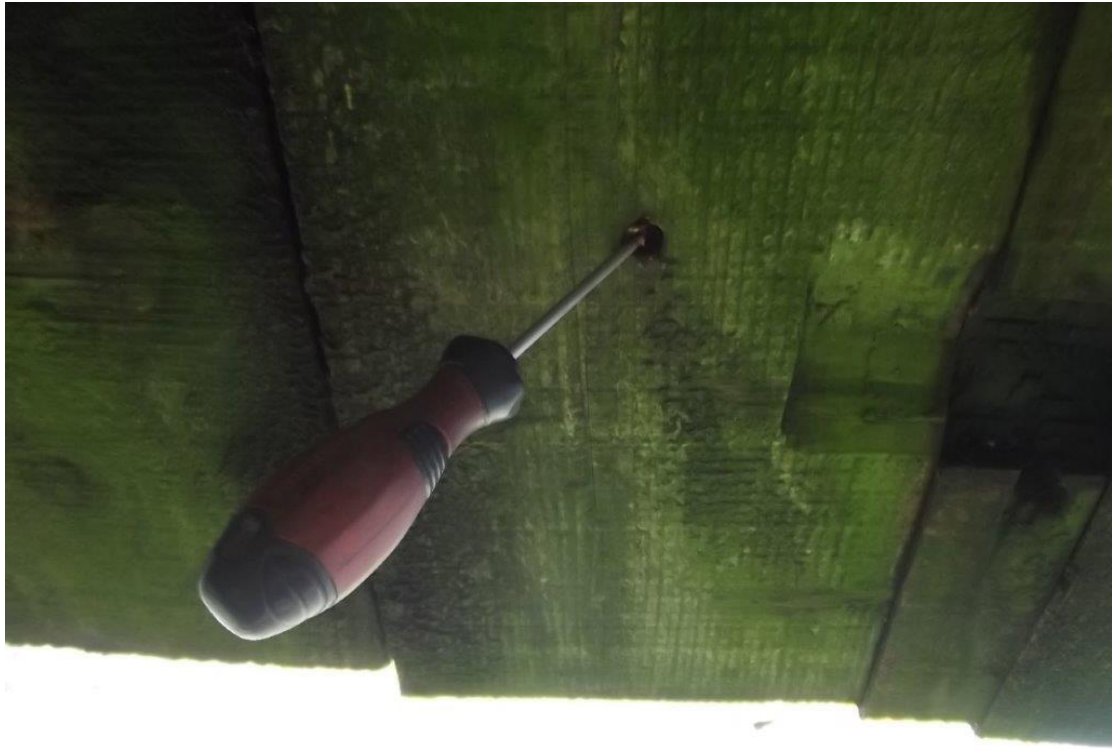
Some cores were taken by Pressler borer for later examination – see figure 4. Notethat many of the boards had additional holes drilled through near the bottom (not utilised for finalised locations of 'J' bolts).

Bay	Board	Comment
<b>Phase 1: 2000+</b>		
Bay 1	Board 2.	Bottom soft and decayed at hole.
Bay 1	Board 4.	Bottom of board broken and decayed.
Bay 2	Board 1.	Decay at hole, board 3 decay at hole.
Bay 3	Board 3.	Decay at hole – see Figure 4
Bay 3.	Board 7	Decay at hole.
Bay 4.	Board 3	Decay at hole.
Bay 5.	Board 3	Decay at hole.
Bay 5.	Board 8.	Decay at hole.
Bay 10.	-	Decay at a series of holes.
Bay 20.	Board 2	End of board soft
Bay 20.	Board 12	Decay at notch to underside – see Figure 5
<b>Phase 2: 2016+</b>		
Bay 25.	-	Natural colour of larch visible on underside. Decay not seen in bays 24-30
Bay 30.	-	Two larch boards, remainder of spruce.
<b>Phase 3: 2022+</b>		
Bays 30-60.	-	Spruce. No decay seen.

Figure 4. Decay at hole with screwdriver inserted deeply.

Decay, and hence weakening of the boards, was widespread in the Phase 1 section of the Crash Deck at Cross Cove. These boards must be considered unfit for continued service and should be replaced. Note that loss of impact strength due to fungal attack

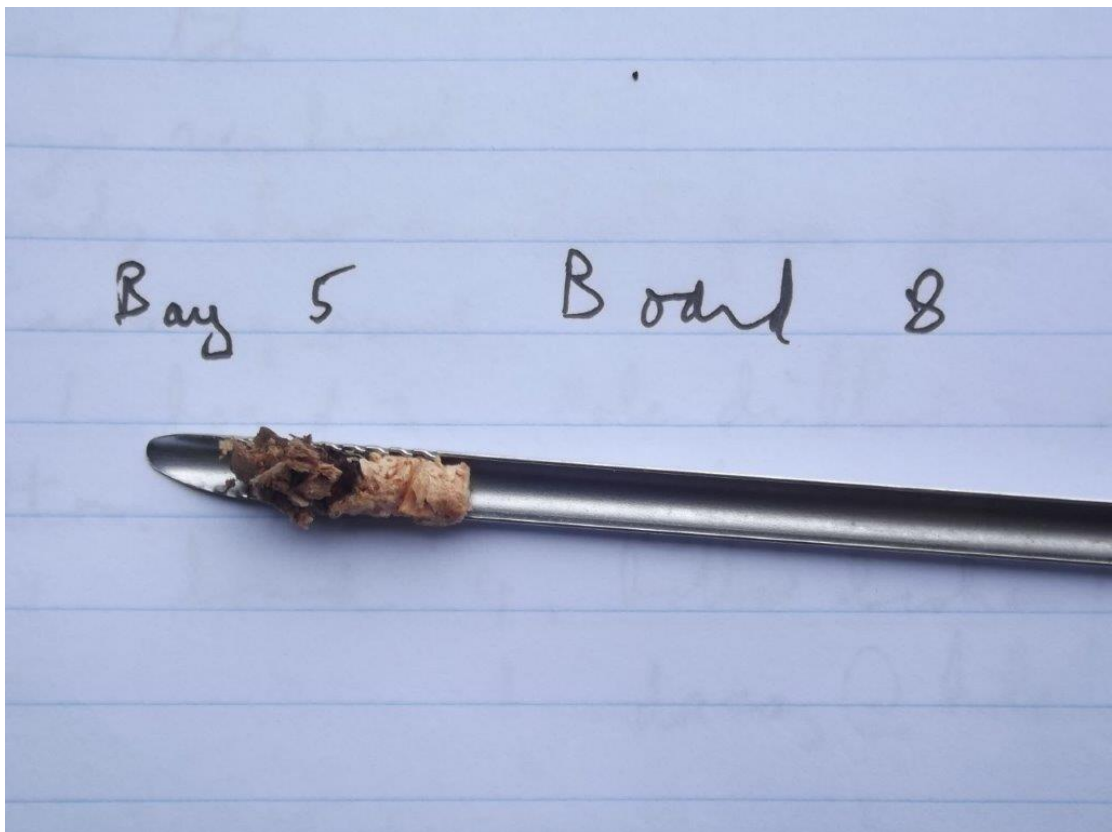
Cores taken by Pressler borer were also examined. Some, as shown in Figure 6, were relatively sound on the surface but had decay within the boards. Fungal hyphae (strands) were seen to penetrate the cell walls, confirming fungal decay.

Figure 5. Section of core taken with Pressler borer, sound near surface, decay inside.

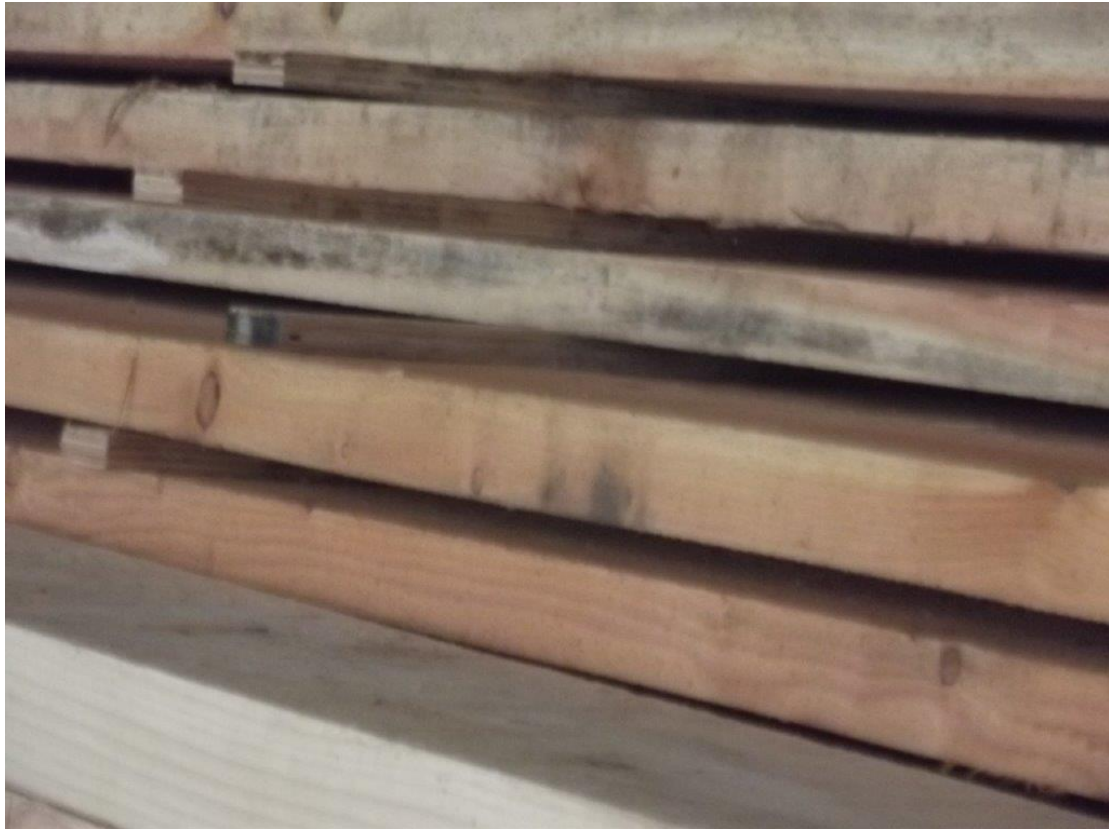
- Most knots were small and well-spaced and overall the boards can be taken as of SS (Special structural) grade. The boards were generally clean and bright but with some staining in the sapwood (the outer, less durable portion of the log) – see figure Z below. Decay was not seen.

Boards stickered out in depot, with sap-stain at edge of centre board.

- If some of these boards are to be used as replacements to the timber deck to the Crash Desk in Cross Cove, any sapwood should be trimmed away, and the slower-grown material preferentially used.

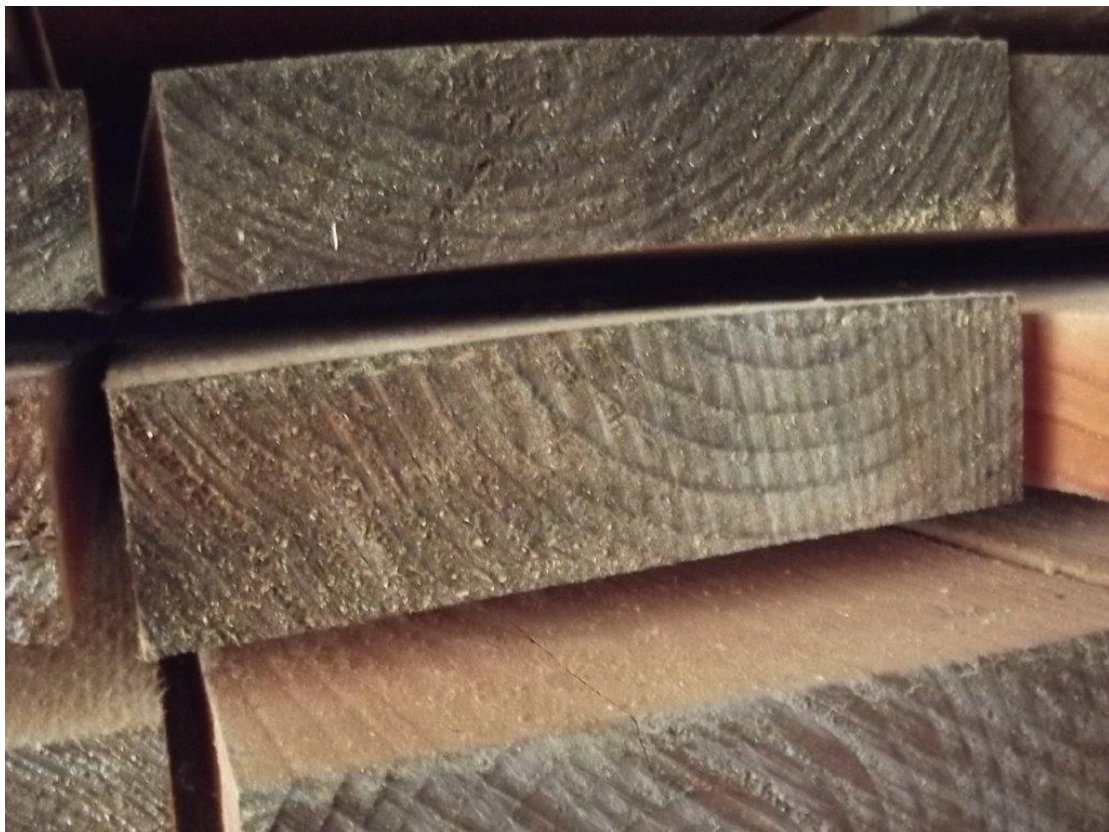
- The moisture content of the boards was uniformly 11-12%. The rate of growth of the boards varied, most being slow-grown but a small number with annual rings up to 8mm wide.

End-grain of boards in Killarney depot, showing rapid rate of growth.

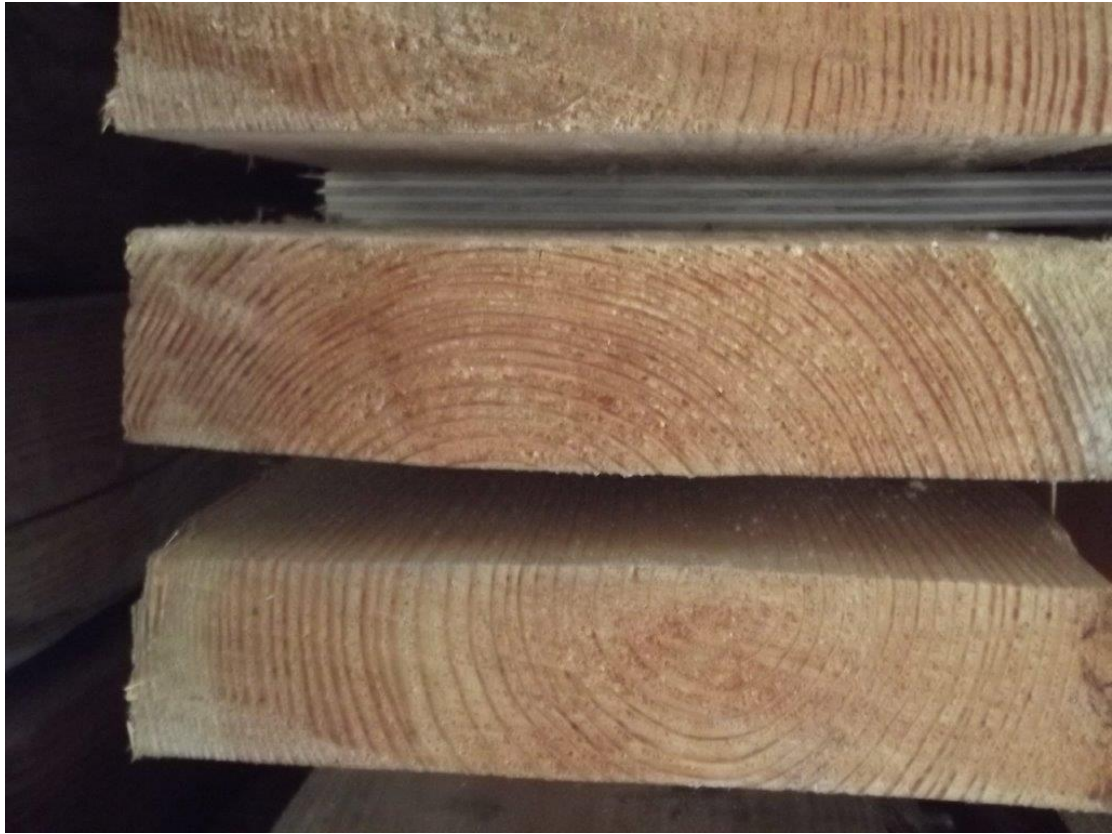
End-grain of slow-grown material. Stain to sapwood at edge of two lower boards.
