Archaeological Method Statement
for the Monitoring of Repairs
to the North Steps,
Sceilg Mhichíl, Co. Kerry.

Alan R. Hayden

May 2025

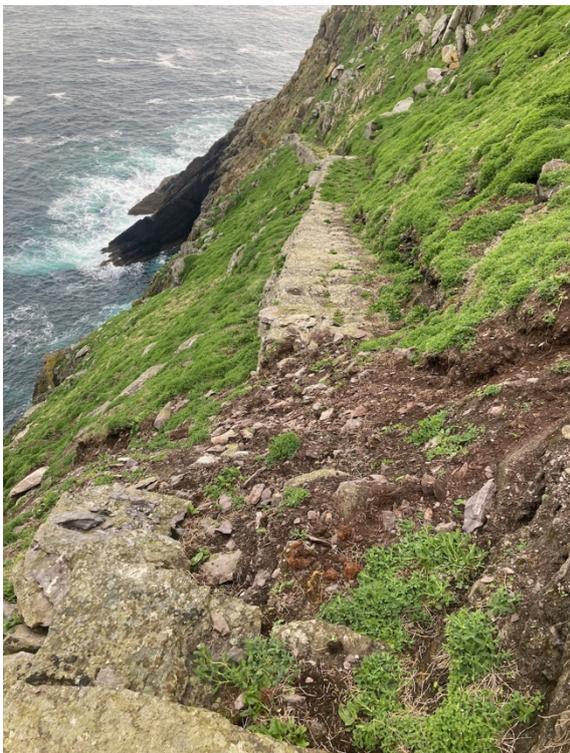
Fig. 2. Looking down on the damaged area.

The drystone masonry of approximately eight steps was damaged and appears to have been largely removed by the rockfall. The outer supporting wall below the steps also appears to have been completely demolished and any masonry that may survive in the base of the

steps is hidden below the loose material that fell onto the area. None of the large slabs which formed the surface of the steps and which would have been pushed downhill were visible on the steep slope below and they may all have been lost into the sea. A few more blocky large stones were present but they appear more likely to be part of the material which fell onto the steps.

The damaged area of the steps will then be cleaned of loose debris under archaeological supervision and any surviving *in situ* masonry will be recorded before any repair or rebuilding is undertaken.

As the original top slabs are probably all lost, new slabs will be required to replace the originals on the surface of the steps. However, the stockpiles of stone currently maintained on the island do not appear to include suitable stone. In any case, they all lie a considerable distance from the damaged area of the North Steps and transporting stone from them to the North Steps would provide difficulties. As a result, stone to replace the missing elements will likely have to be sourced locally. The campion-covered scree slope above the steps is littered with stone and might provide either suitable slabs or larger rocks that could be split to form the required material. Any searching and removal of rock from the area will be archaeologically monitored. There are no known archaeological features on this slope.

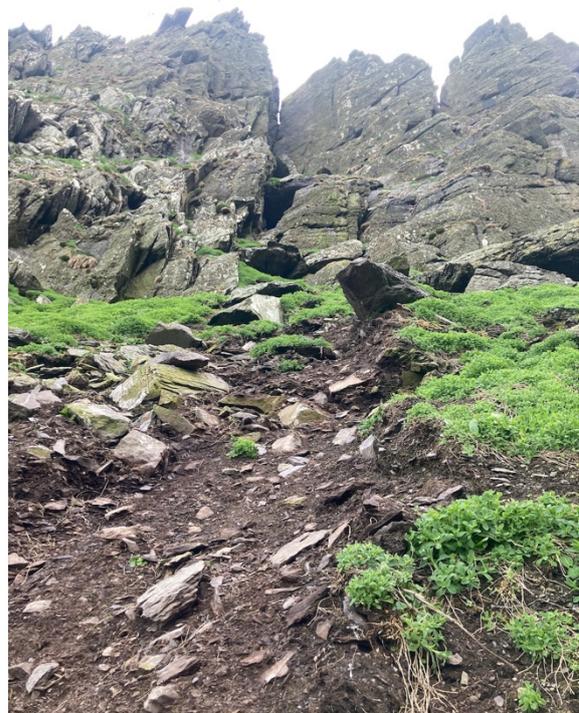
Fig. 3. The scar on the slope above the steps.

There was a deep scar about 10m in length in the campion cover on the slope above and adjacent to the east side of the damaged section of the steps. There were no visible marks that a rock had detached from the high cliffs above and so the damage may have been caused by a large rock slipping downslope from the scree slope above the steps.

The area of the scar above the steps will be examined to identify and remove any further material that might be in danger of slipping and the area will be stabilised. The steep slope below the steps will also be searched for any fallen masonry, which will be retrieved for reuse.
