Archaeological Monitoring of Repairs to the North Steps, *Sceilg Mhichíl*, Co. Kerry.

Ministerial Consent No. C001455, Excavation Licence No. E005831,
Detection Licence No. R000767 and Works No. W000820.

Alan R. Hayden,
September 2025

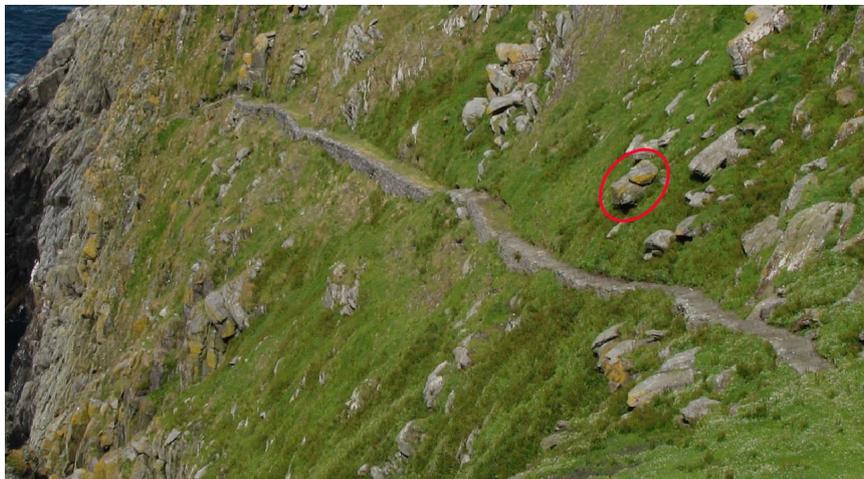
Fig. 7. 2010 photograph showing the two large rocks which slipped in the winter of 2024/25 and caused the recent damage to the North Steps (A.R. Hayden).

Two large rocks lying between five and ten metres above the roadway (*fig. 7*) slipped downwards and damaged approximately ten of the drystone masonry steps of the upper part of the North Steps. There was a deep scar about 10m in length on the slope above and adjacent to the east side of the damaged section from where the rocks had slipped (*figs. 8, 9 & 11*). Any bird nests in this area are likely to have been destroyed.

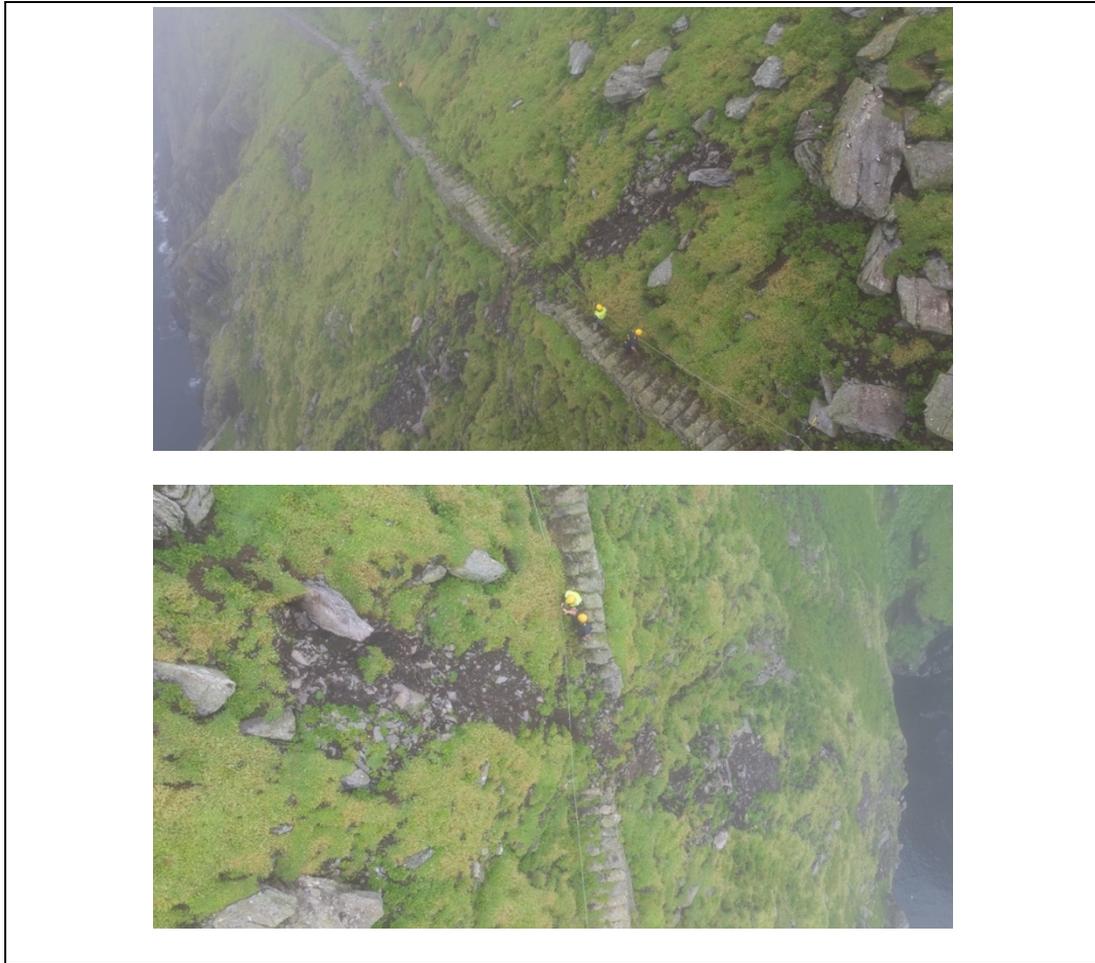
Figs. 8 & 9. Drone photographs of the damaged area on the North Steps (F. Flannery).

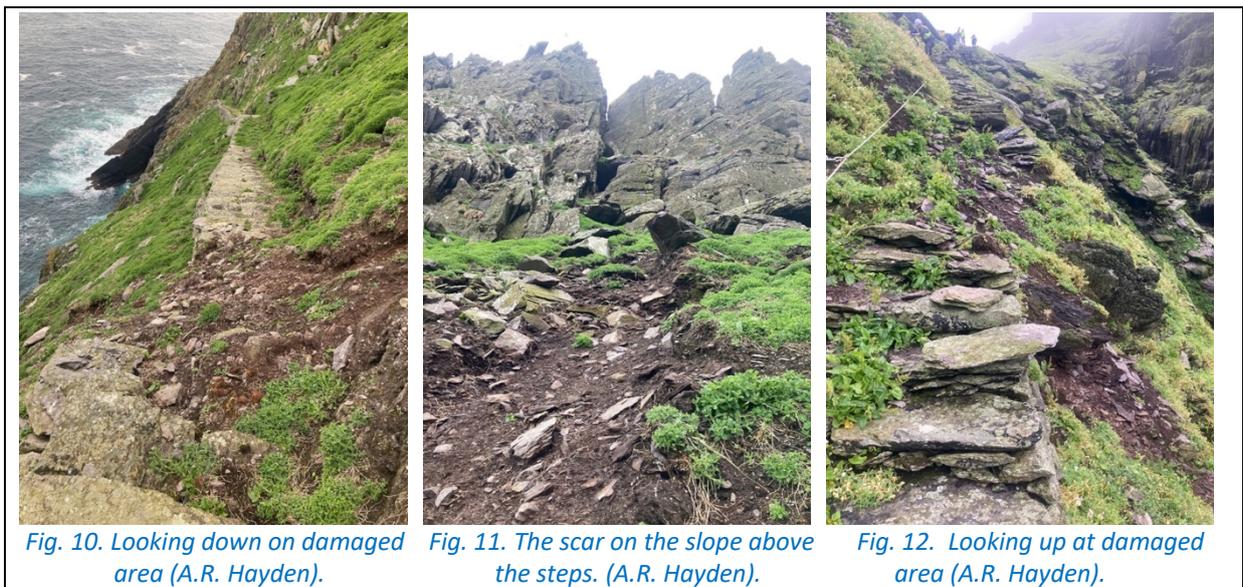
Bedrock lies close to the surface beneath the area damaged on the steps (*fig. 12*). As a result, there would only ever have been 2 or 3 courses of masonry, totalling 200-400mm in height at most here. The low height of the original masonry provided little cushioning and so almost all the masonry was likely to have been removed by the slipped rock.

The outer side of the two steps immediately above the damaged area were also partly loosened and their other sides were pushed outwards by the impact (*fig. 10*). The steps below the damaged area were undisturbed (*figs. 10 & 12*). They lie on top of a more than a metre-high drystone wall, as the underlying rock drops vertically immediately below the damaged area.

Fig. 10. Looking down on damaged area (A.R. Hayden).

Fig. 11. The scar on the slope above the steps. (A.R. Hayden).

Fig. 12. Looking up at damaged area (A.R. Hayden).

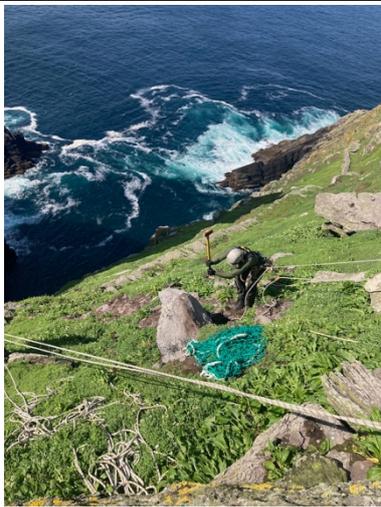
(a) Attempting to split rock in scar.

After the conclusion of the sweep, the area of the deep scar left by the slipped rock above the steps was stabilised and any loose material was removed and stone retrieved for potential reuse. This area included one large rock that weighted several tonnes and which was loose. Attempts made to split it failed and as it could not be secured in place, it had to be slid down the slope and beyond into the sea for safety. The rope access personnel successfully achieved this without causing any damage (*fig. 13*).

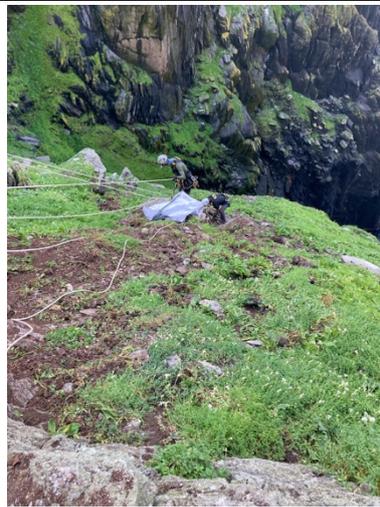
(b) Gathering rock from below.

The steep slopes below the steps were also searched and any loose rocks present were first examined by the archaeologist and the NPWS ECoW, Brian Power before being hauled up by the rope access personnel for reuse.

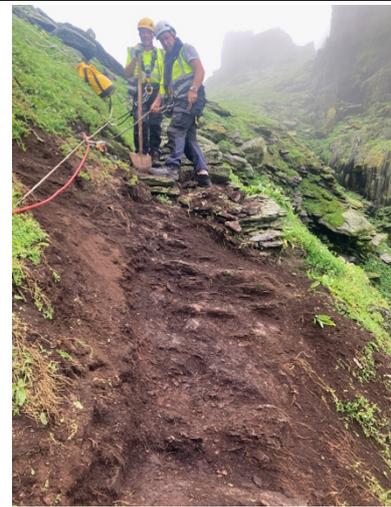
Following the sweep and after safe rope access was established to the damaged area of the steps, the fallen material in the damaged area was cleared by hand and the underlying rock below was cleaned down and recorded photographically by the archaeologist. The material removed consisted of loose campion soil, clay and stones and measured up to 400mm in thickness. Its clearance revealed that none of the original masonry survived of the eight lower steps damaged and that only the outer side of the two uppermost steps damaged survived. This masonry had been pushed outwards and loosened (*fig. 13.*).

(c) Damaged area after cleaning

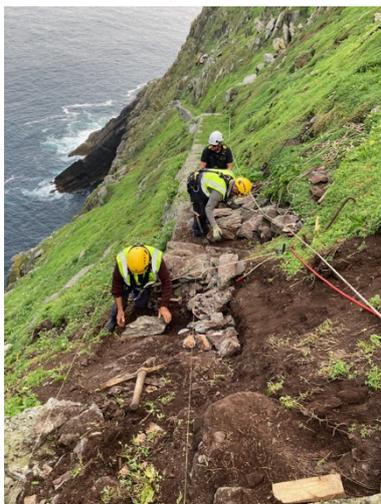
(d) Work on rebuilding first steps.

Using the stone gathered, the OPW foreman mason Pat O'Shea and OPW mason Mike Connors assisted by the rope access personnel and Tom Kerrisk, and observed by the archaeologist, rebuilt the eight missing steps and repaired the upper two partially damaged steps in drystone masonry, replicating the format, style, size and height of the other steps (*fig. 14.*).

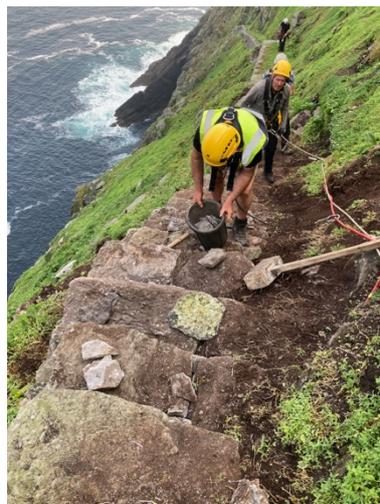
(e) Rebuilding nearing completion.

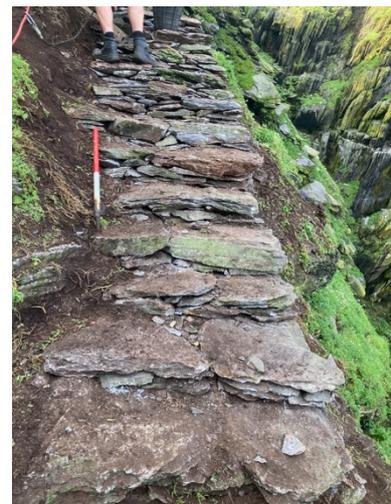
(f) Rebuilt steps before final clean up.

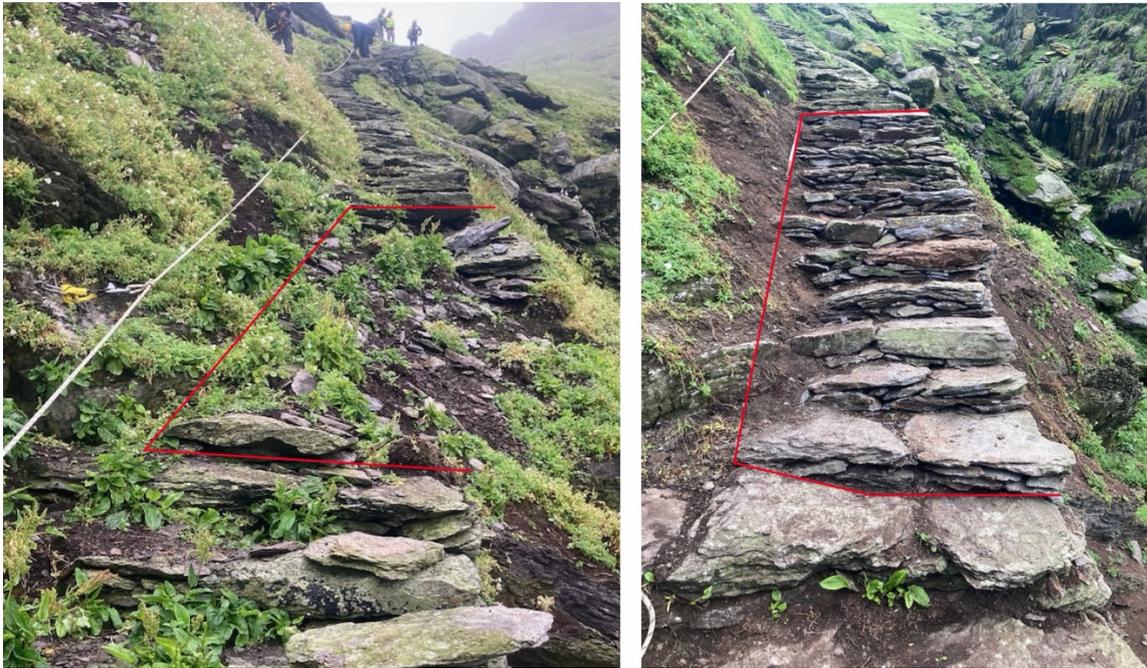
(a) Before (left), after (right), view looking up to the damaged & repaired section of the stairway.

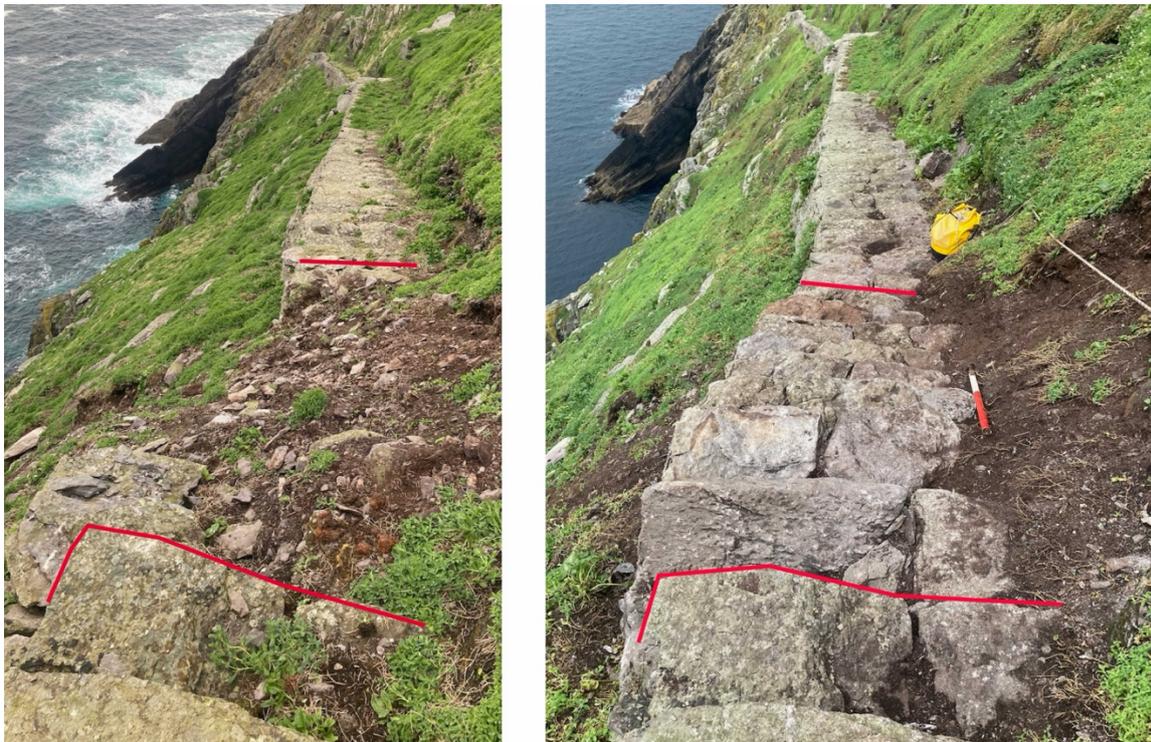
(a) Before (left), after (right), view looking down on the damaged & repaired section of the stairway.

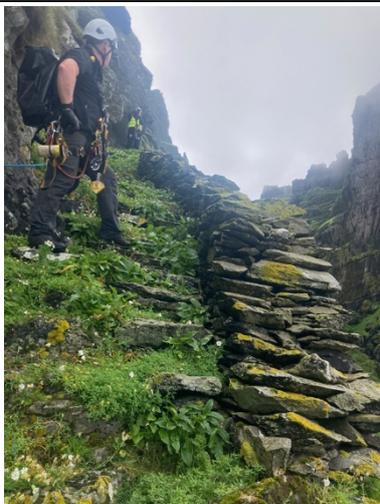
After work was completed on the steps and after a safety line had been established, the opportunity was taken to examine and remove weed growth from the lower part of the masonry steps up from the north landing. The lower end of the wall defining the outside of these steps was apparently damaged by high seas in 2012 and appears not to have been rebuilt afterwards, presumably due to a lack of stone. The masonry of the presently surviving lower end of the standing wall is loose and will require tightening if more of the walling is not to be lost in the future (*fig. 16.*). The stone on the top of a considerable length of the lower section of the wall has also been loosened and tossed about by wind and sea and could also do with being relaid to secure it and the top of the wall.

(a) Surviving lower end of wall.

The lower end and the top of the wall defining the outer side of the North Steps, close to the start of the lowest masonry section, which appears to have been rebuilt or created by the OPW in the 1980s-early 2000s, requires some tightening and relaying.

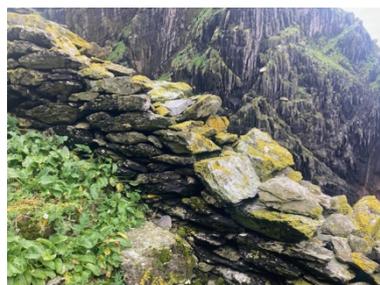
(b) Side view near base of wall.

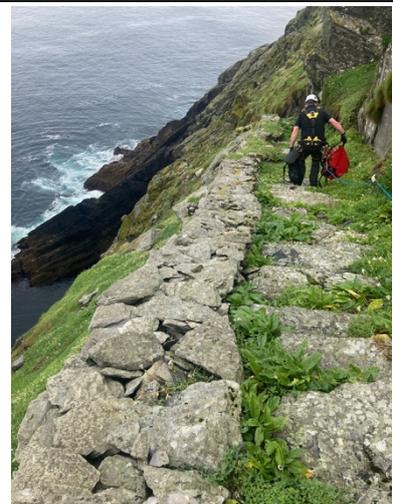
(c) View down over lower part of wall and steps.
