Skellig Michael World Heritage Site Works Season 2020 UNESCO Report v. 2.0

1. Introduction

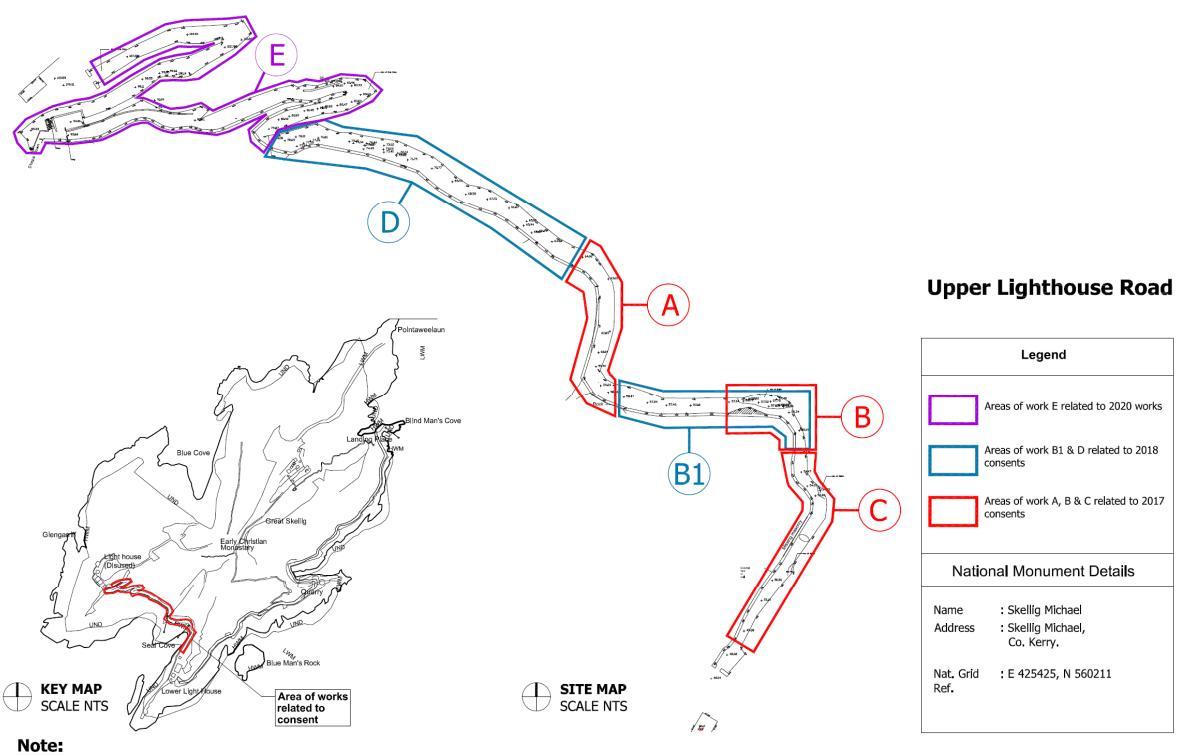
Fig. 5. – Works to Upper Lighthouse Road 2017 - 2020.

Repair works during the 2020 season to the Upper Lighthouse Road included the clearance of organic build up and debris under archaeological supervision, the cleaning of the original drainage system, the replacement of missing wall capstones with locally sourced Valentia slate and the retention and repair of existing sand stone capstones. Repair works were undertaken using lime mortar and traditional construction techniques.

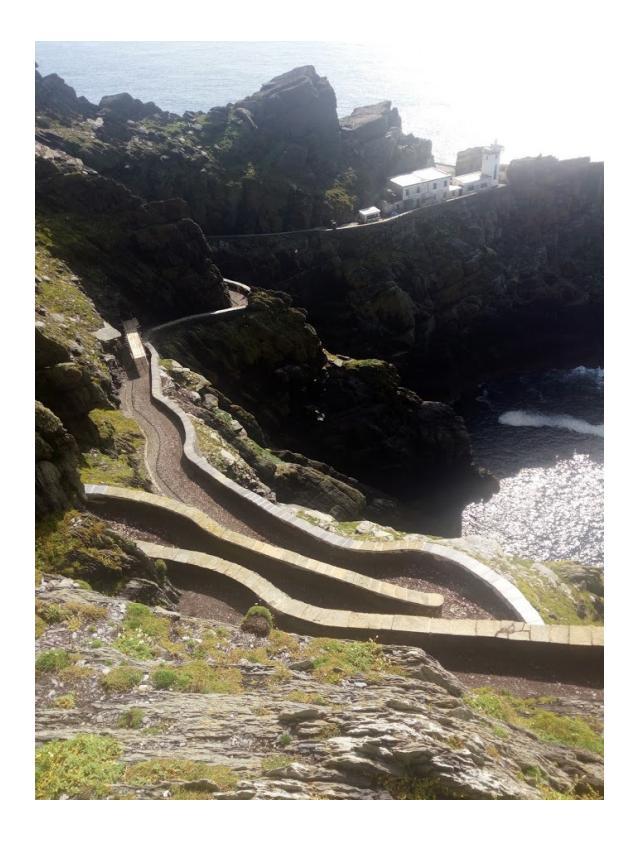
Fig. 6. – View of Upper Lighthouse Road from Upper Lighthouse Gate. Debris removed, wall tops repaired.

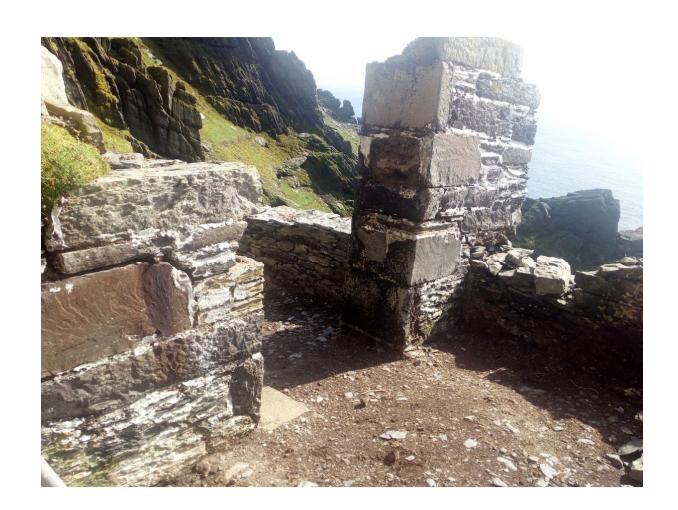
Fig. 11. – View of Outer Gate to Upper Lighthouse. It is currently in a precarious condition and will require repair in 2021 to prevent further deterioration.

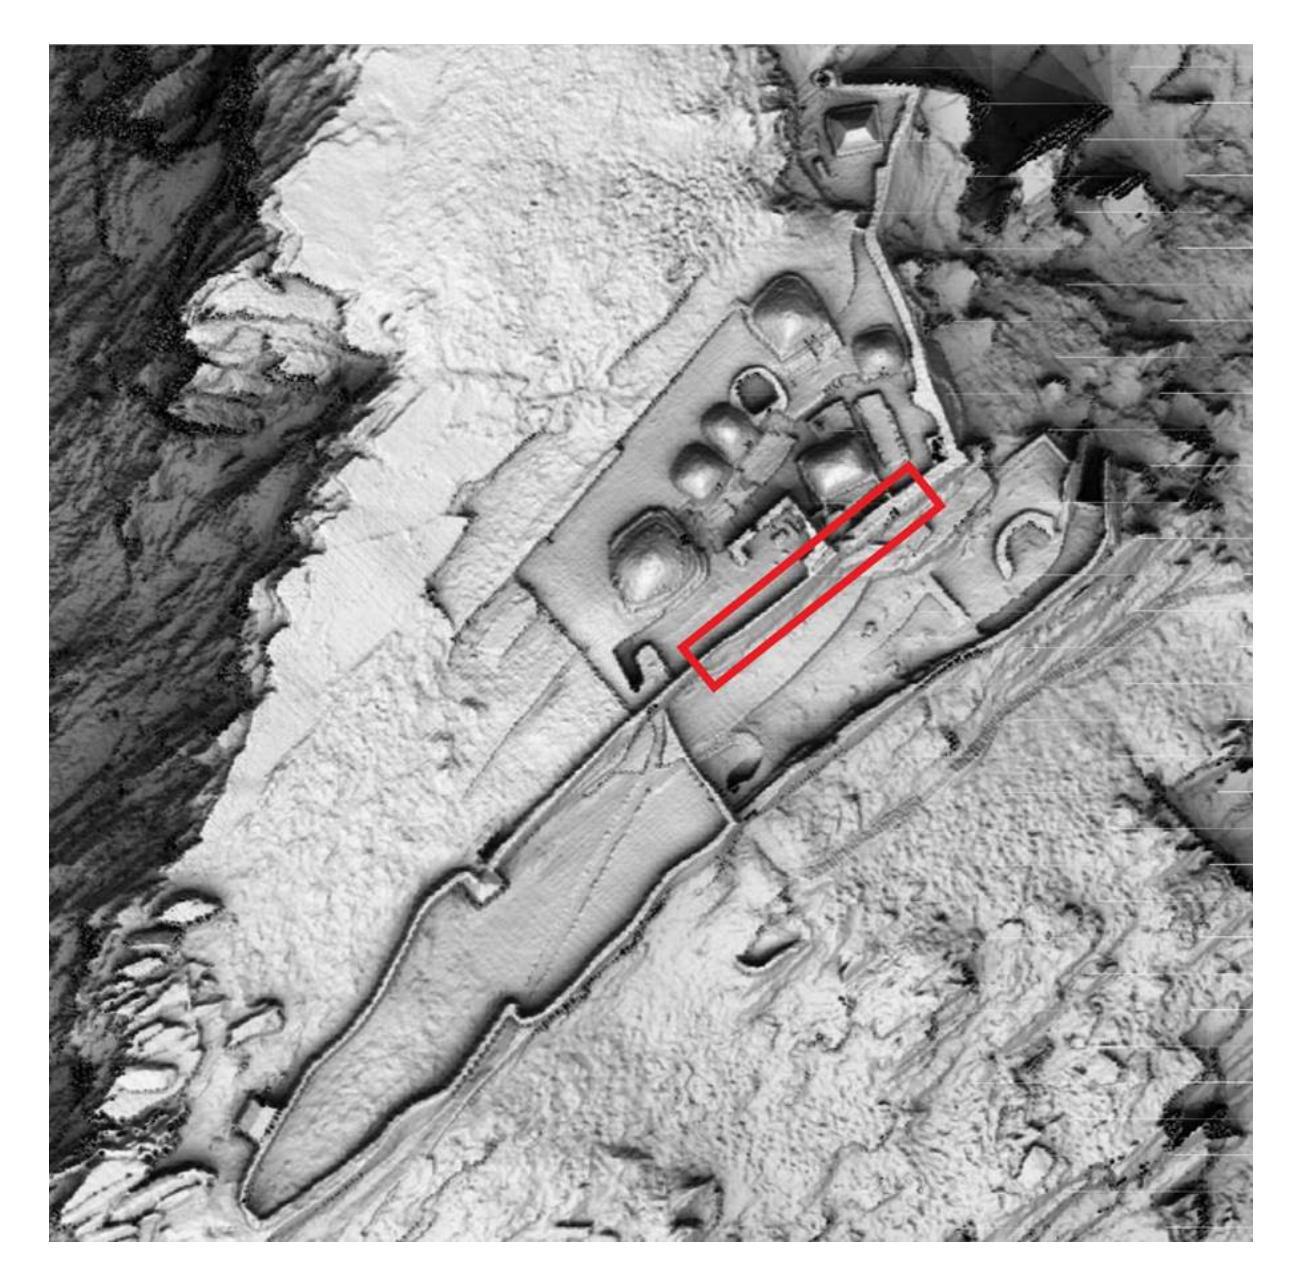
Since 2015, the Discovery Programme have been monitoring the movement of the main retaining wall of the monastic settlement. Markings were added in 2017 to the South Peak to determine the stability of the structures at that location. The Discovery Programme issue an annual report to the OPW with their findings and recommendations. In August 2020, the Discovery Programme undertook a survey of the monastic settlement and published their findings in September 2020 (See Appendix B). The report concluded that a section of the retaining wall directly below St. Michael's chapel is currently undergoing slight movement beyond acceptable tolerances. This section of the monastic wall has been historically susceptible to collapse, with major reconstruction having been undertaken during the 19th century.

Fig. 14. - Location of movement to retaining wall below St. Michael's Chapel.

Due to increased rainfall and pressure from runoff rainwater, the OPW will be undertaking repairs to this section of the enclosing wall over the coming years. All works will be subject to consent and best conservation practices will be implemented. All proposed repair works will be subject to archaeological supervision, recording and monitoring.

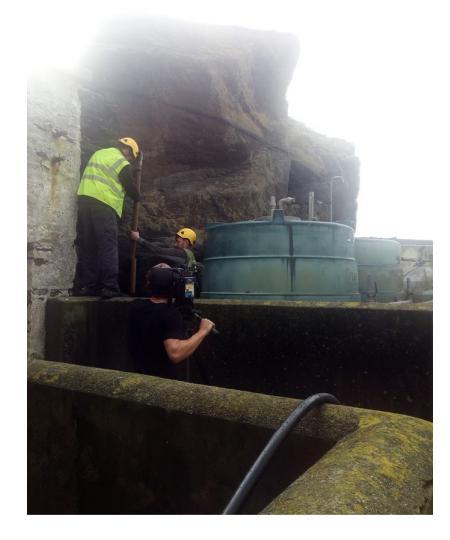
Fig. 15.- Dismantling of fuel storage tanks at Lower Lighthouse, September 2020.

Work commenced on the dismantling of the former fuel storage tanks of the Lower Lighthouse complex. A contractor safely removed the oil from the decommissioned storage tanks between July and August 2020. The physical dismantling of the tanks commenced in September and the tanks will be fully removed in 2021.

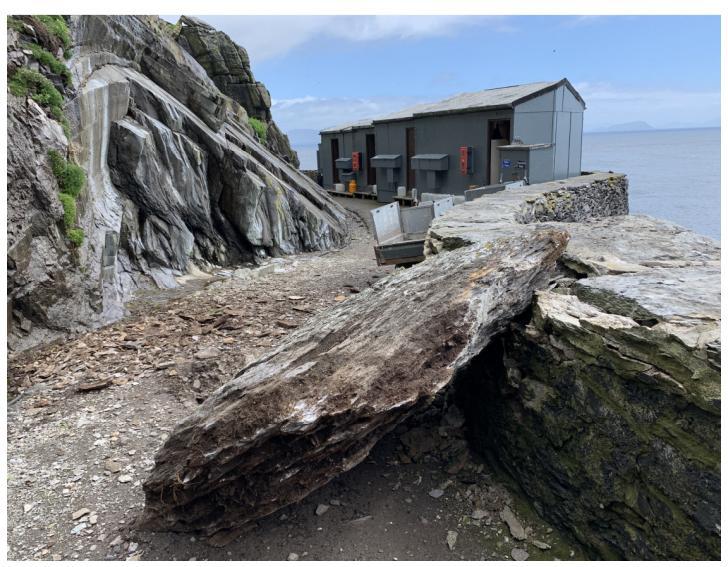
Rock-falls have increased in frequency in the past five years, due to the effects of climate change. March and June were very dry months and were followed by unseasonably high levels of precipitation in July. This led to soil erosion and a substantial rock-fall occurred on the morning of July 27th 2020 on the lighthouse road. Luckily, OPW operatives were not on the island at the time although there was a film crew on site. The rock fall was in close proximity to the OPW site operative huts. A similar event had occurred at this exact location in 2017. The overhanging area was swept and loose rocks were fastened or removed. A temporary crash deck was installed at this location and at another two high risk locations on the Upper Lighthouse Road to protect OPW operatives from falling debris.

Fig. 27. – Rock Fall on 27th July 2020.

In response to the threat to the health and safety of the workers, the OPW tendered for engineering services for the design of three permanent crash decks for the Lighthouse Road. Downes Associates were appointed as engineers for the design of permanent crash decks. All design proposals will be subject to consent approval from the DHLGH and will be designed in collaboration with the OPW Conservation Architects. The installation of permanent, well-designed and robust crash decks is critical for the safety and wellbeing of OPW workers on site and for the future access and use of the upper lighthouse road by visitors. The viability of the island as an accessible tourist location is dependent on safe access conditions on the Lighthouse roads.

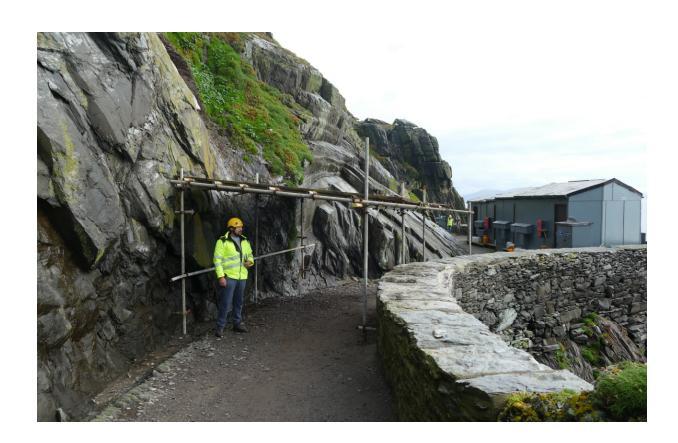
Fig. 28. – Temporary crash deck location A near site huts and installed following rock-fall.

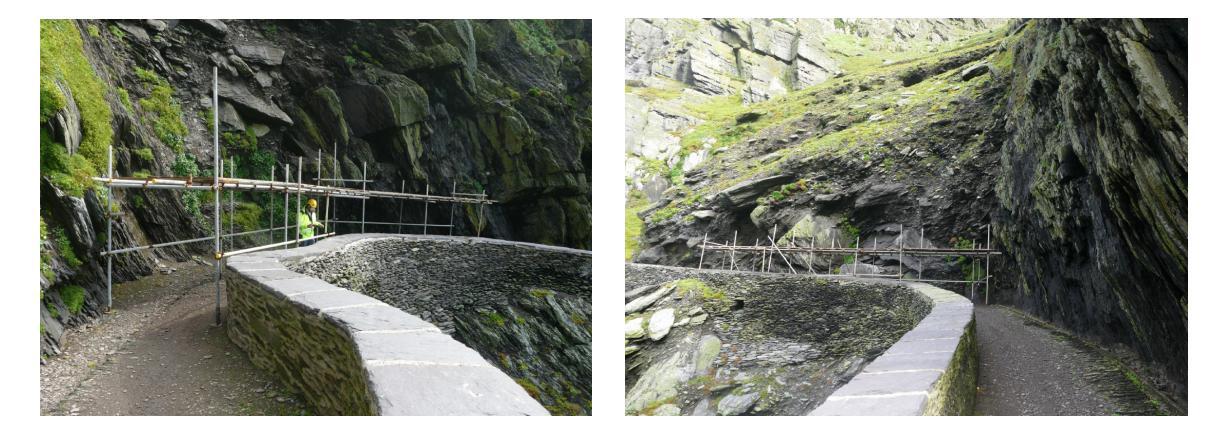
Fig.29. – Temporary crash deck location B & C on the Upper Lighthouse Road.

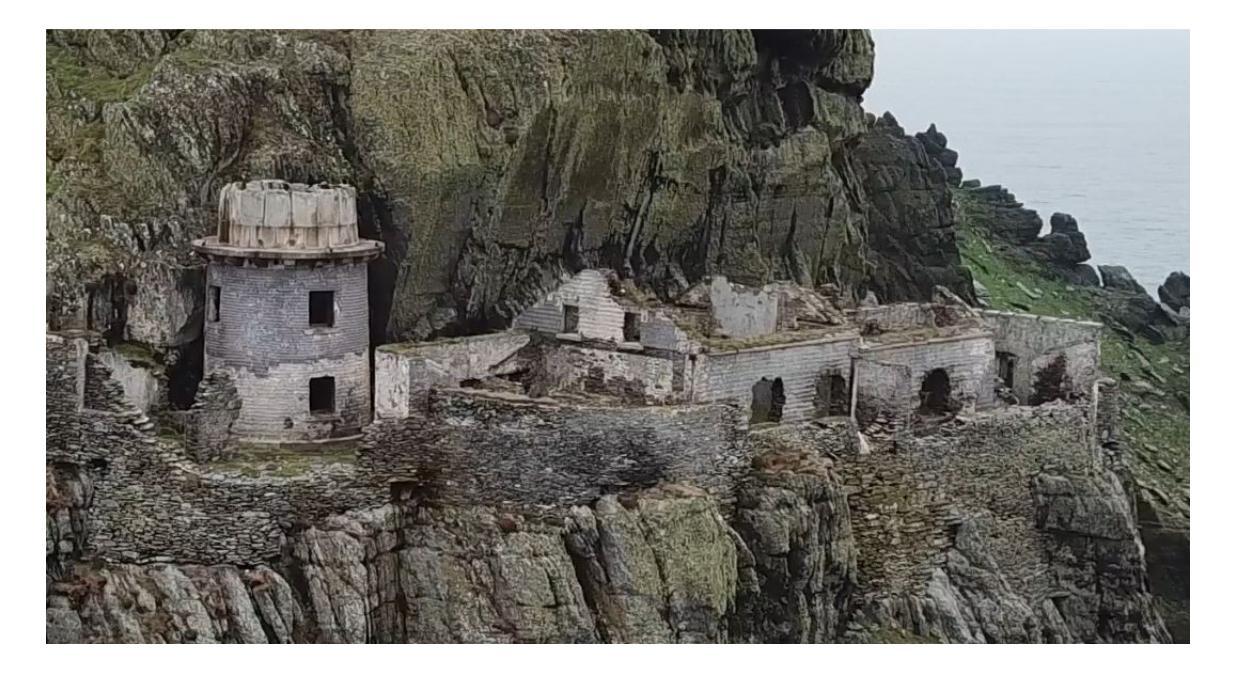
Fig. 30. – Proposed repairs to Upper Lighthouse sea wall and removal of debris from buildings in 2021 Season.
