**OPW** Oifig na  
nOibreacha Poiblí  
Office of Public Works

# SKELLIG MICHAEL LOWER LIGHTHOUSE

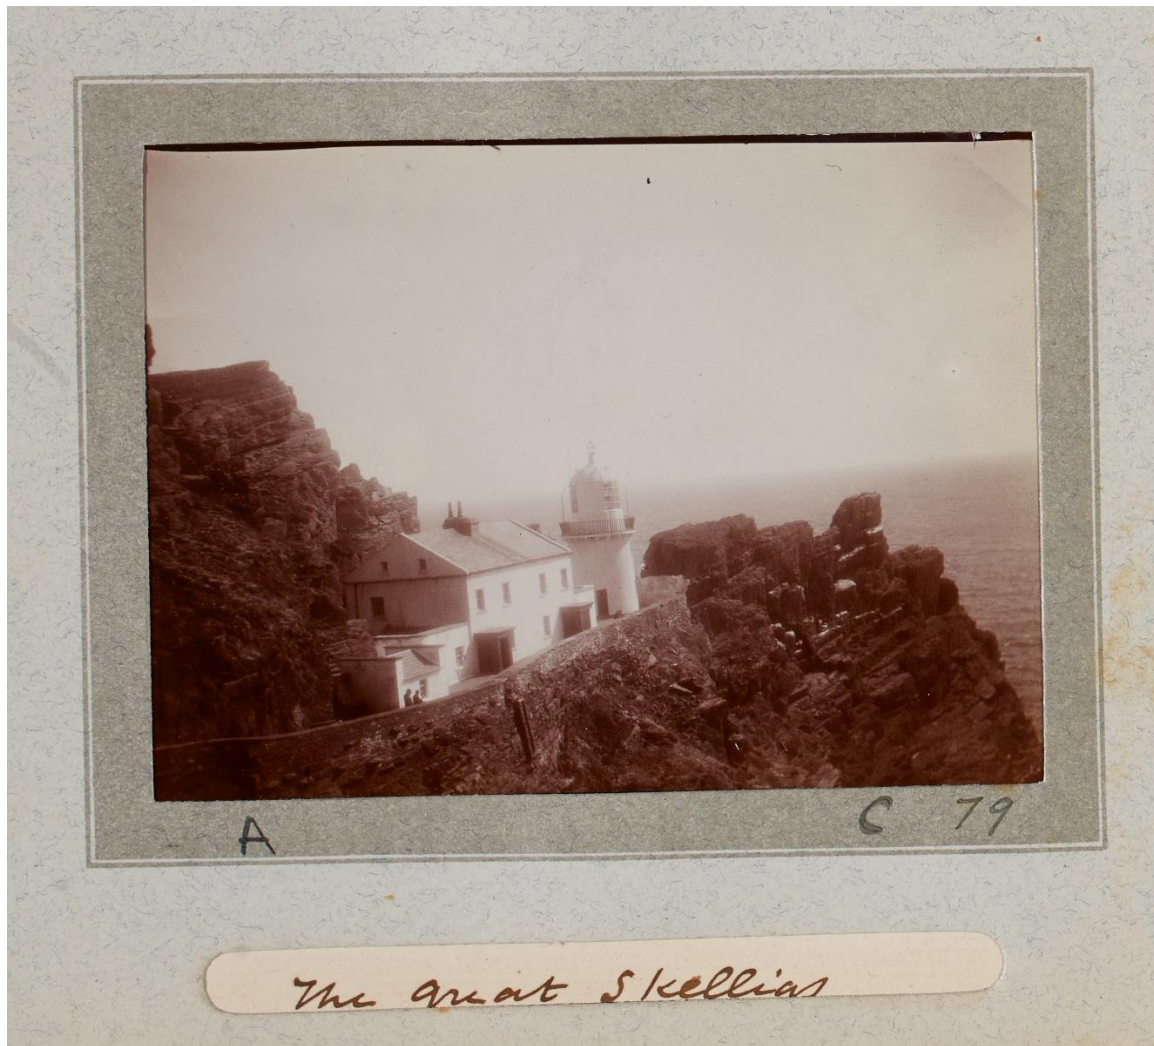
Figure 2. 1903 photo of the Lower Lighthouse showing a pitched roof with a central chimney and two cast iron porticos. (Commissioners of Irish Lights - Album 3, 1903).

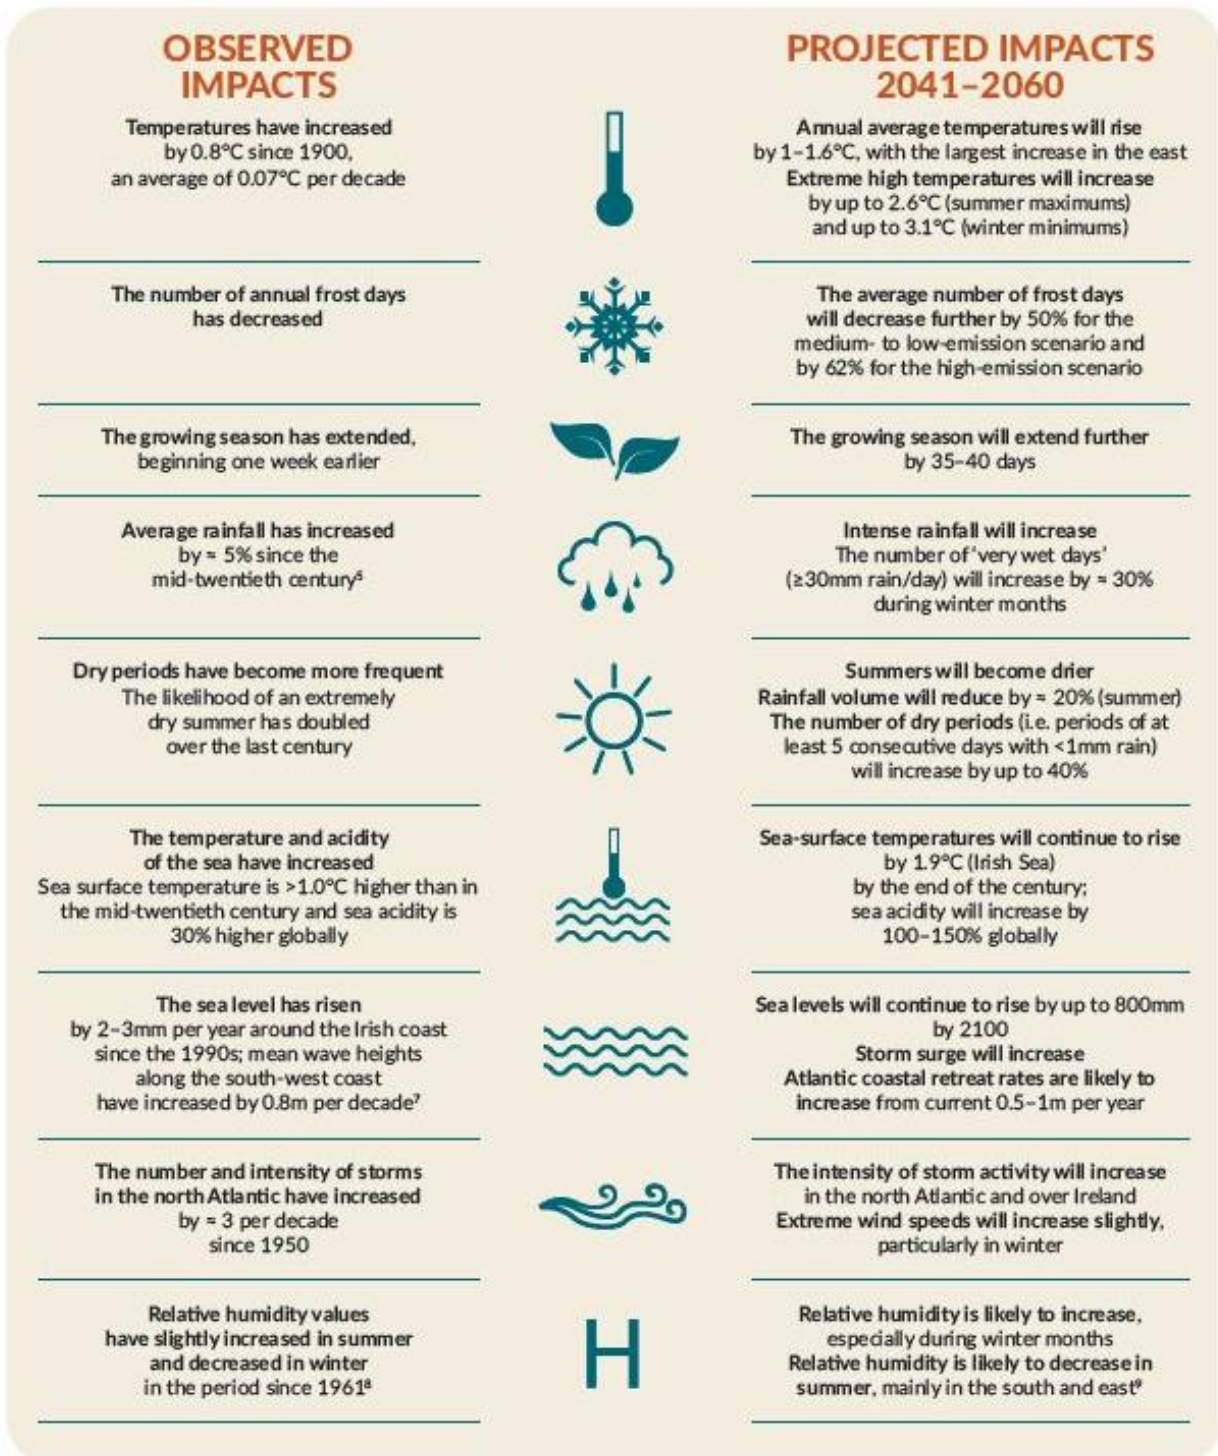
Figure 3. Summary of observed and projected climate change impacts in Ireland (Daly et al., 2019).

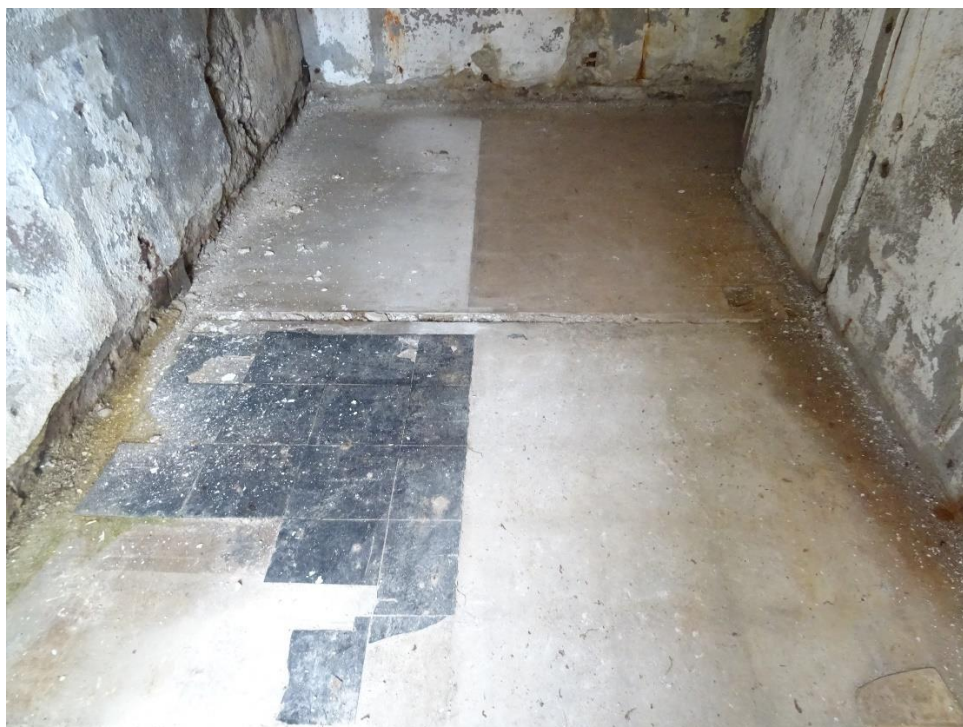
Figure 4. Poured concrete floor at ground floor level with a portion of tiles remaining in place (Carrig, 2020).

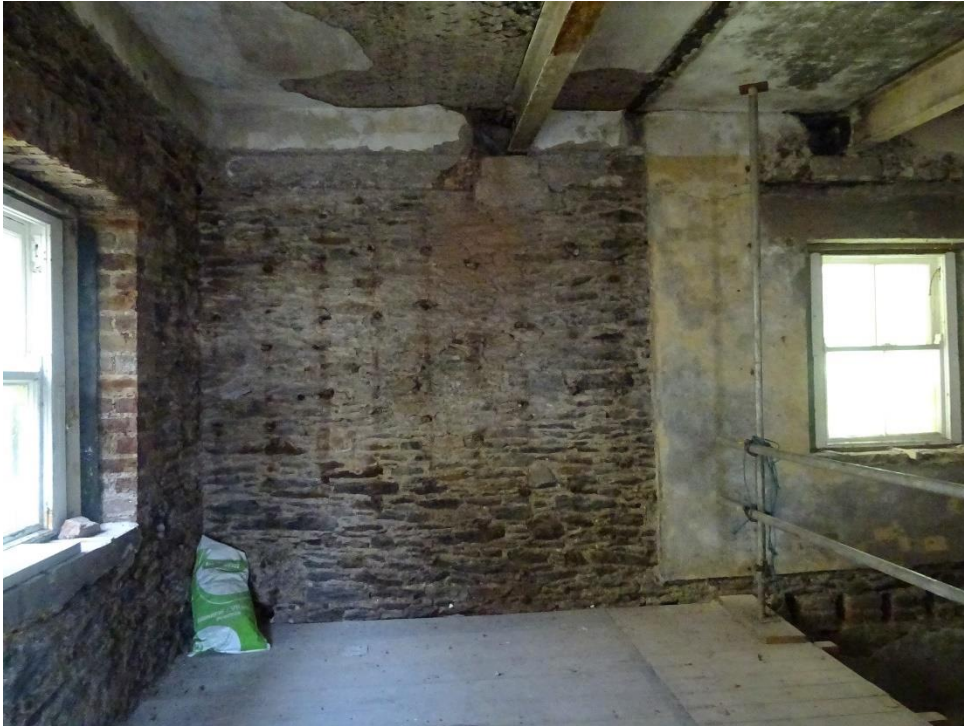
Figure 5. Random rubble external walls with brick window surrounds on the first floor (Carrig, 2020).

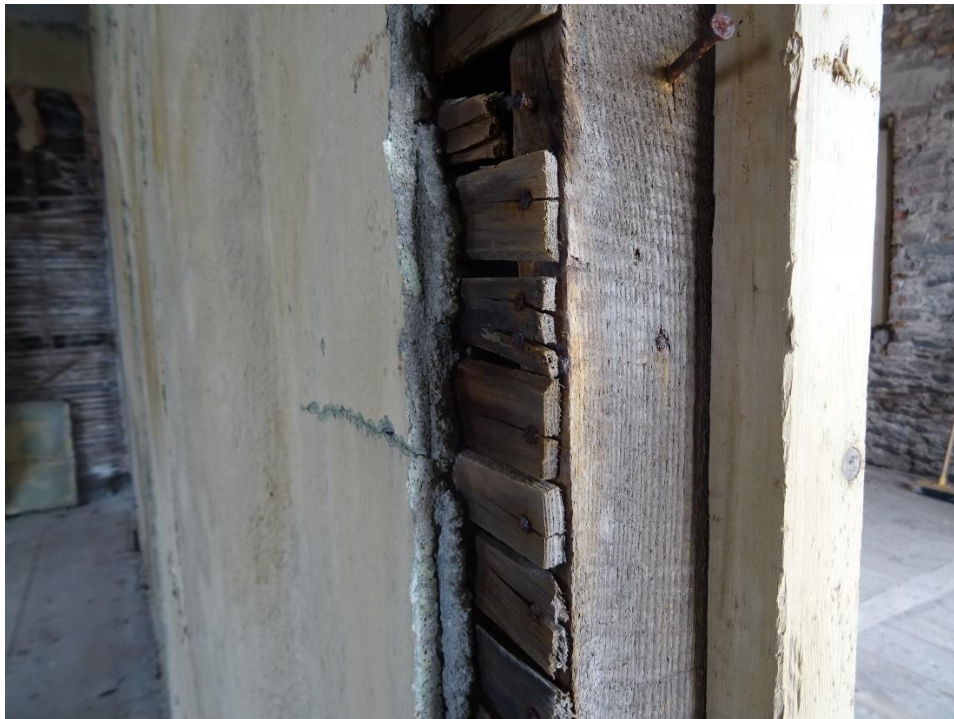
Figure 6. Lath and lime plaster in-situ on an internal wall on the first floor (Carrig, 2020).

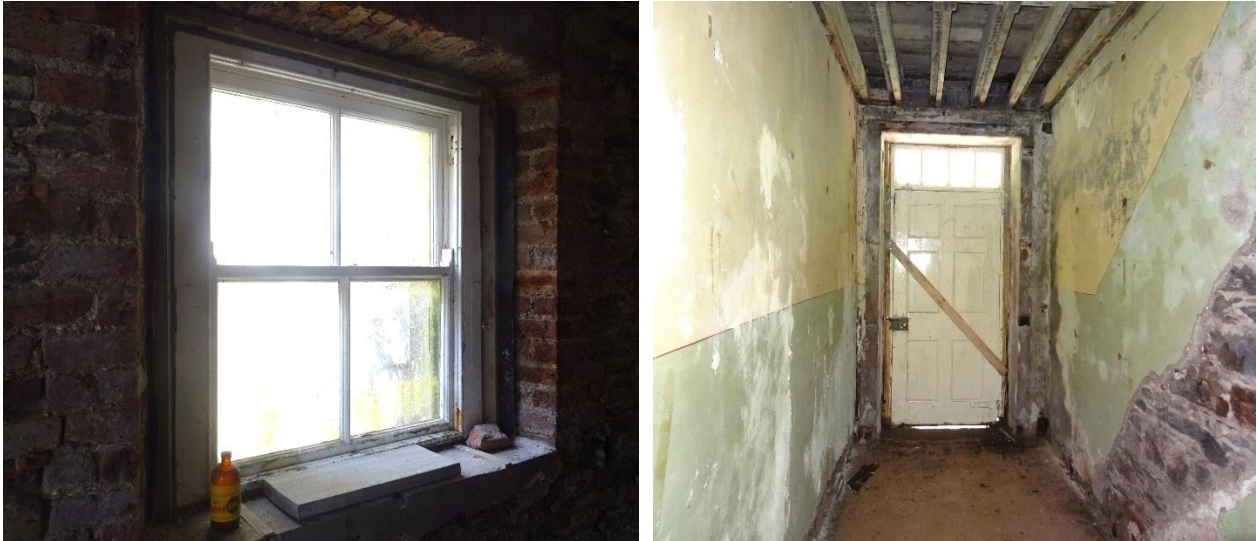
Figure 7. Typical historic timber framed singled glazed window (Carrig, 2020).  
Figure 8. Timber door and transom window on the ground floor (Carrig, 2020).

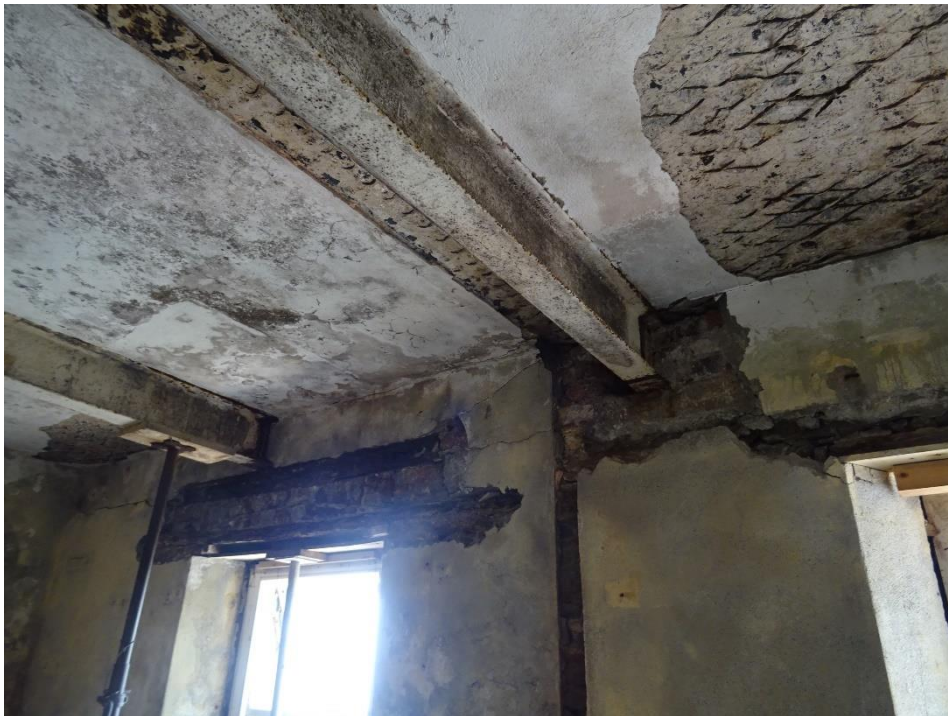
Figure 9. Underside of the reinforced concrete roof. Both the reinforcing mesh and steel I-beam supports are showing signs of corrosion (Carrig, 2020).

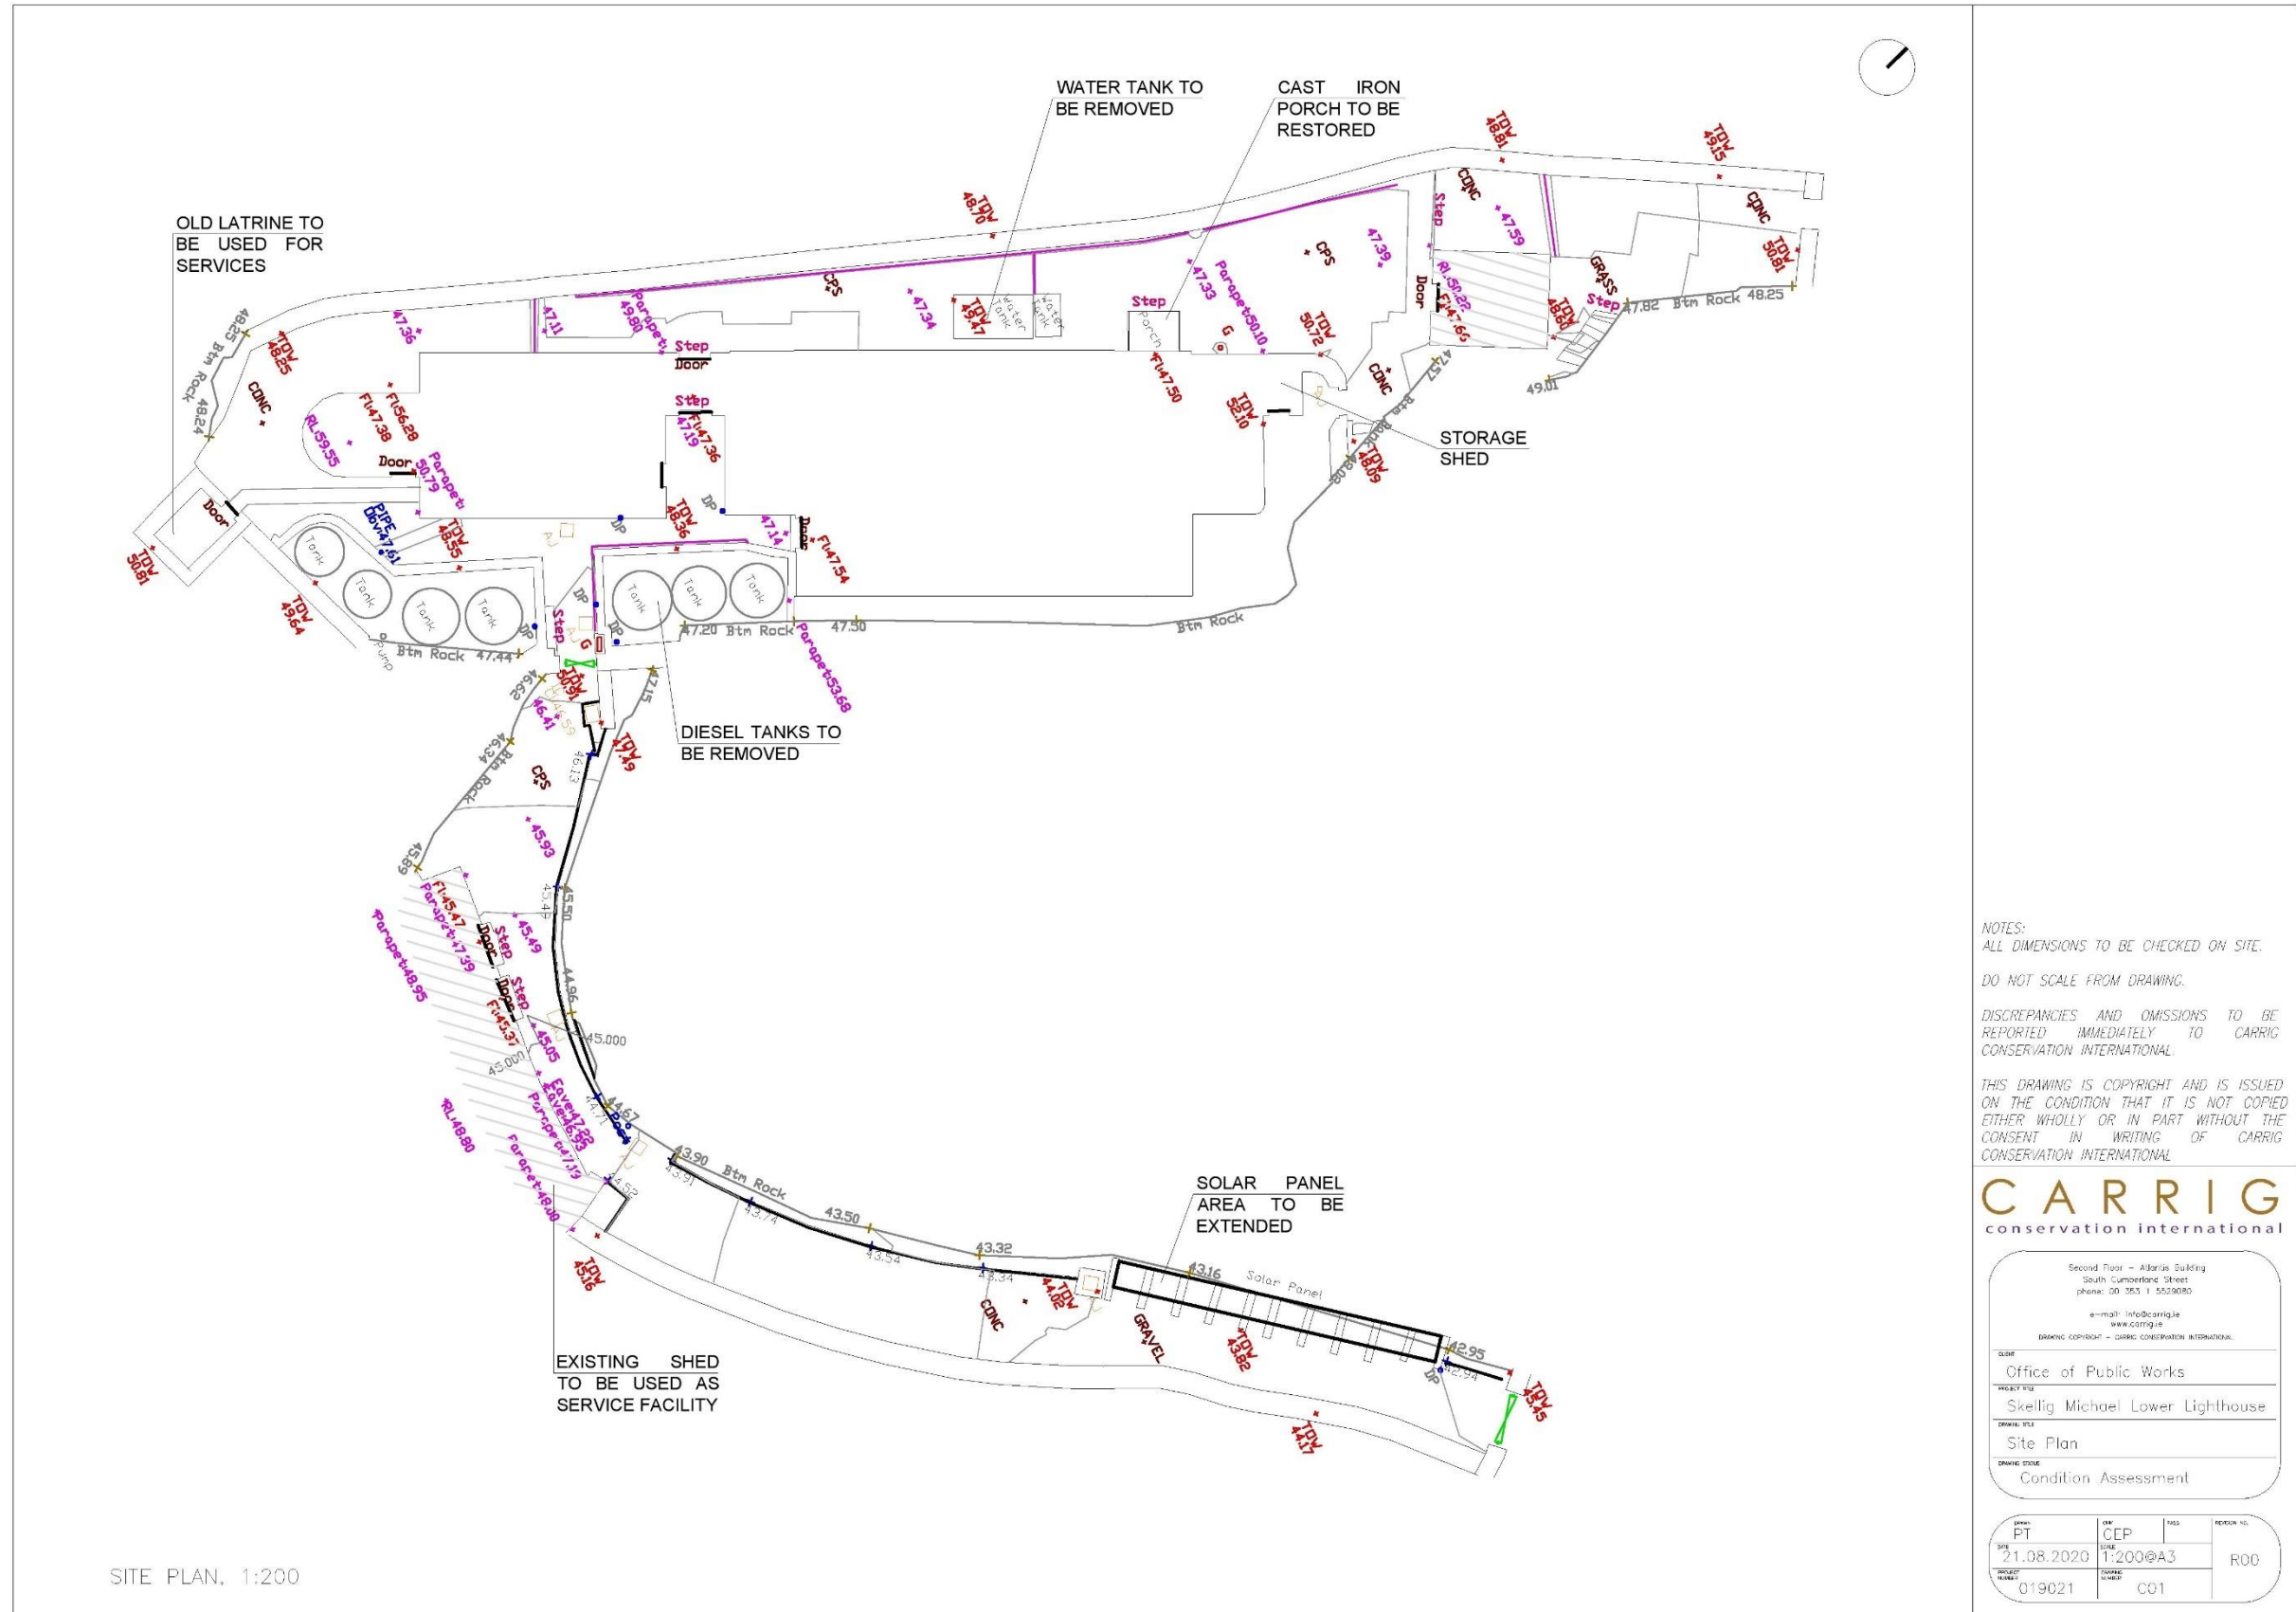
Figure 10. Condition Assessment - Site Plan (Carrig, 2020).

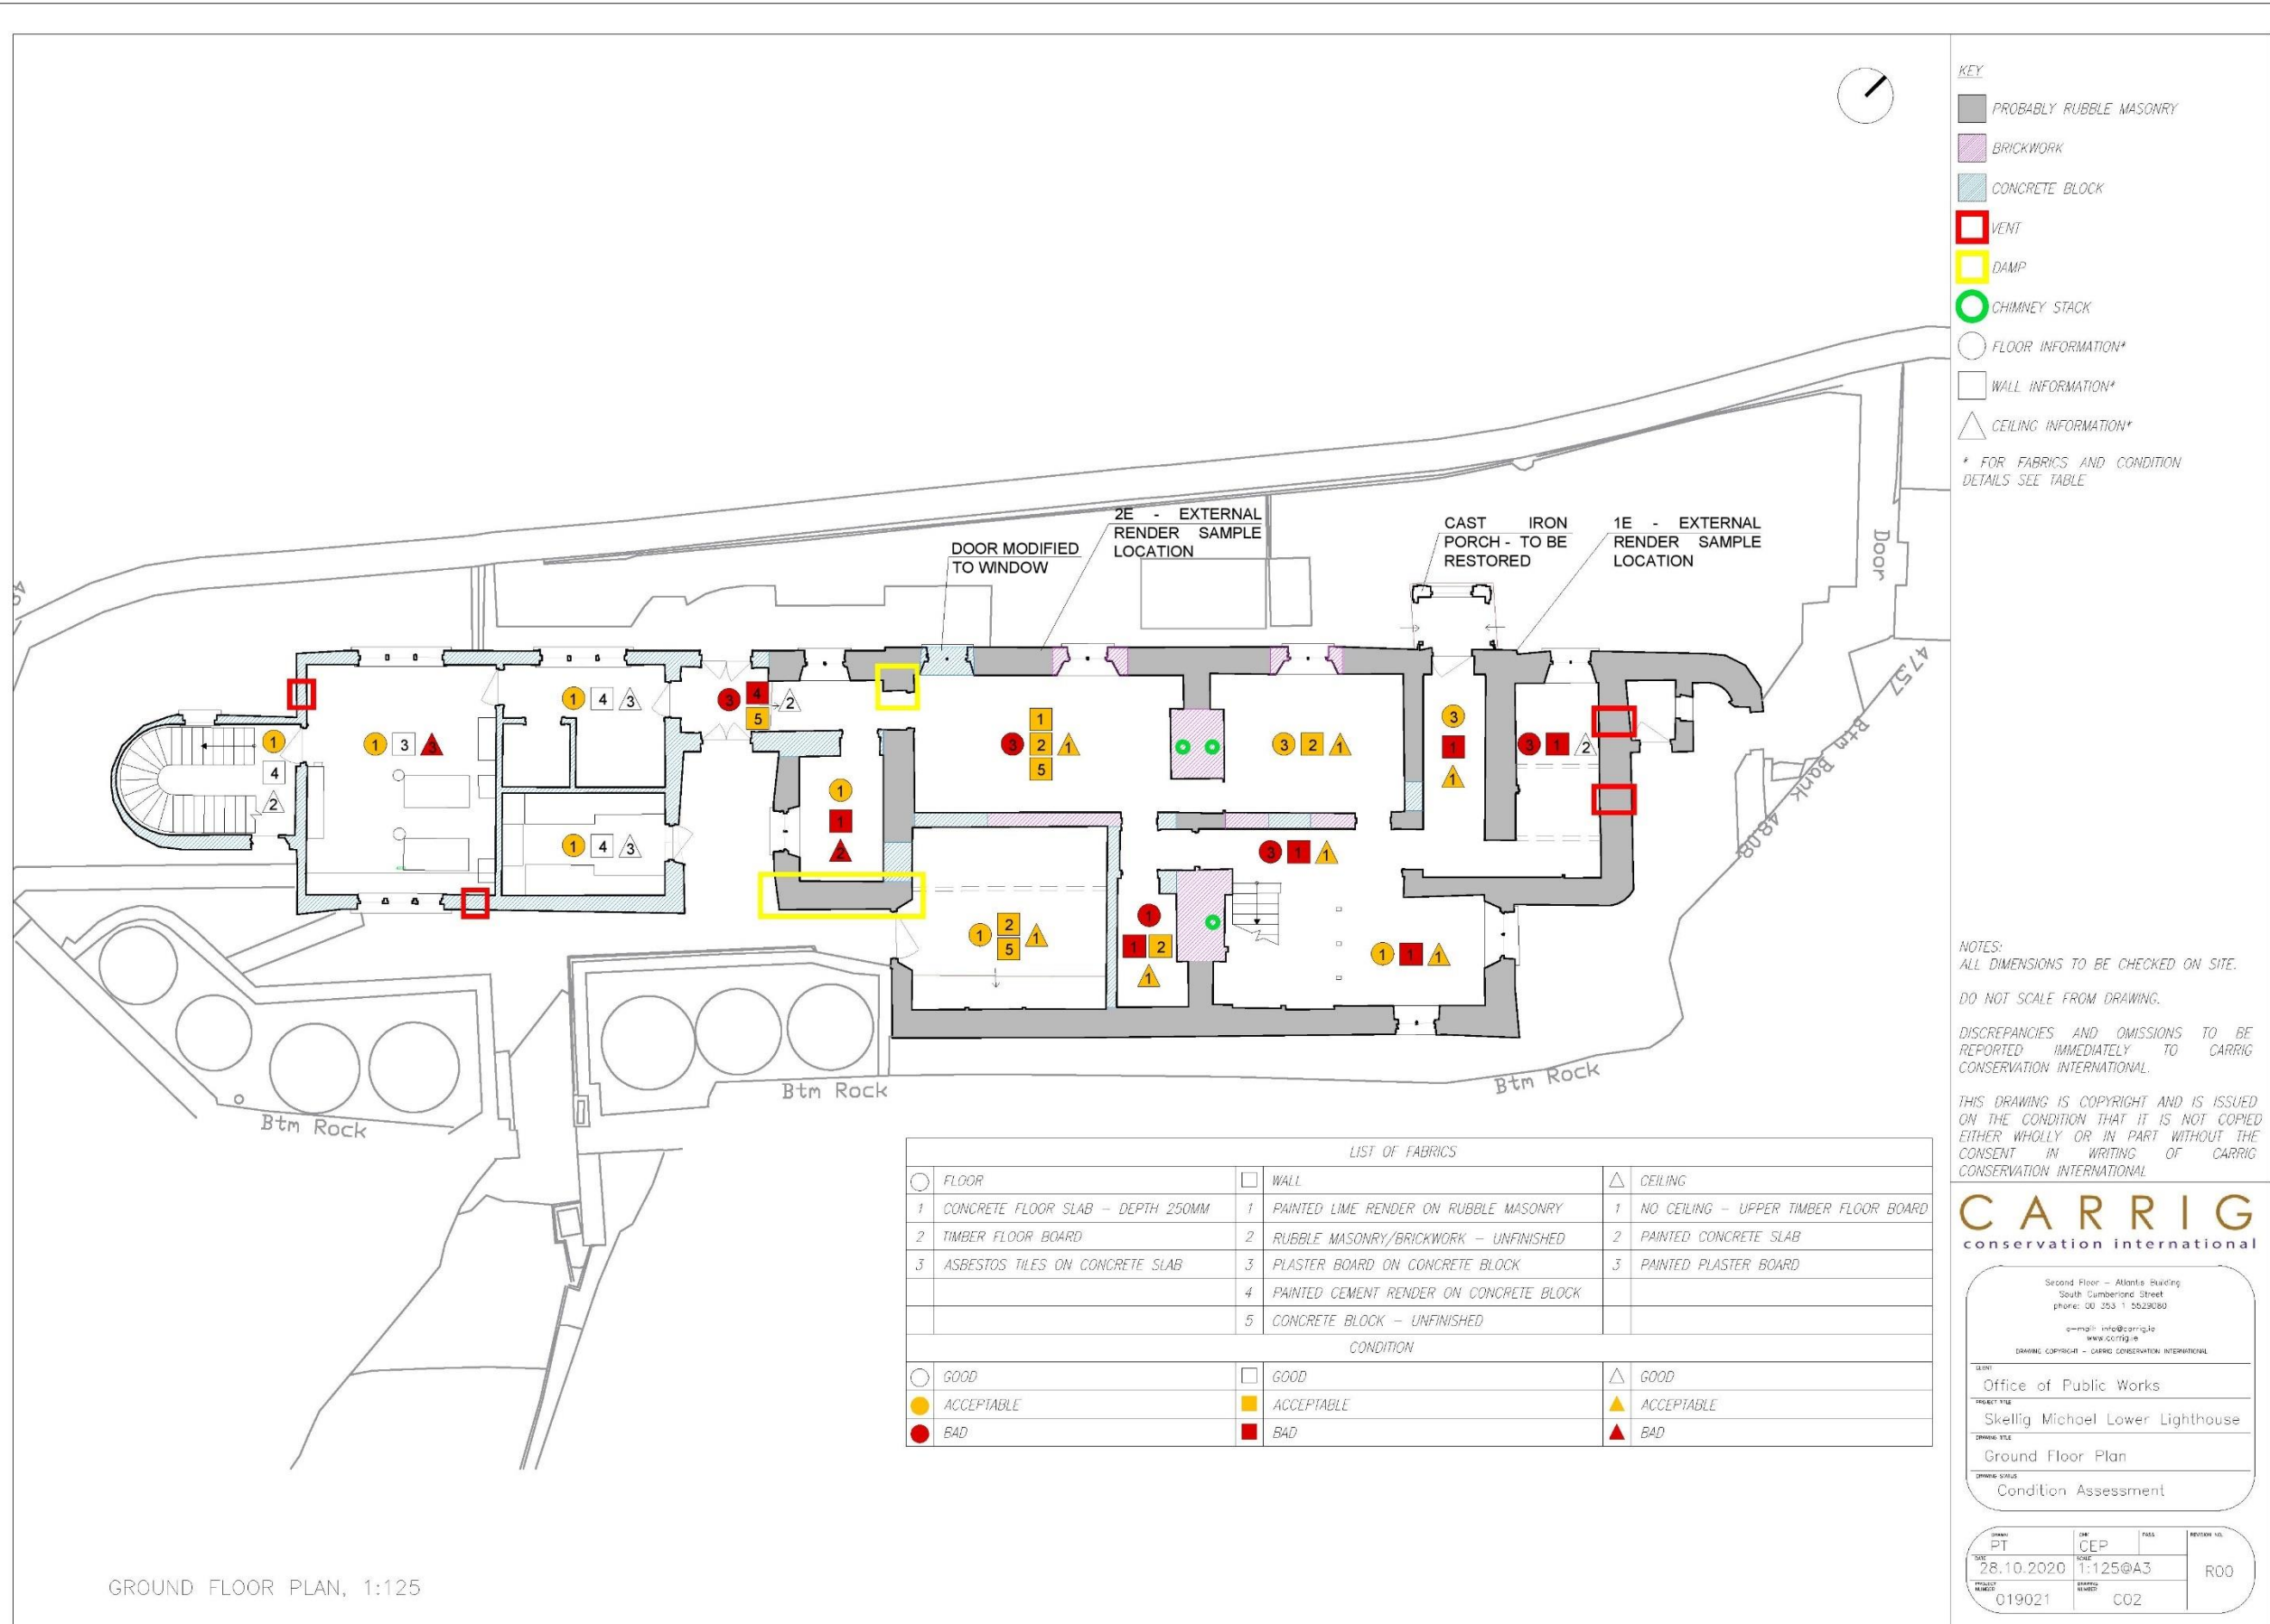
Figure 11. Condition Assessment - Ground Floor Plan (Carrig, 2020).

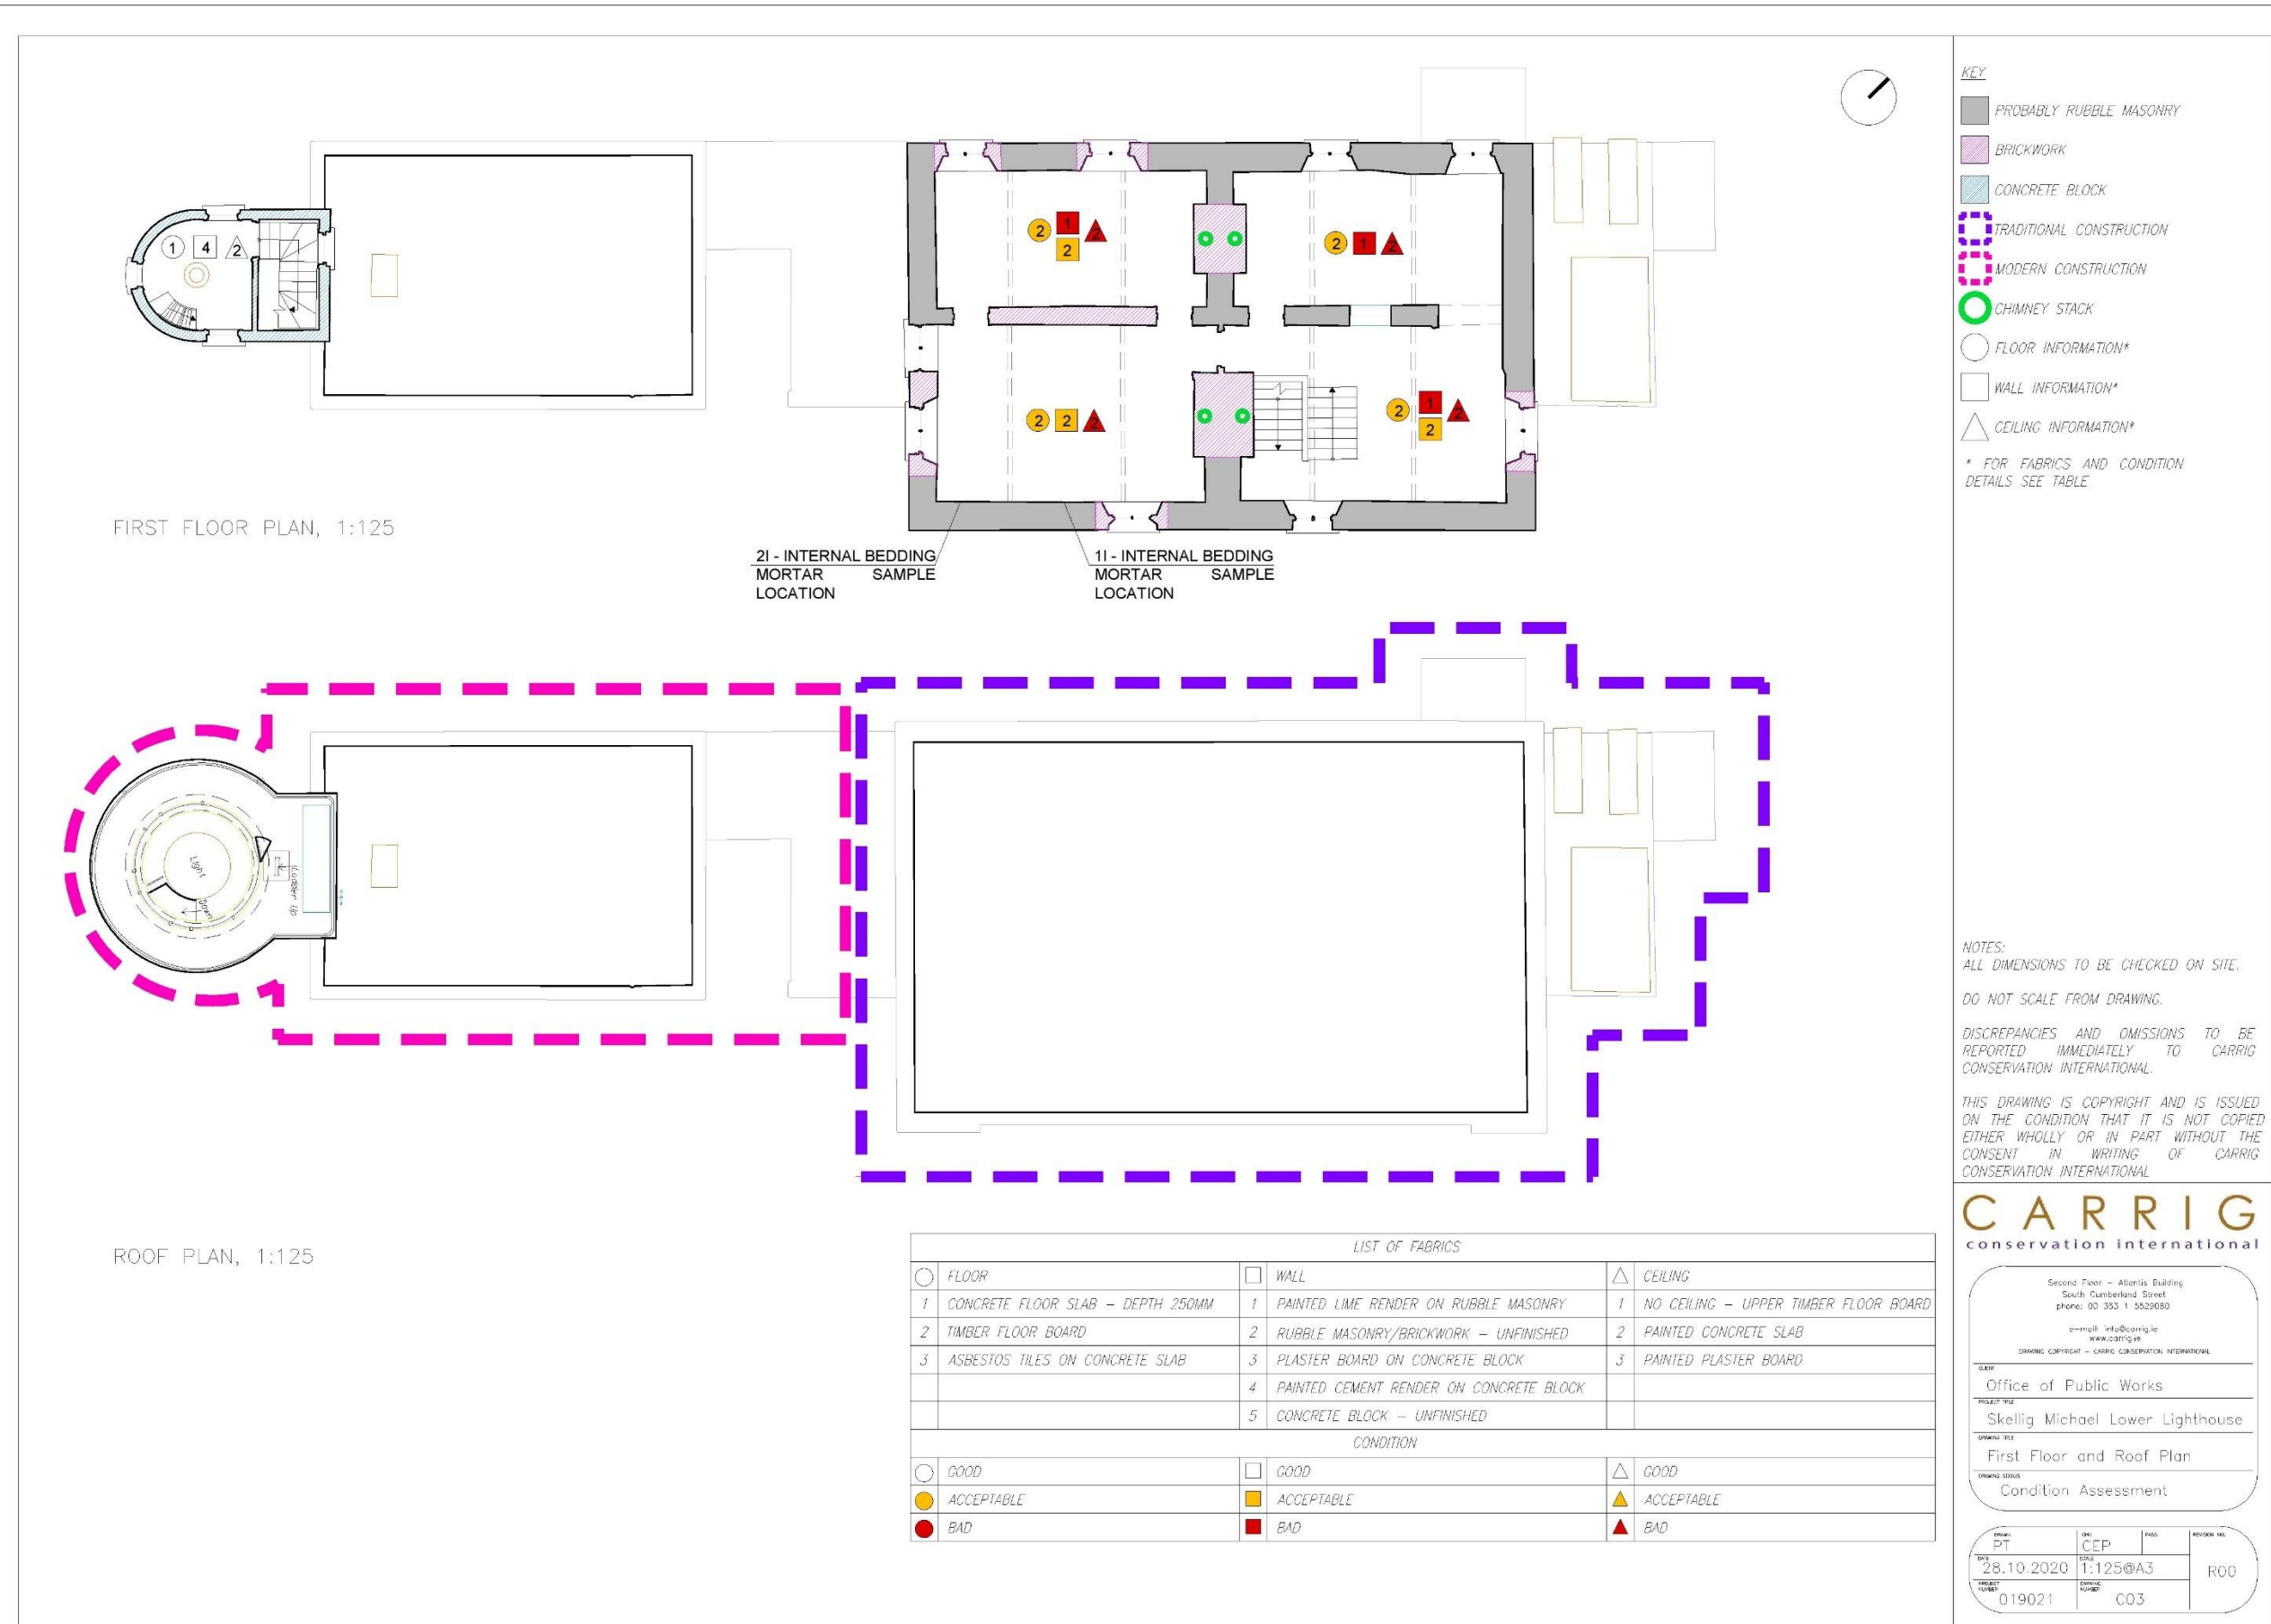
Figure 12. Condition Assessment - First Floor Plan (Carrig, 2020).

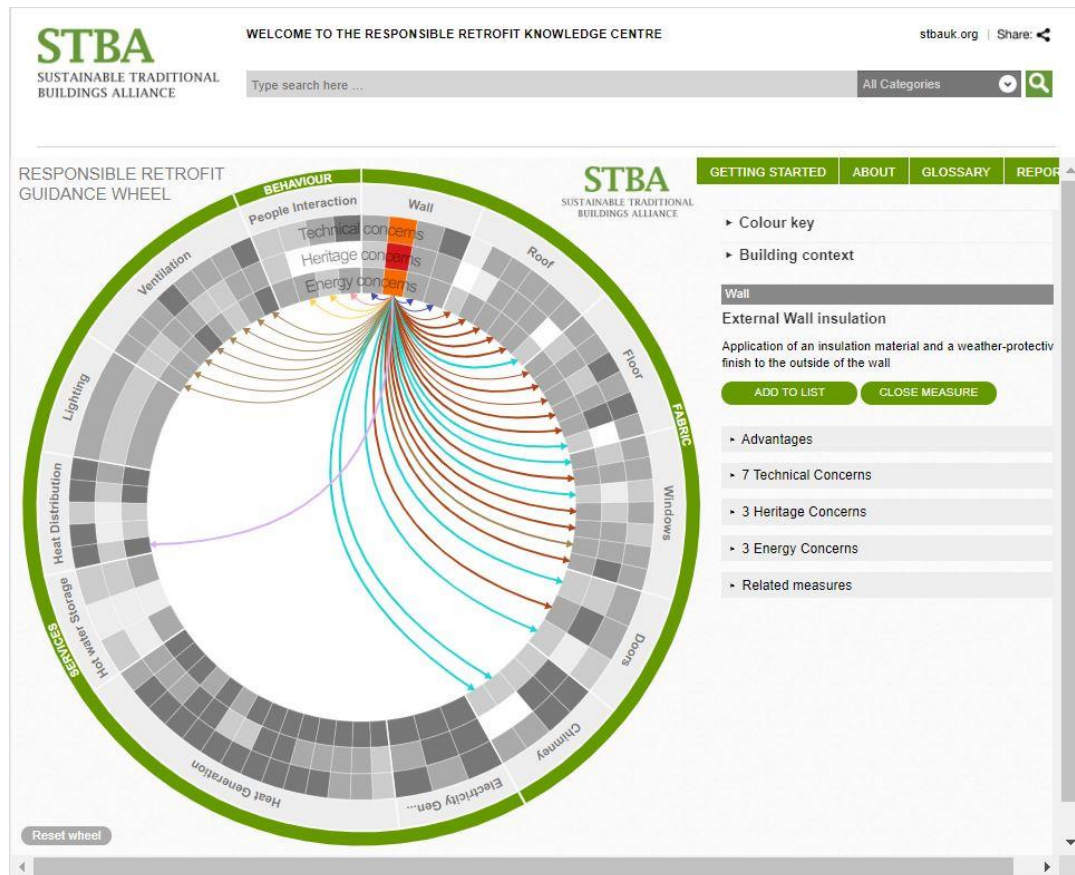
Figure 14. The STBA Responsible Retrofit Guidance Wheel developed to inform the decision making process (STBA, 2017).

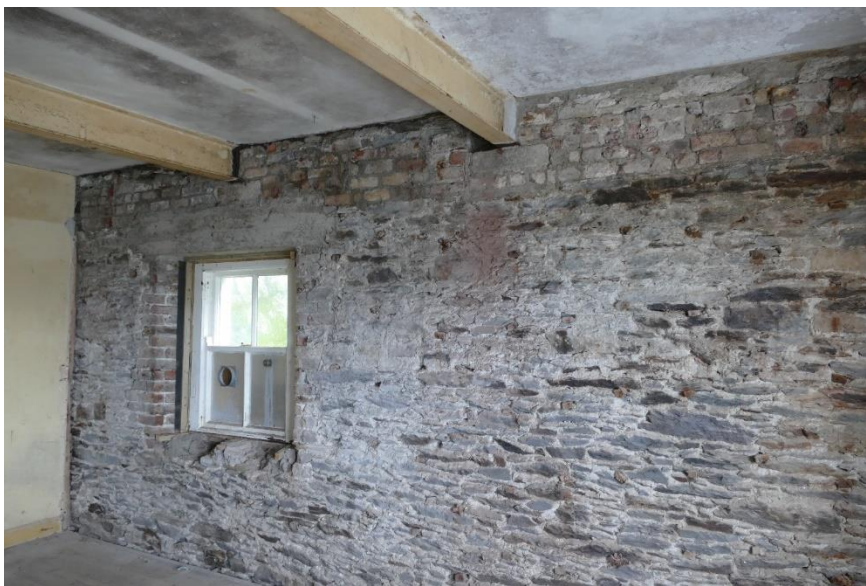
Figure 15. The calculated u-value is based on the above wall, which is primarily composed of slate and lime mortar to a depth of approximately 600 mm (OPW, 2020).

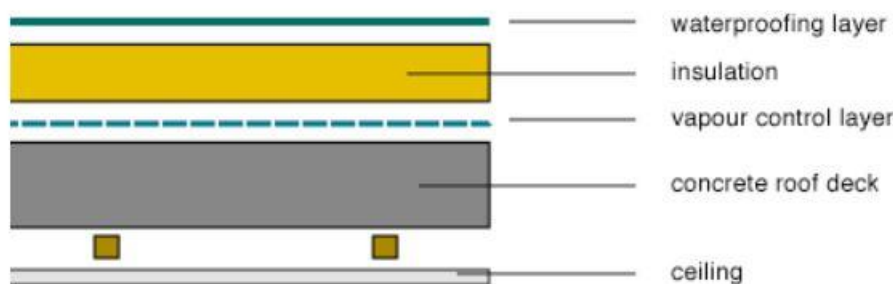
Figure 16. Build-up of the 'warm roof' insulation method for flat concrete roofs (Greenspec, 2020).

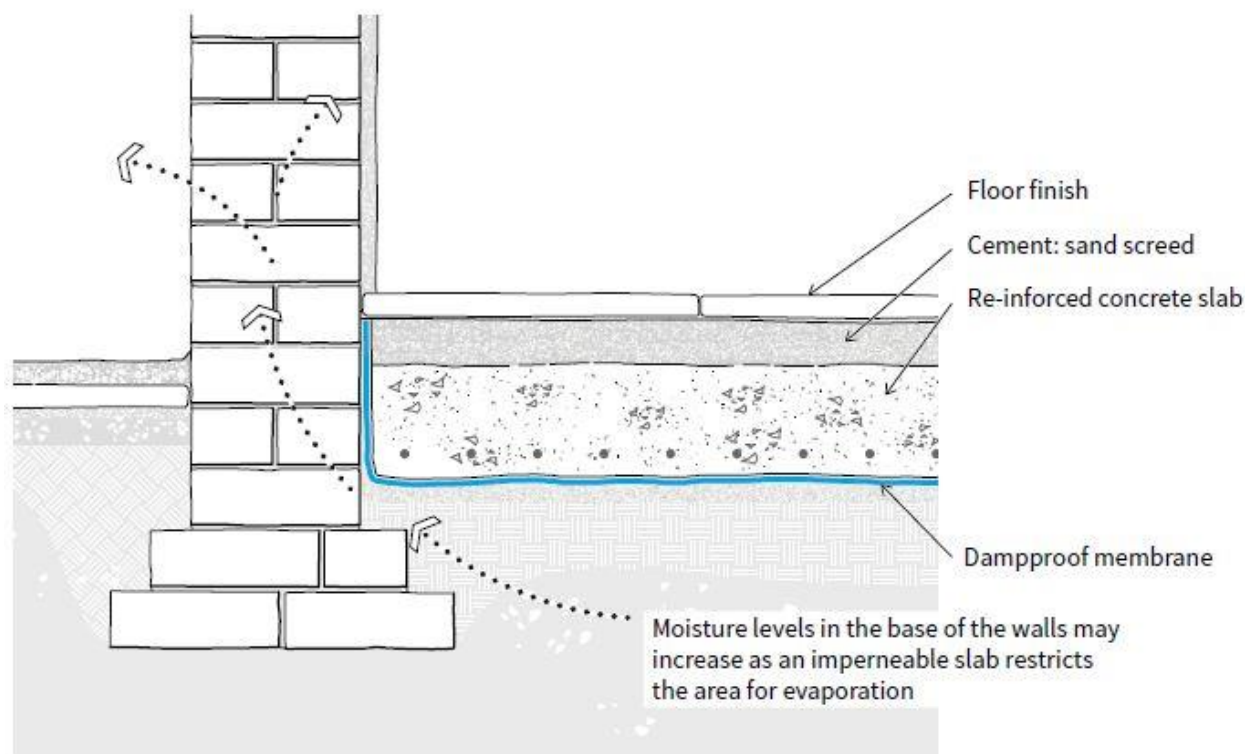
Figure 17. Moisture movement in a traditionally constructed building after the installation of a concrete floor and damp-proof membrane (Pickles, 2016).

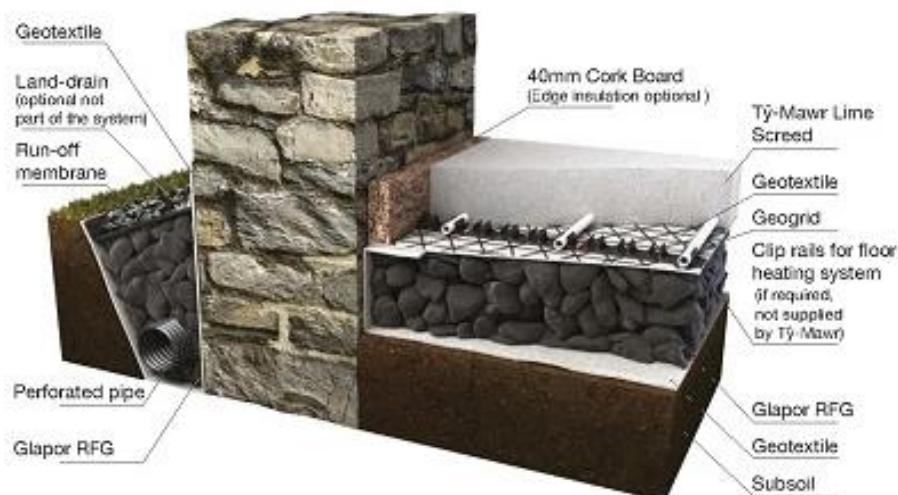
Figure 18. Insulated limecrete floor with underfloor heating (Tŷ-Mawr Lime Ltd., 2020).
