Archaeological Impact Assessment
of
Proposed Canopy Installation,
Lower Lighthouse Road, Skellig Michael Co. Kerry.

Alan R. Hayden

Archaeological Projects Ltd.

June 2022.

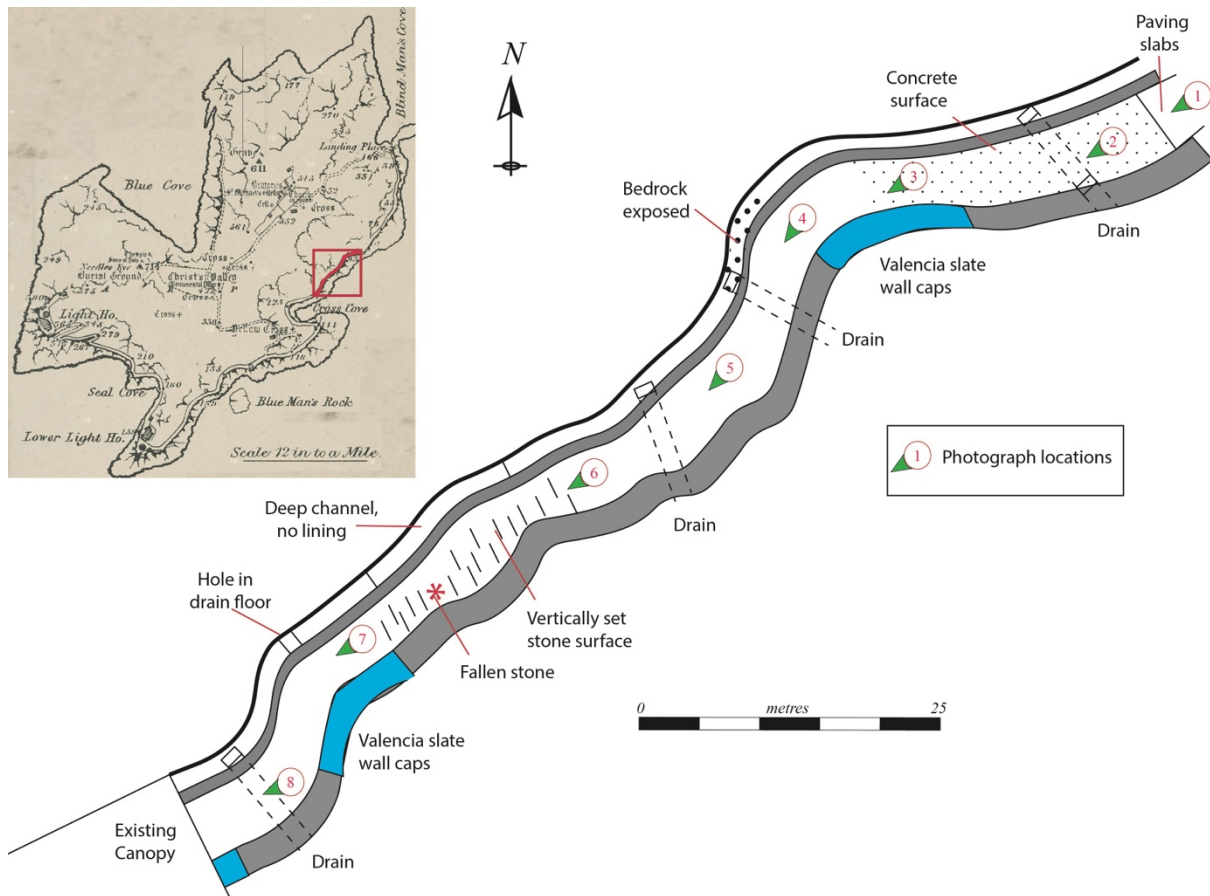
Fig. 1. Location and scale sketch plan of the length of roadway to be canopied with features evident and location of photographs marked.

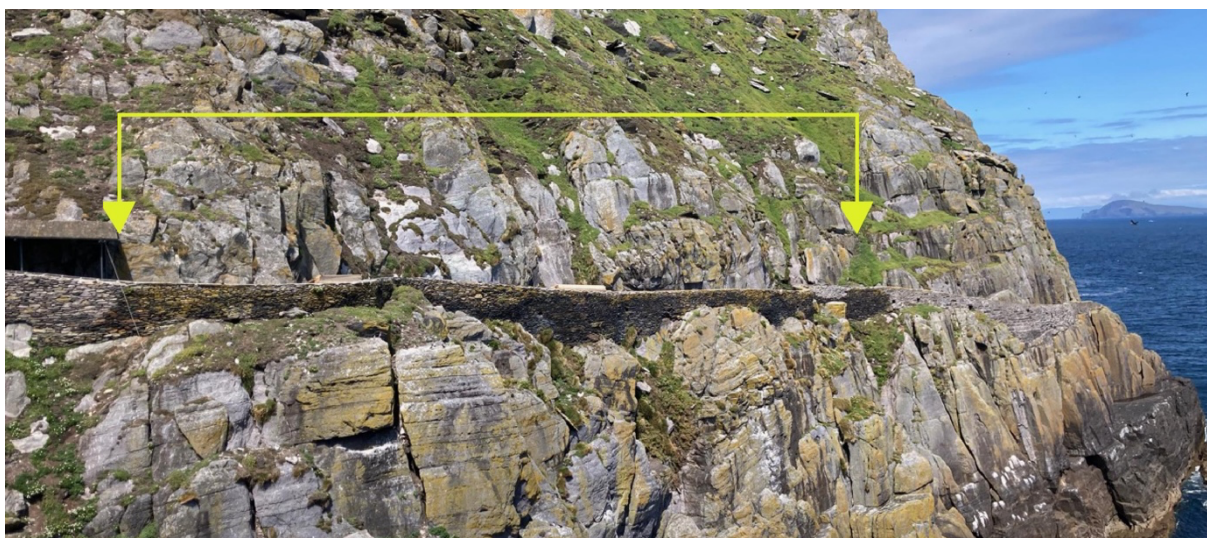
As a result of a recent rockfall on the lighthouse roadway below Cross Cove, the OPW propose to install an extra c. 100m-length of canopy on the roadway leading to the already canopied length at Cross Cove. (figs. 1 & 2). The proposed canopy will be of similar construction to that already in place in Cove Cove (Photo 8) and will consist of pairs of linked scaffold poles, the outer set in a pit dug into the fill of the roadway immediately inside the parapet wall and the inner in a pit in the base of lateral drain or on bedrock, carrying a 4" thick sloping timber deck.

Fig. 2. The length of roadway to be canopied, viewed from the helipad.

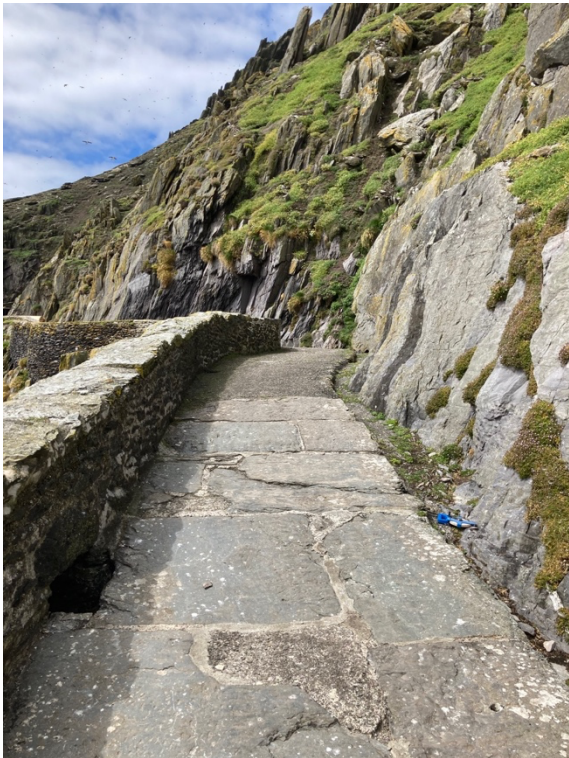
The lowest part of the road to be canopied is the end of the paved section up from the landing (Photo 1). The next section up has a concrete surface both on the roadway and in the lateral drain (Photo 2). The concrete is likely to date to the first half of the twentieth century. There is a stone-lined

Photo 1. Stone paved road surface.

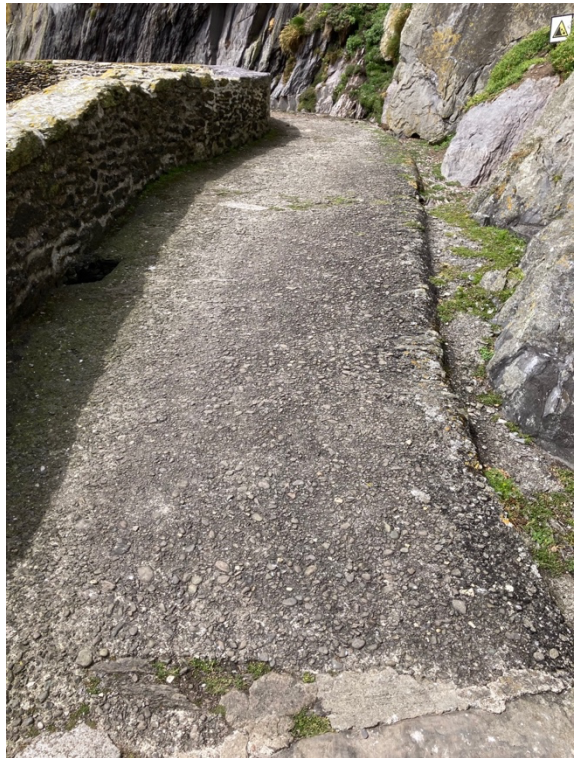
Photo 2. Concrete road surface and lateral drain

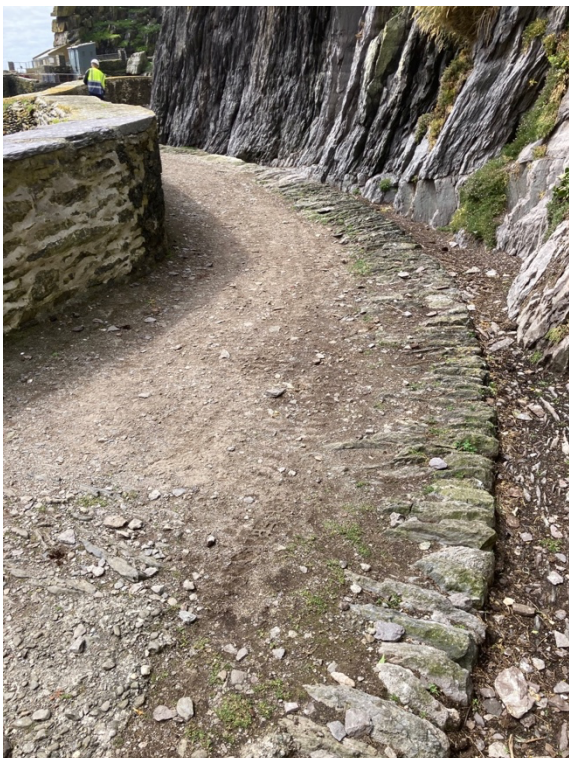
Photo 3.

drain crossing beneath this section. The road surface above this point is composed of clay and stones (Photos 3-5 and 7-8) except for a short section where it is partly composed of vertically-set stones (fig. 1 & Photo 6). The lateral drain on this length generally has a lining of small vertically-set stones except in one area where it is rock cut (Photo 4). There is one short section where the lateral drain is much deeper and has no stone lining (fig. 1) and higher up one short length where the stone lining is missing (fig. 1). There are three stone-lined drains, the lowest is partly rock cut (Photo 4), crossing beneath this section of the road.

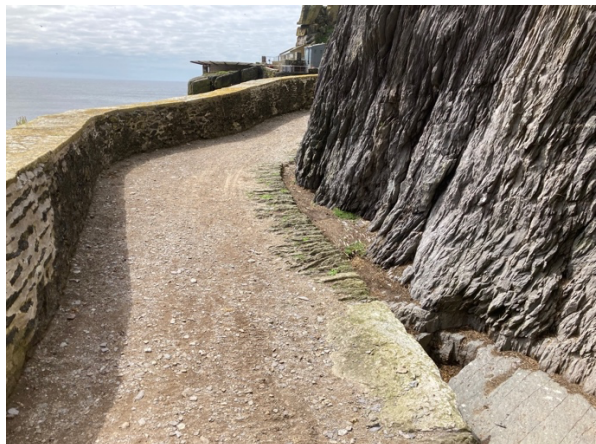
Photo 4. Rock cut drain and lateral drain base on right.

Care should be taken not to locate any of the poles of the outer line of supports on top of the line of any of the four drains crossing beneath the roadway.

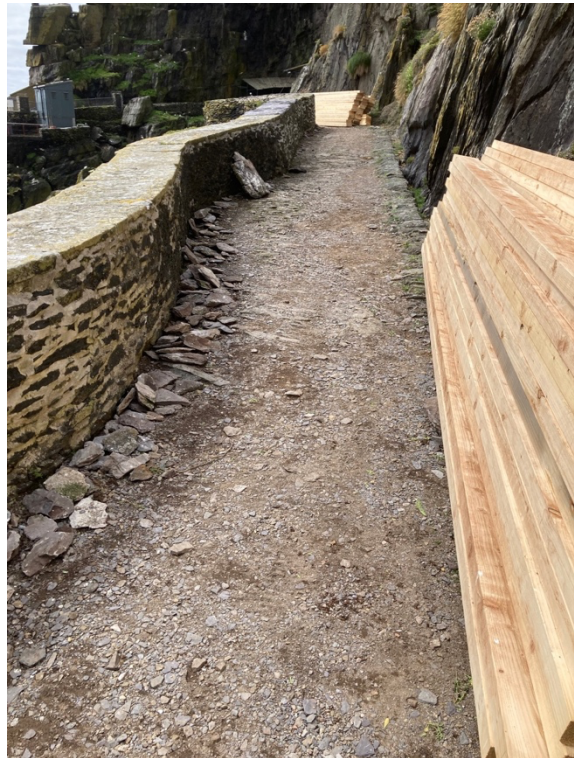
Photo 6. Vertically set stone surface on roadway

The posts at the inner side of the canopy will either be set on bedrock where it is exposed or in pits dug through the vertically set stone lining of the base of the lateral drain. There will be no cultural material encountered in this work and therefore it also has no archaeological impact. The lifting and replacement of the vertically-set stone lining has been done in the past when the canopy was previously extended at Cross Cove. Both there and in repairs undertaken to the base of the lateral drain on the upper lighthouse roadway it was a simple matter to lift and replace the vertically set stones. This was done successfully on many occasions and a after a short while the replaced stones blend in perfectly with the original. It is important that the lifted stone is replaced to avoid weakening the adjacent stonework.

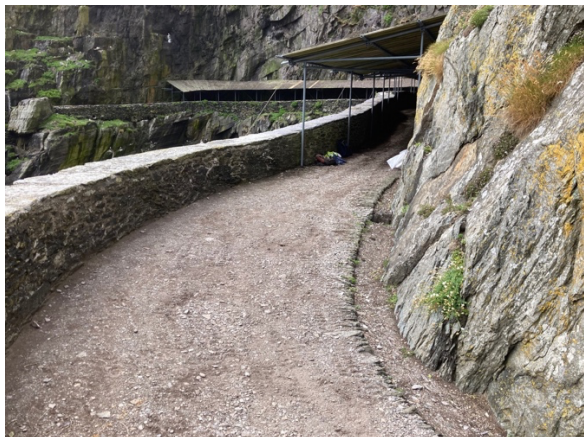
Photo 8. The uppermost part leading to existing canopy.
