Sceilg Mhichíl World Heritage Property Management Plan 2020–30

Prepared by Department of Housing,
Local Government and Heritage
[gov.ie/housing](https://www.gov.ie/housing)

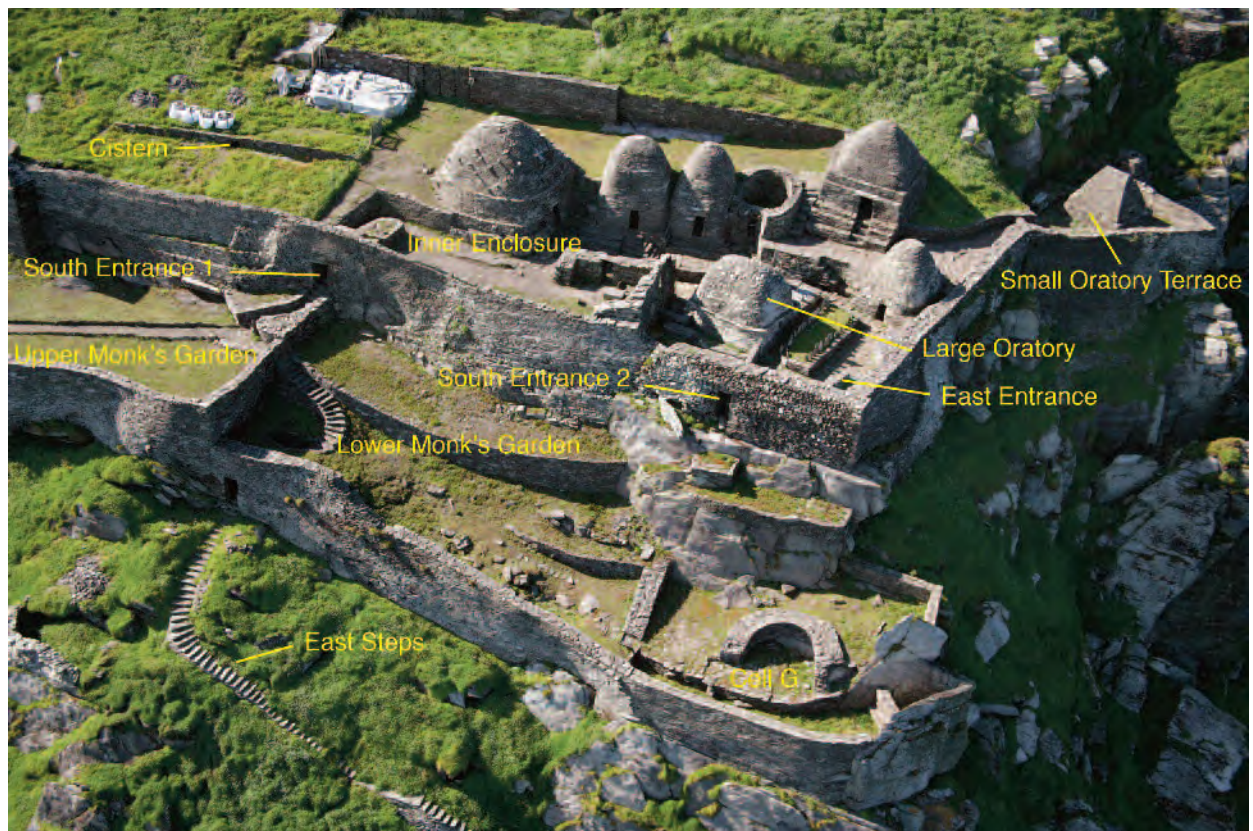
Pl. 4 Aerial view of the monastery, showing the Inner Enclosure (illustrating the location of cells, oratories, church and leachtanna in the Lower Outer Enclosure). This view also shows the top of the East Steps and the original entrance to the monastery.

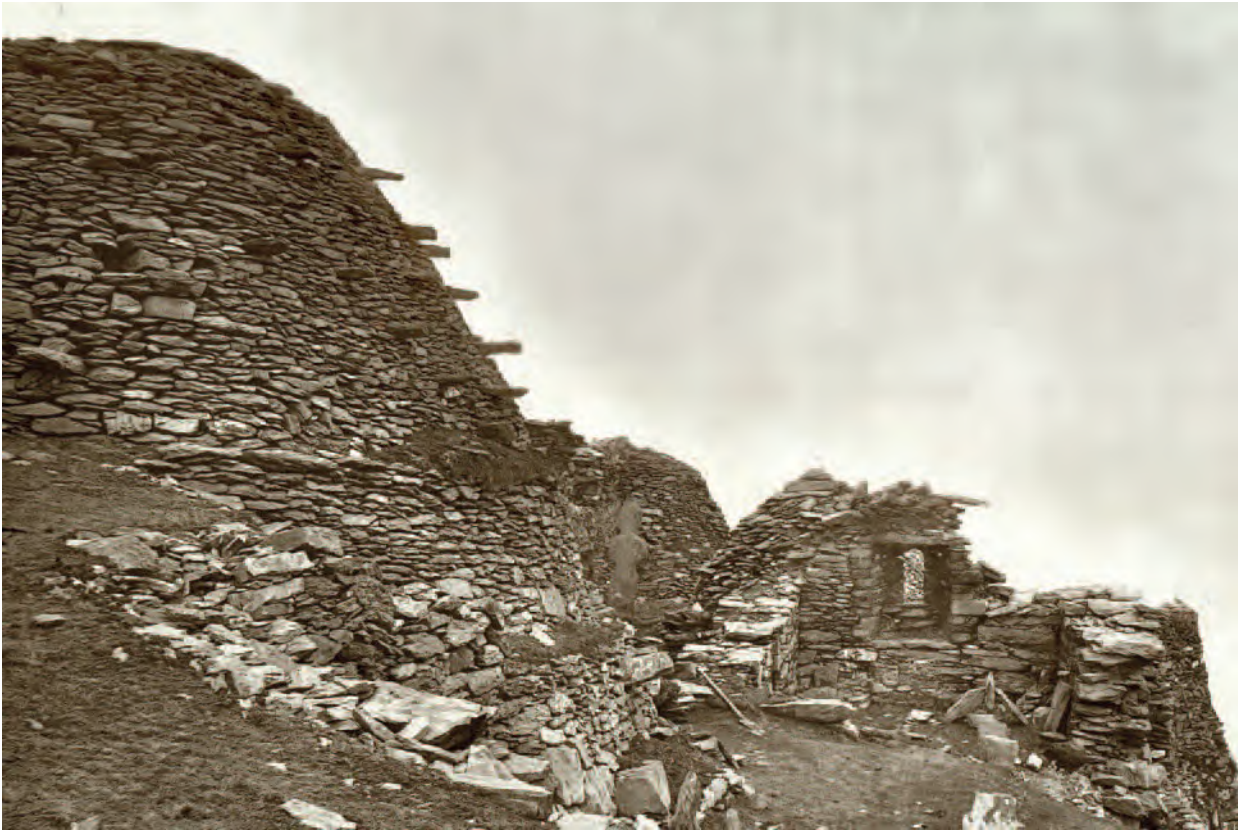
Pl. 6 A nineteenth-century view of St Michael's Church, showing the collapsed retaining wall on the south side, published in Dunraven's Notes on Irish Architecture, vol. 1.

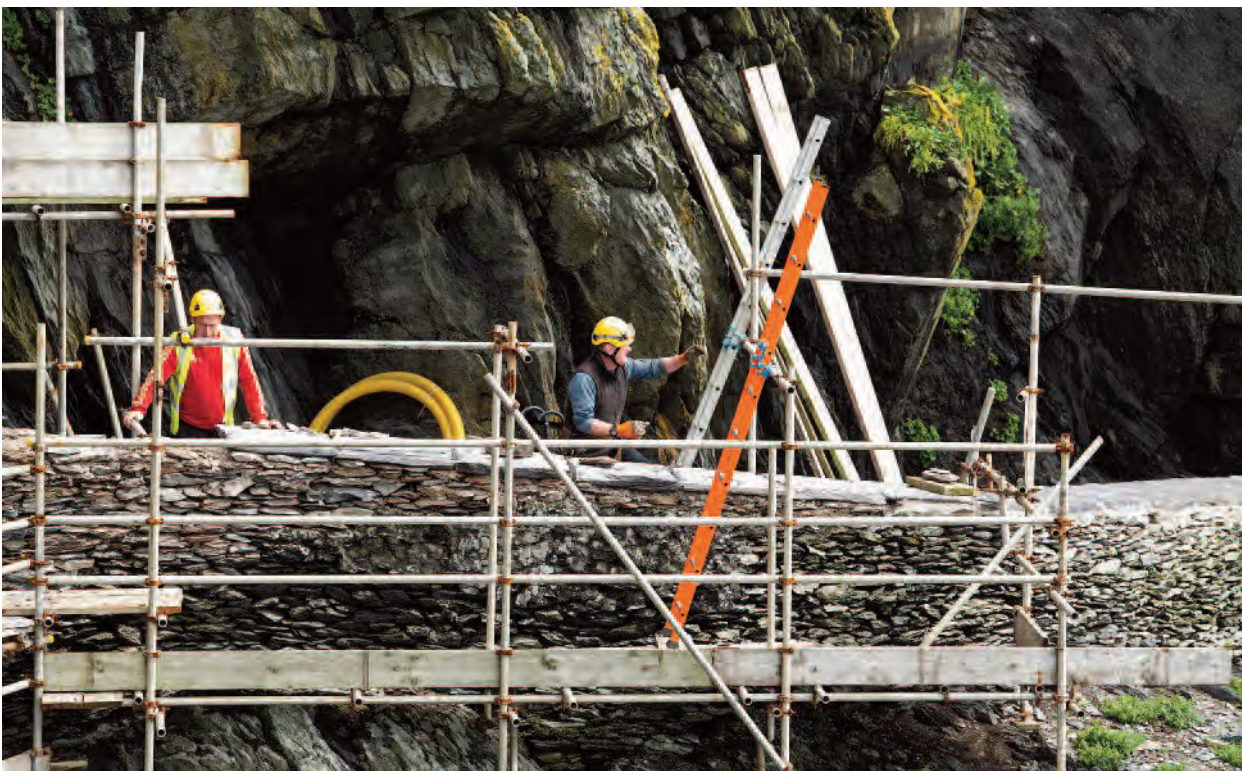
Pl. 18 Relaying Valentia slate capstones on the sea wall north-east of the Lower Lighthouse complex.

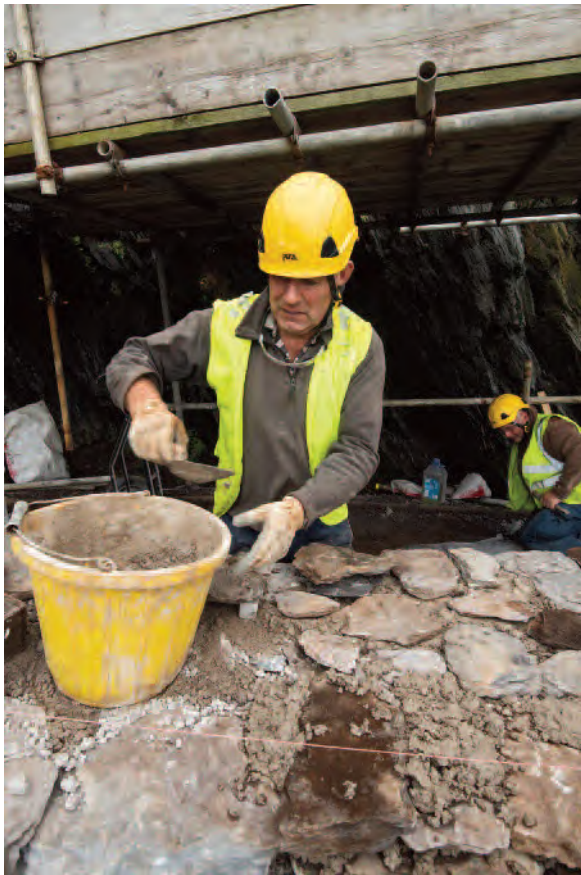
Pl. 19 An OPW mason laying the base for new capstones on the sea wall, Upper Lighthouse Road.

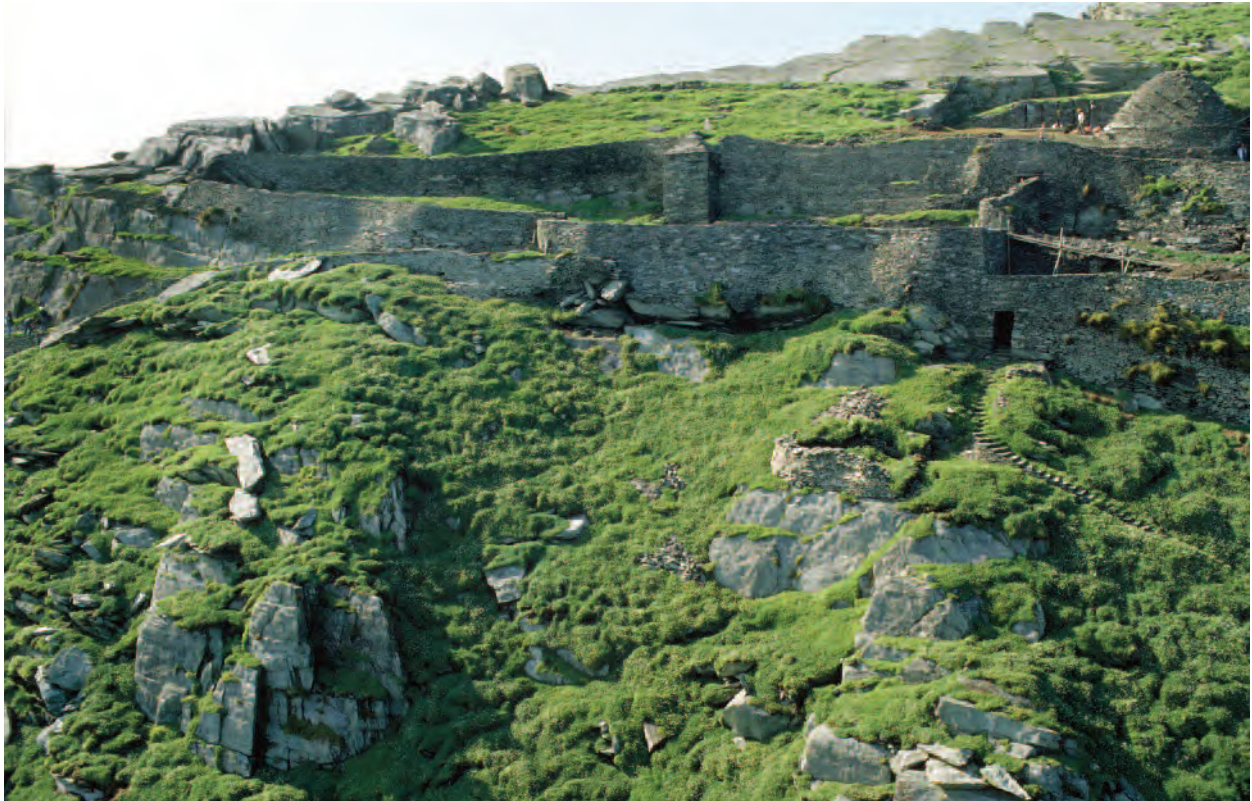
Pl. 42 The west end of the monastery, showing the retaining walls.

Terrace is substantially original. It had moved significantly over the centuries, with the top section falling inwards; a revetment was added in antiquity to prevent it falling onto the terrace. This wall has now been stabilised *in situ*.

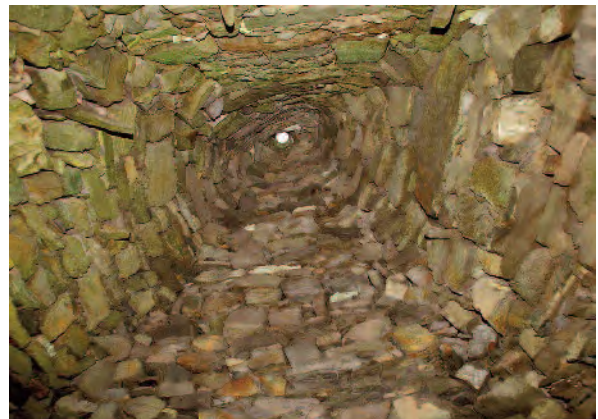
Pl. 45 The inner dome of Cell F, showing corbelling and projecting stones.

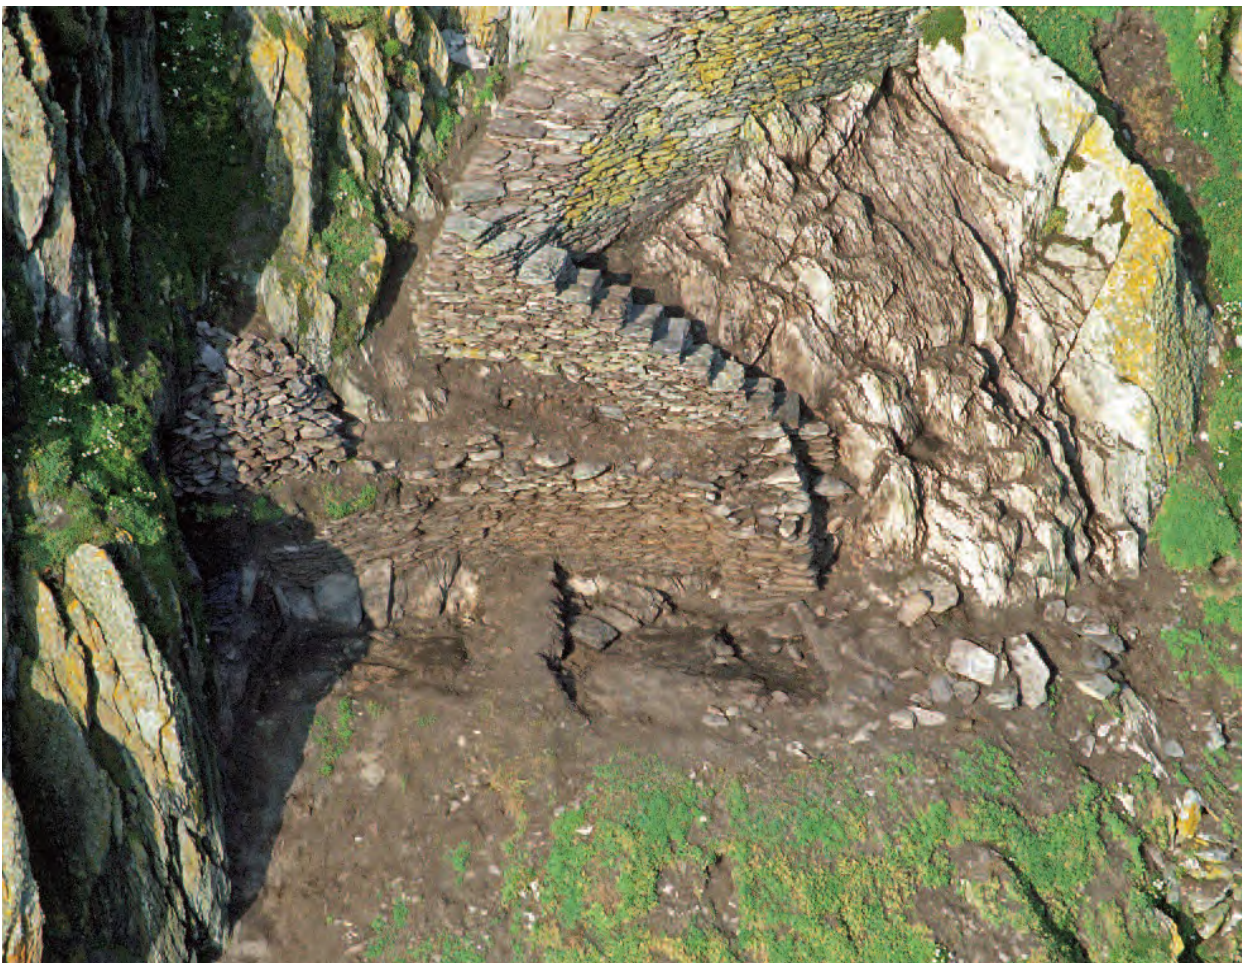
Pl. 50 Excavation of the boathouse structure above the landing and adjacent to the East Steps.

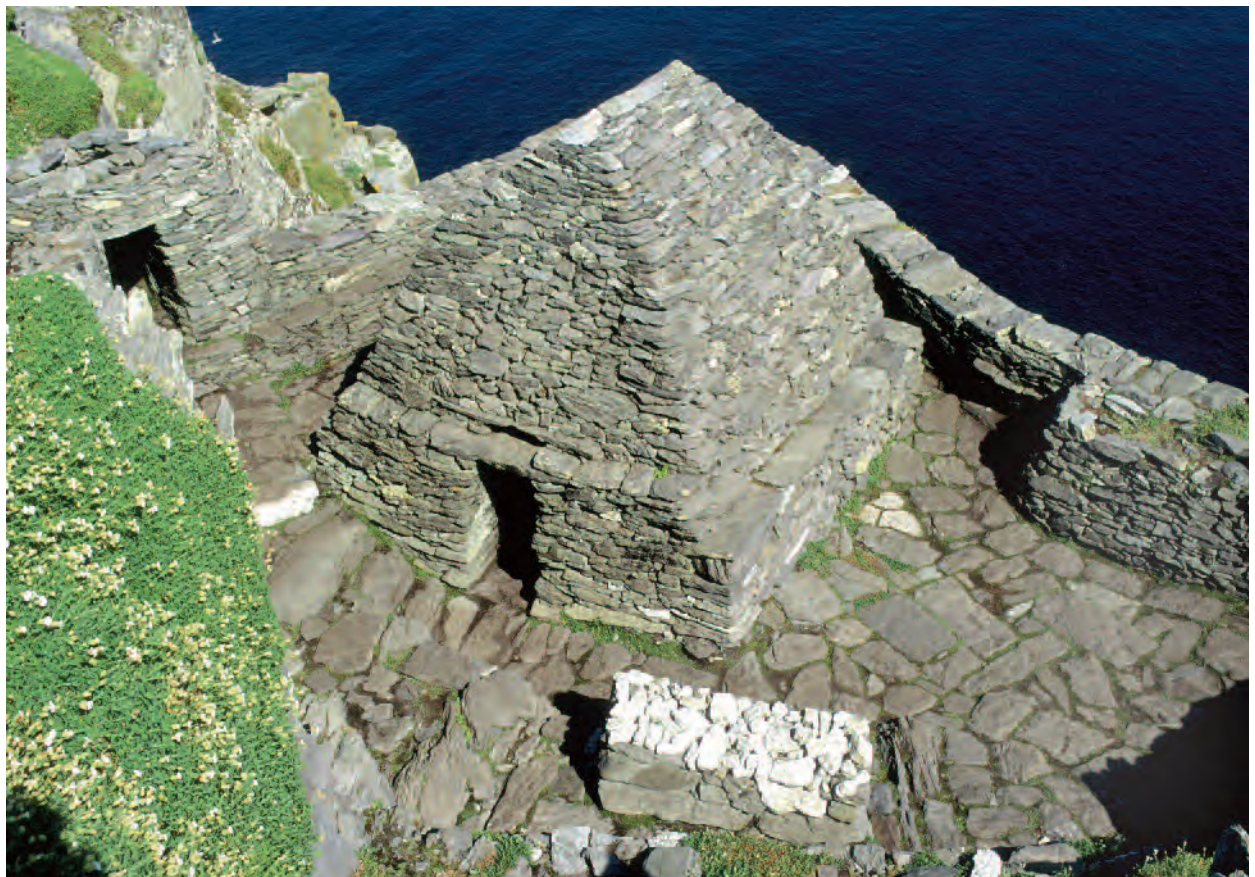
Pl. 59 The Small Oratory Terrace after excavation, consolidation and conservation works.

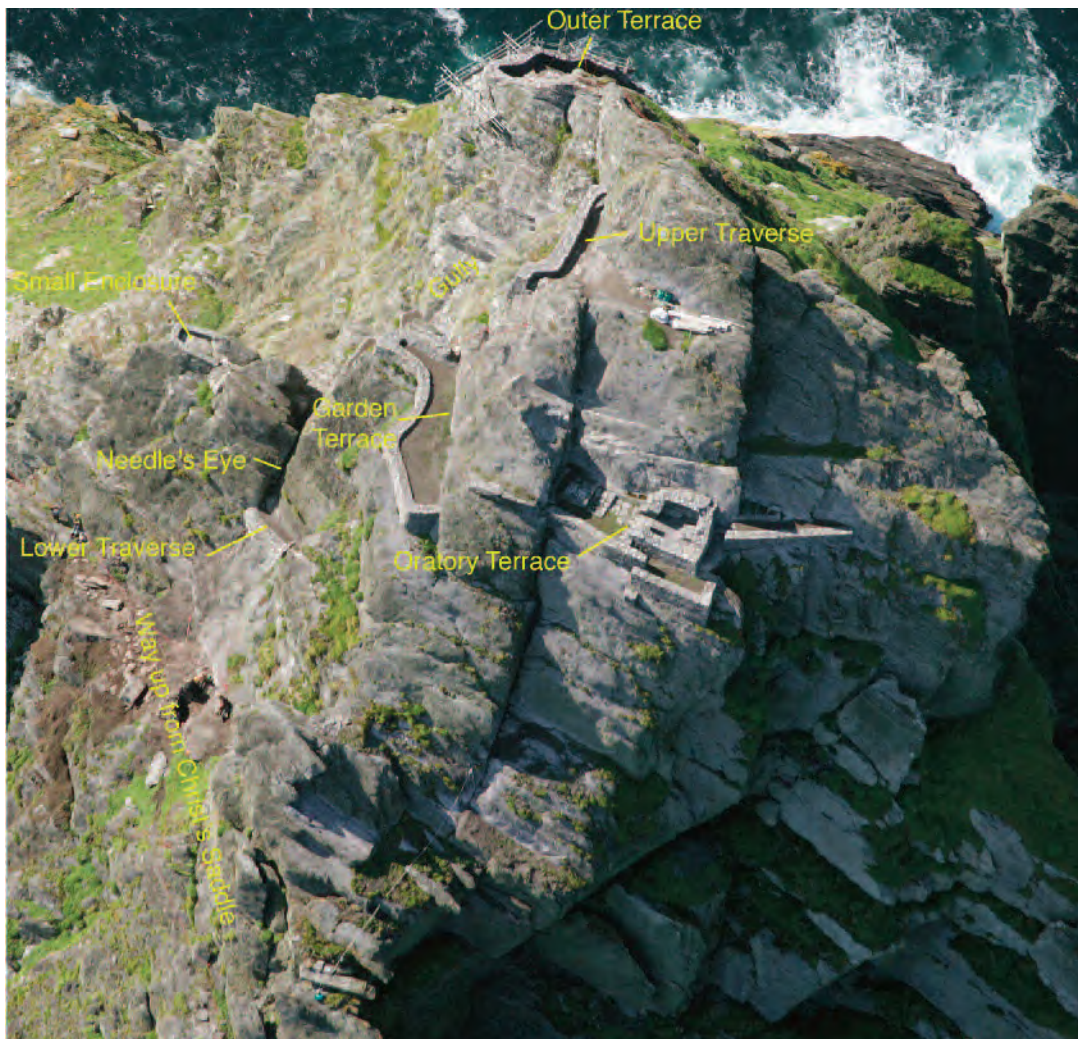
Pl. 60 Aerial photograph of the South Peak indicating its principal features.

Initial work to the structures on the South Peak focused on the access platform (Lower Traverse) just below the Needle's Eye. Excess soil from a gully above had built up at one end and this was removed to reveal a short flight of original monks' steps in very good condition. Some repairs were undertaken to the retaining wall supporting the platform, where it had become unstable. Above the Needle's Eye a small contemplation or prayer station was excavated and conserved.
