SKELLIG MICHAEL, CO. KERRY: THE MONASTERY AND SOUTH PEAK

Archaeological stratigraphic report: excavations 1986–2010

Edward Bourke, Alan R. Hayden, Ann Lynch

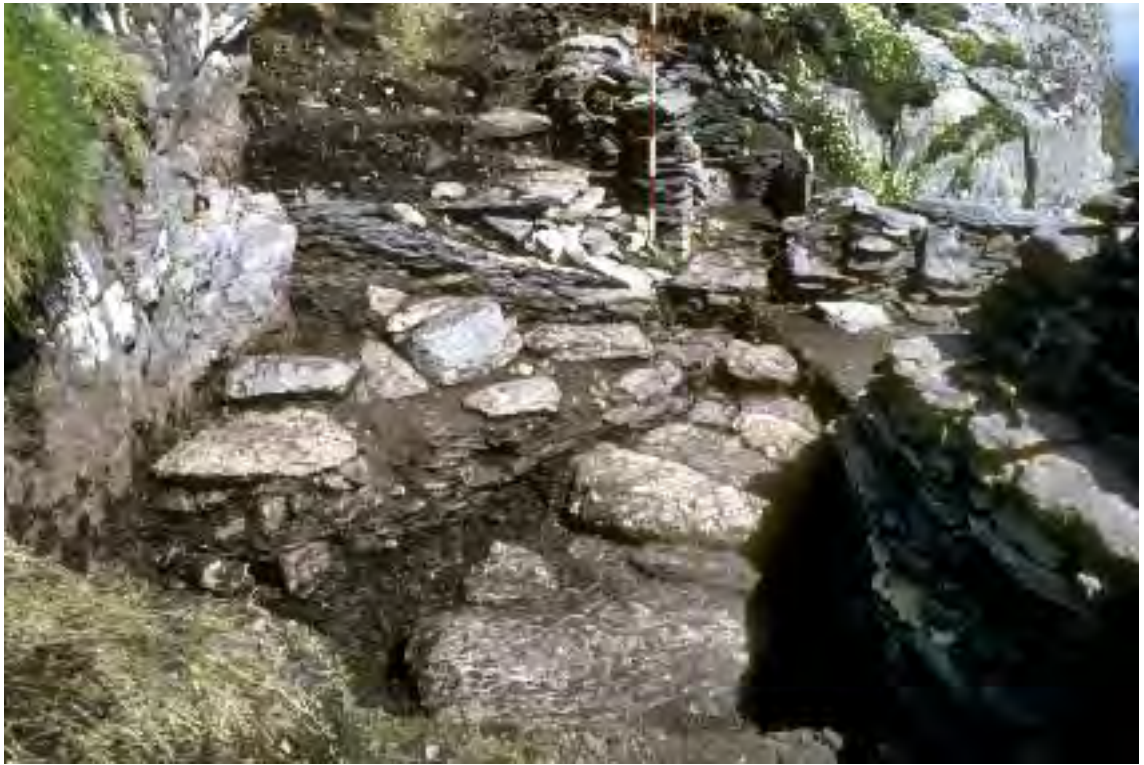
Ill. 2.13—The low retaining wall (F207) and paving stones (F208) during excavation (A. Lynch).

A drystone retaining wall (F207) curves north-eastwards from the rock face to the retaining wall (F216) at the entrance to the 'latrine' (Ill. 2.13). This wall, constructed of sandstone, survives to an average height of 0.2m and averages 0.35m in width. At its northern end, stones on edge define its inner face, but elsewhere a stone and clay fill (F214) lies directly behind its rubble core. This retaining wall defines one side of a triangular terrace, the other two sides of which were formed by the rock face on the west

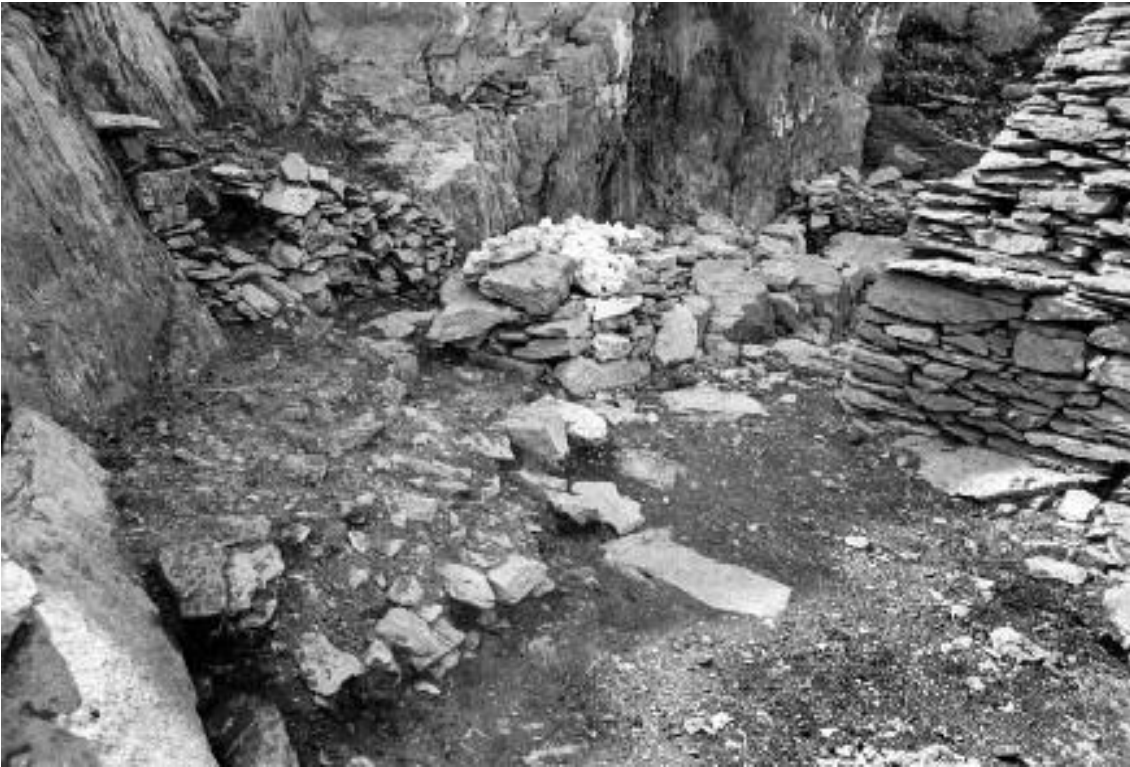
Ill. 2.14—The small oratory terrace during excavation, showing retaining wall (F234) in background, the *leacht* and the remains of a possible retaining wall (F238) in foreground. (A. Lynch)

Just to the west of the *leacht* and 0.6m distant from it, a drystone wall (F234) was uncovered linking two projecting outcrops of the rock face, which resulted in the creation of a small terrace behind. The

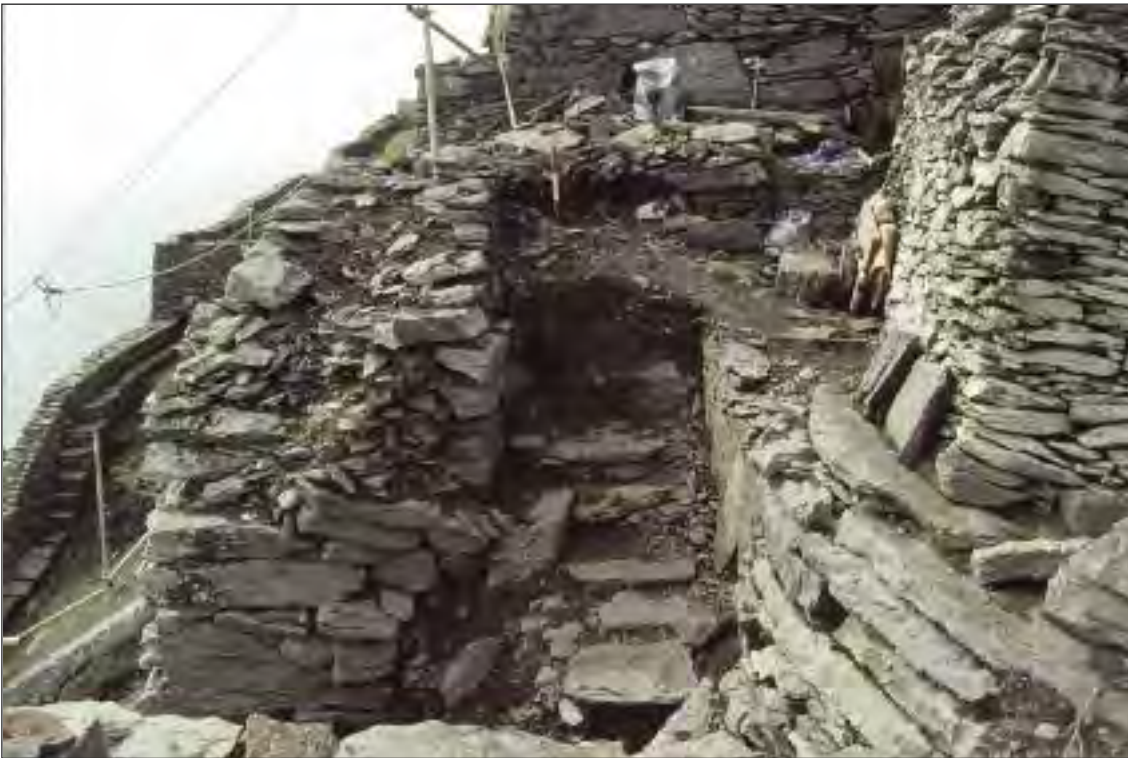
Ill. 2.41—Upper level of steps, south entrance I, from east (E. Bourke).

(F550), up to 0.2m thick, which overlay both F551 and F552. Within this layer (F550) were two steps (Ill. 2.41) that had been displaced by pressure from the weight of the plinth of the large oratory. It is not clear whether these two steps were *in situ* when F550 was deposited, and therefore would have belonged to phase 1, or whether they form part of the phase 2 steps. The drystone risers had fallen away when the steps were displaced and it is therefore not clear whether they were steps of phase 1 or new steps inserted as part of the less formal stairway of phase 2.

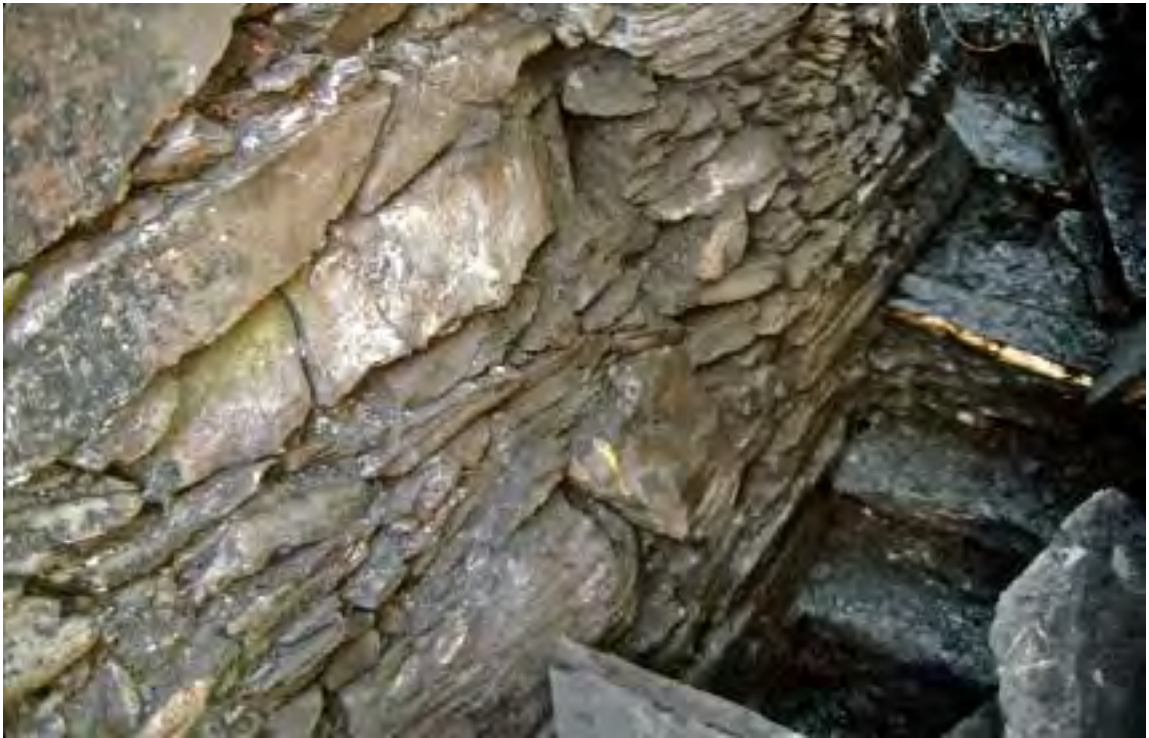
Ill. 2.67—Section through east entrance, inner enclosure (phase 3) (C. McHale).

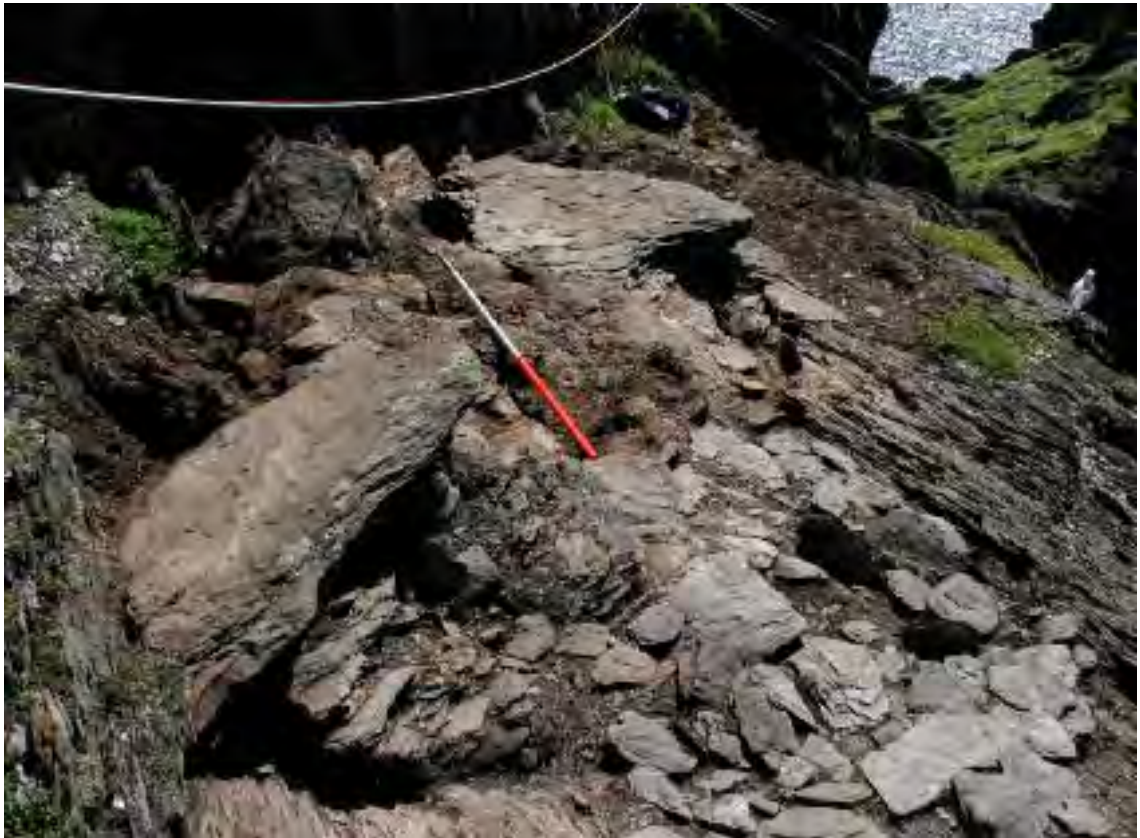
III. 2.222—Plan of the broad ledge after the completion of excavation.

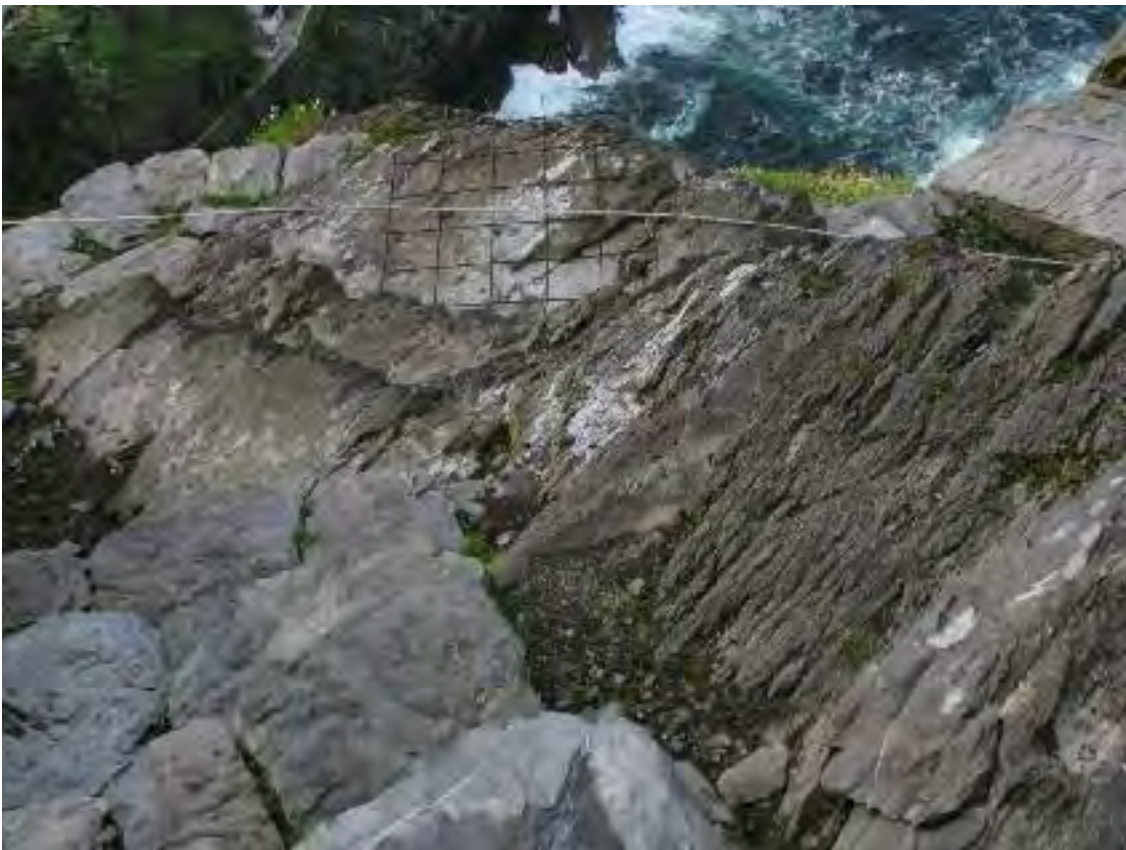
Ill. 2.239—The stepped ledge viewed from above (north). The rock-cut slot visible in the bottom right corner of the planning frame drains water from the inner side of one of the quarried surfaces (A.R. Hayden).

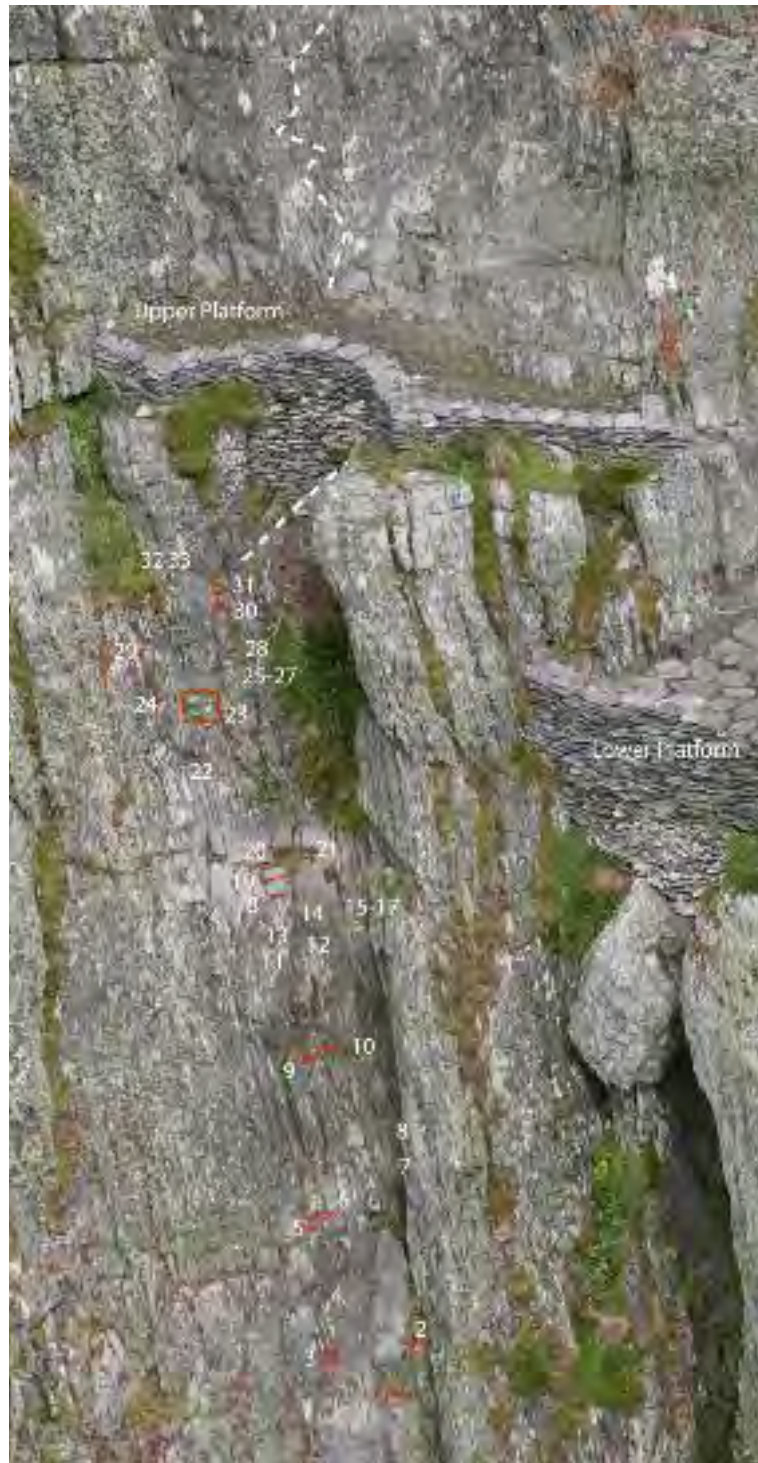
III. 2.294—
Steps (red) and
handholds
(yellow)
recorded in
the lower half
of the gully
(Con Brogan,
DAHG; survey:
A.R. Hayden).
