SKELLIG MICHAEL, CO. KERRY: THE MONASTERY AND SOUTH PEAK

Archaeological stratigraphic report: excavations 1986–2010

Archaeological stratigraphic report:
excavations 1986–2010
(E338; 90E34; 93E195)

Edward Bourke, Alan R. Hayden, Ann Lynch

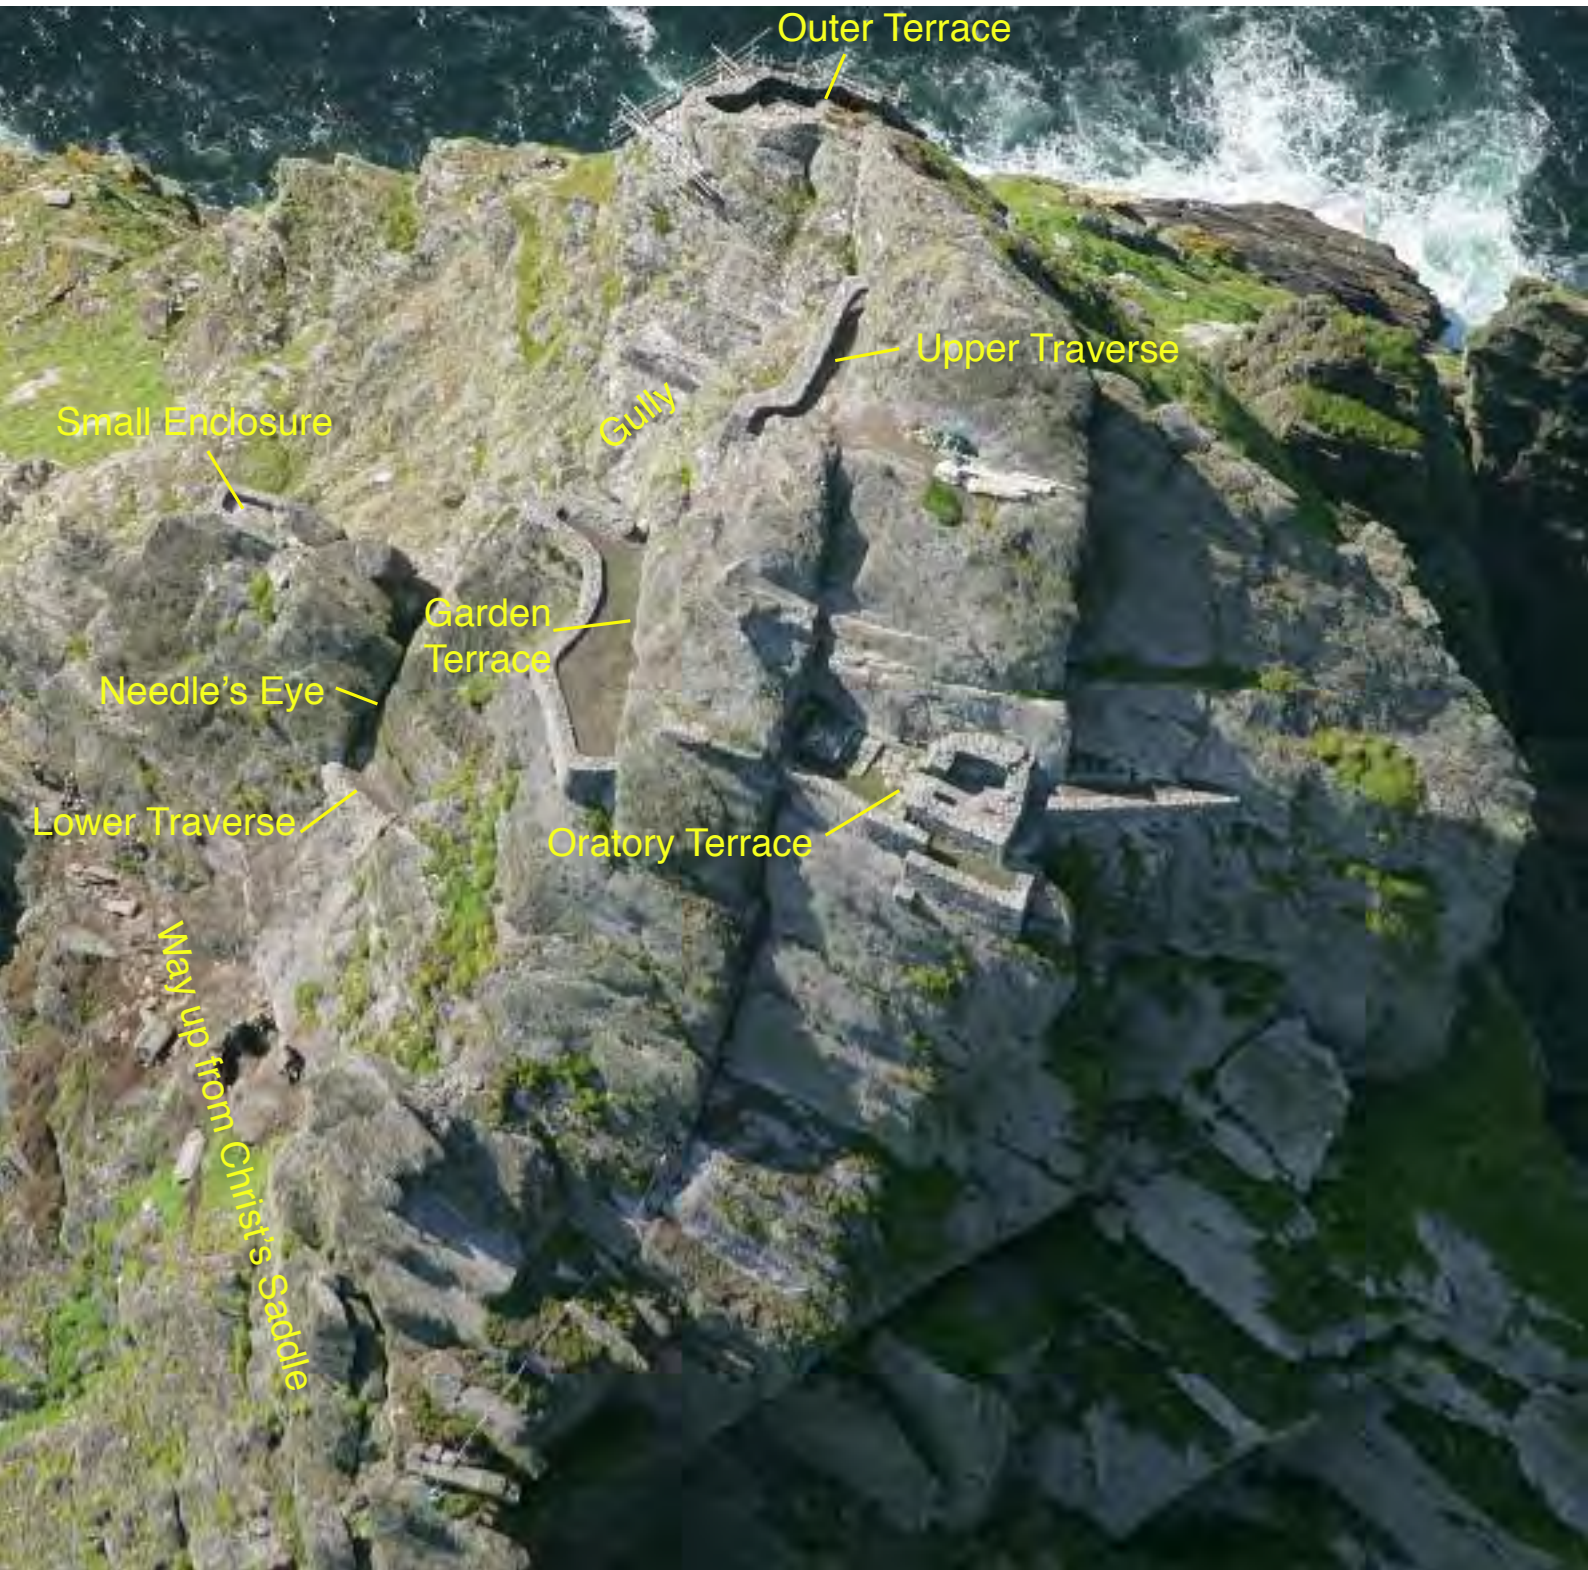
Ill. 1.4—Aerial photograph of south peak indicating principal features.

On the other side of the island, rock-cut steps and ledges lead up to the structures on the South Peak. They comprise a series of platforms, traverses, enclosures and terraces daringly constructed on quarried ledges just below the peak (Ill. 1.4). The oratory terrace still retains its original features: an oratory, altar, *leacht*, bench, water cisterns and a possible shrine. Crosses and a cross-slab were also found on the South Peak.

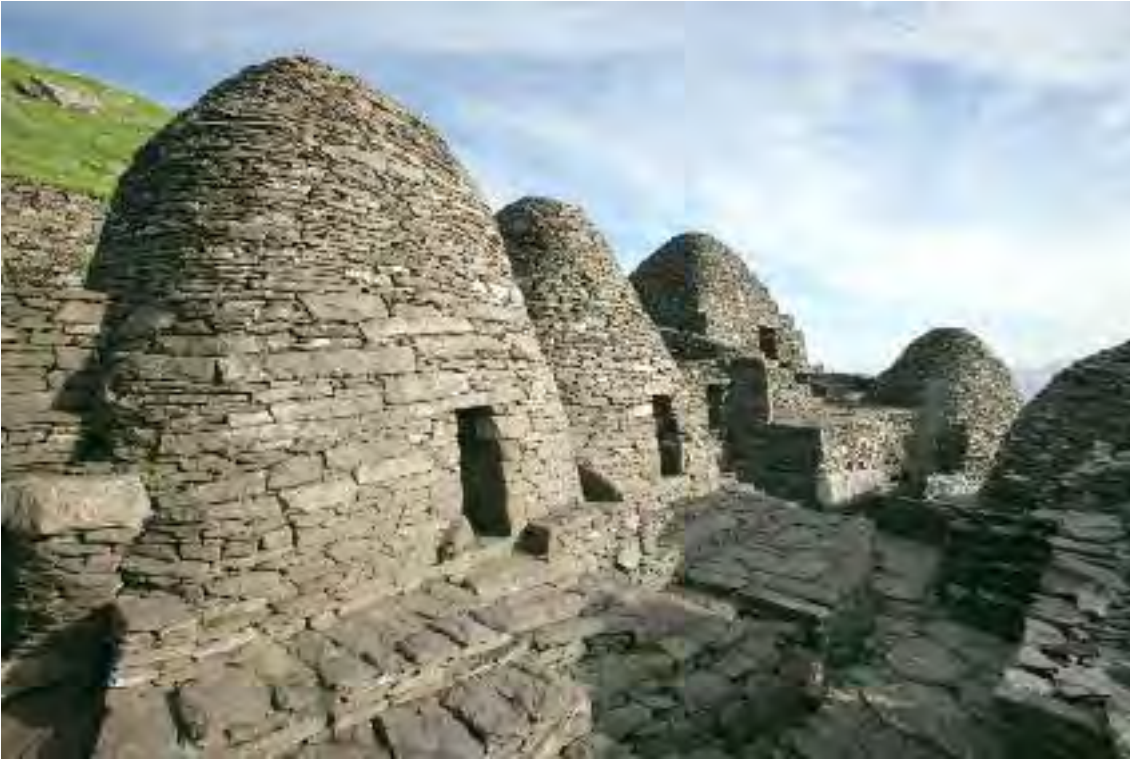
Cell A is the largest and clearly had a communal function. It is particularly imposing and has very thick walls, with several offsets to facilitate construction. The walls, 1.8m thick at the base, are built of small flat stones and there are a number of projecting stones on the outside at the upper level, again a construction feature. The door has a double lintel, inside and out, and the floor retains most of its original paving.

The internal space measures 4.6m by 3.8m and the cell is 5m high. It is subrectangular at floor level,

Ill. 1.7—The cells viewed from west (Con Brogan, DAHG).

evolving into an ovoid shape about 1m above ground level. There are two cupboards and projecting stone pegs (probably used for storage purposes). Uniquely, there are window openings, one of which focuses on the South Peak and another on the Little Skellig.

The dwelling cells (Ill. 1.7)

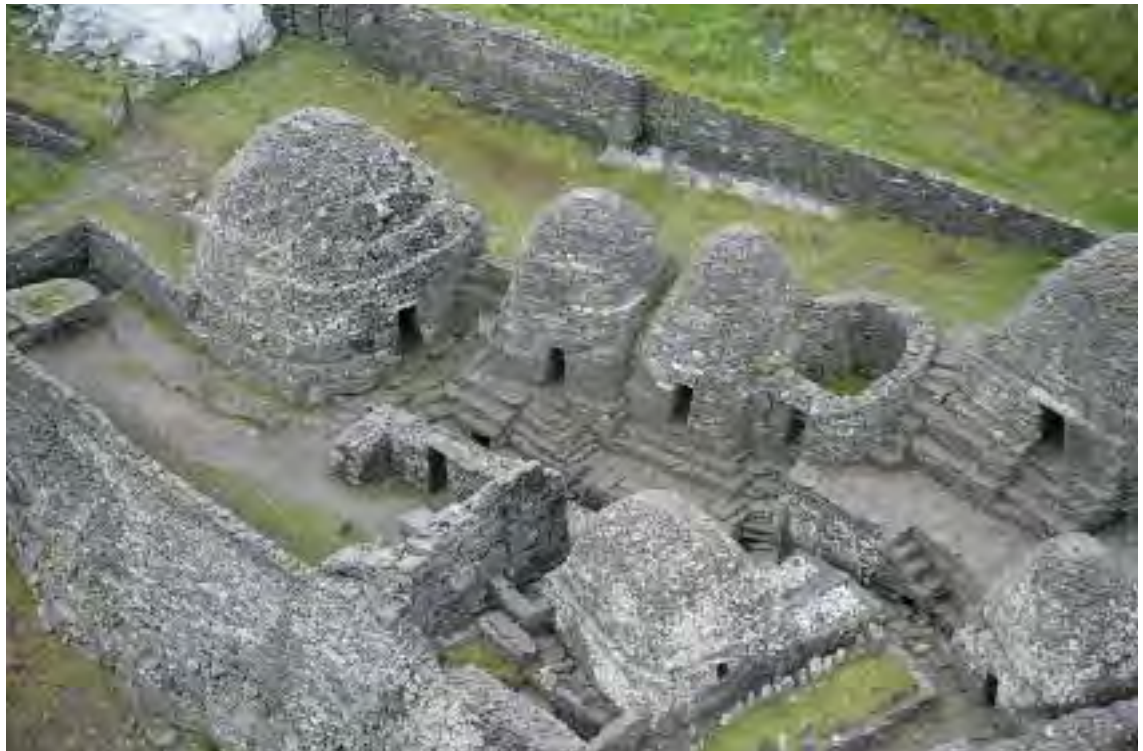
St Michael's Church lies to the west of the large oratory (Ill. 1.8). Part of this mortared church collapsed in the late nineteenth century when the enclosure retaining wall to the south collapsed. The church is rectangular in plan and has straight sides with sharp, rectangular corners. It would have had a timber roof structure. There is an east window and a doorway on the north side. There is evidence of two distinct phases of construction: an earlier, smaller, mortared church, constructed of large blocks of stone, was later expanded to provide a larger church, the masonry of which is primarily oblong stones laid horizontally with definite coursing. Sandstone for the door and window of this later church was sourced on nearby Valentia Island. There is evidence that this later church was rendered externally.

Ill. 1.8—The monastery viewed from south-east, with the remains of St Michael's Church in centre foreground (Con Brogan, DAHG).

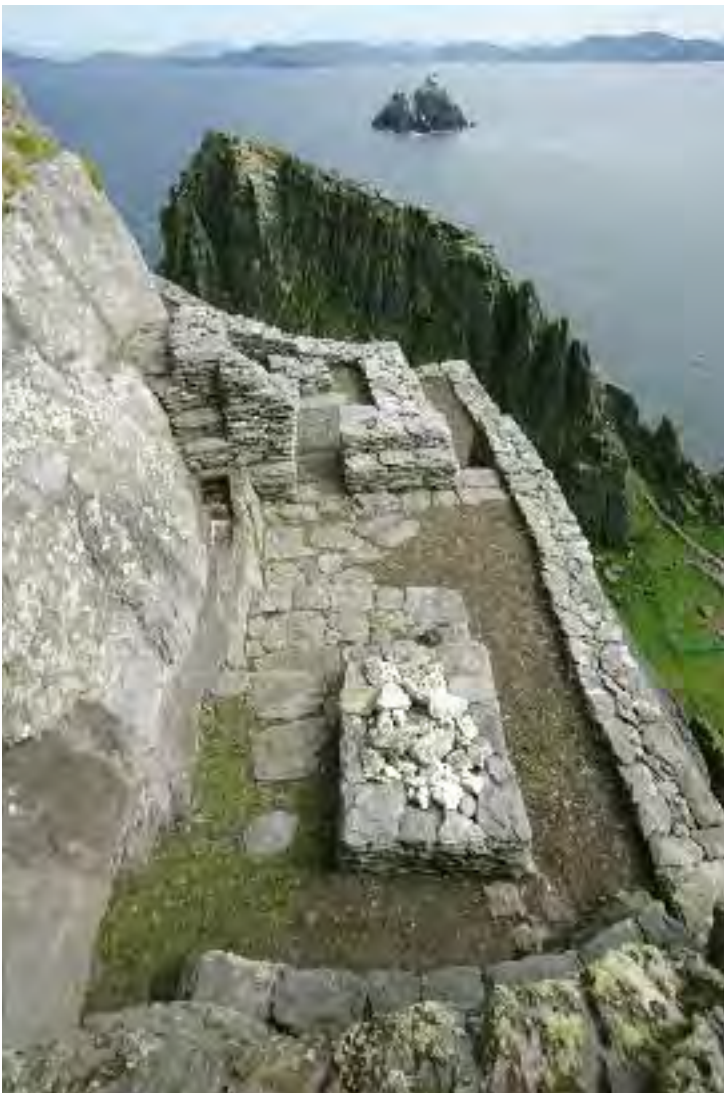
The second and most important of the terraces on the South Peak, the oratory terrace lies at right angles to the garden/dwelling terrace and 4m above it (Ill. 1.10). The main structure is a corbelled oratory with a narrow entry midway along the west wall and its east wall partially built on a stone slab bridging a cleft in the rock. Internally it measures approximately 2.3m by 2m. Against the east wall are the remains of an altar. Two small, interconnected rock-cut basins are located beside the church. These hold water—a vital resource for a monk in this inhospitable place. The monks had cut channels into the near-vertical exposed rock faces above this terrace to channel the rainwater down into the basins below.

At the western end of the terrace, approximately 1m east of the rock face, are the remains of a rectangular *leacht*, 1.1m by 1.6m. This is most likely to have been an external altar. A low drystone bench runs along the rock face, looking towards the oratory. This terrace appears to have been fully paved originally. It is constructed in quite a complex way to allow for circumnavigation of the oratory itself. A similar arrangement can be seen on the small oratory terrace within the monastery, indicating that this must have been an important liturgical requirement. To the east of the oratory terrace is a long, narrow,

Ill. 1.10—The oratory terrace on the South Peak, with Little Skellig and the Kerry coastline in the background (Con Brogan, DAHG).
