Natura Impact Statement
Repair of Sea-wall along Old Lighthouse Road
Skellig Michael Island– *Phase 4*

ISSUE FORM	
Project number	12242
Document number	6034
Document revision	D
Document title	Natura Impact Statement: Repair works to seawall along the Old Lighthouse Road on Skellig Michael Island– <i>Phase 4</i>
Document status	Final
Document prepared by	FMk (MWP- 20/04/2020), HD, Rev D HD (10/03/2021)
Document checked by	MKy (MWP– 28/02/2020) HD (MWP – 21/04/2020) MK (MWP – 15/05/2020)

Project Title	Repair works to seawall along the Old Lighthouse Road and Old Lighthouse Ruin on Skellig Michael Island (Phase 4 of Upper Lighthouse Road conservation project).
Project Proponent	The Office of Public Works (OPW)
Proposed Mitigation Measures	<ul style="list-style-type: none"> • Preconstruction surveys will take place for all bird species prior to any work being carried out as this will provide baseline information and inform construction works using the appropriate mitigation measures. • Preconstruction tape playback surveys for Storm petrel and Manx shearwater 7-10 days prior to works commencing to identify potential nesting sites. Additionally an endoscope will be used to investigate

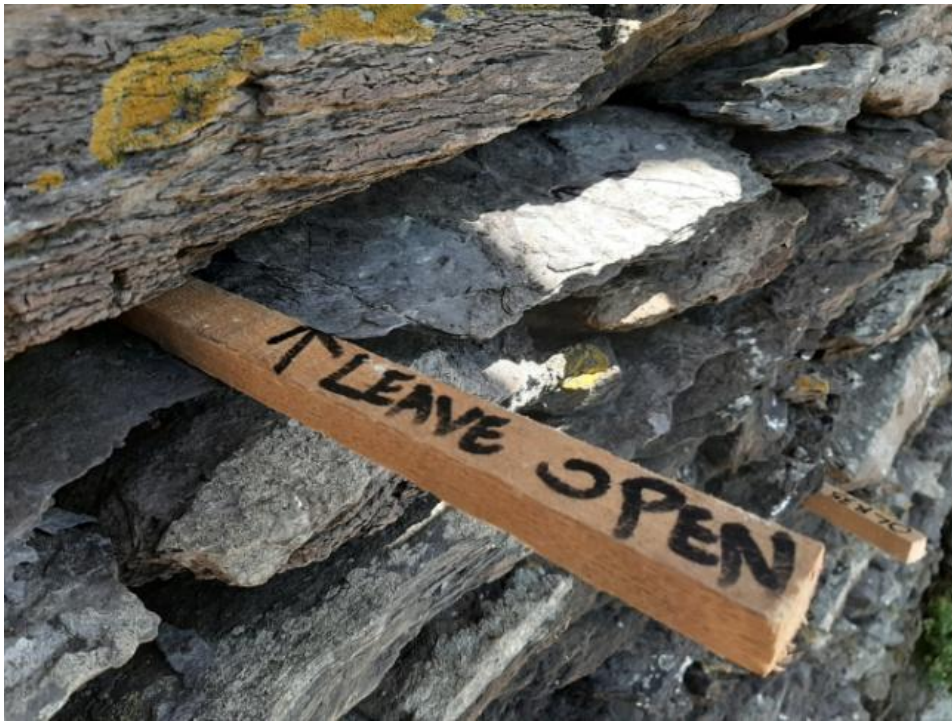
Figure 2. Storm petrel nest site marked with wooden baton along the retaining wall (plate extracted from 2019 Skellig Michael Bird Report by MWP)

Nests shall be marked out and labelled with wooden batons within each works area prior to works commencing (See **Figure 2** below).

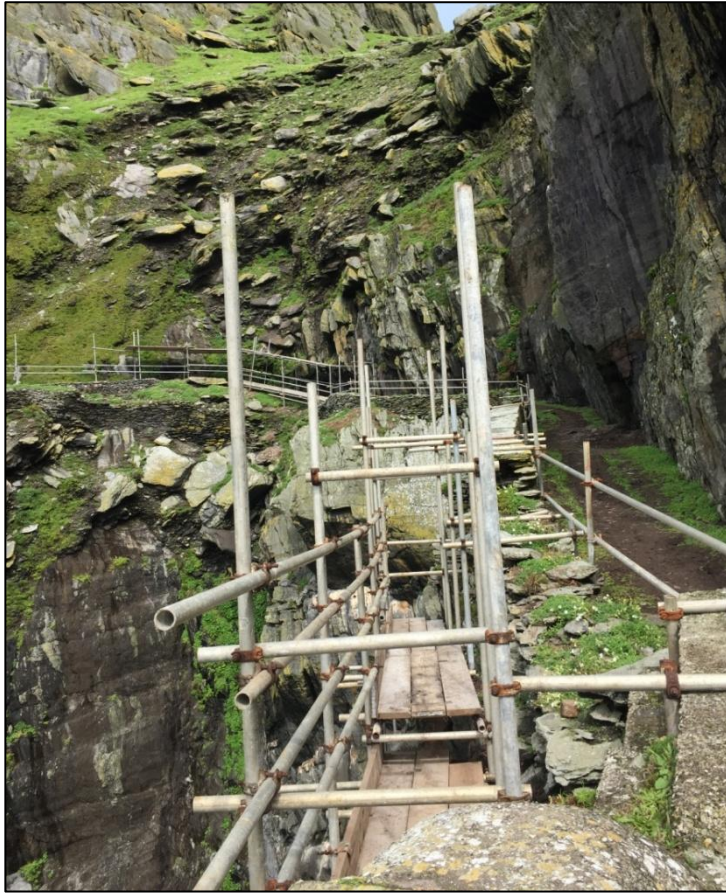
Figure 2: Typical scaffolding set-up along breached section of seawall and roadway

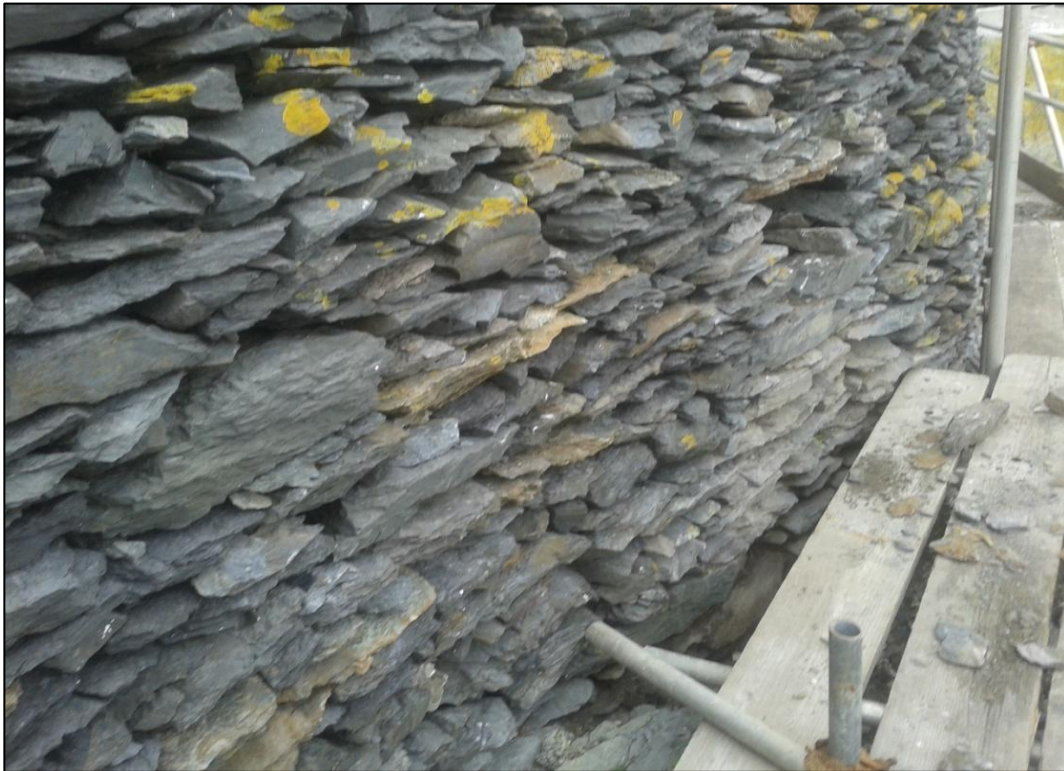
Figure 3. Typical section of masonry seawall undergoing wall tightening works

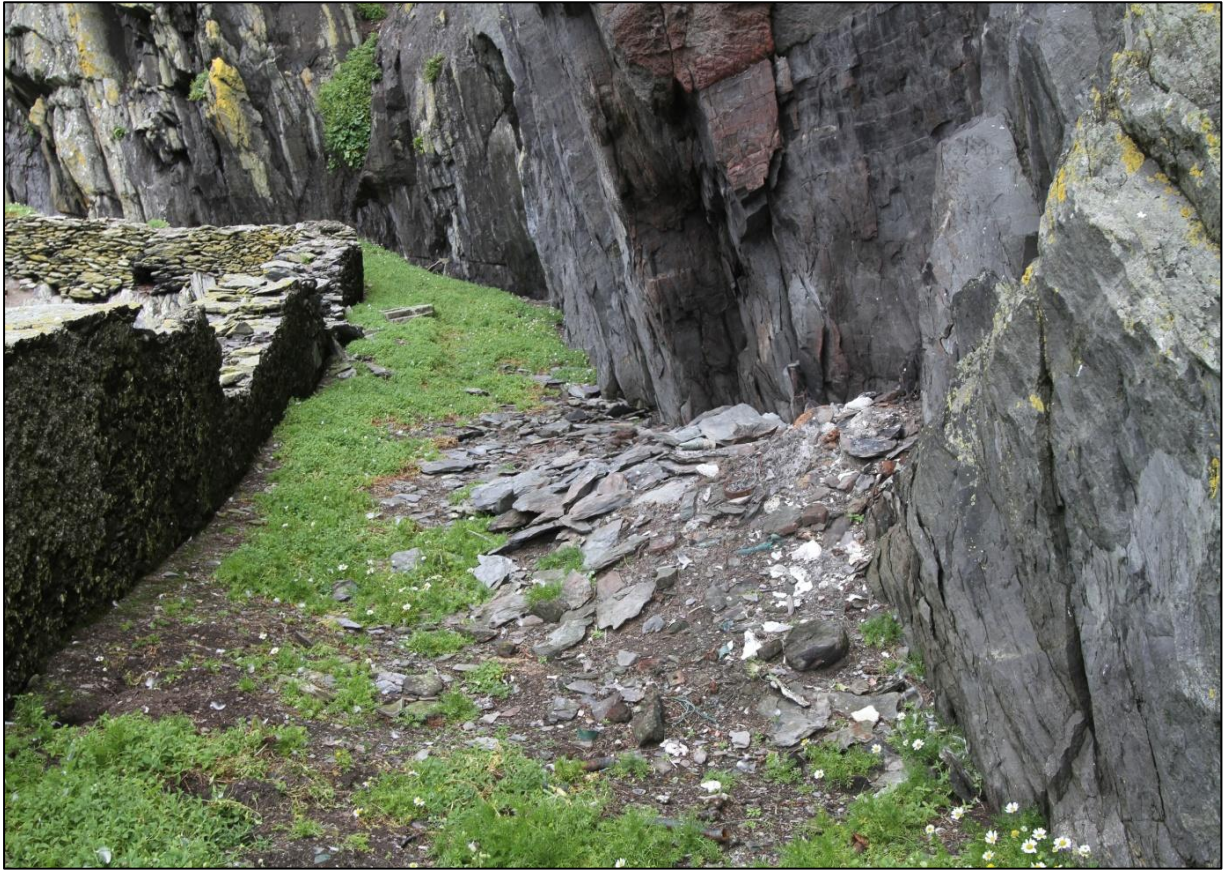
Figure 4. Typical road surface along Upper Lighthouse Road prior to removal of surface vegetation

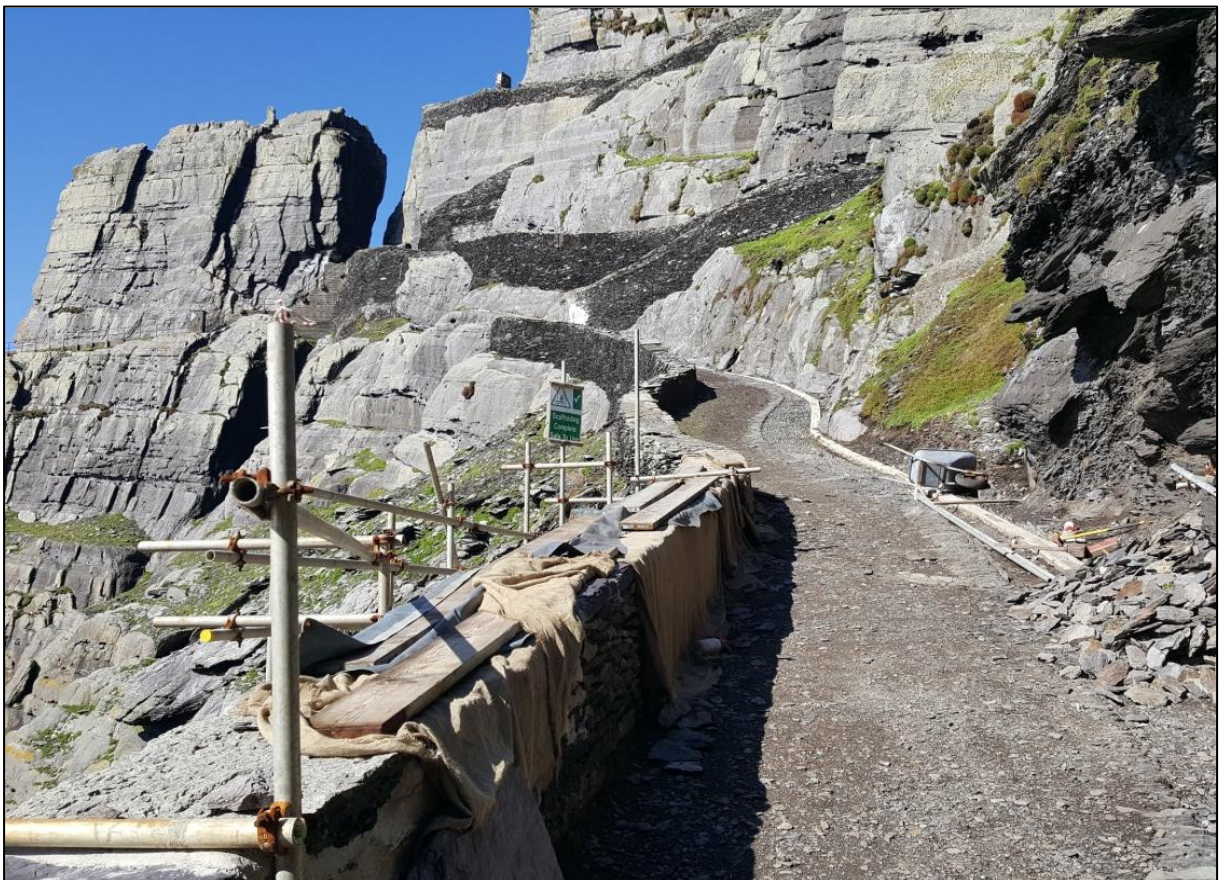
Figure 5. Typical road surface along Upper Lighthouse Road following removal of surface vegetation and infilling

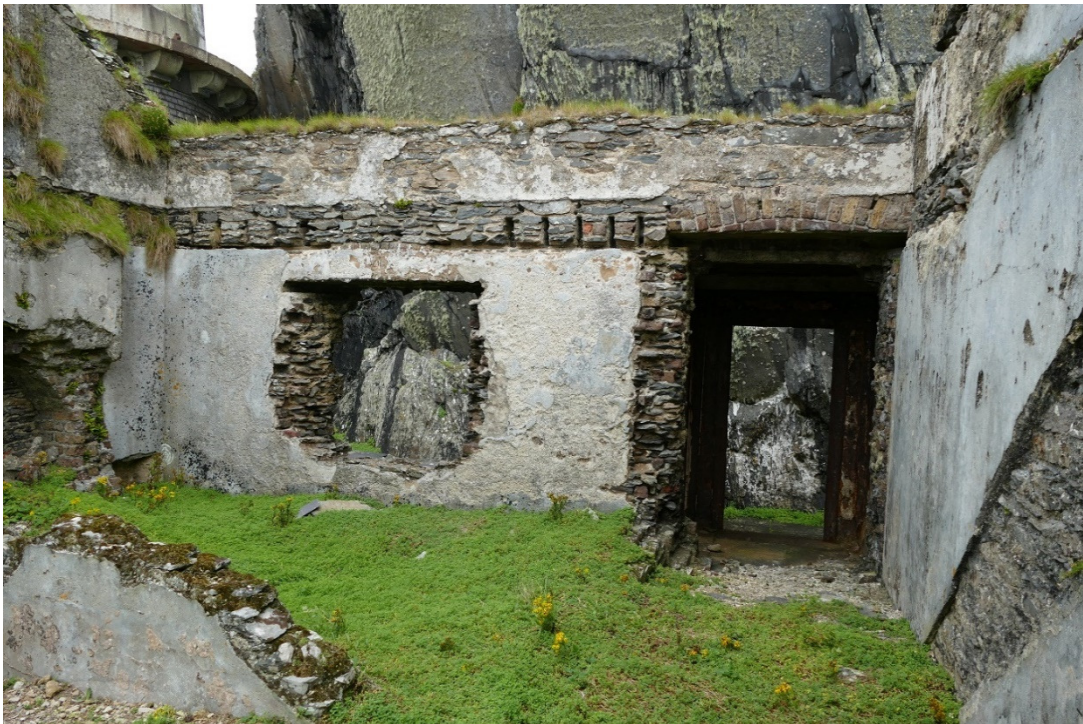
Figure 4 – Existing debris in Upper Lighthouse

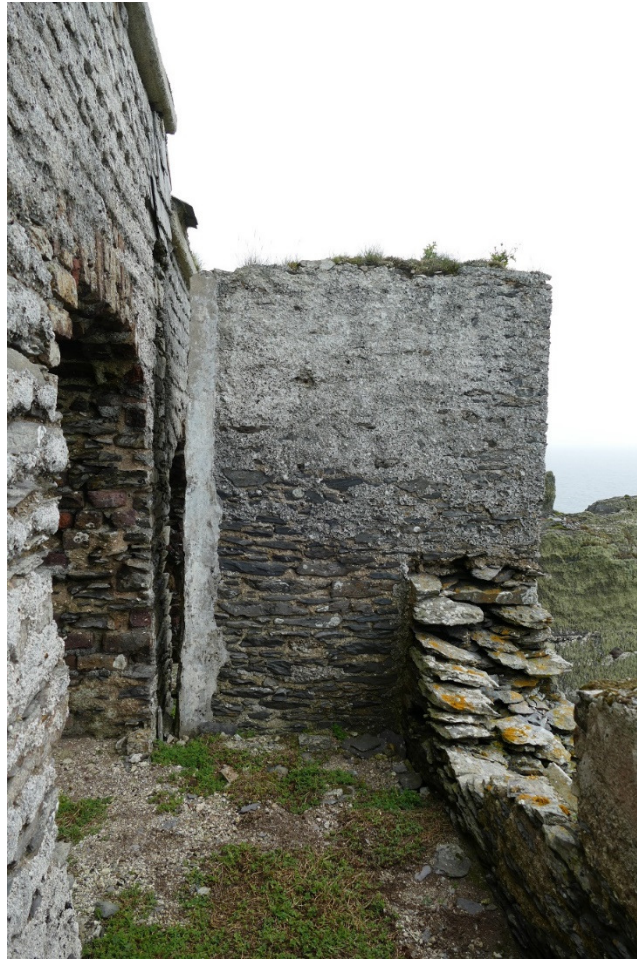
Figure 5 - Existing debris in Upper Lighthouse

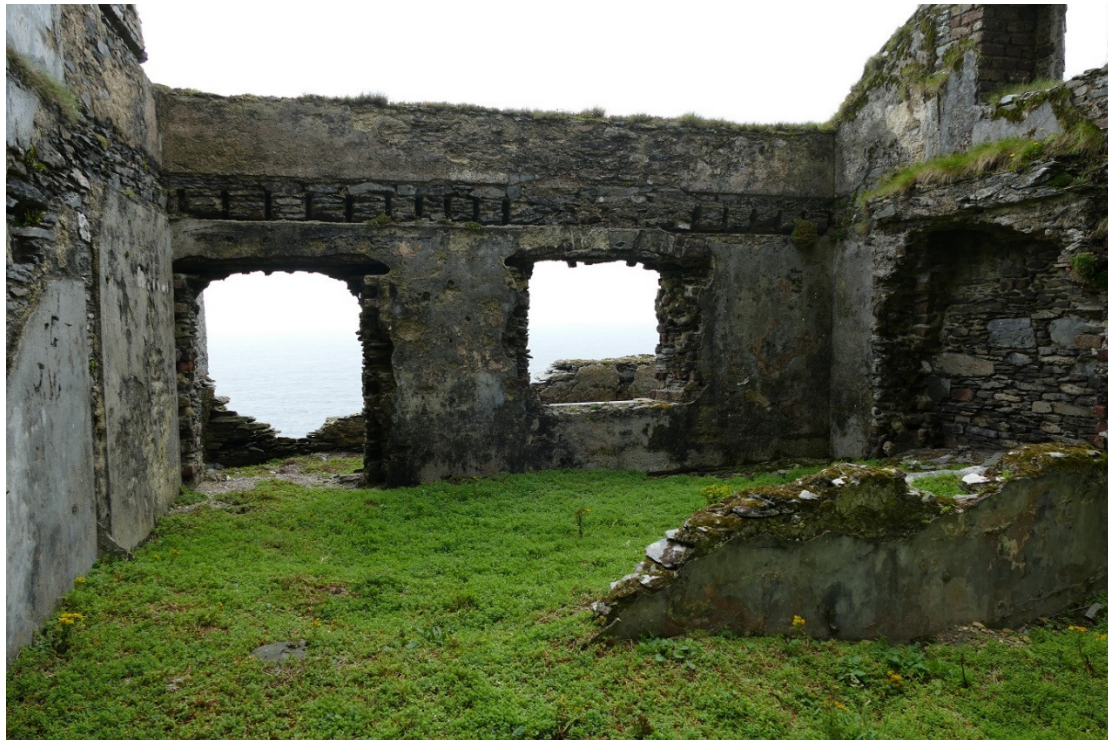
Figure 6 - Existing debris in Upper Lighthouse

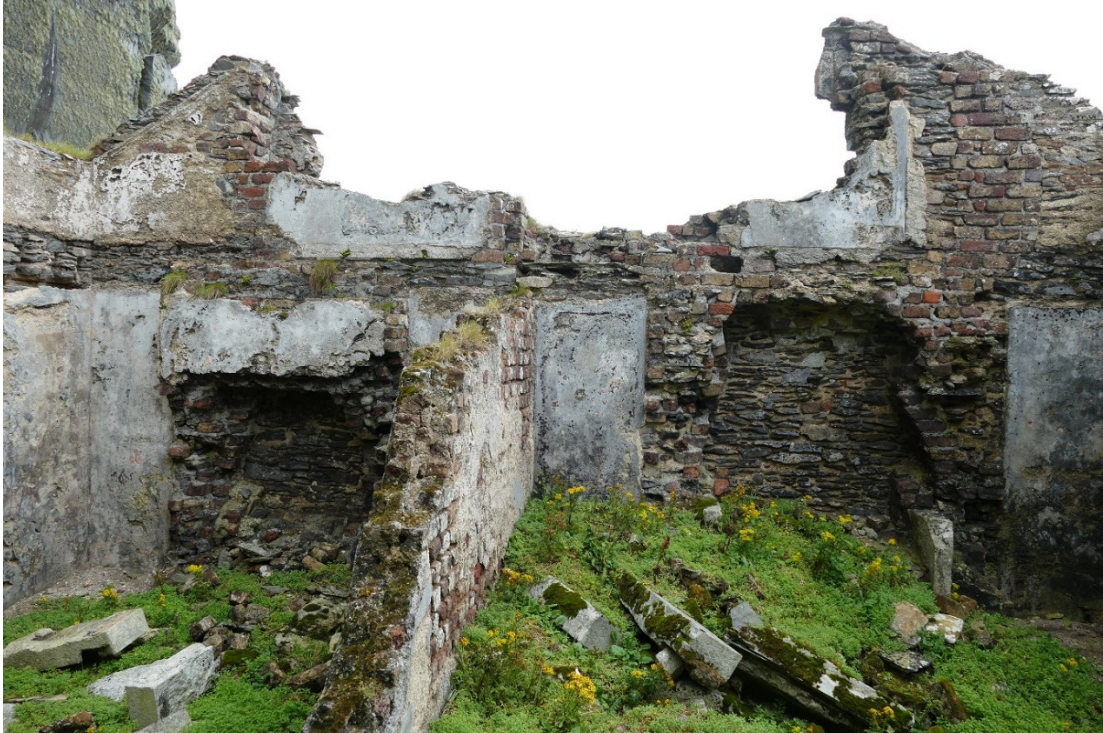
Figure 7 - Existing debris in Upper Lighthouse
