Sceilg Mhichíl World Heritage Site Management Plan 2020–30

Draft for Consultation
November 2020

An Roinn Tithíochta,
Rialtais Áitiúil agus Oidhreacht
Department of Housing,
Local Government and Heritage

OPW

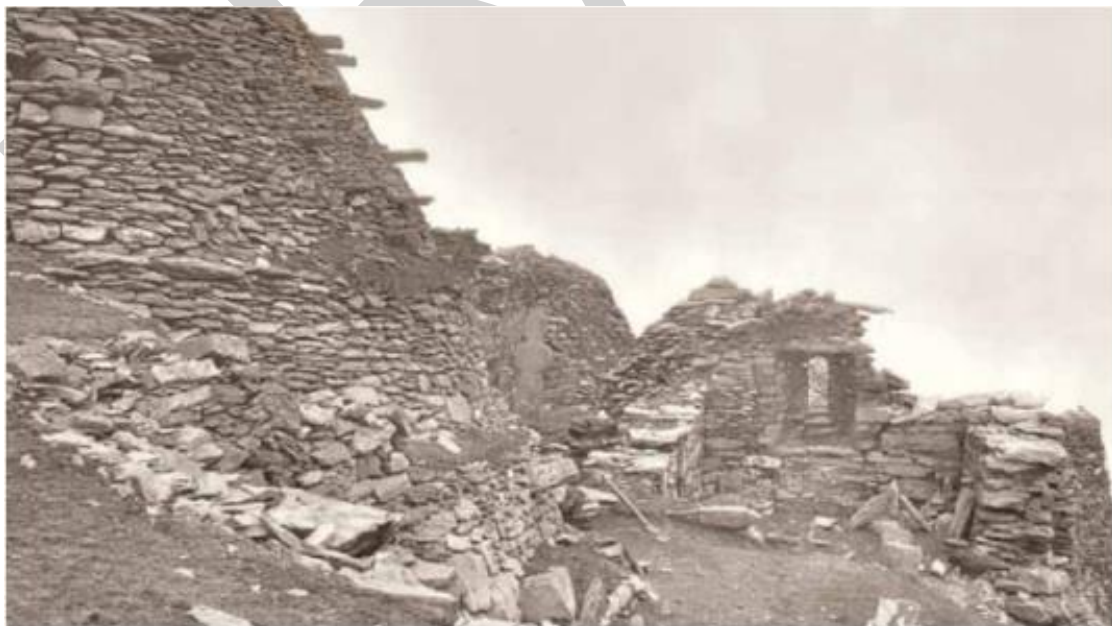
Pl. 6 View of St Michael's Church, showing the collapsed retaining wall on the south side.

In 1880 OPW took the monastic remains into guardianship and commenced a project for the repair of the collapsed structures. Since that time, OPW has continued in its efforts to maintain and preserve the monastic remains. The state purchased the island in 1989 from CIL, with the exception of the lower (working) lighthouse and its curtilage and the helipad area with its adjacent store. CIL also retained a right-of-way over the road. The lower lighthouse has now been decommissioned and OPW are leasing the lighthouse in order to use it for accommodation for workers and academics and as toilet facilities for both workers and visitors.

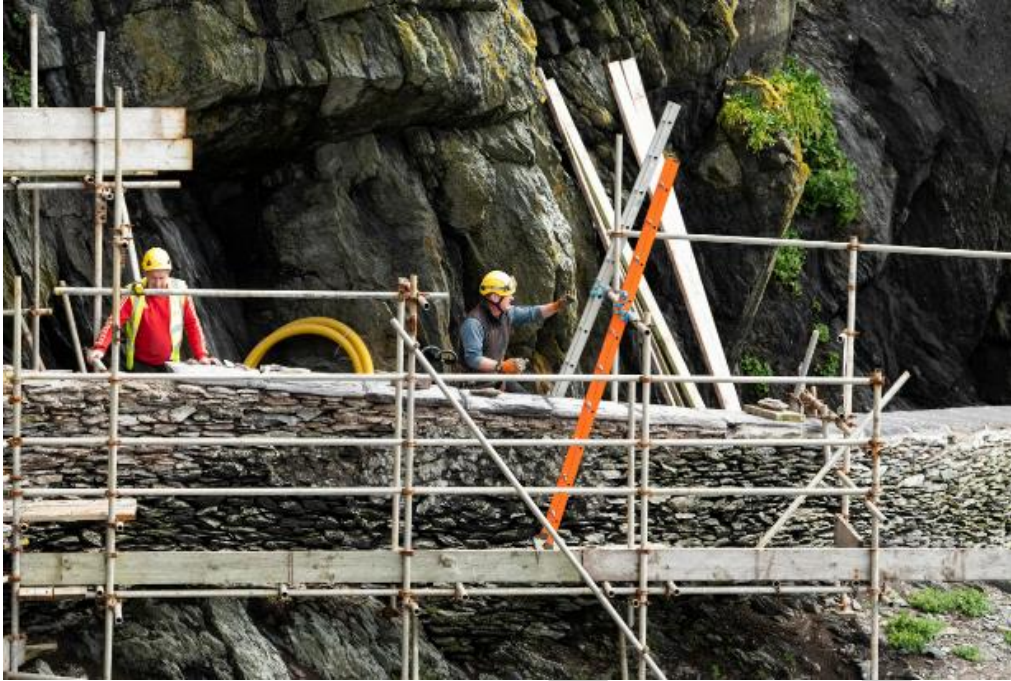
Pl. 17 Re-laying Valentia Slate capstones on the sea wall north east of the Lower Lighthouse Compound

Since the construction of the original Lighthouse Road there has been continual damage to the capstones from landslides. During the lighthouse occupation these were often replaced with shuttered concrete, which itself caused further problems and it has been necessary to remove this concrete. In addition, a considerable number of capstones have been lost from the Upper Lighthouse Road retaining walls. It is essential that replacement capstones are heavy and robust and in the repair works it has been necessary to take stone from Valentia to Sceilg Mhichíl. This stone is similar in composition to the local island stone.

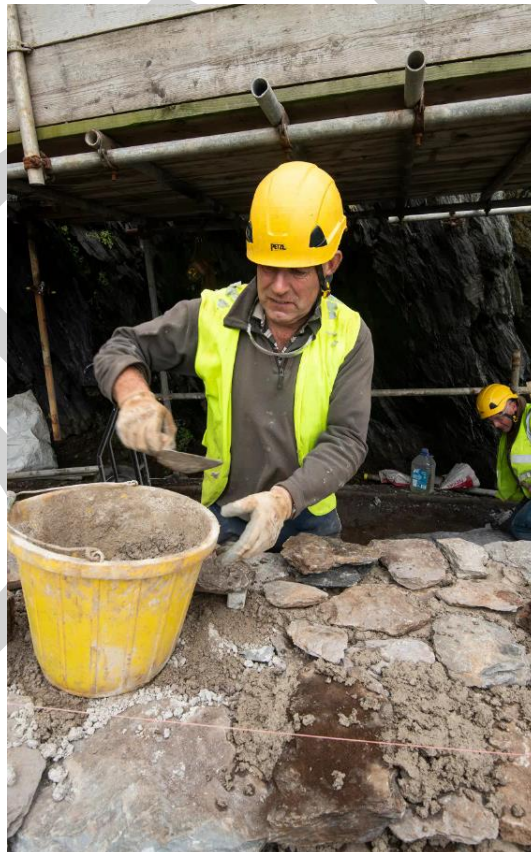
Pl. 18 OPW mason laying base for new capstones on the sea wall, Upper Lighthouse road.

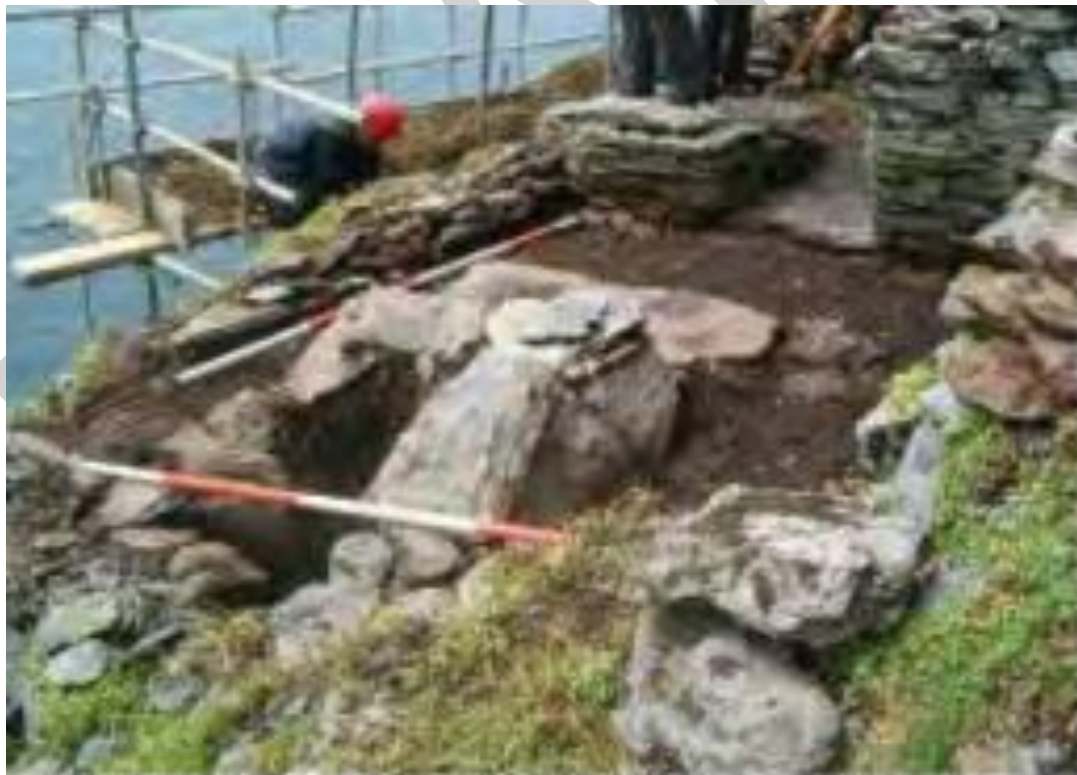
Pl. 24 Interior of oratory on the South Peak after excavation and before conservation

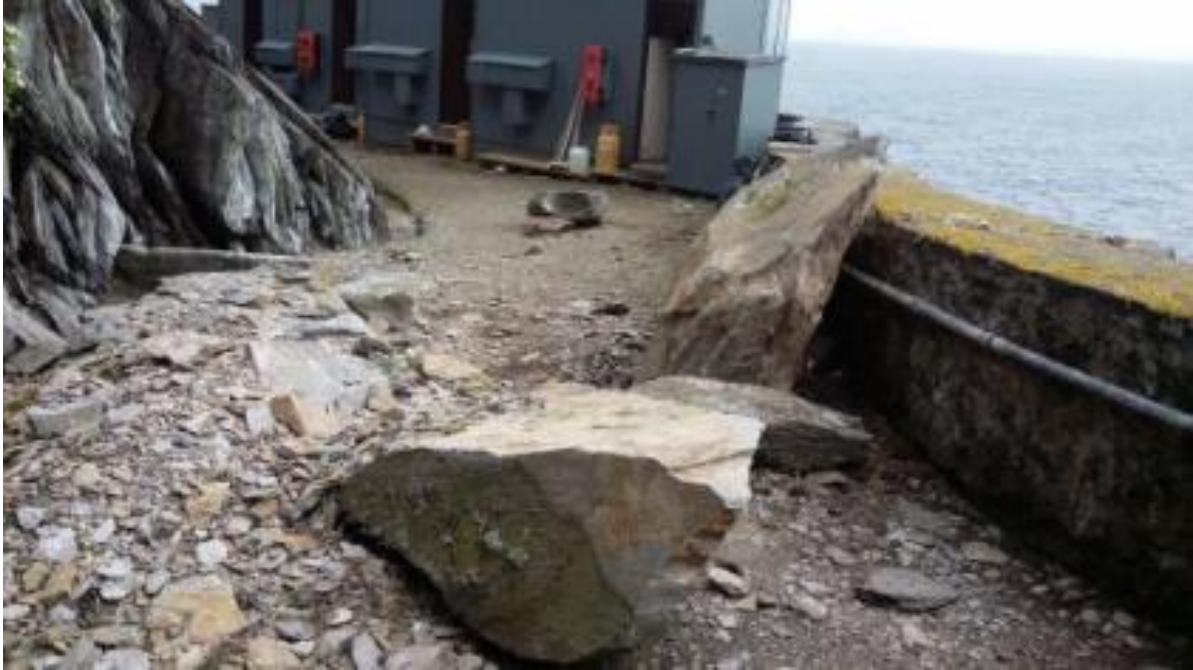
PI 25A Rock fall close to staff accommodation.

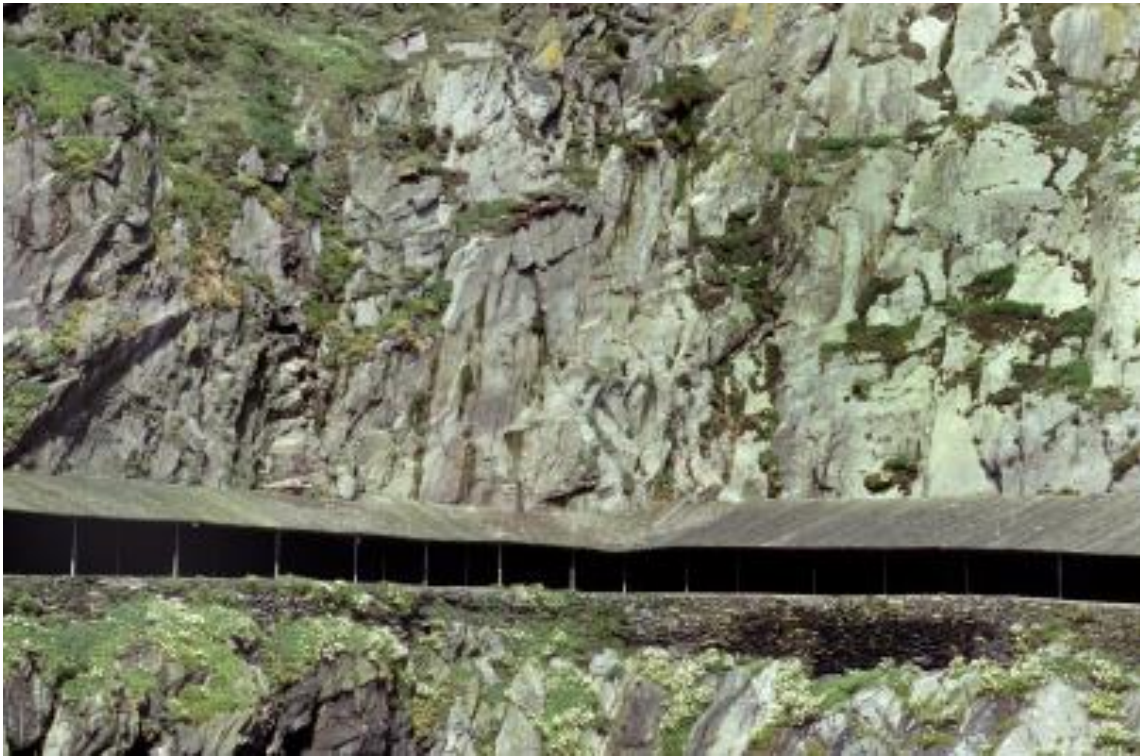
Pl. 25B The protective canopy at Cross Cove.

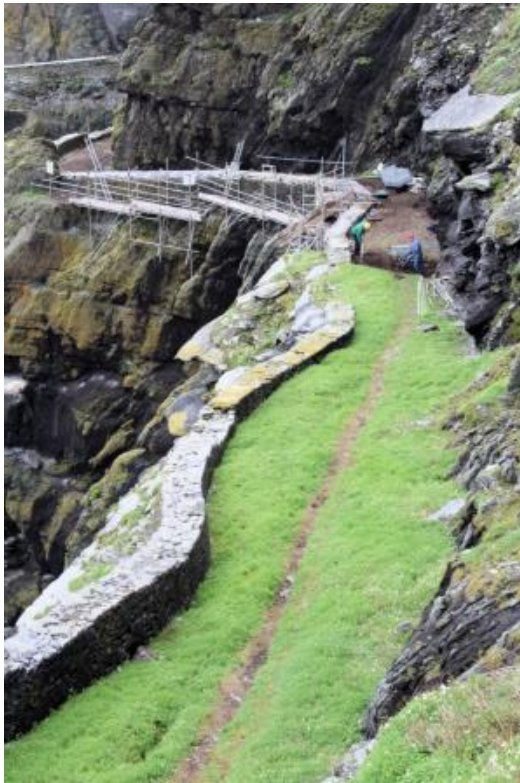
Pl. 26A Upper lighthouse road covered with material deposited from above (excavations ongoing in background).

A detailed assessment of this length of roadway, involving a full structural analysis and ornithological documentation, has been completed for the lower section and a programme of works began in 2017, starting from the lower lighthouse compound. The works required here are significant and they are being undertaken with full archaeological and ornithological input. In one location it was necessary to construct a permanent canopy similar to that at Cross Cove. The method used on the exterior wall was as before, but much more rebuilding was required. This work is scheduled to be completed in 2021.

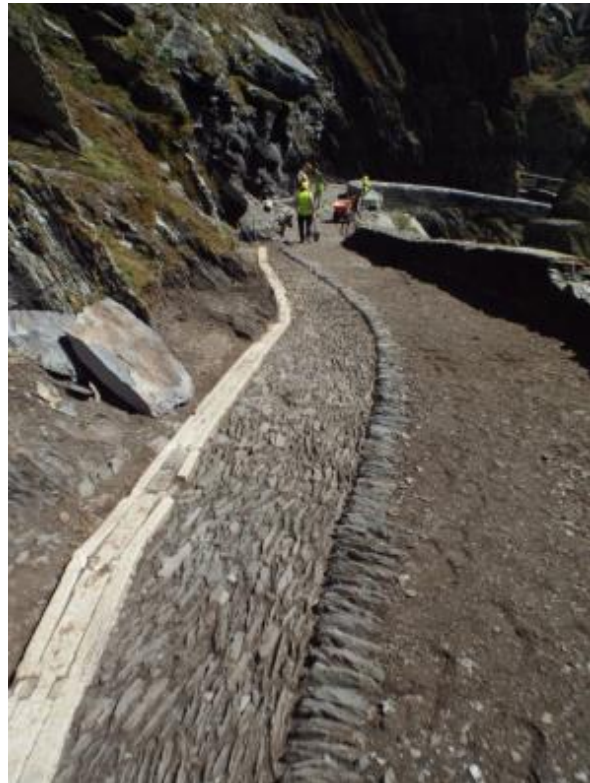
Pl. 26B Upper Lighthouse road, post excavation, showing original road surface, drains and an electrical conduit inserted in the early 20th century

Regular repairs to and cleaning of the gullies and drains along this roadway form part of the annual maintenance programme.

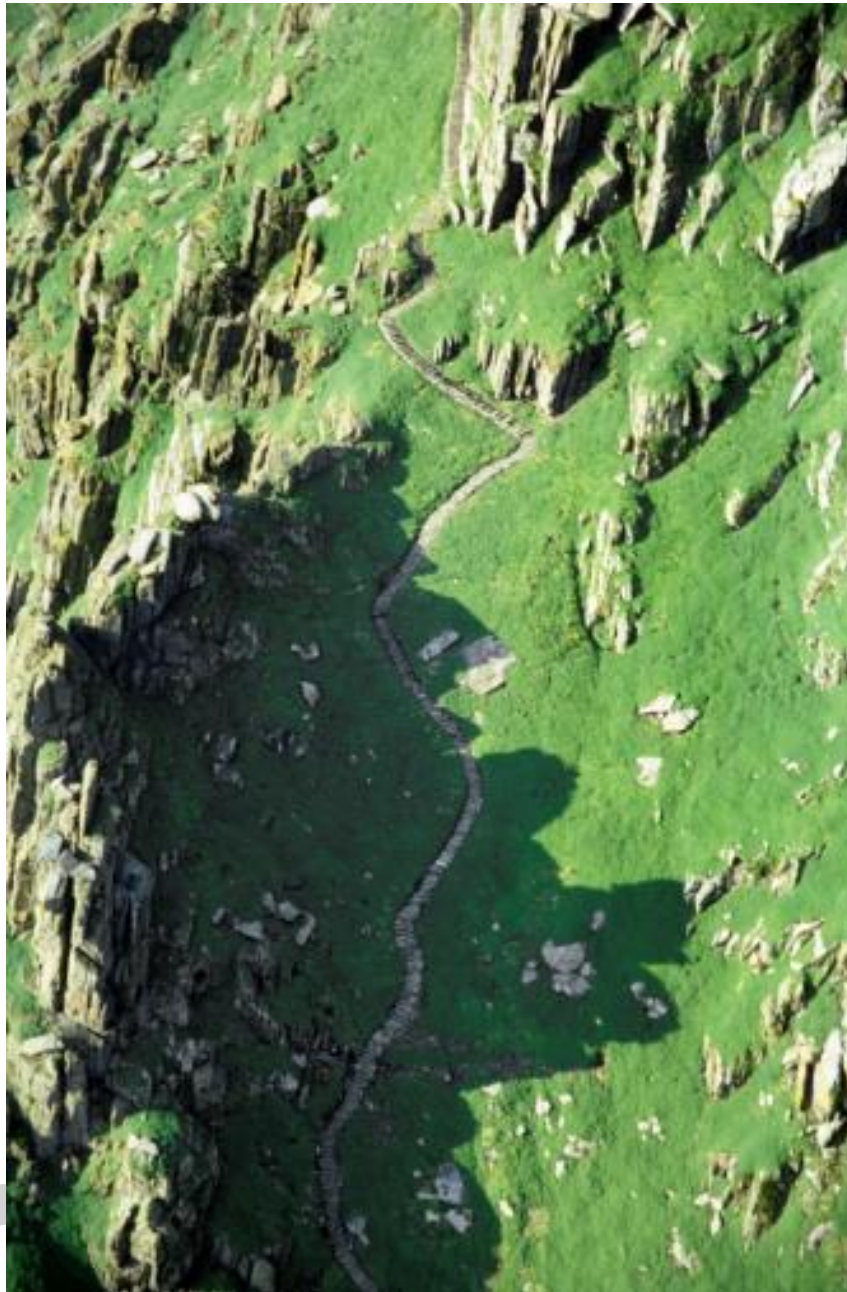
Pl. 32 Aerial view of the East Steps.

The base of the East Steps was blasted away by the lighthouse-builders when they constructed the pier and the Lighthouse Road. Above this level the steps have been conserved and are in very good condition. The remains of a structure that may have sheltered a boat or housed provisions are located here.

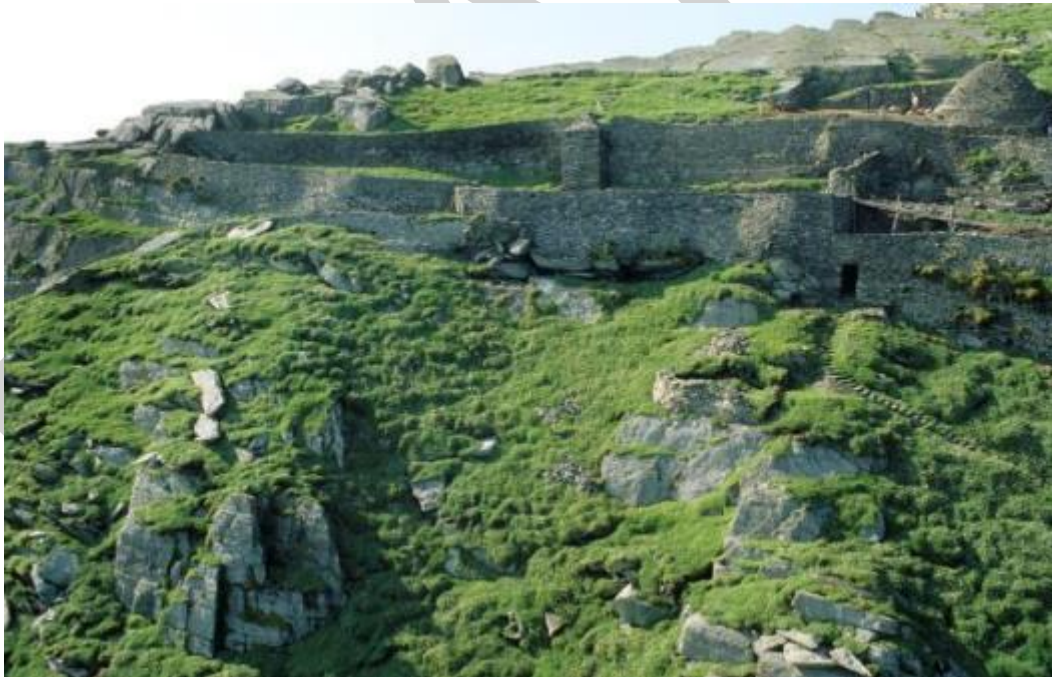
Pl. 37 The west end of the monastery, showing the retaining walls.

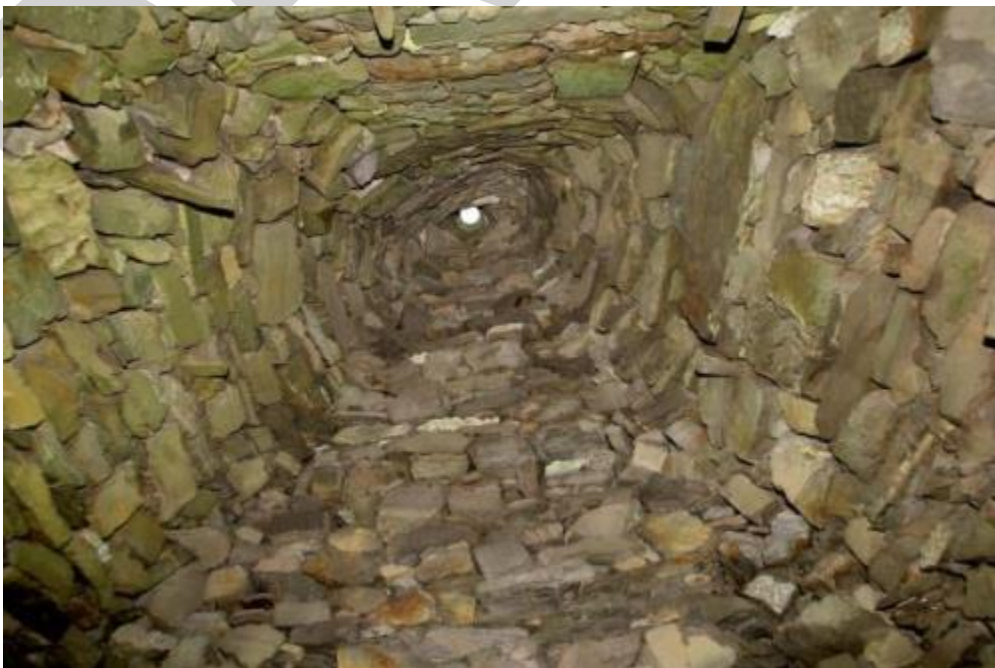
Pl. 40 The inner dome of Cell F, showing corbelling and projecting stones.

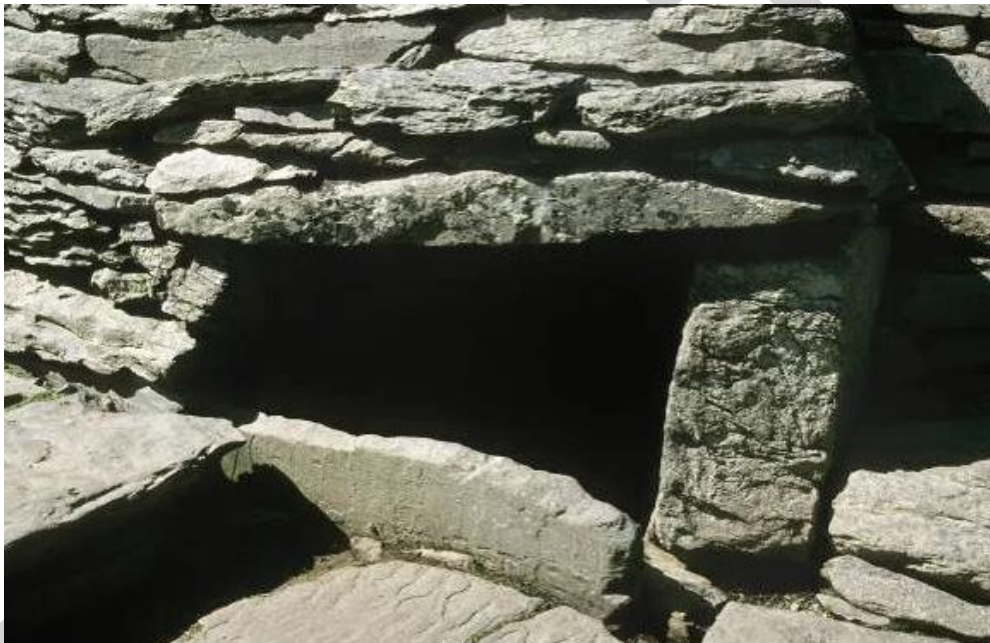
Pl. 44 A water cistern located just below Cell B in the Inner Enclosure.

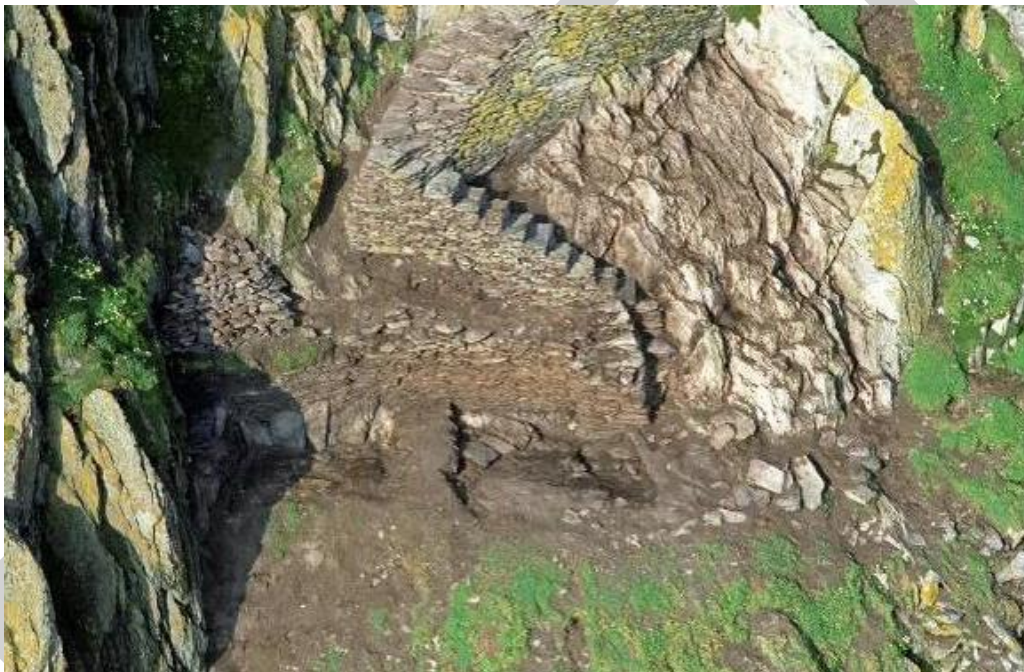
Pl. 44A Excavation of the Boathouse structure above the landing and adjacent to the East Steps, just above the area dynamited to clear a path for the lower lighthouse road.

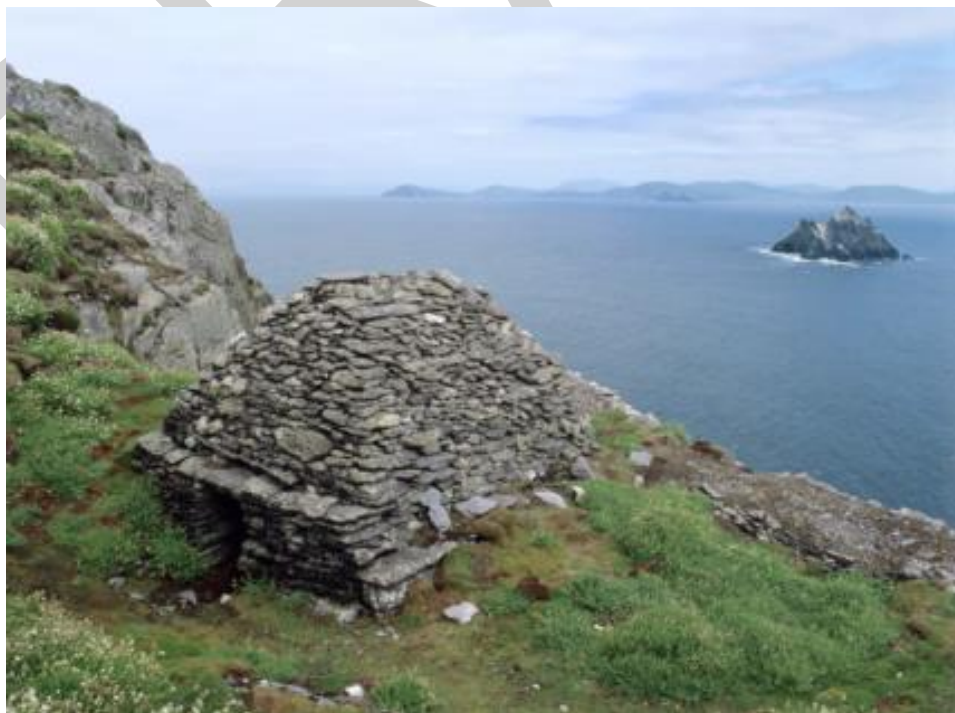
Pl. 51 The Small Oratory prior to excavation and conservation works.

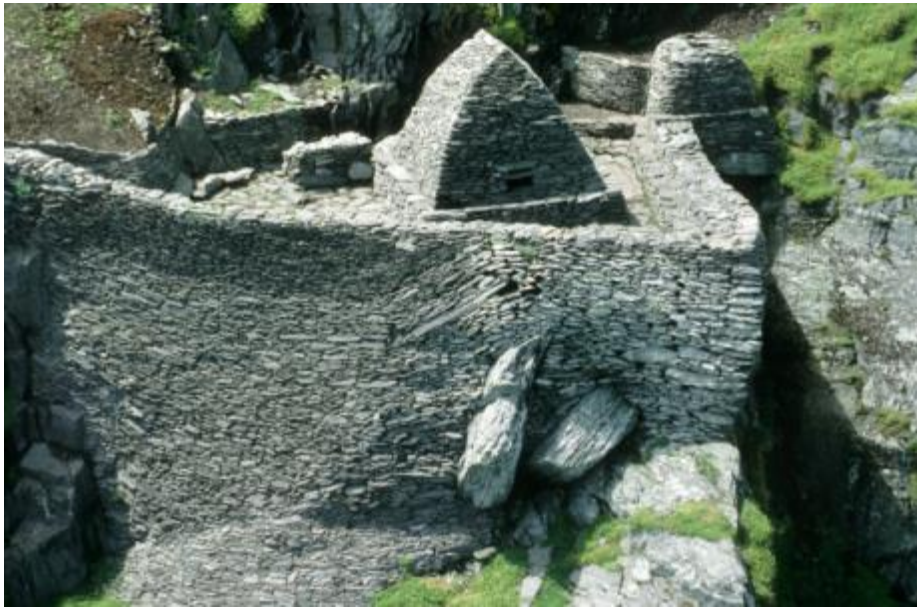
Pl. 52 The Small Oratory Terrace after excavation, consolidation and conservation works.

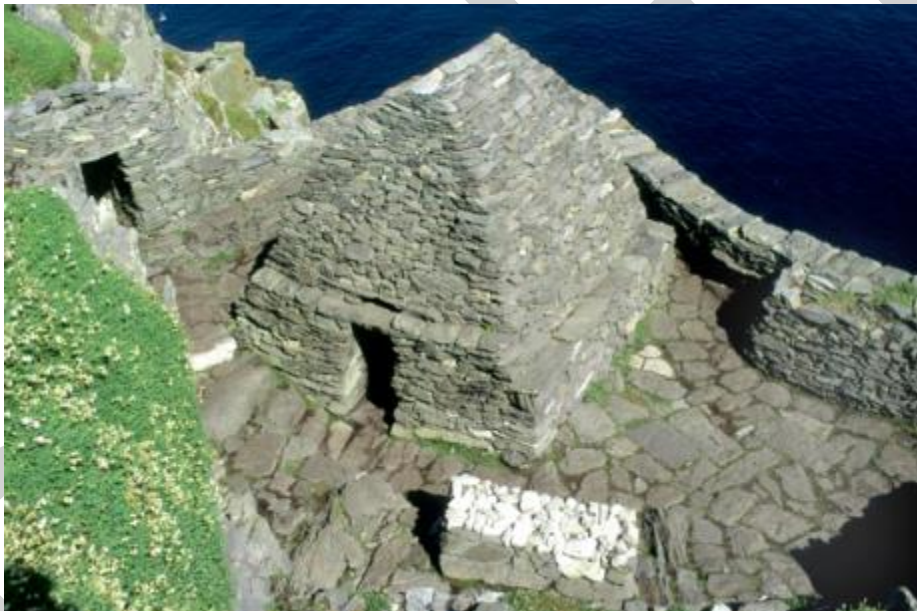
Pl. 53 The Small Oratory Terrace post excavation, consolidation and conservation works

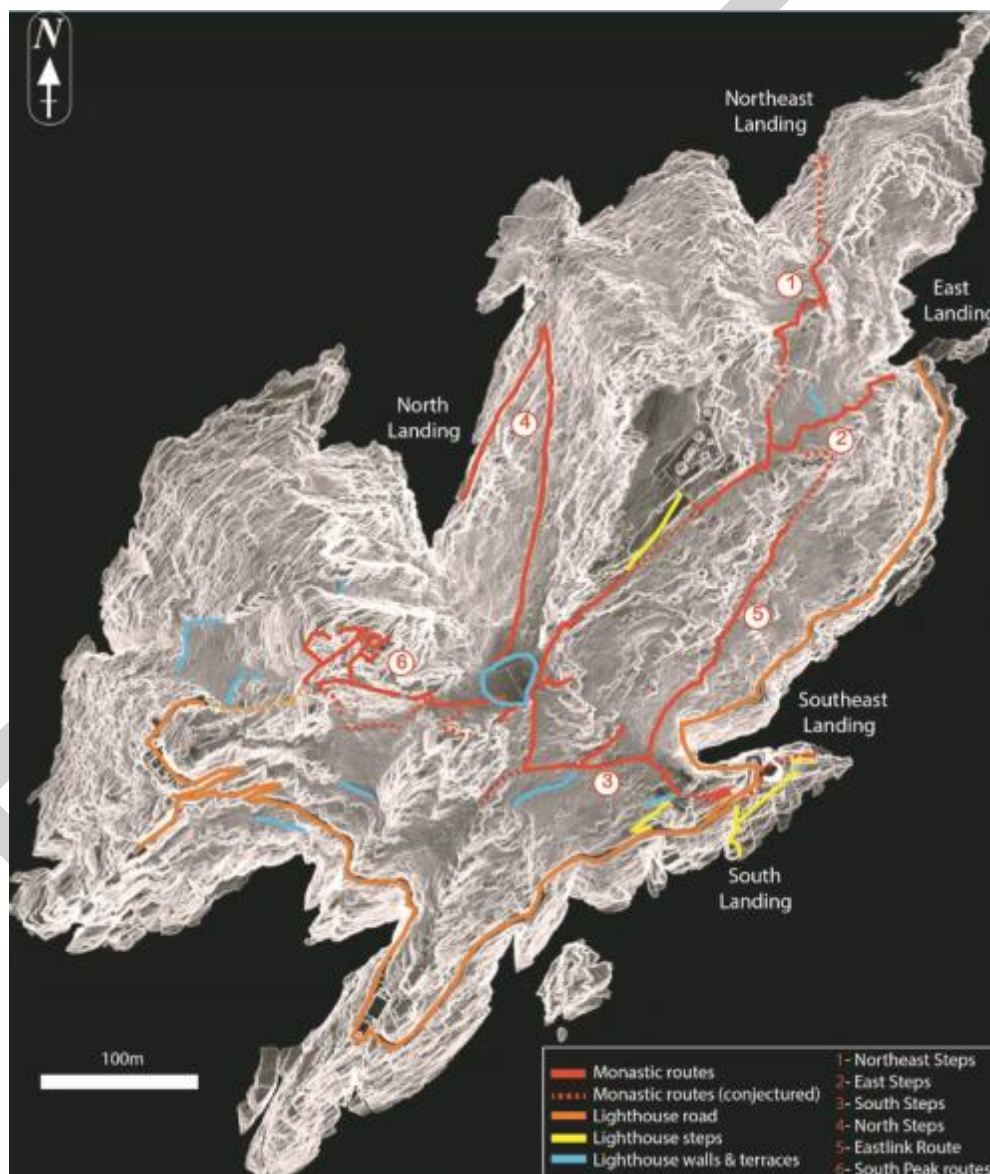
Fig 9 Lidar image showing routes and landings
