Environmental Incident Report

Skellig Michael

30th May 2022

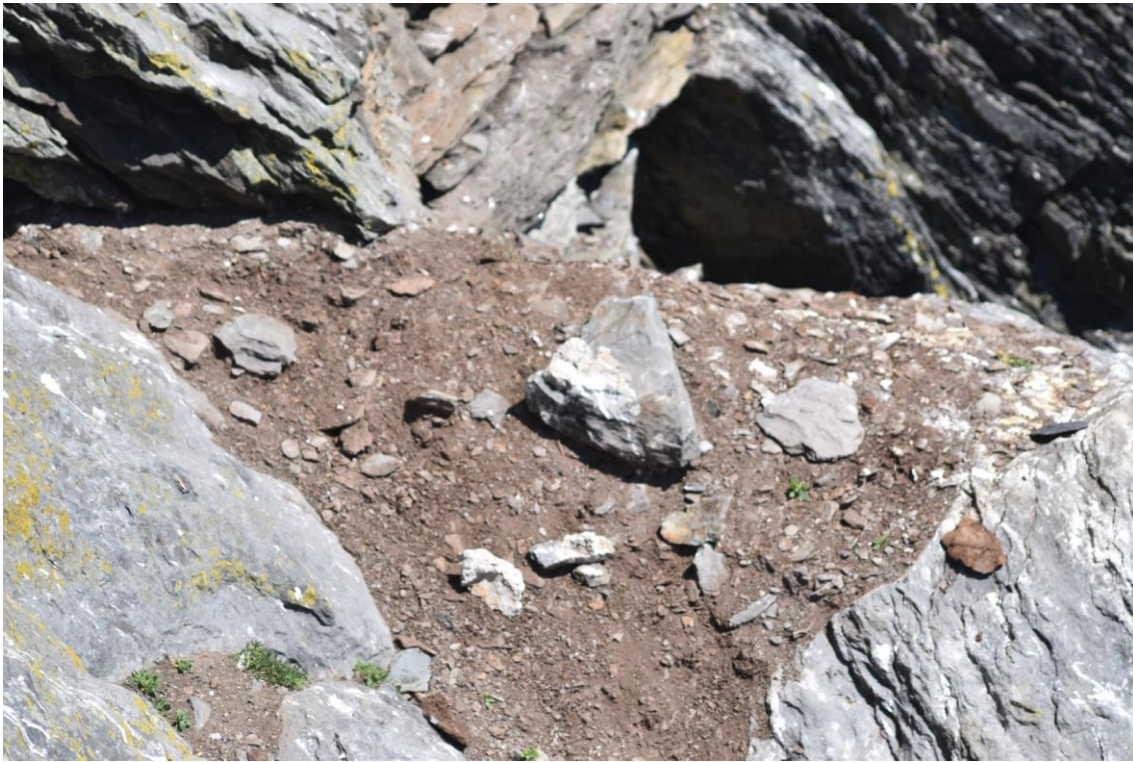
A considerable amount of debris made it over the wall, and as a result, immediate disturbance was noted with Kittiwake and Fulmar taking to the air. Impacts on the birds below cannot be ruled out and the response of Auk species below could not be seen from the vantage point. The timing of this heavier fall lasted approximately 15 minutes and it would have been unsafe for the workers to continue to base without completing the process. A considerable amount of data is available on the cliff nesting birds in this area and this may contribute to an assessment on any potential impacts on the birds from the rock fall.

Figure 1: Debris on a known Fulmar ledge

Given the extent of material that came down, and while understanding the health and safety related issues, if possible, I would strongly recommend that this work not be carried out this far into the season. It would also be beneficial to have the early season sweeps observed to assess potential impacts.

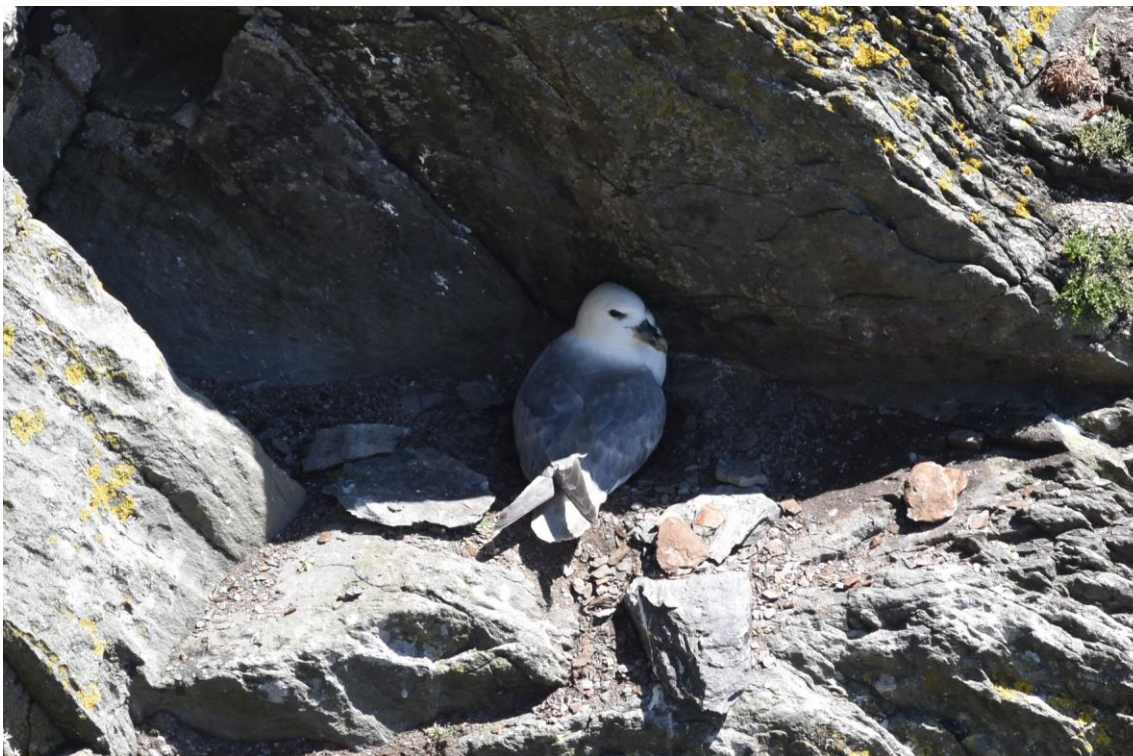
Figure 2: Debris around a known fulmar ledge

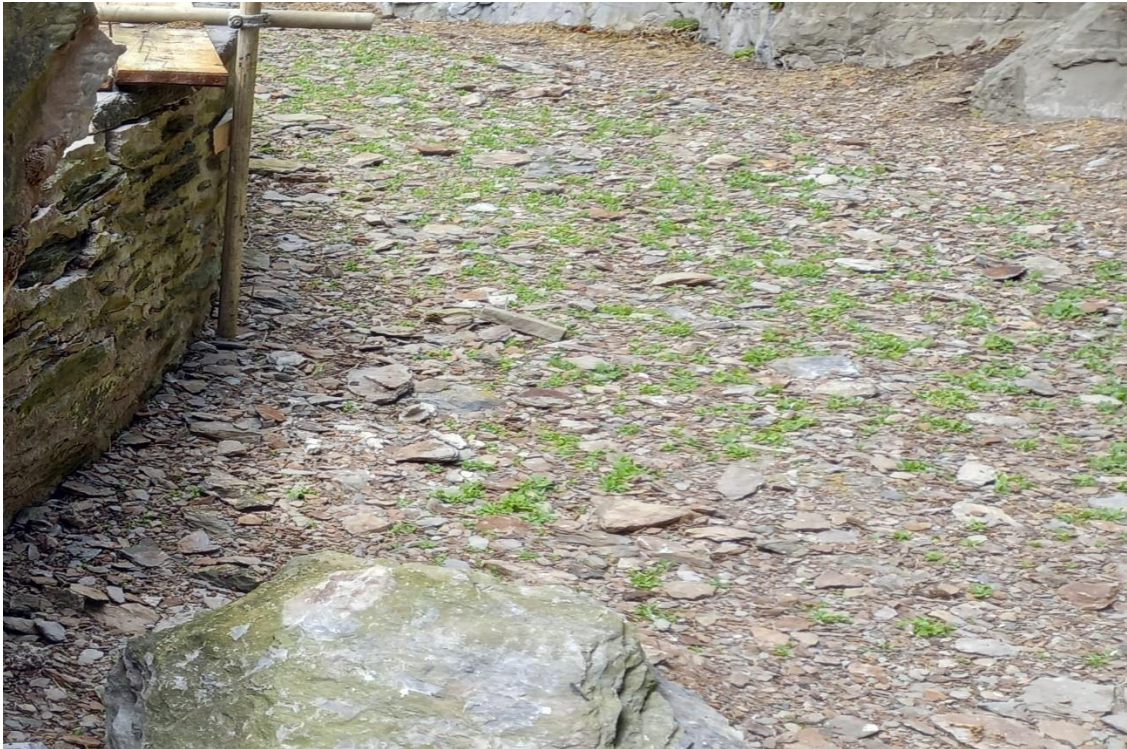
Figure 3: Path prior to works

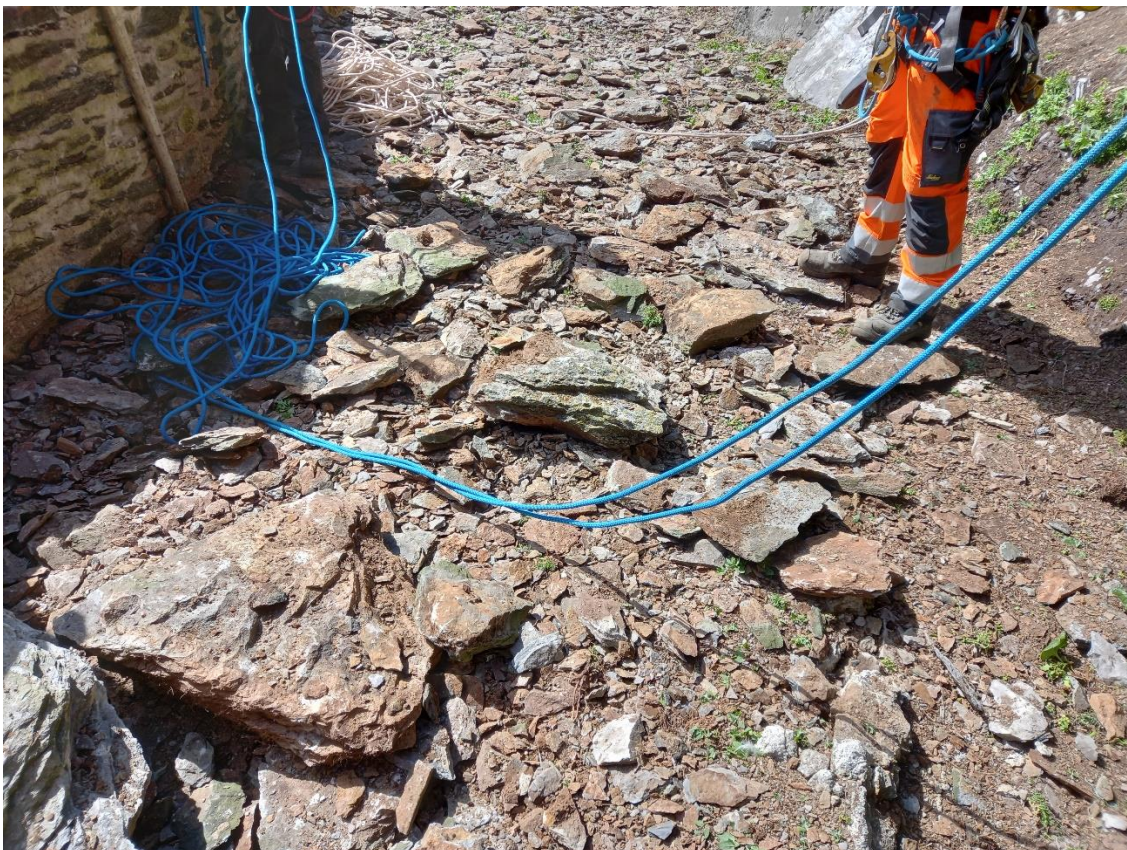
The entire process was completed in approximately two hours, the majority of this taking place in a restricted access area with ropes used by the team to carry out the work. The actual rock removal works took approximately 25 minutes to complete. It was anticipated that rock fall or movement would be minimal, however, this was not the case on the day, and a substantial amount of debris

made its way down onto the path.

Figure 4: Path post works
