Skellig Michael: Monitoring of miscellaneous minor works in the Lower Lighthouse and Monastery 2022.

Alan R. Hayden
Archaeological Projects Ltd.
November 2022

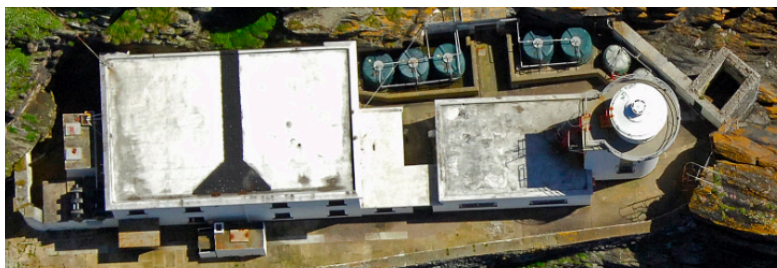
Fig. 1 The bund walls removed are those surrounding the green plastic oil tanks (removed last year) at the top right of the photograph.

(1) The concrete block, bund walls, which surrounded the green plastic oil tanks that were removed last year from the northeast side of the lower lighthouse station, were demolished to facilitate the transport of materials for the construction of Crash Decks 2 and 3 and for a proposed composting toilet.

The bund walls were built in the 1980s when the plastic oil tanks were lowered into place by helicopter (R. Foran *pers. comm.*). That west of the entrance to the lighthouse was entirely of modern construction and replaced an original store which had been for paint and later housed a generator but which was demolished in the 1980s. However, that east of the entrance rested on the chamfered masonry plinth of the original 1820s general store, the rest of which had been demolished in the 1980s. The plinth was composed of sandstone rubble masonry with the upper stone chamfered on its top outer edge. The concrete block walling was carefully removed and the plinth was retained *in situ*. The ground level outside the bund areas was raised with stone rubble and clay to the level of the top of the plinth to facilitate transit of the tractor and trailer bringing materials up to the sites of the crash decks. The clay and rubble remains in place as further materials will have to be brought up for the crash deck construction next year.

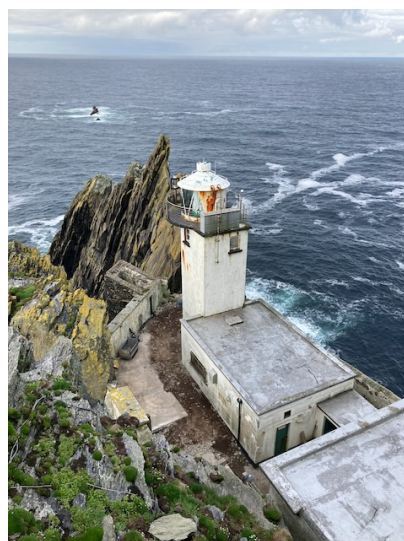
Fig. 2. After removal of bund walls.

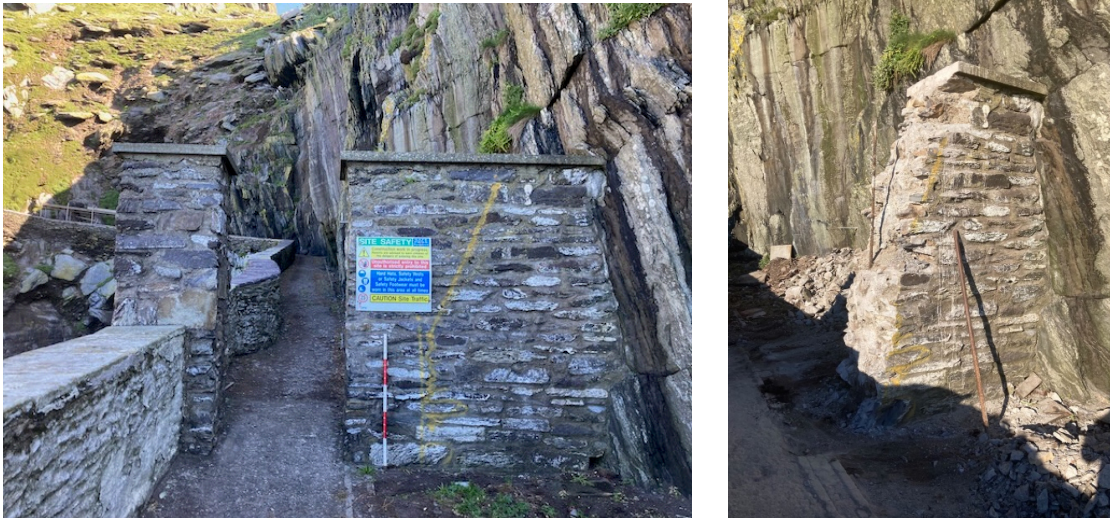
Fig. 3. The north gateway of the lighthouse before and after removal of part of its east side.

(2) After approval from the NMS the east side of the gateway north of the lower lighthouse was cut back to facilitate the transport of materials for the construction of Crash Decks 2 and 3. This gateway was built in 1987 when the lighthouse was automated. Unlike the gateway south of the lighthouse, which measures nearly 2m in width, the gateway north of the lighthouse measured only 1m in width. Removal of the pier on the west side of the gateway would not have added sufficient width to the gateway and so part of the east pier was removed. It proved to have been composed of sandstone rubble holding a heavy core of concrete containing vertical rebars. An approximate width of 800mm was removed. It is proposed to rebuild the pier in 2023 but leaving the gateway significant wider than its original form which would be too narrow to allow transport of materials up the Upper Lighthouse Road.

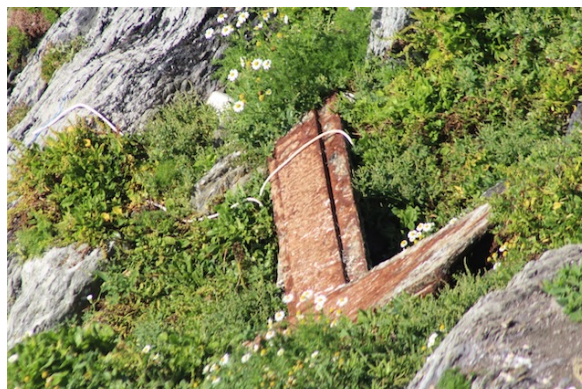
(3) Two rusted iron panels lie on the cliffs outside the northwest side of the lower lighthouse station. Examination of them using a long photo lens showed that these are part of the original 1820s iron porch removed from the western of the two dwellings. These should be retrieved before they disappear.

Fig. 4. Part of original porch of house below lower lighthouse

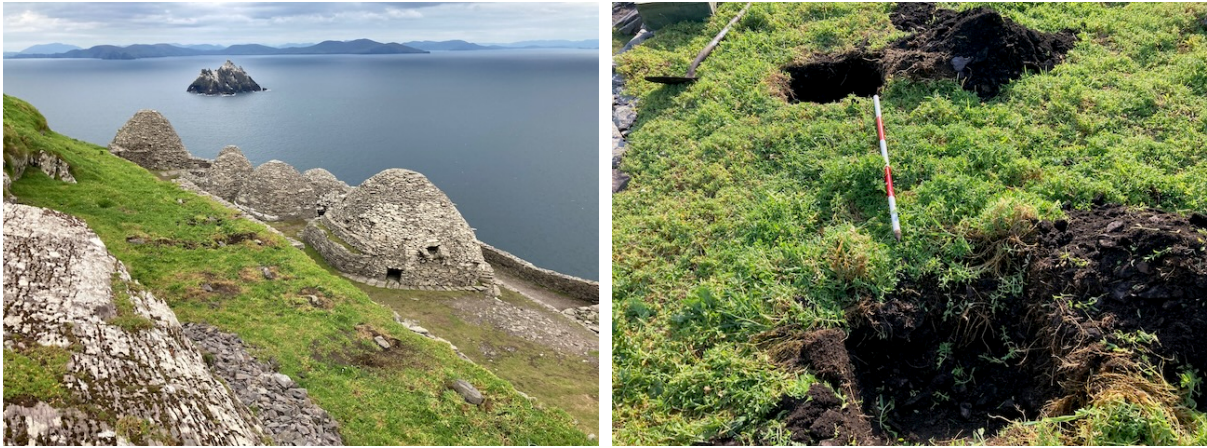
(4) The excavation of a number of 300mm by 600mm by 300mm deep pits for the installation of shearwater nest boxes was monitored in the relatively flat area above the high nineteenth-century drystone wall that delimits the north side of the monastery. The top of this wall was

likely heightened or rebuilt in the 1980s and modern material was deposited to raise the ground level behind it. The excavation of the holes yielded a number of 1980's objects- tins and wine carafe caps- but also a sherd of nineteenth-century stoneware. The soil removed was all topsoil composed of campion rooted organic soil overlying stony clay. Nothing of archaeological interest or significance was encountered.

Fig. 5. Location and size of holes excavated for nest boxes above the monastery.
