Sceilg Mhichíl
World Heritage Property
OPW Works Season 2022
UNESCO Report – Final Issue 13.02.2023

1. Introduction

5. Works Descriptions 2022

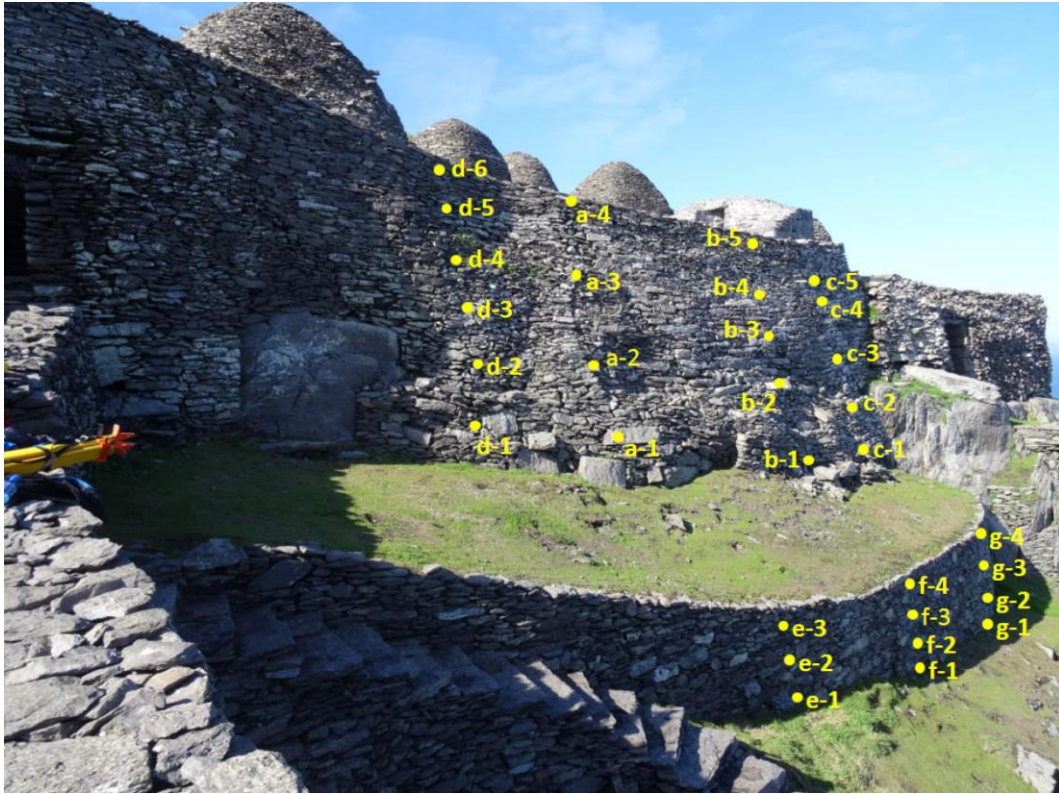
Fig. 12. - Discovery Programmed marker point locations at monastery retaining wall

Since 2015, the Discovery Programme have been monitoring the movement of the main retaining wall of the monastic settlement. Markings were added in 2017 to the South Peak to determine the stability of the structures at that location. The Discovery Programme issue an annual report to the OPW with their findings and recommendations. In September 2022, the Discovery Programme undertook a survey of the monastic settlement and issued their report to the OPW (See Appendix A).

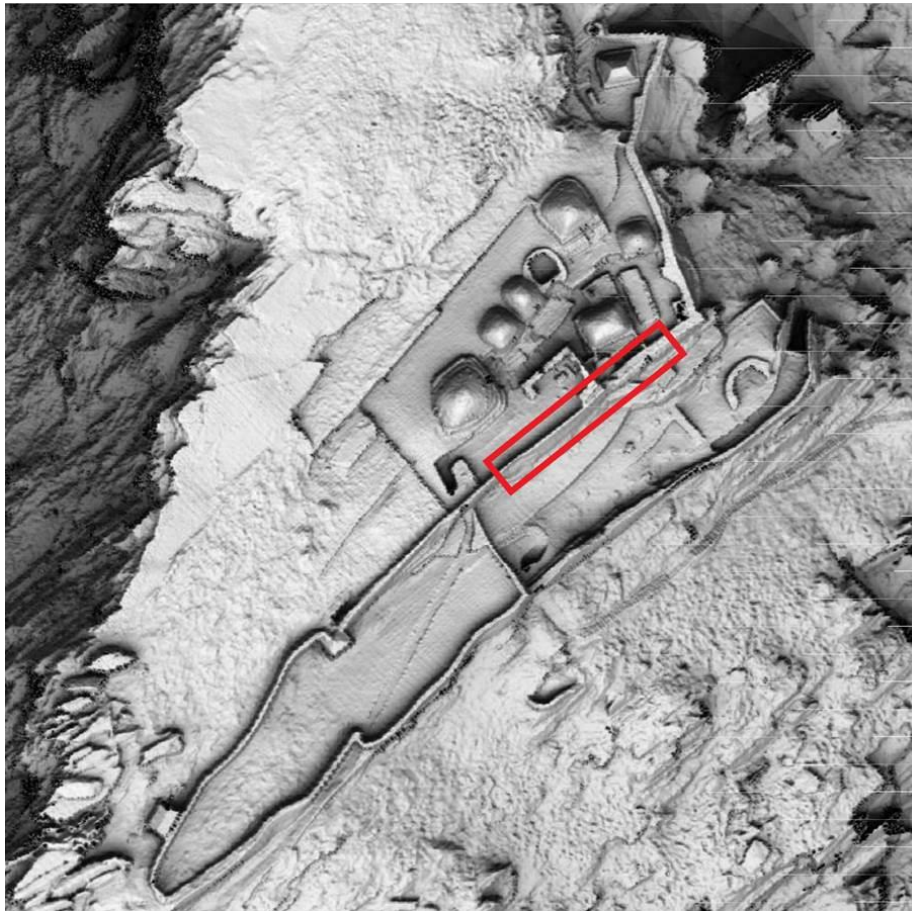
The 2022 report confirmed that a section of the retaining wall directly below St. Michael's chapel is currently undergoing slight movement beyond acceptable tolerances, but with a possible reduction in the annual rate compared to previous years. This section of the monastic wall has been historically susceptible to collapse, with major reconstruction having been undertaken during the 19th century.

Fig. 13. - Location of movement to retaining wall below St. Michael's Chapel.

Due to increased rainfall and pressure from runoff rainwater, the OPW will be undertaking repairs to this section of the enclosing wall over the coming years. The OPW commissioned a digital survey of the Monastery in 2021 to facilitate the future repair works. All works will be subject to Ministerial Consent and best conservation practices will be implemented. All proposed repair works will be subject to an agreed archaeological mitigation strategy.

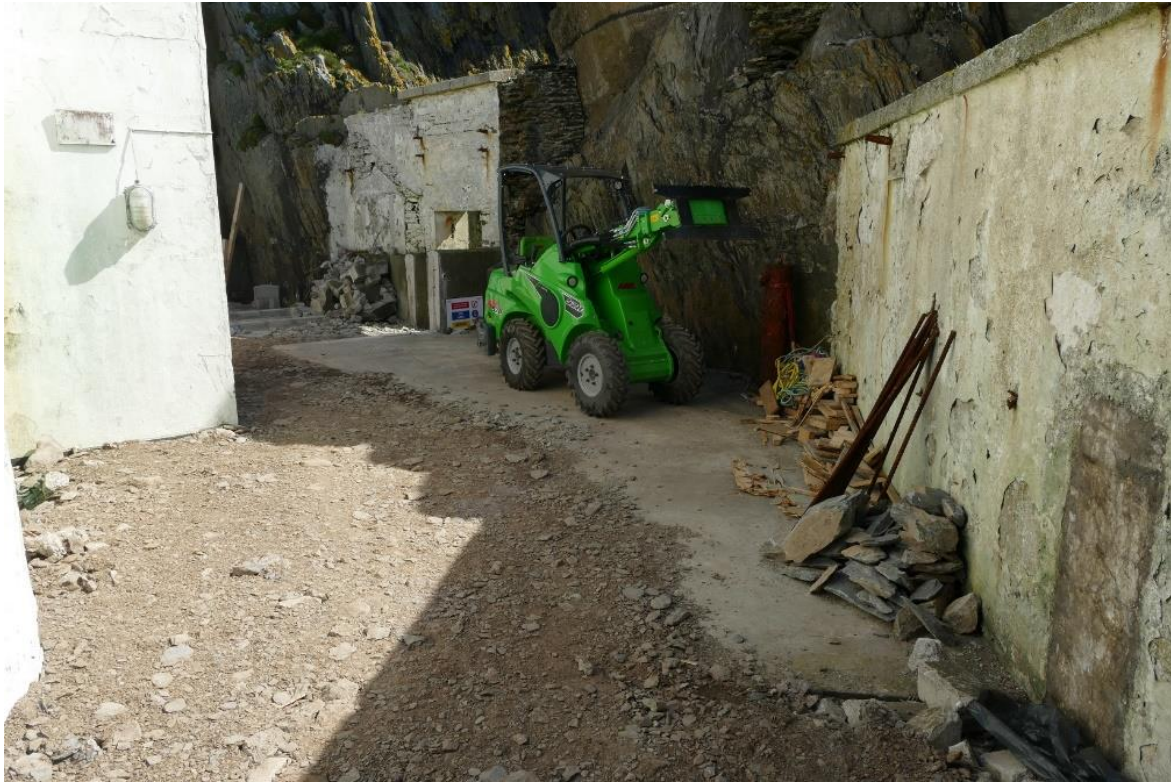
Fig. 14. - Bund wall removed at the Lower Lighthouse compound

The OPW removed additional sections of the existing bund wall at the Lower Lighthouse complex to facilitate the transportation of construction materials during the Crash Decks installation works.

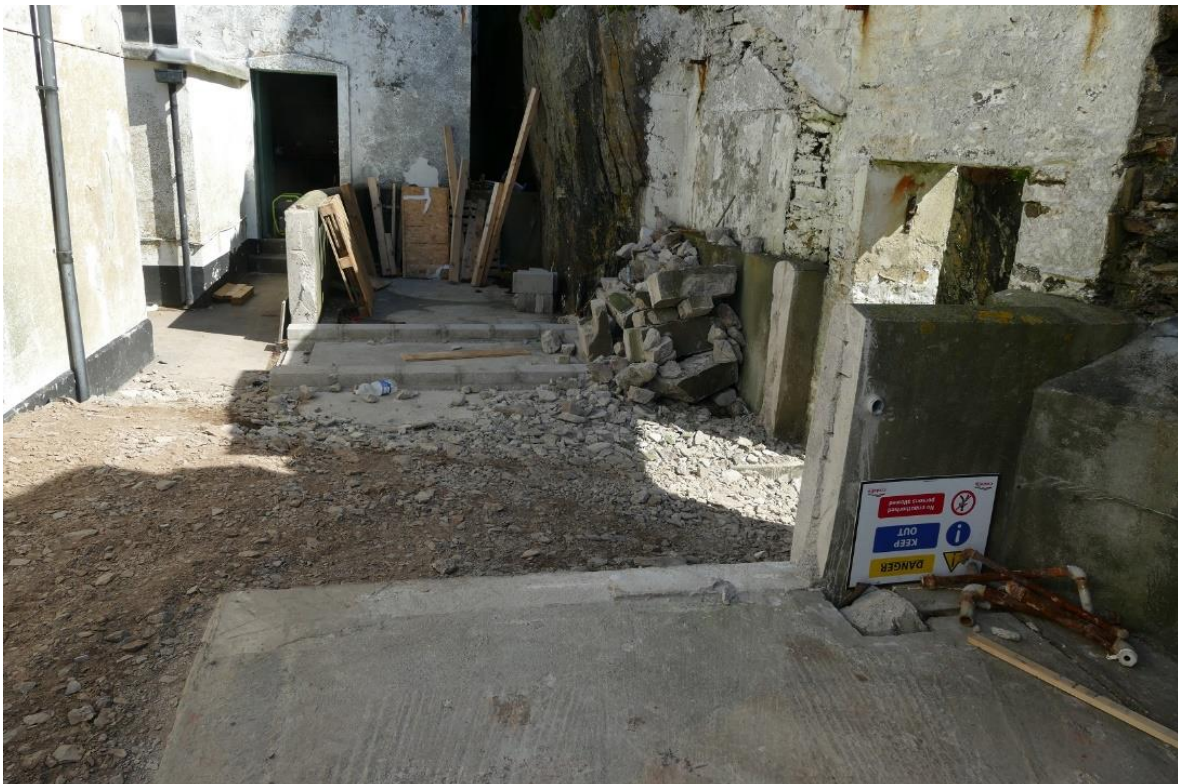
Fig. 15. - Bund wall removed at the Lower Lighthouse compound

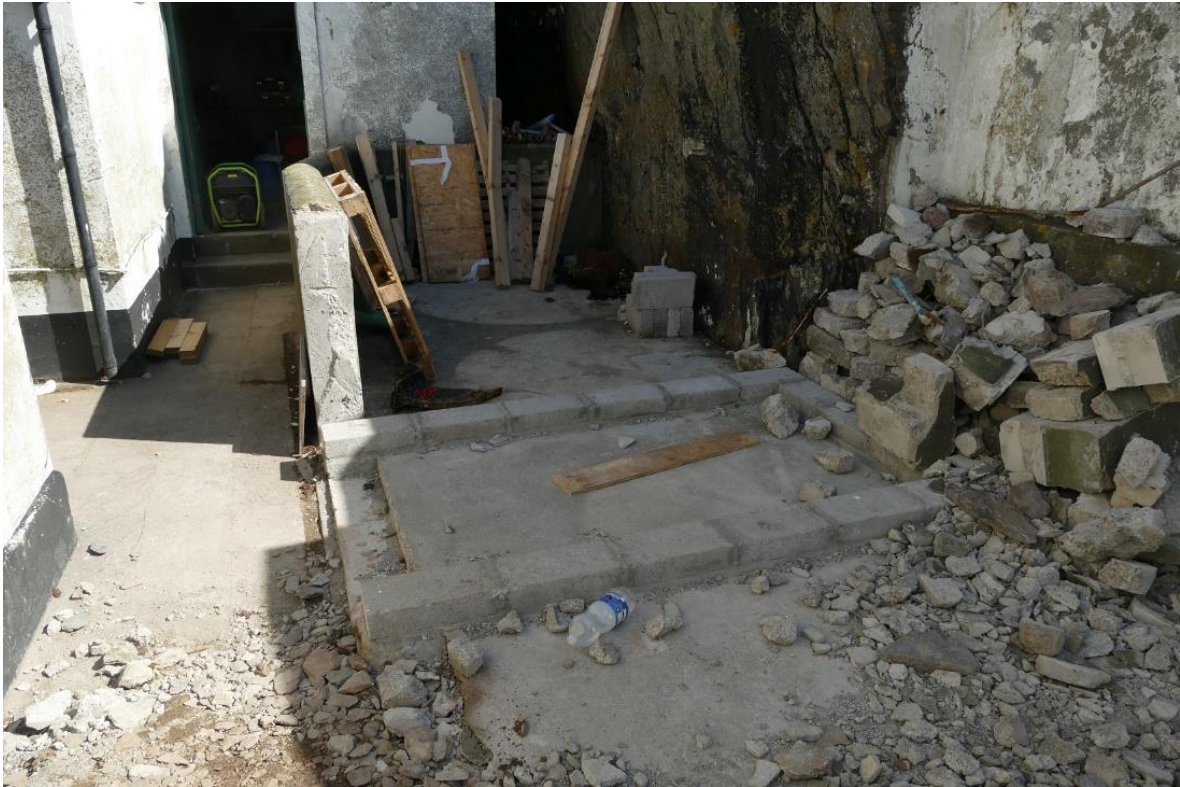
Fig. 16. - Foundation for the proposed composting toilet installed at the Lower Lighthouse compound

The section of the bund wall was removed in the 2022 season and the foundation for the proposed composting toilet was installed on site. The installation of the new composting toilet at the Lower Lighthouse complex was postponed until the 2023 season due to weather events and limited accommodation on site for OPW workers.

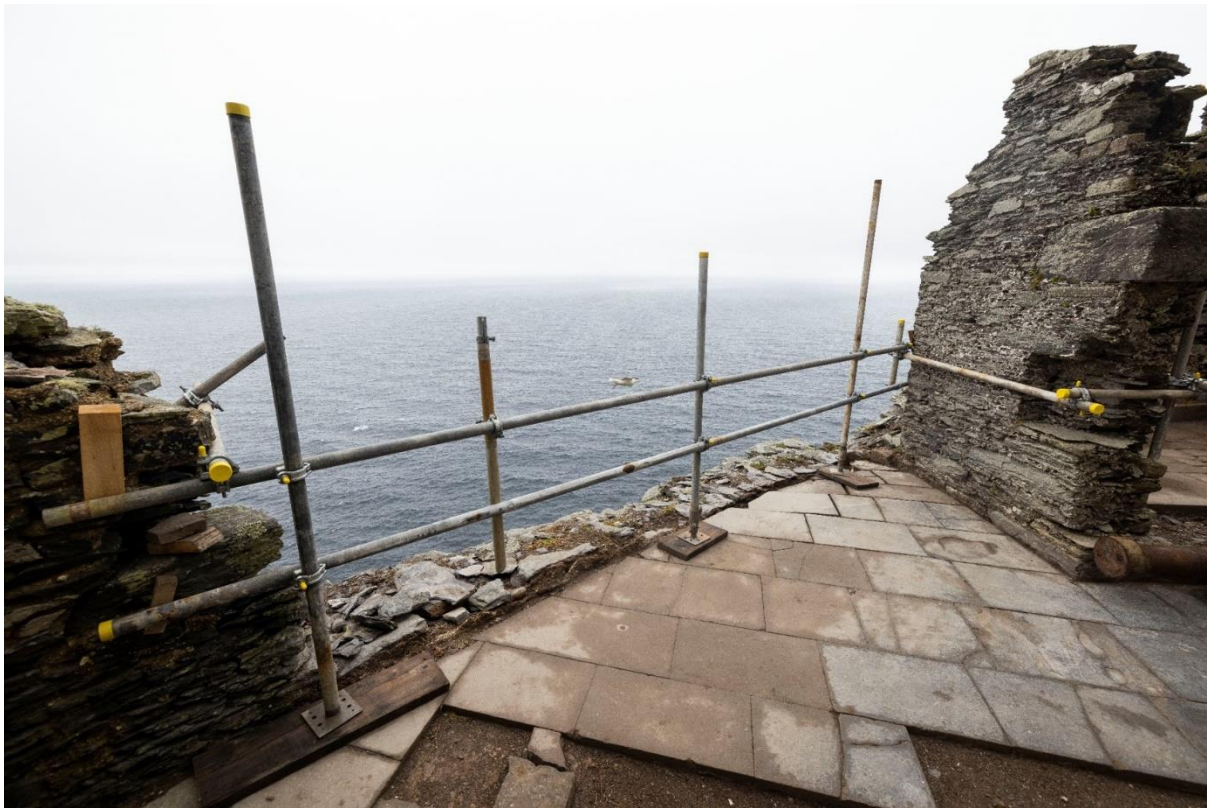
Fig. 19. - View of the existing sea wall at the Upper Lighthouse

The OPW submitted a DHLGH Ministerial Consent for the repair of the Upper Lighthouse Outer Gate Pier in January 2021. The OPW also obtained DHLGH Ministerial Consent for the repair works to the Upper Lighthouse sea wall in April 2021. The works were postponed in the 2022 season due to weather events and limited accommodation on site. The OPW will be installing scaffolding and carrying out repair works to the sea wall in the 2023 season.

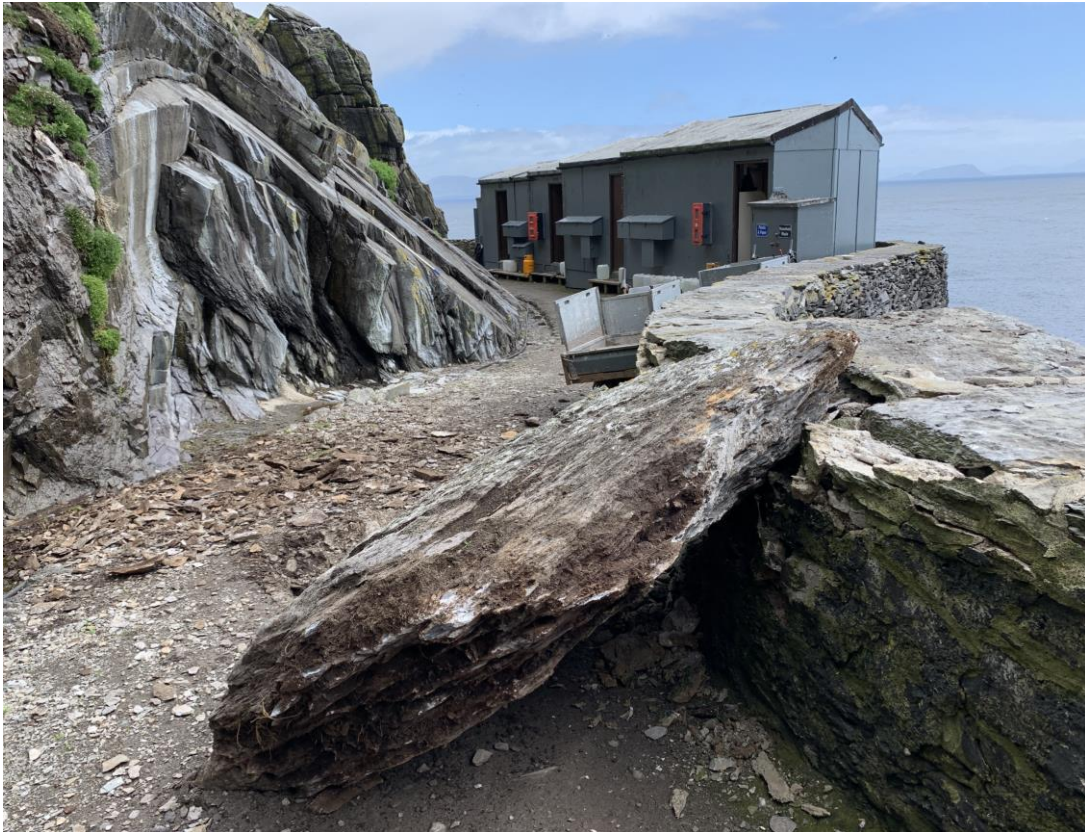
Rock-falls have increased in frequency in the past five years, due to the effects of climate change. The high levels of precipitation are leading to soil erosion and rock falls. The substantial rock fall which occurred in 2020 on the lighthouse road near the site huts resulted in the installation of a temporary crash deck at this location and at another two high risk locations on the Upper Lighthouse Road to protect OPW operatives from falling debris.

Fig.31. - Rock Fall on 27th July 2020

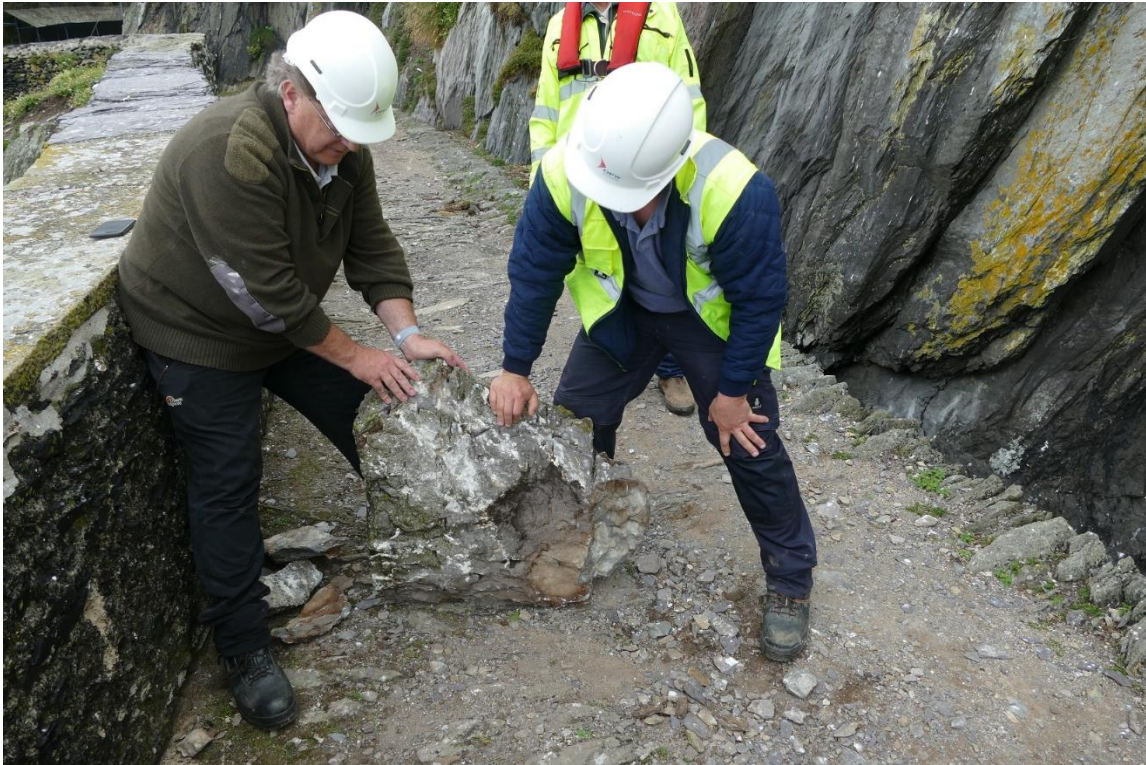
A serious rock fall occurred on the lower lighthouse road on 13th June 2022. The island was closed to the public with immediate effect for 3 weeks from 13th June 2022 and re-opened on 4th July 2022. A site visit was carried out on 17th June 2022 by OPW Senior Architect, OPW Safety Officer, MWP Consultant Engineers and CHE Ltd Consultant Geologist.

Fig. 33. - View of the existing rock from the rock fall that occurred on 13th June 2022 on the Lower Lighthouse road

To mitigate the effects of rock falls, the OPW installed a new canopy on the lower lighthouse road of approximately 100 linear meters in length following a grant of Ministerial Consent by DHLGH. The Ministerial consent application was accompanied by an Appropriate Assessment / Natura Impact Assessment produced by Envirico Ltd (Appendix I), and an Archaeological Impact Assessment produced by Alan Hayden Consultant Archaeologist (Appendix J).

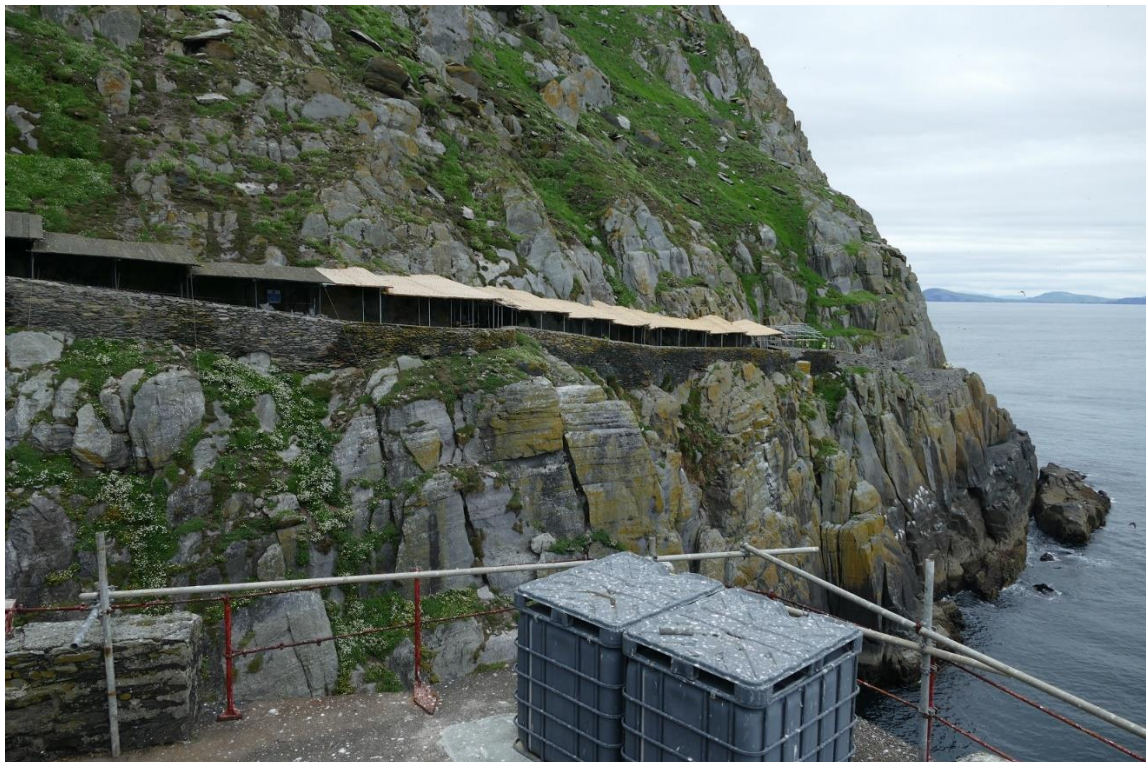
Fig. 34. - View of the canopy being installed at the Lower Lighthouse road following the rock fall that occurred on 13th June 2022

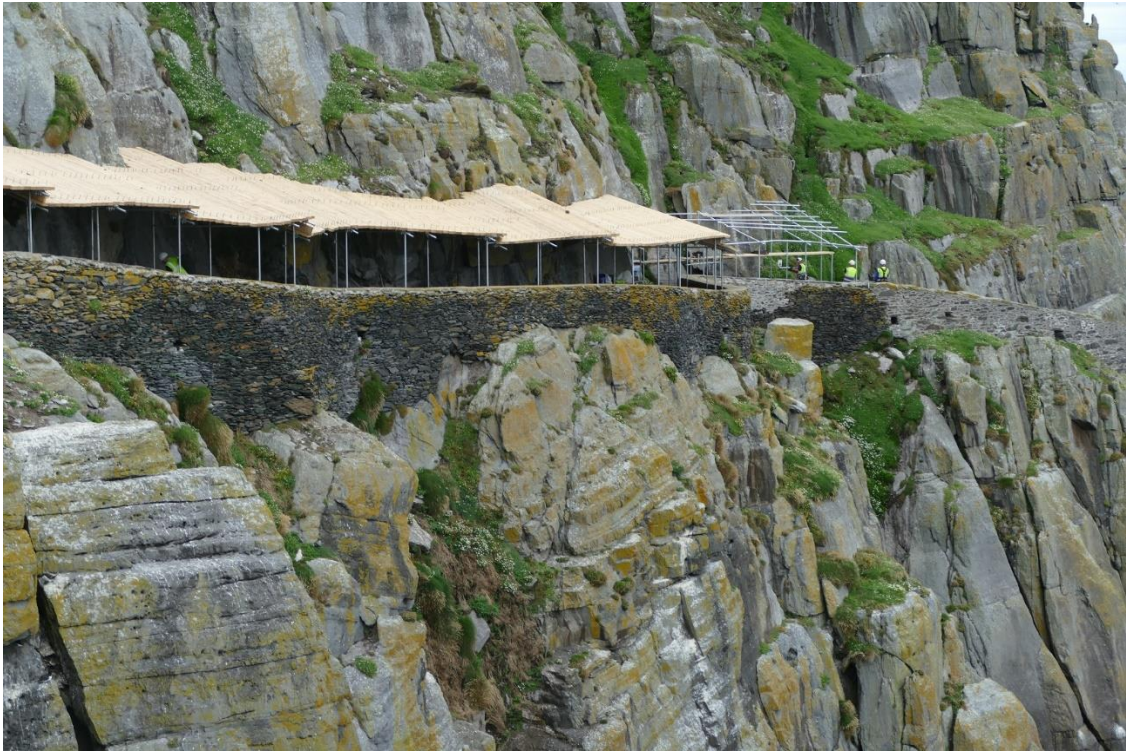
Fig. 35. - View of the canopy being installed at the Lower Lighthouse road following the rock fall that occurred on 13th June 2022

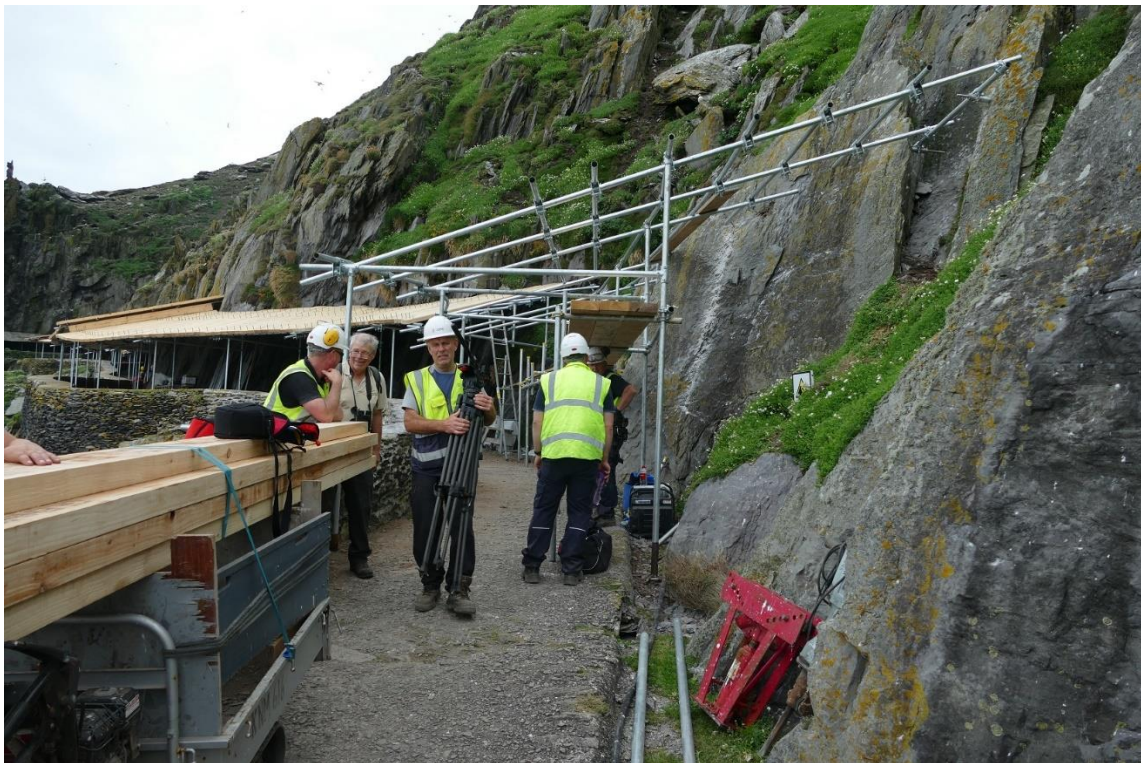
Fig. 36. - View of the canopy being installed at the Lower Lighthouse road following the rock fall that occurred on 13th June 2022

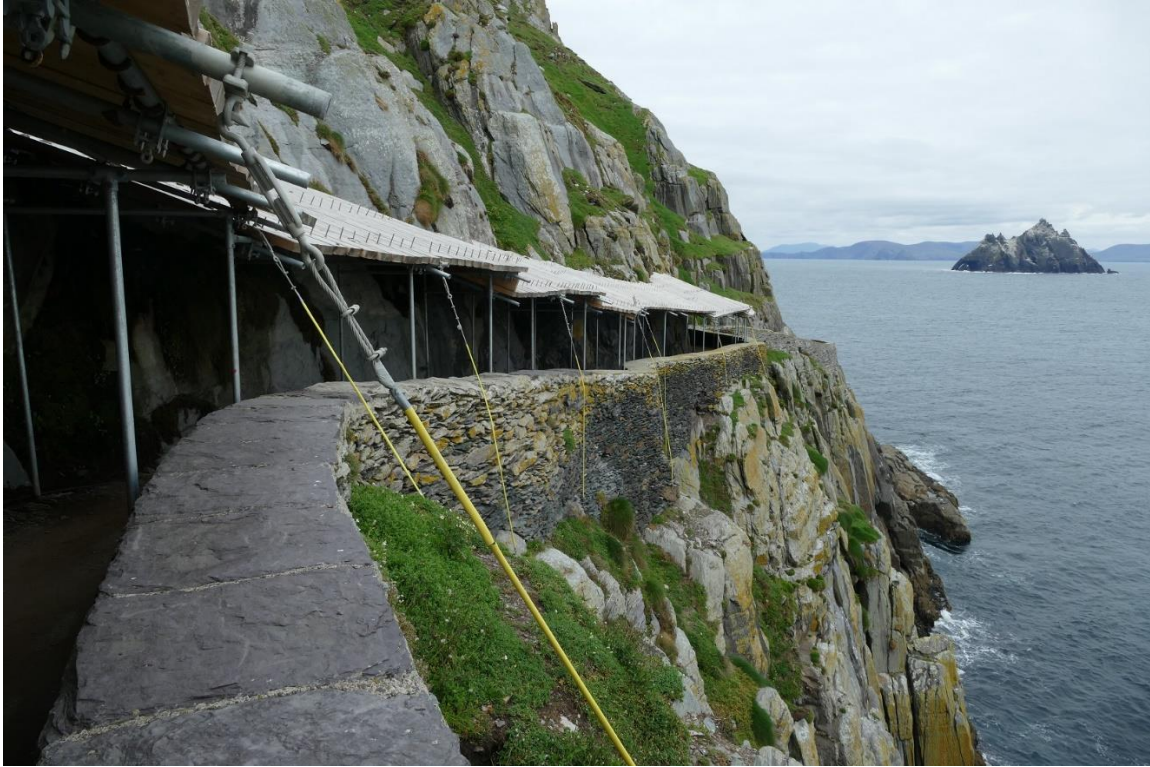
Fig. 37. - View of the canopy installed at the Lower Lighthouse road following the rock fall that occurred on 13th June 2022

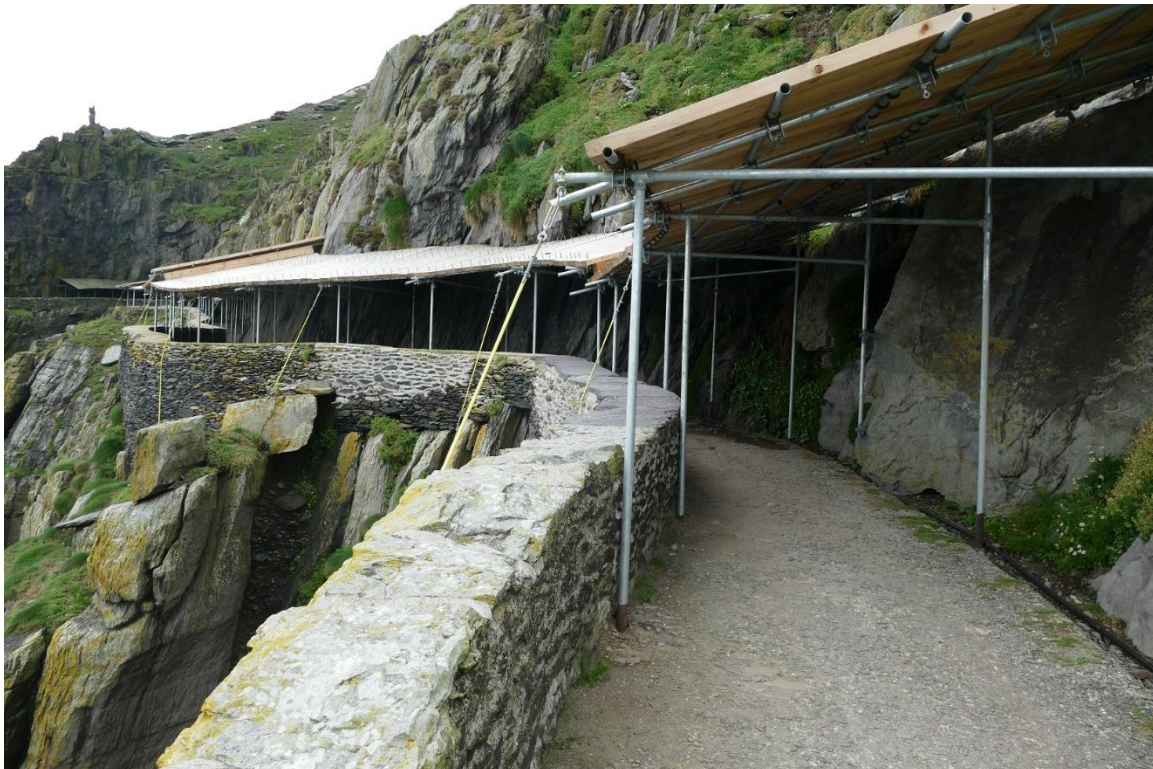
Fig. 38. - View of the canopy installed at the Lower Lighthouse road following the rock fall that occurred on 13th June 2022

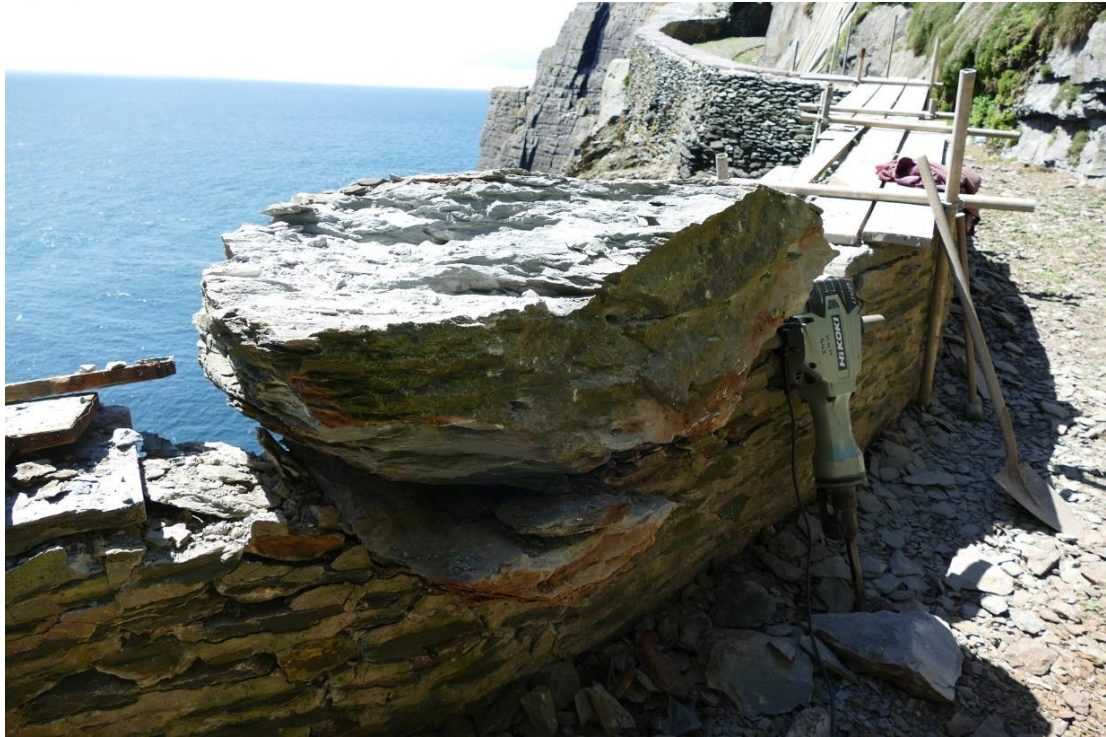
Another rock fall was recorded on the Upper Lighthouse road which occurred before OPW accessed the island in the 2022 season in the location of crash deck no. 2. The rock fall caused significant damage to the sea wall. The OPW installed a temporary railing as a temporary safety measure in the location of the rock fall. The OPW will be carrying out repair works to the damaged section of the sea wall in the 2023 season.

Fig. 39. - View of the rock fall in the location of crash deck no.2 on the Upper Lighthouse road

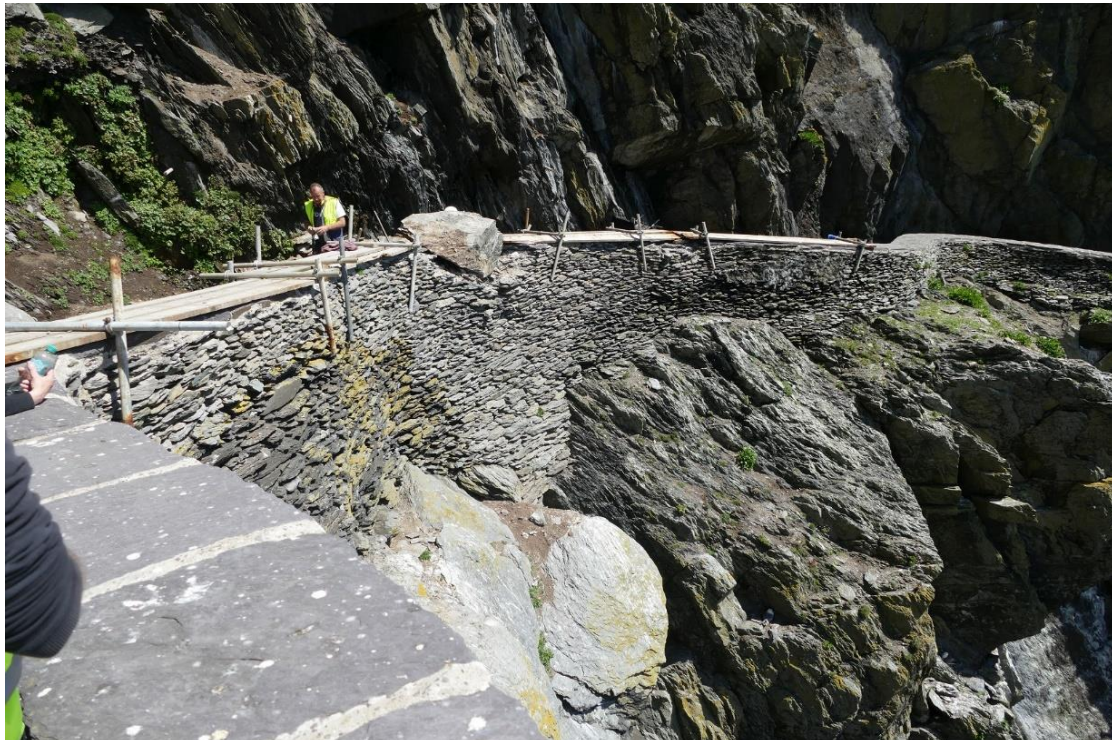
Fig. 40. - View of the rock fall in the location of crash deck no.2 on the Upper Lighthouse road

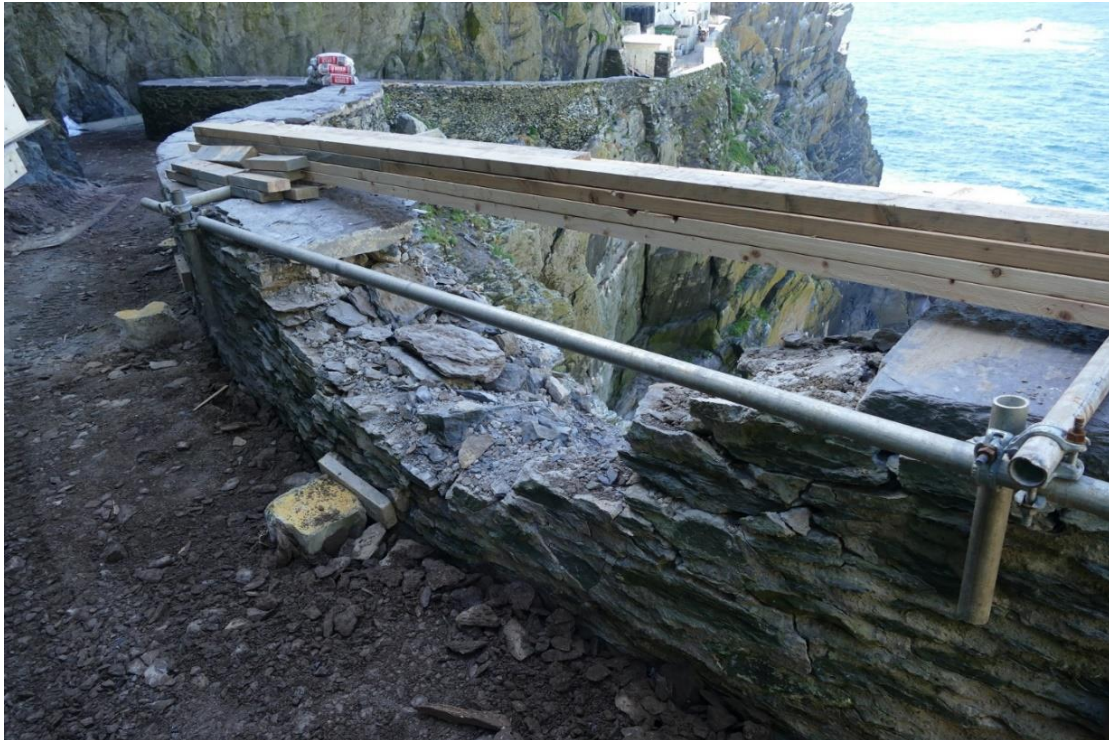
Fig. 41. - Temporary safety railing installed on site by OPW where the rock fall occurred in the location of crash deck no. 2 on the Upper Lighthouse road

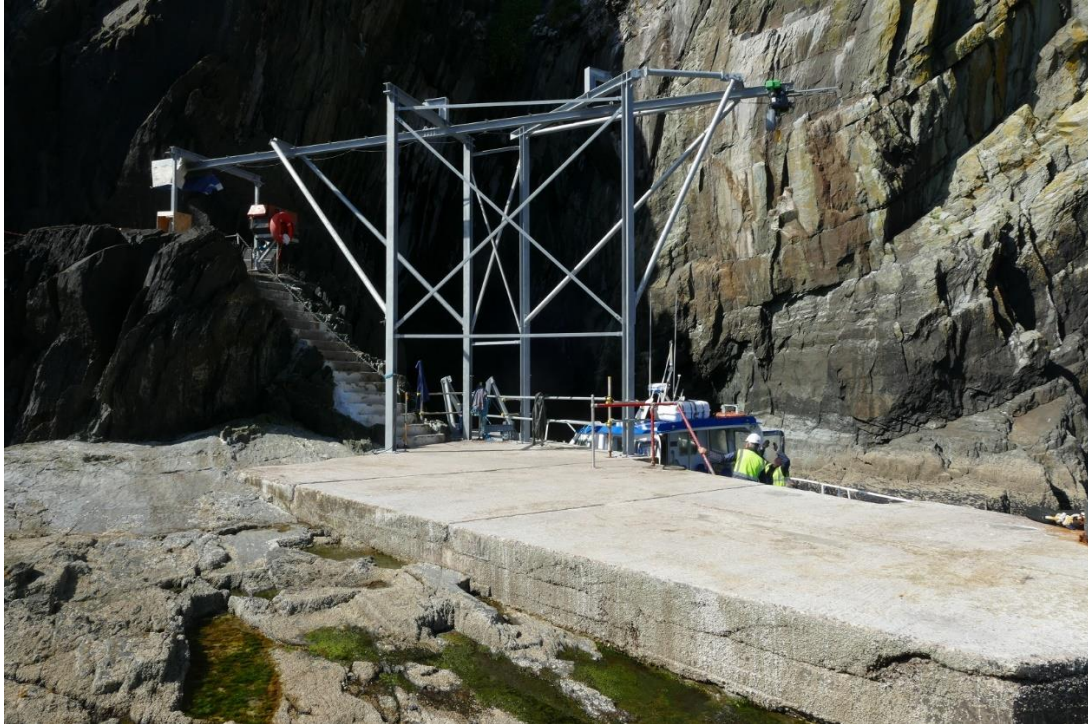
Fig .42. - Crane installed at the landing pier by Eamon Costello (Kerry) Ltd to facilitate lifting of steelwork and other heavy construction materials

The OPW appointed Eamonn Costello (Kerry) Ltd as main contractor the Crash Decks installation works following a tender process. The installation of the permanent crash decks commenced in the 2022 season. To facilitate the transportation of construction materials, the main contractor installed a temporary crane at the landing pier. The structures of 3 no. crash decks were installed on site by the main contractor. The works were halted on 29th September 2022 due to deteriorating weather conditions. The stainless steel mesh and canopy for the 3 no. crash decks will be installed by the main contractor in the 2023 season.

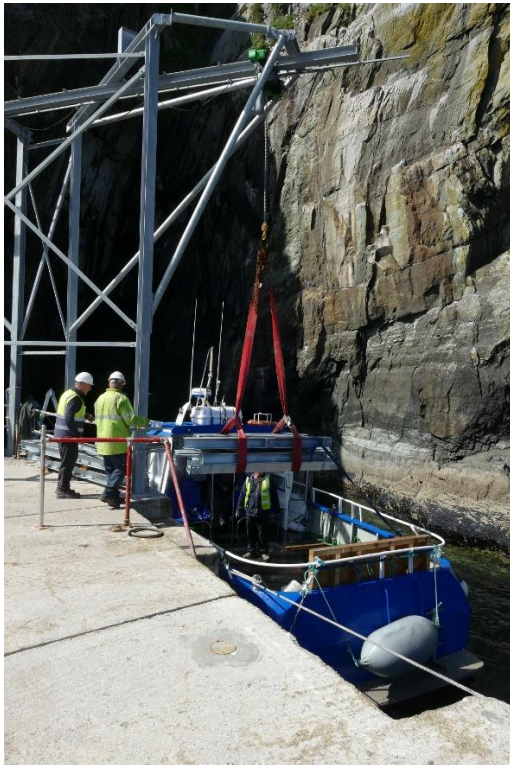
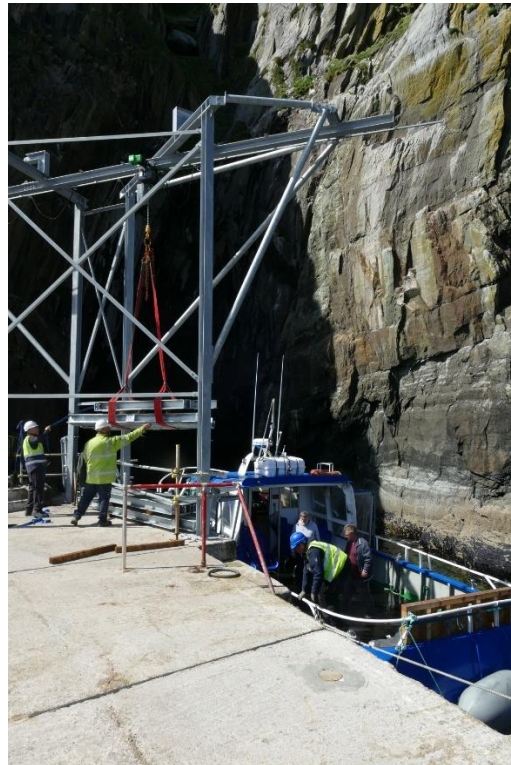
Fig. 43. - Crane installed at the landing pier by Eamon Costello (Kerry) Ltd to facilitate lifting of steelwork and other heavy construction materials

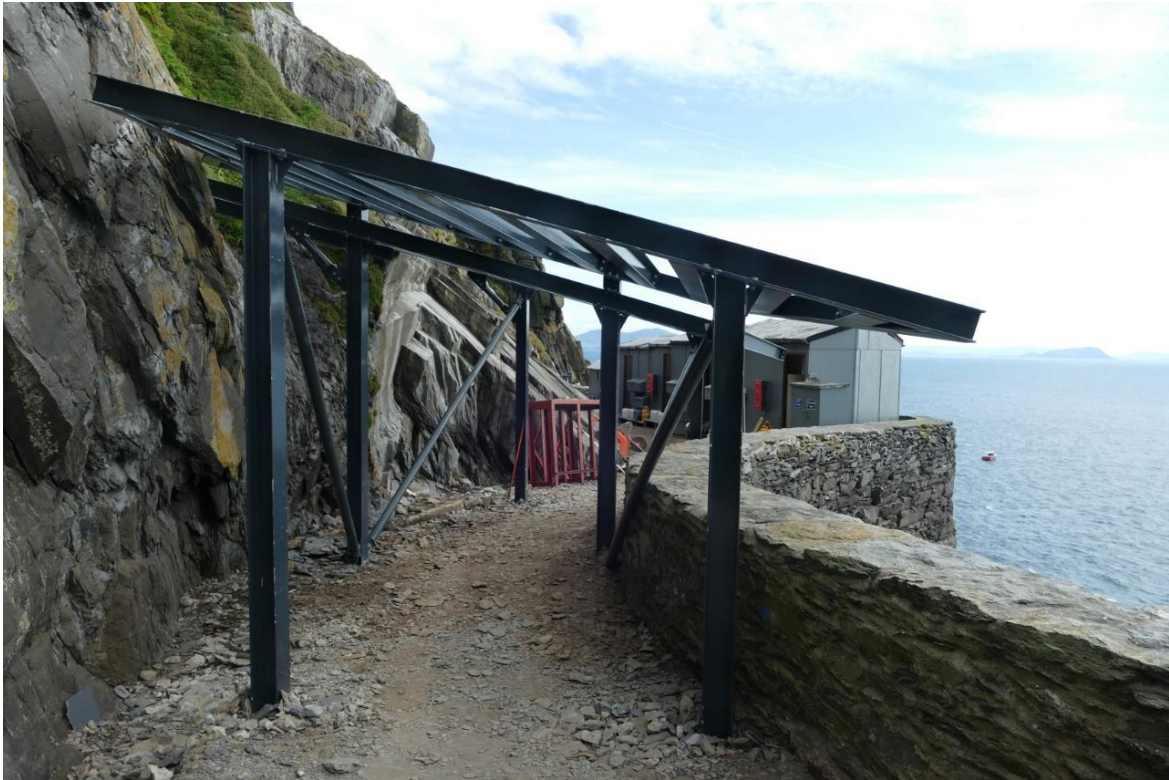
Fig. 44. - Crash Deck No. 1 – Steel structure installed on site

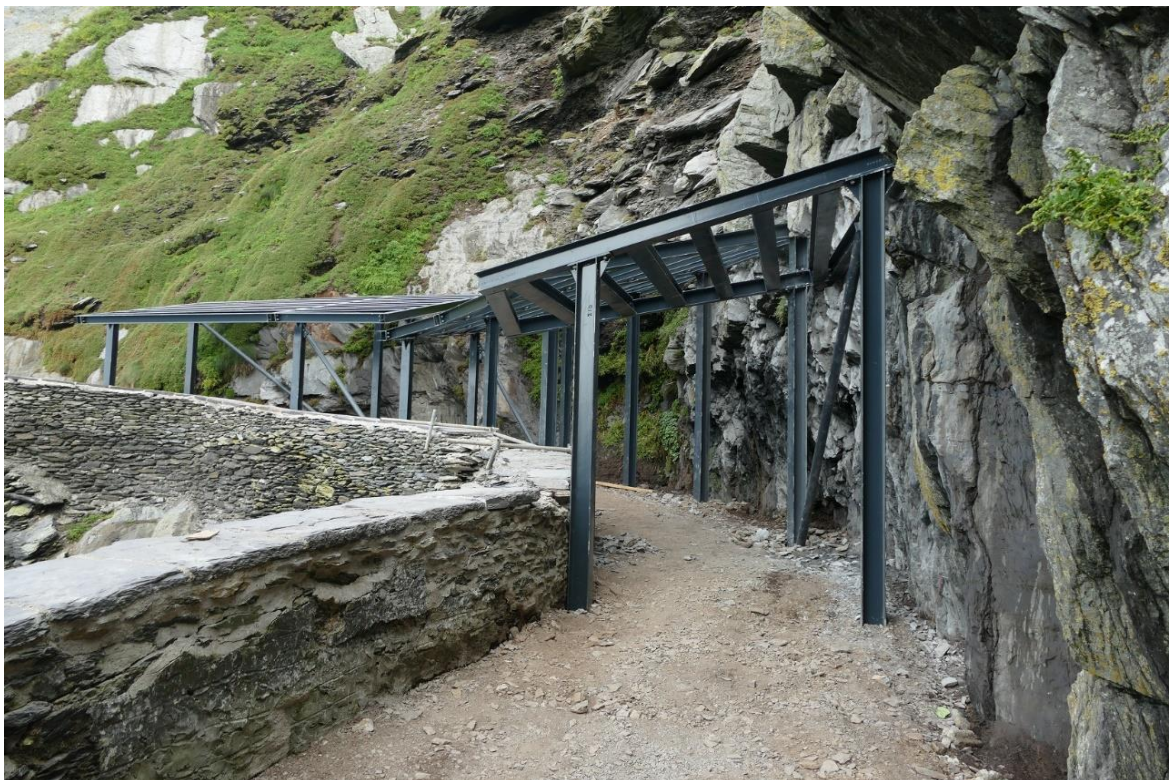
Fig. 45. - Crash Deck No. 2 – Steel structure installed on site

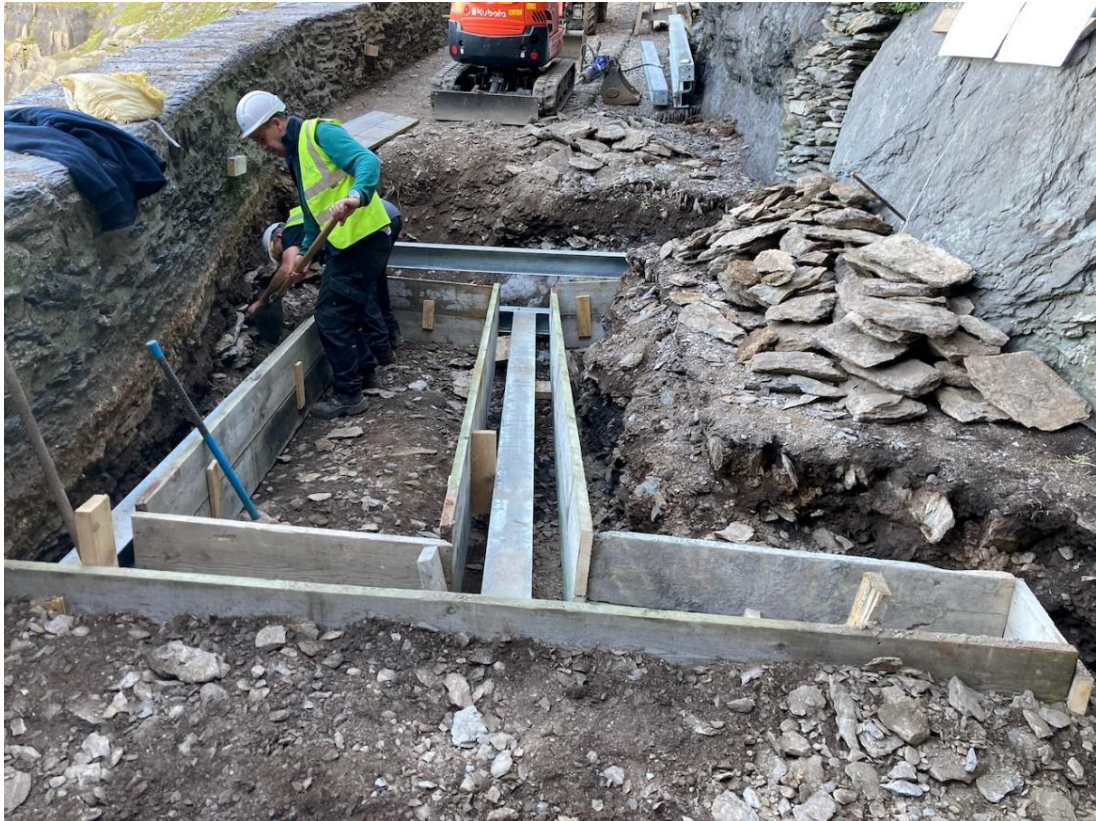
*Fig. 46. - Crash Deck No. 3 – Installation of concrete foundation and associated ground works on site
(Photo taken by Alan Hayden)*

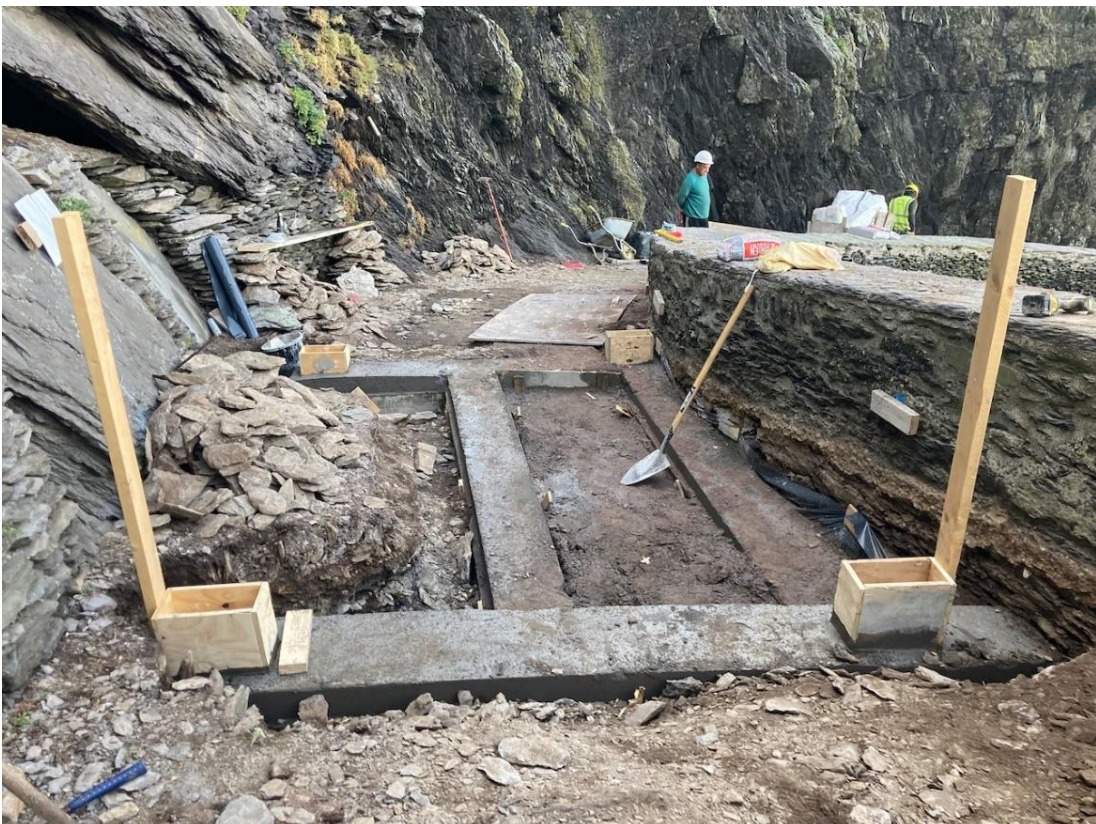
*Fig. 47. - Crash Deck No. 3 – Installation of concrete foundation and associated ground works on site
(Photo taken by Alan Hayden)*

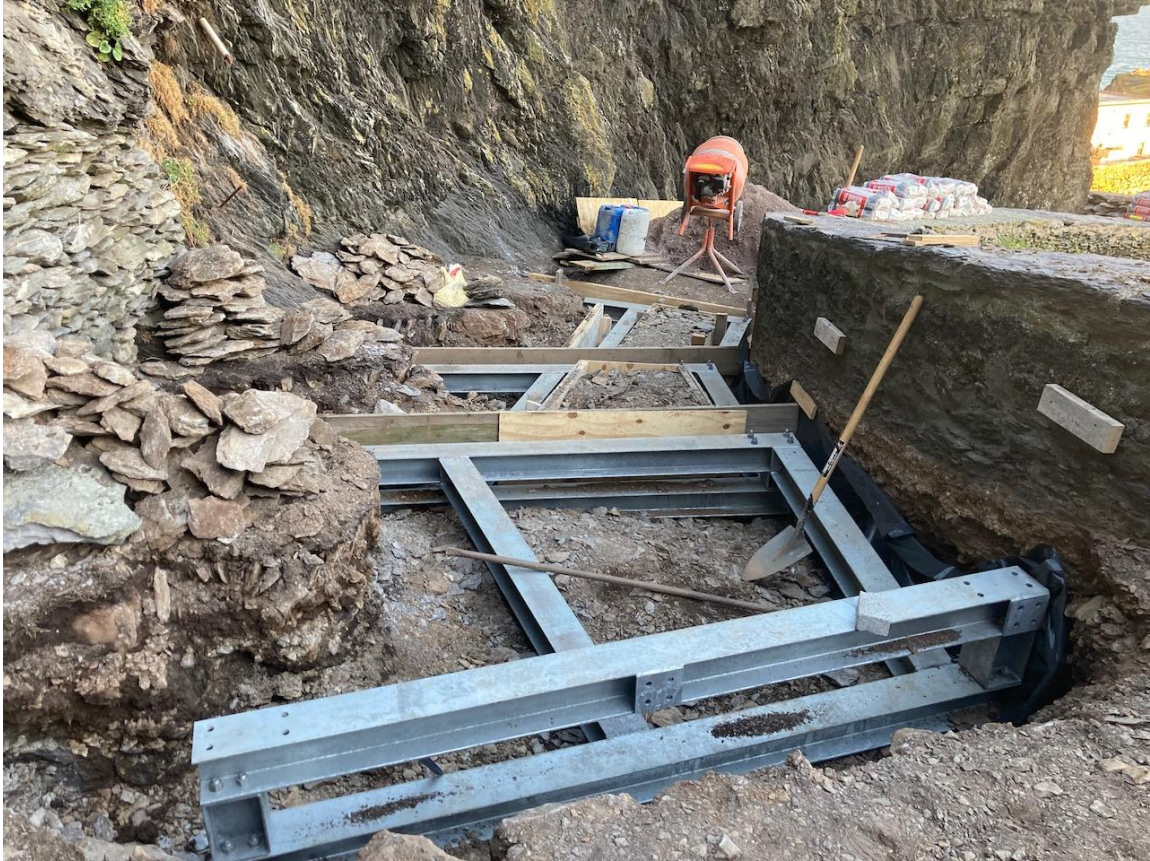
Fig. 48. - Crash Deck No. 3 – Installation of steel foundation on site (Photo taken by Alan Hayden)

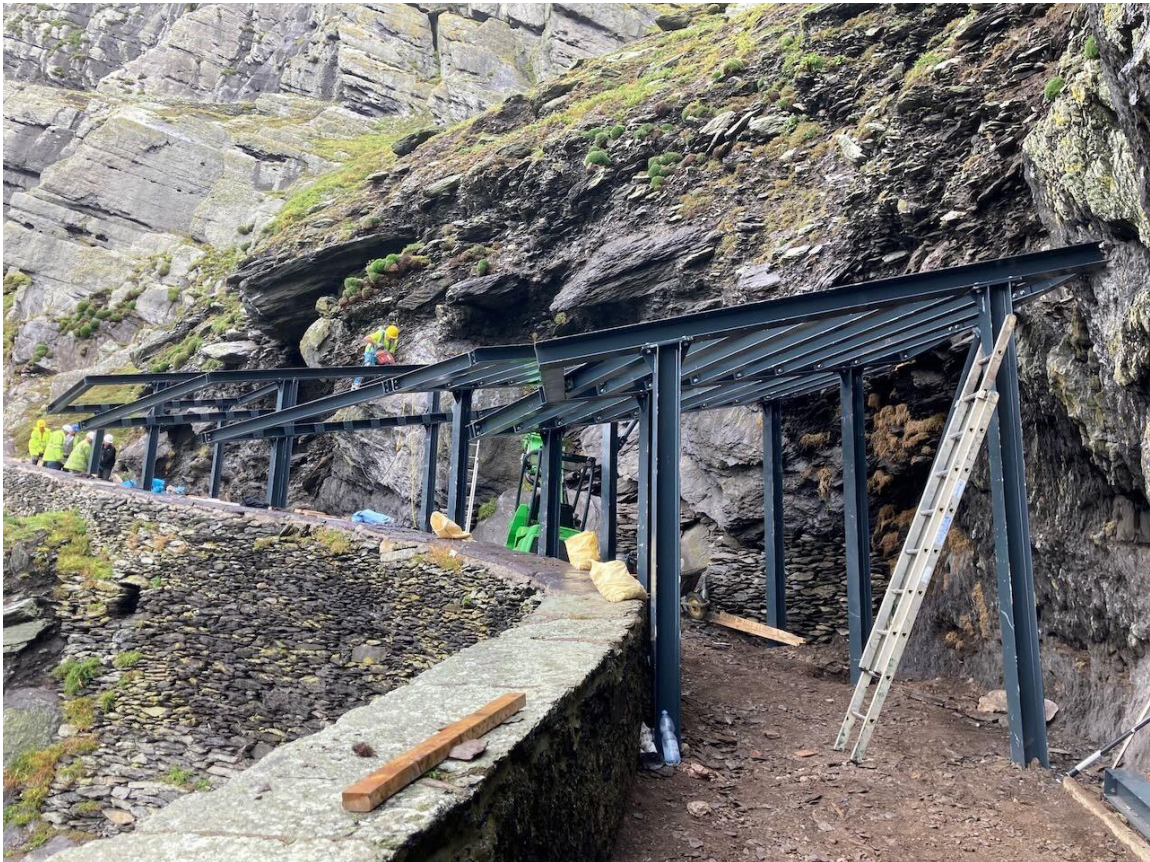
Fig. 49. - Crash Deck No. 3 – Steel structure installed on site
