Sceilg Mhichíl
World Heritage Property
OPW Works Season 2022
UNESCO Report – Final Issue 13.02.2023

1. Introduction

5. Works Descriptions 2022

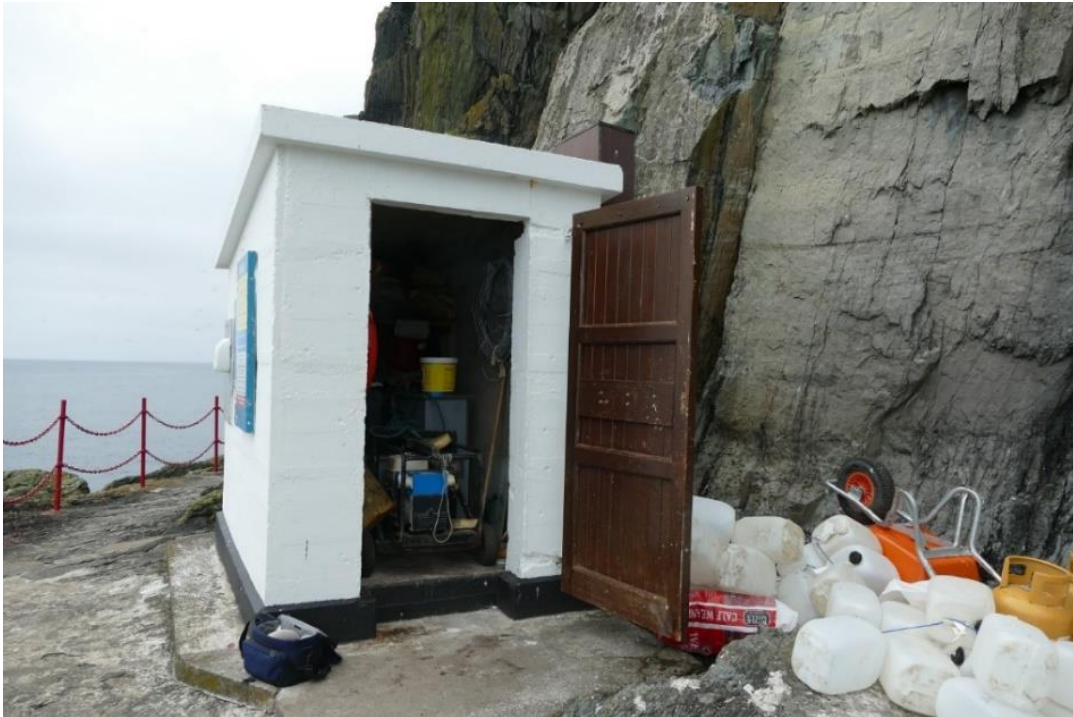
Fig. 50. - Proposed location of CCTV on the storage building adjacent to the landing pier

The OPW will endeavour to provide greater security to the site. The OPW are proposing to install CCTV and solar panels on the storage building adjacent to the landing pier. The OPW were granted DHLGH Ministerial Consent in April 2022 for the proposed installation of CCTV on the storage building adjacent to the landing pier. Technical information was provided by OPW M&E Engineering section to accompany the Ministerial consent application. A Natura Impact Statement Document was commissioned from Envirico specialist environmental consultant to accompany the consent application (Appendix M). The CCTV installation works were not carried out in the 2022 season due to unfavourable weather conditions. It is hoped to carry out the CCTV installation works in the 2023 season.
