**Archaeological Method Statement**

**Annual Safety Sweep,**

***Sceilg Mhichíl, Co. Kerry.***

## Archaeological Method Statement for Monitoring of Annual Safety Sweep

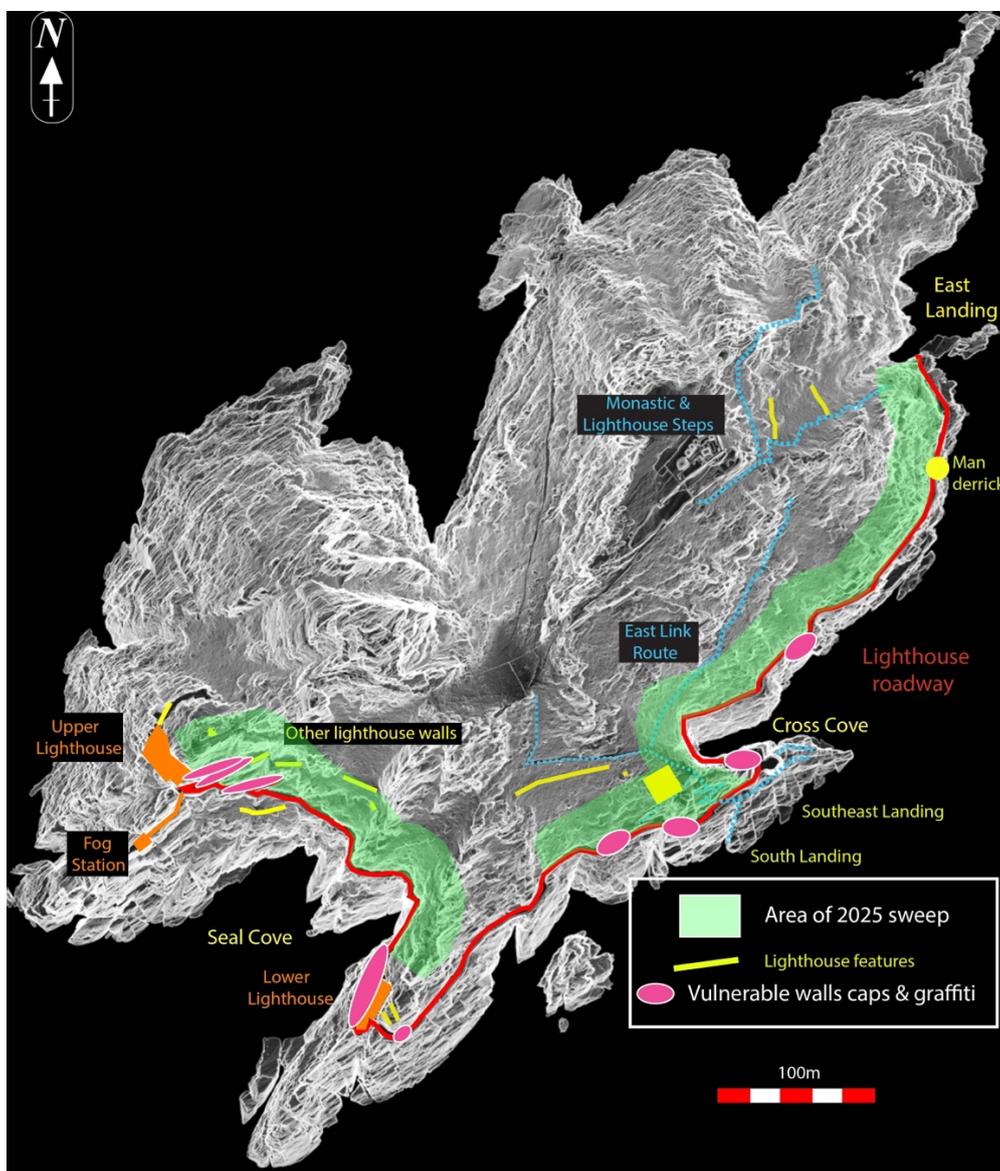
Fig. 1. Lidar image of *Sceilg Mhichíl*, showing the area of the sweeps (green) and the known principal archaeological features in their vicinity.

the parapet wall that contain original sandstone capstone (see fig. 1) which would be vulnerable to falling materials.

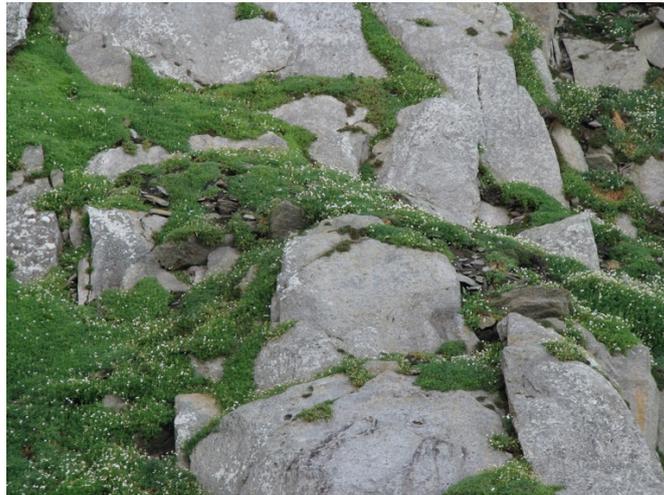
*Fig. 2. Photograph (taken from helipad) of potential masonry terrace / traverse on East Link Route above cross cove.*

Above the area of Cross Cove the sweep crosses part of the line of the known East Link Route- an early pathway used by pilgrims to reach Christ's Saddle and the South Peak from the East Steps to the monastery. The east end of this early routeway was explored by Michael Gibbons who found the remains of a beehive hut and crosses cut from the rock. The exact location of these features is not known. The remainder of the route has been tentatively identified from the LiDar survey of the island (fig. 1) but has not been visited or explored, so what exactly it contains and indeed its exact route is not known. The line of the part of the route above Cross Cove is visible from both the Helipad and just above the Wailing Woman Ledge. There appears to be a clear terrace crossing the slope but whether this is of early date or of lighthouse construction is unknown. At the east end of this terrace there are what appear to be further potential terraces (fig. 2), areas of masonry and possible masonry steps, none of which have been examined up close. These and any other features that survive here are particularly vulnerable as none are known for certain and many may not be readily recognisable as archaeological features.
