Archaeological Monitoring

Annual pre-Season Sweep

Sceilg Mhichil, Co. Kerry

Ministerial Consent C001189

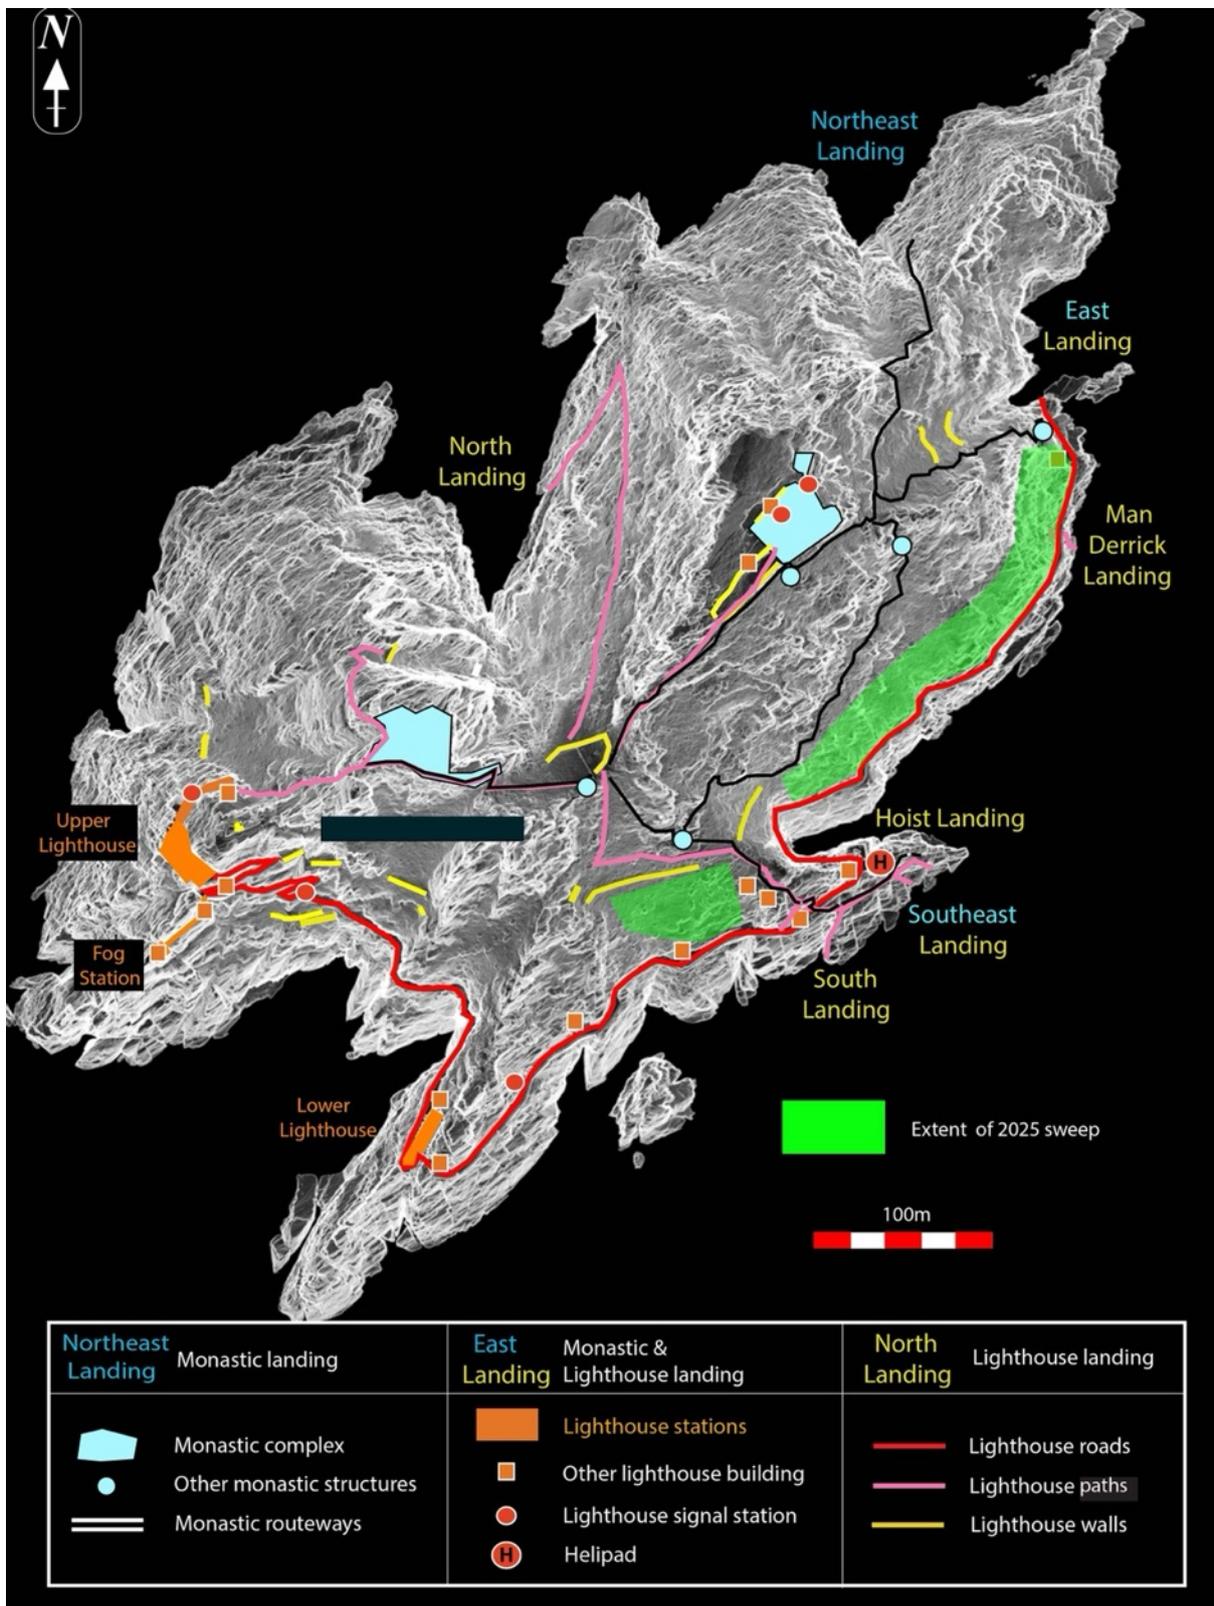
Fig. 1. Locations of the areas swept in 2025 and the principal early-medieval and lighthouse features on Scelig Mhichil.

The 2025 sweep consisted of nine transects above the Lower Lighthouse Roadway extending from the East Landing to the east side of Cross Cove and a walkover of the slope above the area from the Wailing Woman ledge to the west end of the workmen's huts. (fig. 2). Each area was examined for loose material, which if located was placed in a secure setting where it could not fall.

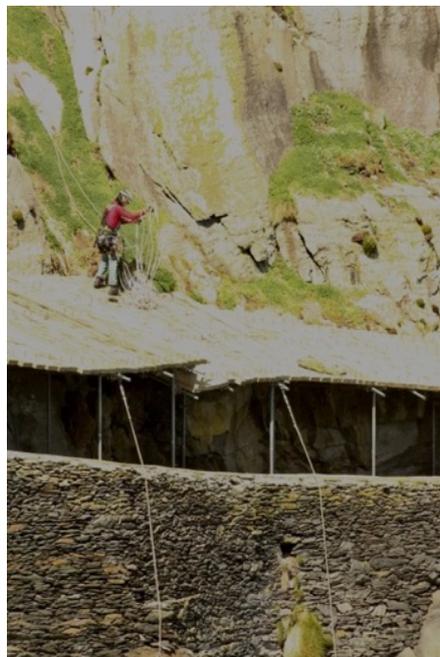
One large stone, which had fallen onto the roof of the canopy built in 2022 (fig.2) was pushed over the side avoiding both the parapet wall and nesting birds below. Single areas of the 2016 and 1959 canopies in Cross Cove were also damaged by falling rocks, which did not lodge on the them.

Fig. 2. Large stone lodged on roof of 2022 canopy.

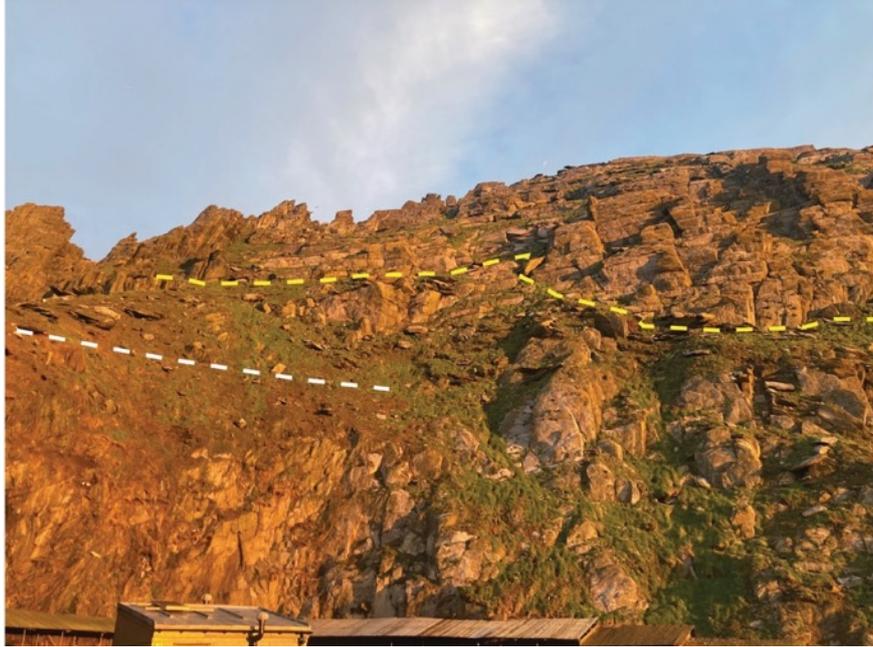
Fig. 3. (Yellow line) East Link route from Crocodile Rock Platform (left) eastwards above Cross Cove; 1959 canopy visible at bottom. (White line) Lighthouse wall above Cross Cove

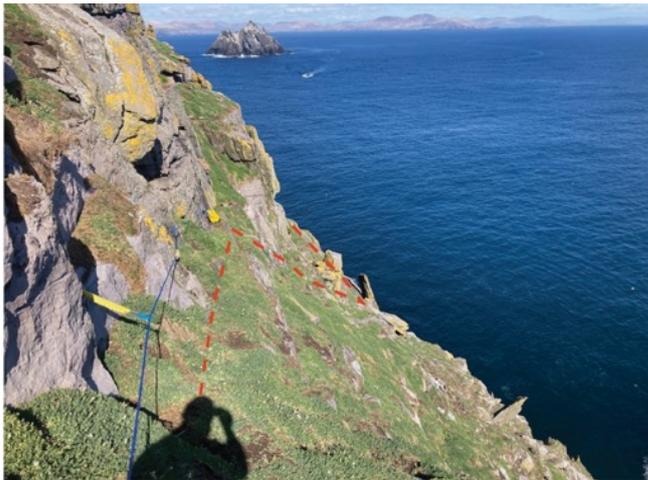
The setting up of safety ropes in 2025 enable the writer to explore the top of the slope above Cross Cove. This revealed the existence of an easily walked route from the known end of the East Link Route westwards. It began with a short and easy uphill climb from the known end up to the top scree slope (fig. 4). The scree slope here has a thick campion cover and so no man-made features were visible. Following the top of the gently rising and easily walked ledge this led to a protruding spur in the cliff (fig. 5) which when rounded came to the top of a slope above the back of the Crocodile Rock Platform above the South Steps (fig. 6). Two rock-cut steps and possible masonry survive on this slope (fig. 7 & 9) while its base led to a set of previously known rock-cut steps marked by a previously-known cross cut from the rock and leading down onto the Platform (figs. 8 & 9)

Fig. 4. Section leading uphill from the previously known west end of the route up to the top of the scree slope

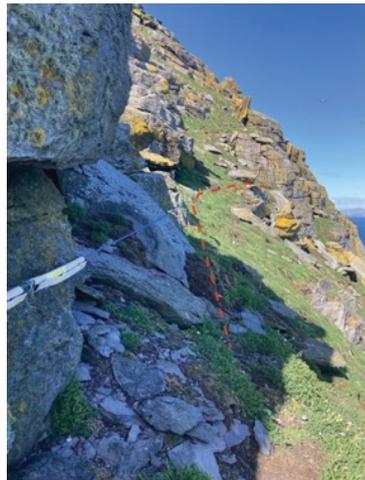
Fig. 5. Route to corner (in foreground)

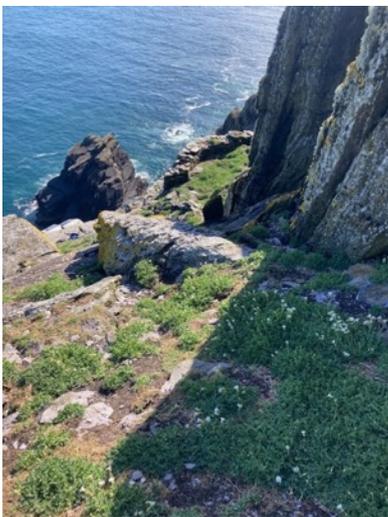
Fig. 6. Looking down on route from corner to back of Crocodile Rock Platform.

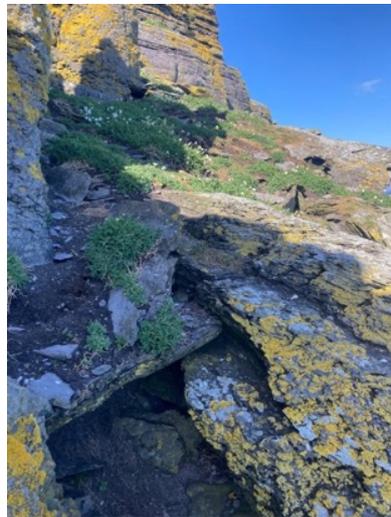
Fig. 7. Rock cut steps on route down from corner to back of crocodile Rock Platform

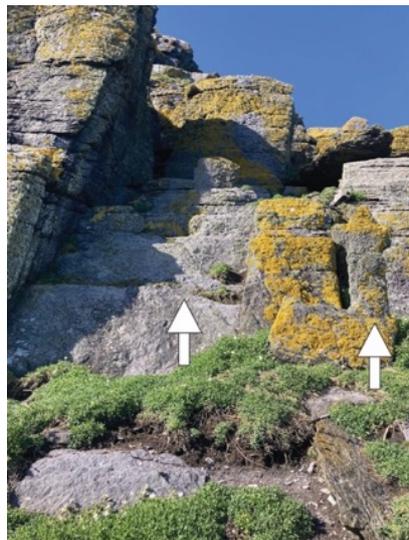
The rock-cut steps here were thought to lead up somewhere to a route uphill to the monastery, however no such route was ever found despite a search of the area above. It is now clear that the steps actually led to the East Link Route.

Fig. 8. Back of Crocodile Rock enclosure. Rock-cut steps up to end of East Link Route (left arrow) and cross cut from rock (right arrow).

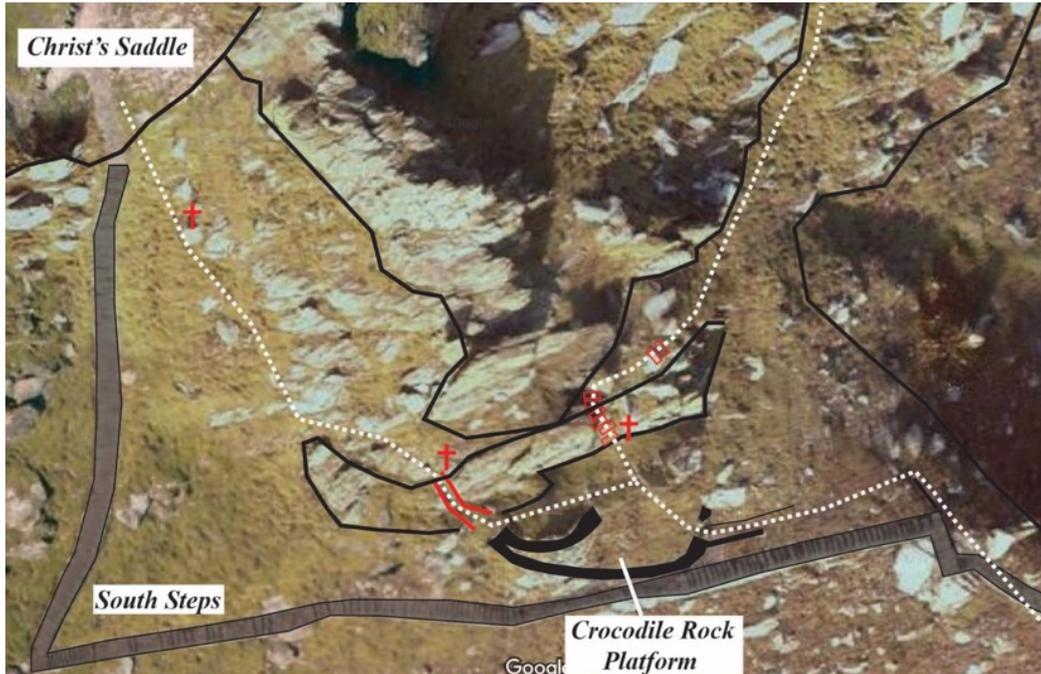
Fig. 9. Satellite photograph of the area around the Crocodile Rock Platform and the routeways through it, showing crosses cut from the rock (red crosses), rock cut steps (red rectangles), walls (thick black lines) and gully (red). The breaks in slope are indicated by the narrower black lines.

There was no clear route leading off the west end of the platform upwards. However a re-examination of the area in 2025 revealed the existence of an easily climbed, narrow and campion filled gully in the rock cliff at the back of the northwest side of the platform (figs. 9-12). The stump of a possible previously unrecorded cross cut from the rock on the flat rock to the right of the top of the gully is visible from the platform indicating that this indeed was a used route. (figs. 11-13)

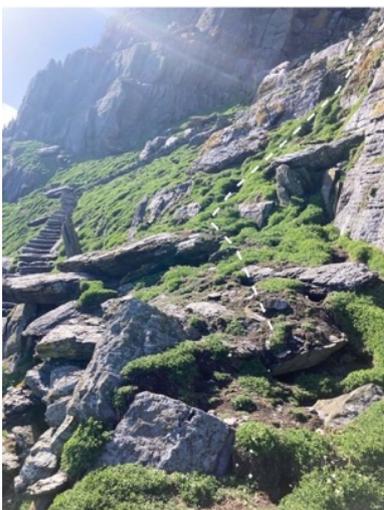
Fig. 10. West end of Crocodile Rock Platform with start of route up gully marked.

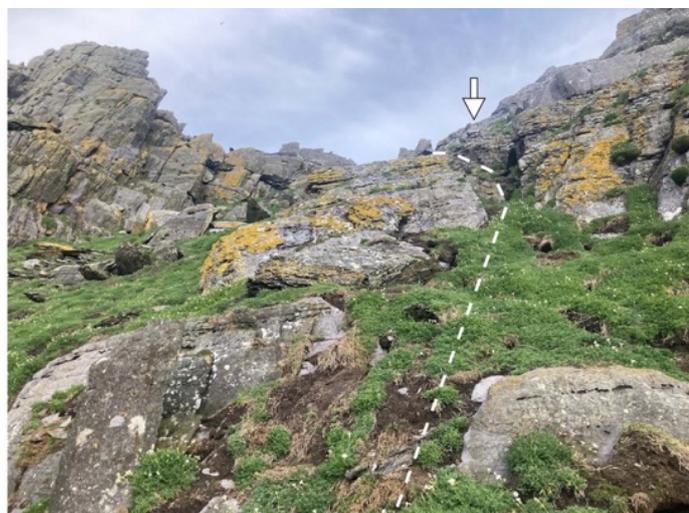
Fig. 11. The route up the gully with cross cut from the rock at its top marked by arrow.

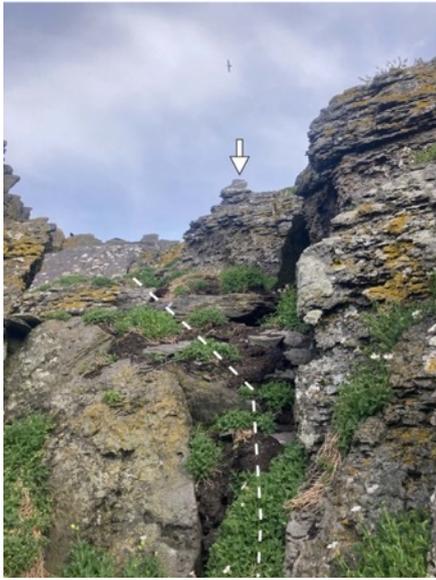
Fig. 12. Top of gully with cross cut from the rock Indicated by arrow.

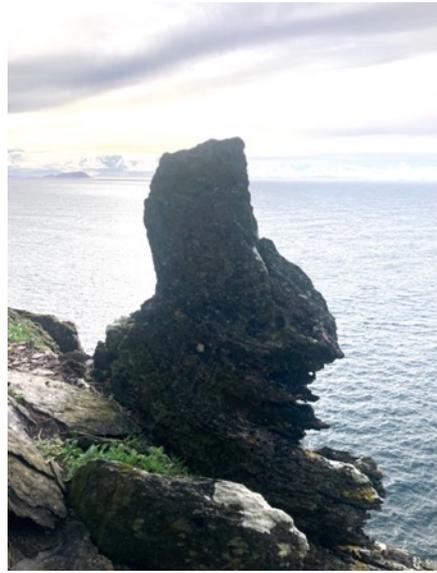
Fig. 13. Close up of cross cut from the rock at the head of the gully

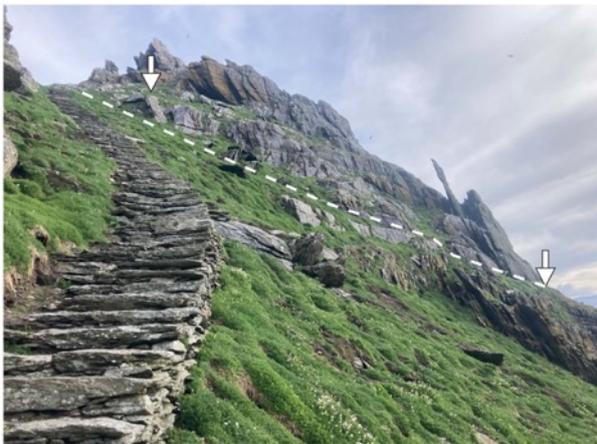
Exiting the top of the gully another and large cross-cut from the rock in visible straight ahead up an easily walked slope which leads up the Saddle to the east of the top of the South Steps (figs. 9, 14 & 15).

Fig. 14. Route above Crocodile Rock Platform, crosses cut from the rock marked by arrows.

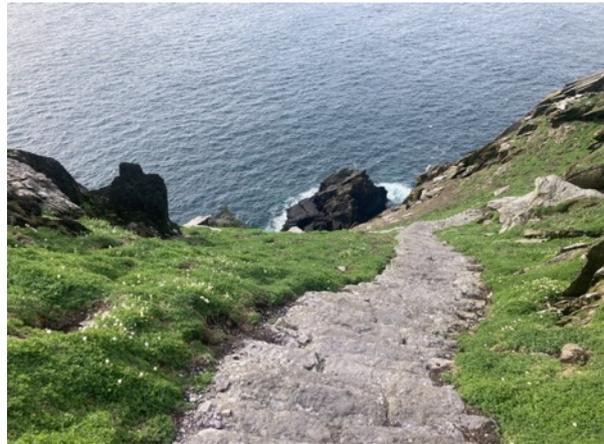
Fig. 15. Looking down from top of South Steps, upper cross cut from the rock visible at left.

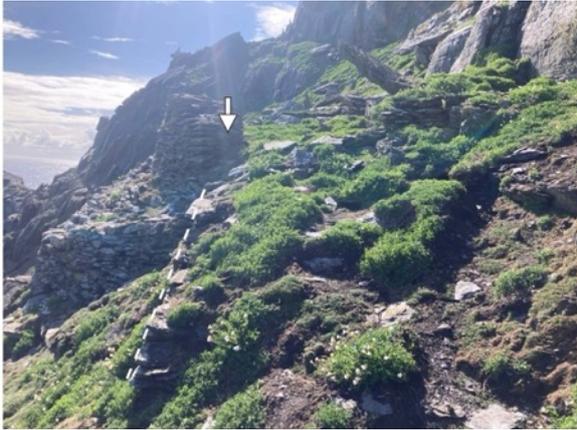
One side of a clear entrance survives in the drystone wall defining the east side of the Crocodile Rock Platform. These leads out onto a small traverse defined by a drystone wall on its south side (fig. 16). Following this line straight eastwards leads to the north end of a north-south aligned unnaturally flat area close to the cliff (fig. 17). This has been remarked on previously by the writer but this year was the first time it was visible devoid of campion cover. A clear edge was visible on its west side cutting across the natural grain of the ground. It would appear that this could have been a man-made traverse leading downslope to the prominent corner (marked by a yellow sign bearing a black arrow) on the South Steps.

Fig. 16. Entrance and terrace leading from east side of crocodile Rock Platform

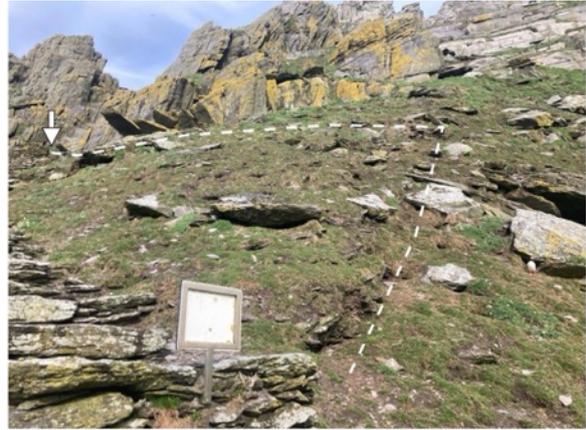
Fig. 17. Possible route east and down from Crocodile Rock platform. Unnatural flat ledge extending downhill at right.

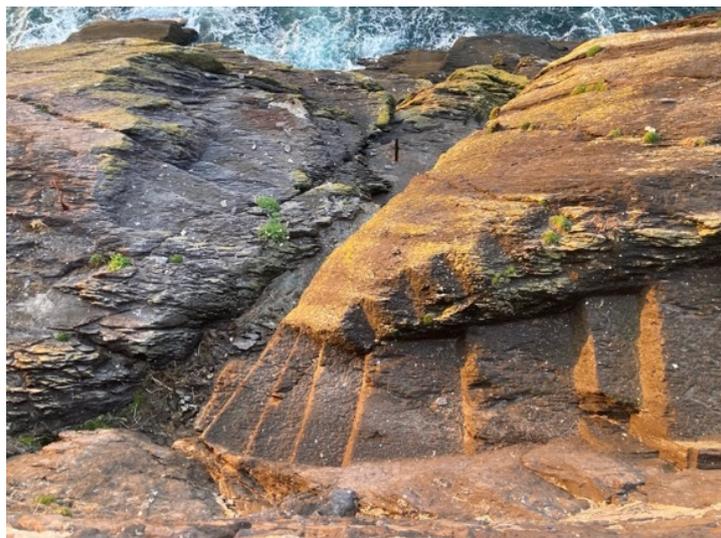
Below the roadway two runs of early rock-cut steps survive, one on the south side of the top of the initial flight of lighthouse rock-cut steps (fig. 18) and another further down and to the east. The area between the two was heavily altered by the routeways constructed and areas blasted out by the lighthouse builders and later by works to erect the helipad.

Fig. 18. A run of small early steps cut through by large lighthouse steps down to south and southeast landings below the lighthouse roadway
