**OPW** Oifig na  
nOibreacha Poiblí  
Office of Public Works

**Sceilg Mhichíl, Co. Kerry**  
**2025 OPW Maintenance Plan**  
**Date of Issue – 8<sup>th</sup> September 2025**

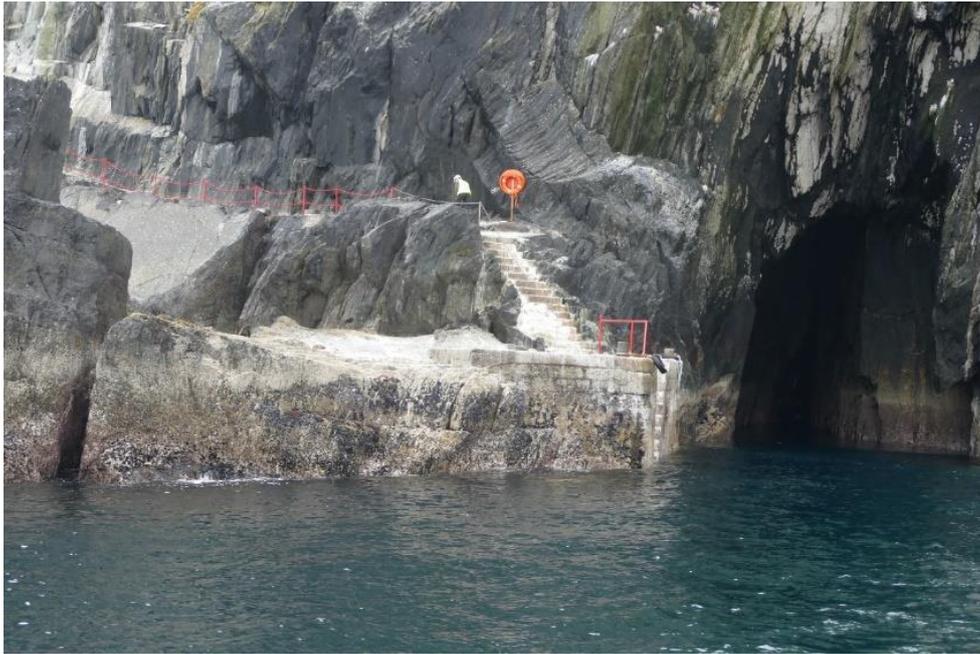
Figure 3 - View of the Landing Pier

The landing pier at Blind Man's Cove is the only point of access to Sceilig Mhichíl by boat. The landing pier is used by tourists, OPW personnel, consultants, etc. It is also used to transport materials to and from the island. The maintenance of the landing pier by the OPW is essential to ensure safe access to the island. The maintenance works to be carried out by the OPW include cleaning the landing pier of debris, ensuring that the access steps and handrails are secure, and securing any loose stones. The landing pier is cleaned with chlorus to remove the algae following the winter months. The removal of algae is essential to prevent serious slipping and tripping hazards. Debris is removed from the crane pit to ensure correct installation of crane.

Following a serious incident on the landing pier on Sceilg Mhichíl involving a member of the public during 2024 visitors season, it was advised to OPW during the investigation process to carry out a survey of the pier. OPW will be appointing contractors in early May 2025 to carry out a survey of the landing pier and steps and to propose options for repairing and upgrading the existing steps and hand railing at the landing pier.

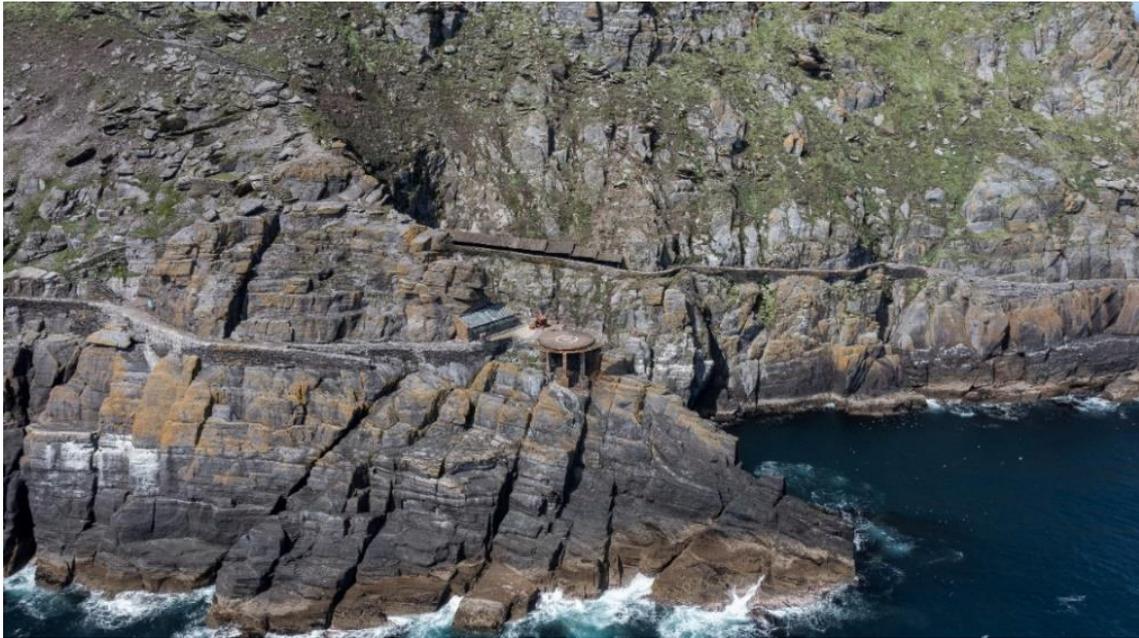
Figure 6 - View of the Lower Lighthouse Road

The OPW replaced the hand railing / chain linkage on the lower lighthouse road in the 2024 season. The OPW will carry out an annual inspection of the hand railing / chain linkage on the lower lighthouse road and replace them as required.

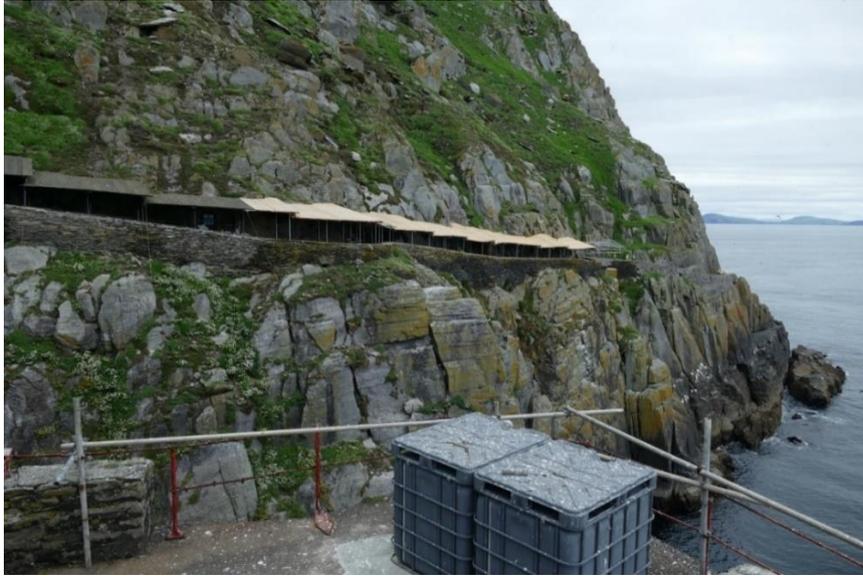
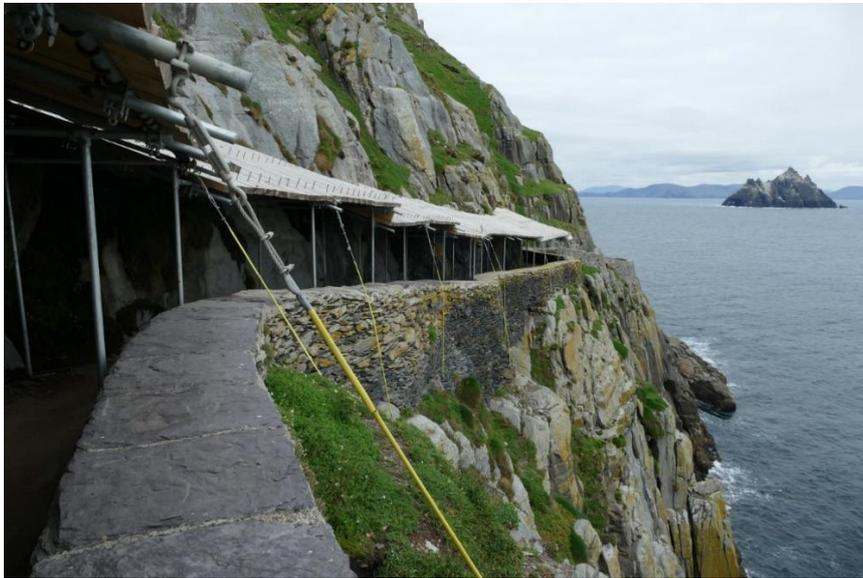
The OPW carry out cleaning works to the protective canopy located on the Lower Lighthouse Road. The purpose of the protective canopy is to deflect stones and debris that fall down from the upper sloped areas. This is to provide safe access for all the visitors to Sceilg Mhichíl. The existing canopy on Sceilg Mhichíl was extended by approximately 100 linear meters in the 2022 season following a serious rock fall that occurred on the Lower Lighthouse Road on 13<sup>th</sup> June 2022.

*Figure 9 - View of the protective canopy on the Lower Lighthouse Road*

*Figure 10 - View of the protective canopy on the Lower Lighthouse Road*

The maintenance works to the canopy include the cleaning of stones, debris and potential rock falls. The works also include inspection and securing of the canopy. The canopy is built of a scaffolding system including scaffolding tubes and timber decking. Due to the larger size of debris that might fall on the lower lighthouse road during the winter months, some of the timber boards may sustain extensive damage and would require replacement. Therefore, timber boards on the protective canopy are inspected and replaced as required. The protective canopy may also require repair works and paintwork as required.

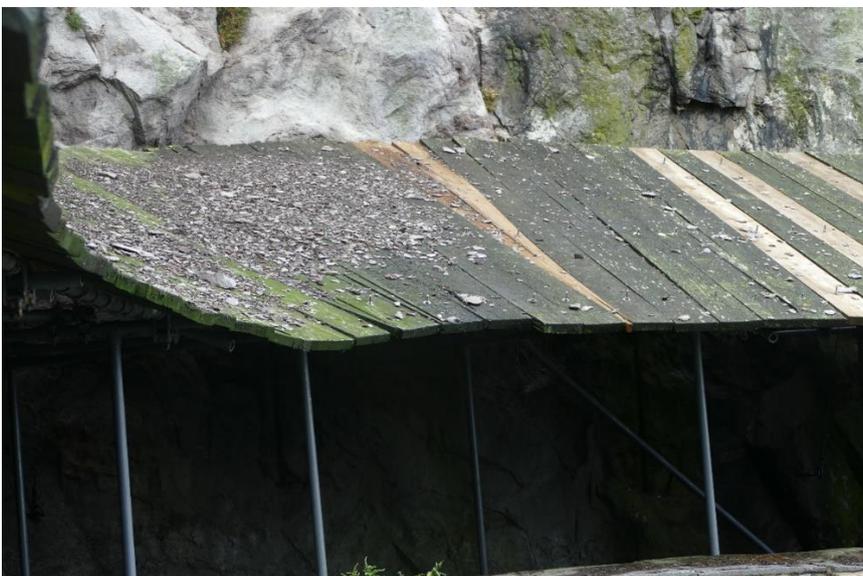
*Figure 11 - View of fallen debris on the decking of the protective canopy on the Lower Lighthouse Road*

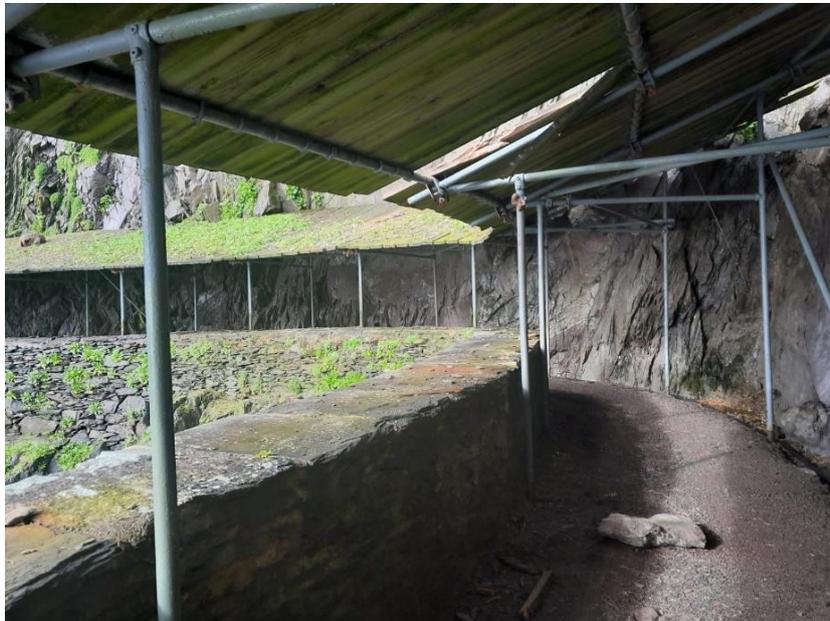
A rock fall occurred on the lower lighthouse road at Cross Cove early in the 2024 season that damaged the timber boarding of the existing crash deck. OPW architects carried out a site visit on 24<sup>th</sup> April 2024 to inspect the rock fall and the damaged timber boarding. OPW appointed Gordon Knaggs consultant timber specialist to inspect the timber boarding. Gordon Knaggs issued a timber condition report to OPW in May 2024 outlining the repairs and maintenance required to the protective canopy. As a result, it was proposed to replace all the timber boarding to the damaged section of the protective canopy. The OPW completed the installation of the new timber decking in June 2024.

*Figure 12 - Rock fall and damage to timber boarding in the 2024 season*

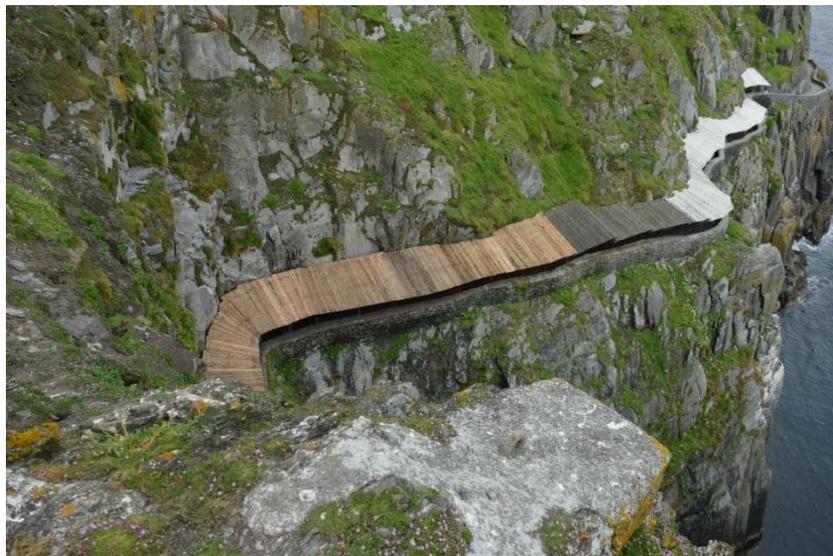
*Figure 13 - New timber boarding installed in 2024 to the protective canopy at Cross Cove*

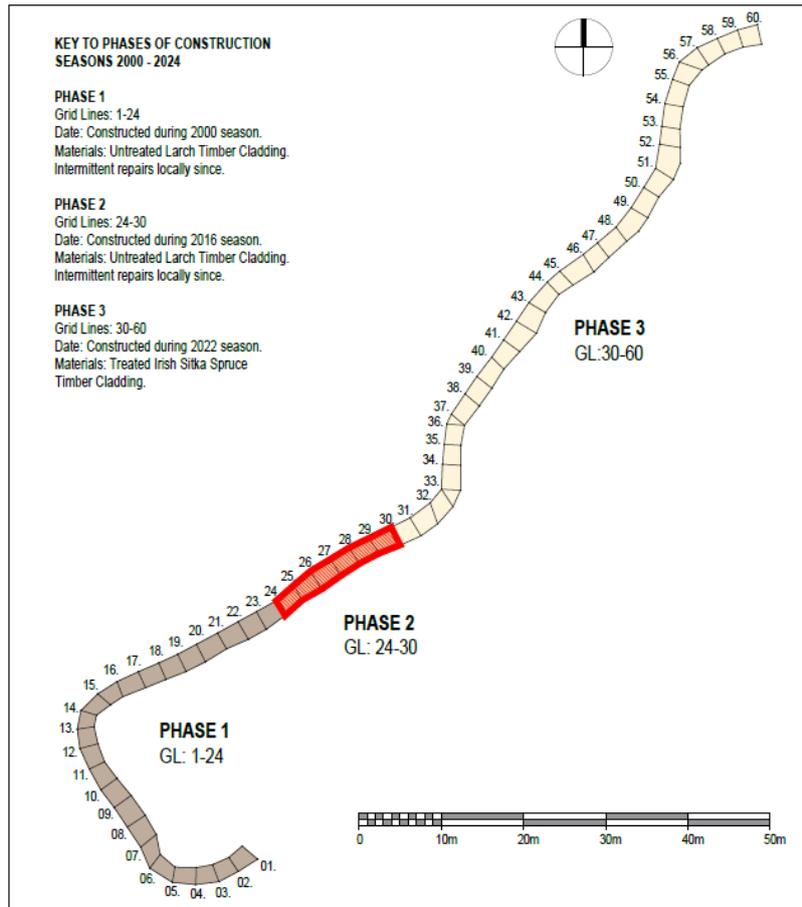
Figure 14 - Drawing highlighting in red the 2016 section of the protective canopy at Cross Cove subject to proposed repair works in 2025

The OPW will be including the repair and maintenance to the crash decks at Cross Cove as part of their yearly maintenance programme. The OPW are proposing to replace the existing timber boarding with new treated larch timber boarding to the 2016 section of the crash deck at Cross Cove in the 2025 season. See figure 14 outlining Phase 2 of the repairs works to existing timber crash decks at Cross Cove.

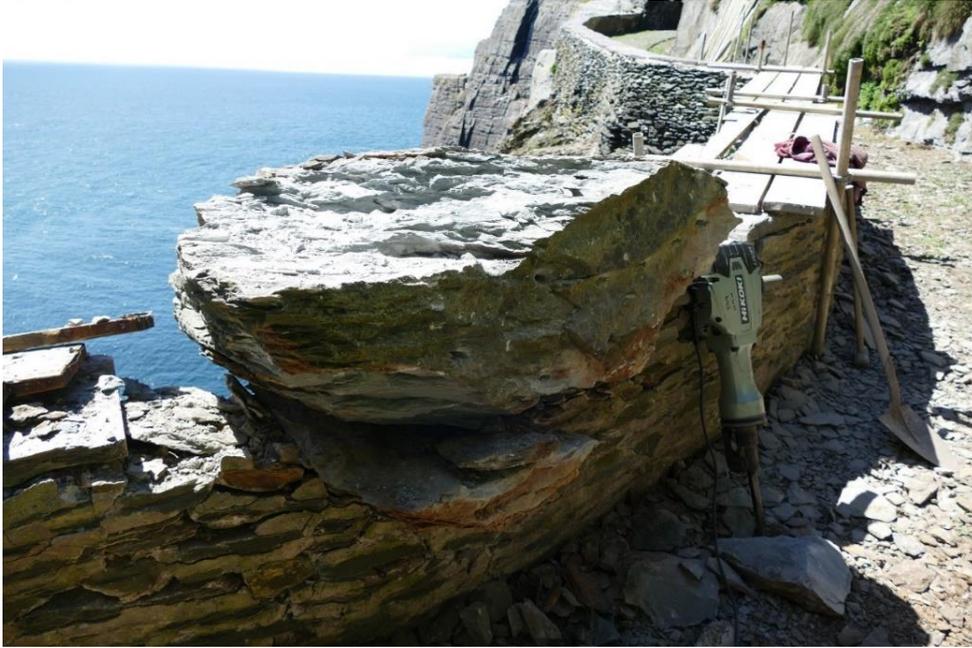
Rock falls have increased in frequency in the past five years, due to the effects of climate change. The high levels of precipitation are leading to soil erosion and rock falls. OPW carry out a safety sweep at the start of each season to identify any potential rock falls that might have occurred during the winter season. The OPW then proceed to clear any fallen rocks by breaking them and salvaging stones for future re-use. Additionally, the OPW endeavour to make the locations of rock falls safe for tourists, OPW staff, and any other visitors to the island.

Figure 15 - Example of rock fall on the Upper Lighthouse Road in the 2022 season

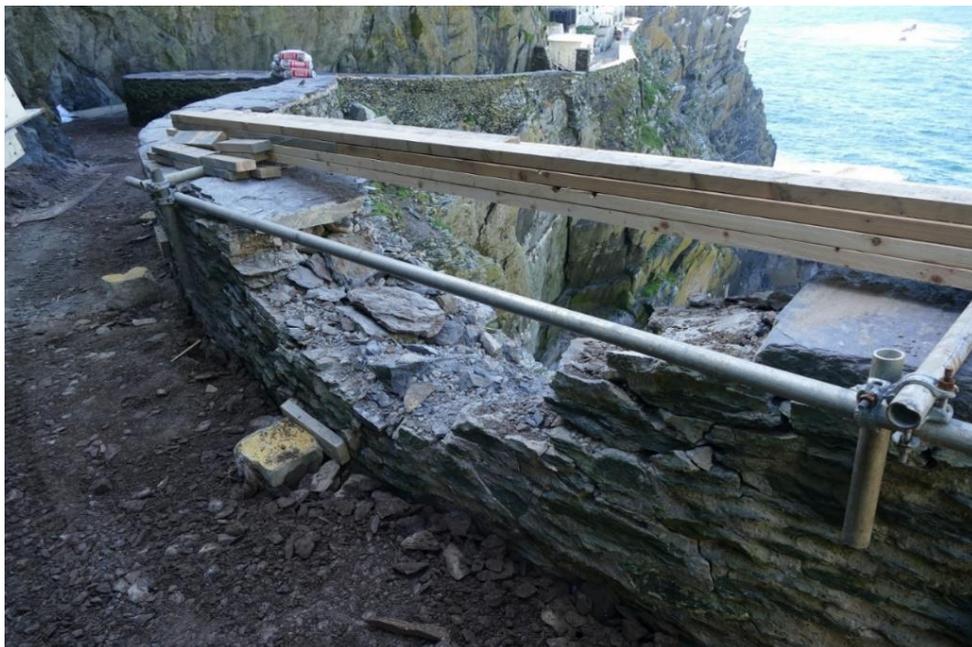
Figure 16 – Example of temporary safety railing installed at the Upper Lighthouse Road by OPW in the 2022 season

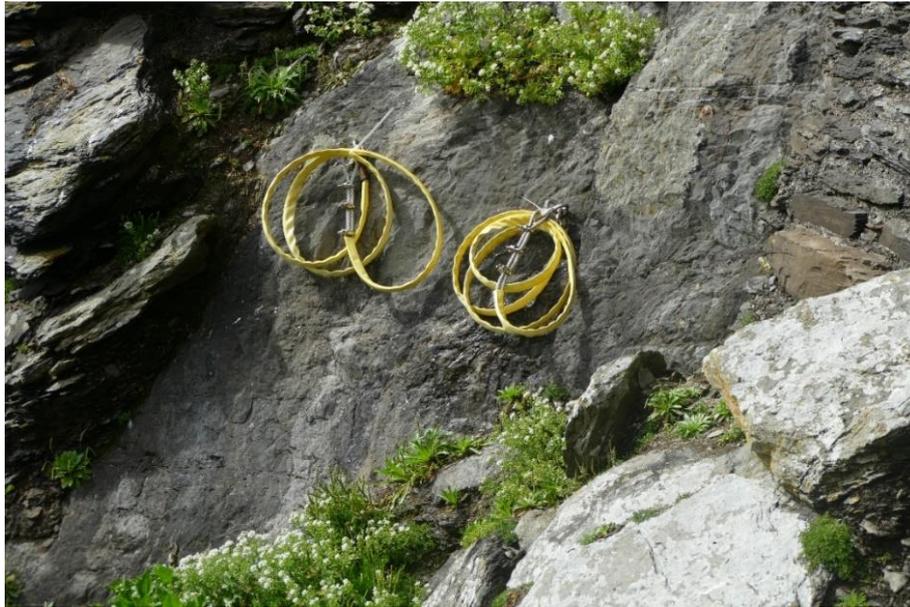
The stainless steel cable stays were also installed by the contractor following receipt of an extension to Ministerial consent from DHLGH. The Ministerial Consent conditions outlined the requirement for the temporary removal of the stainless steel stays on the seawall side of the crash decks during the summer season to avoid injury to the birds during the nesting season. The stainless steel stays are to be re-installed at the end of the summer season before the island closure. OPW will remove the stainless steel stays at the start of the 2025 season. The stainless steel stays will be coiled up and attached to the rock face below the sea walls. OPW will later re-instate the stainless steel stays in September 2025 before the closure of the island. The OPW will also re-instate the stainless steel stays during the season in advance of a major storm event.

Figure 17 – Example of stainless steel stays coiled up and attached to the rock face below the sea walls

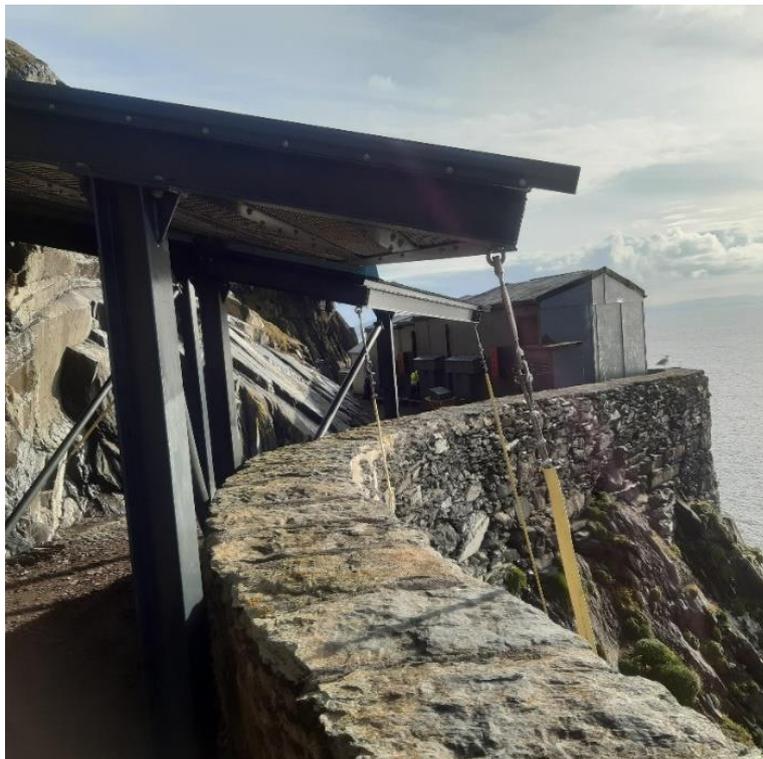
Figure 18 - Stainless steel stays re-attached to Crash Deck no. 1

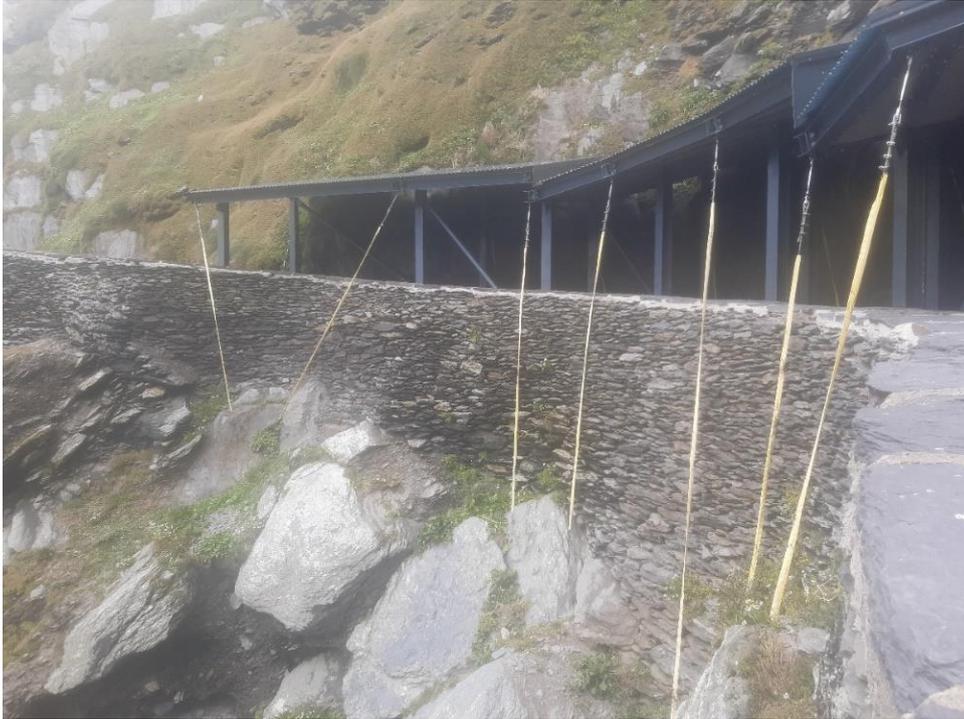
*Figure 19 - Stainless steel stays re-attached to Crash Deck no. 2*

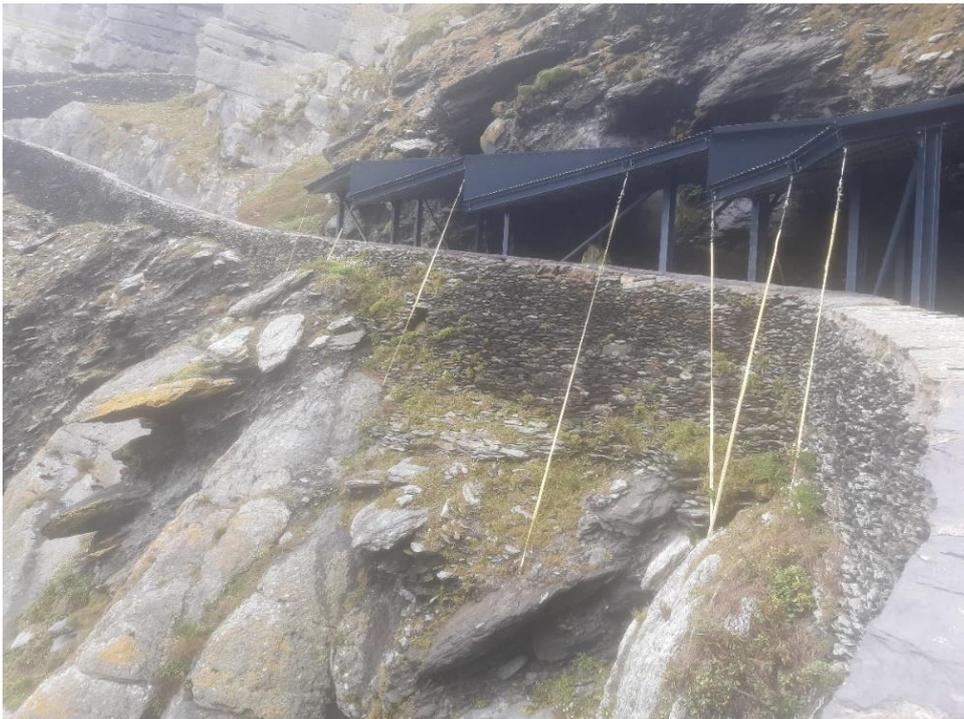
*Figure 20 - Stainless steel stays re-attached to Crash Deck no. 3*

Additionally, the OPW will be appointing a subcontractor for replacing the damaged metal roof sheets/rain sheet cladding to the crash decks in the 2025 season. The sheets were damaged by rock falls and their replacement with new sheets is essential for the structural integrity of the crash decks.

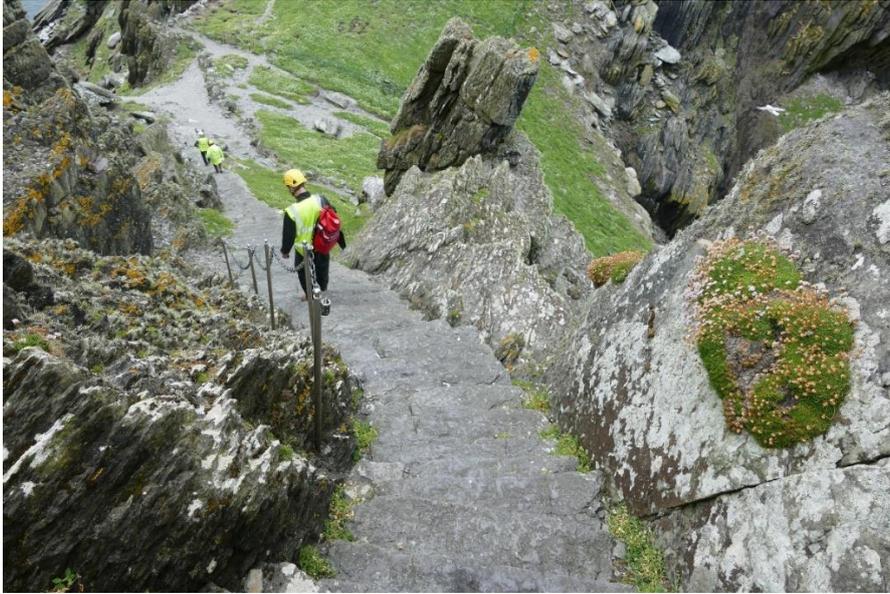
Figure 22 - View of the South Steps

The South Steps at Sceilg Mhichíl are the only access for tourists to the Monastery from the Lower Lighthouse Road. They consist of approximately 600 uneven steps. At the start of each season, prior to the arrival of tourists, and throughout the season, OPW personnel carry out essential maintenance works to the South Steps to ensure safe access for visitors. The maintenance works consist of careful checking and identifying of any repairs required. The OPW then carry out all the necessary dry masonry repairs and cleaning of the steps from overgrown vegetation.

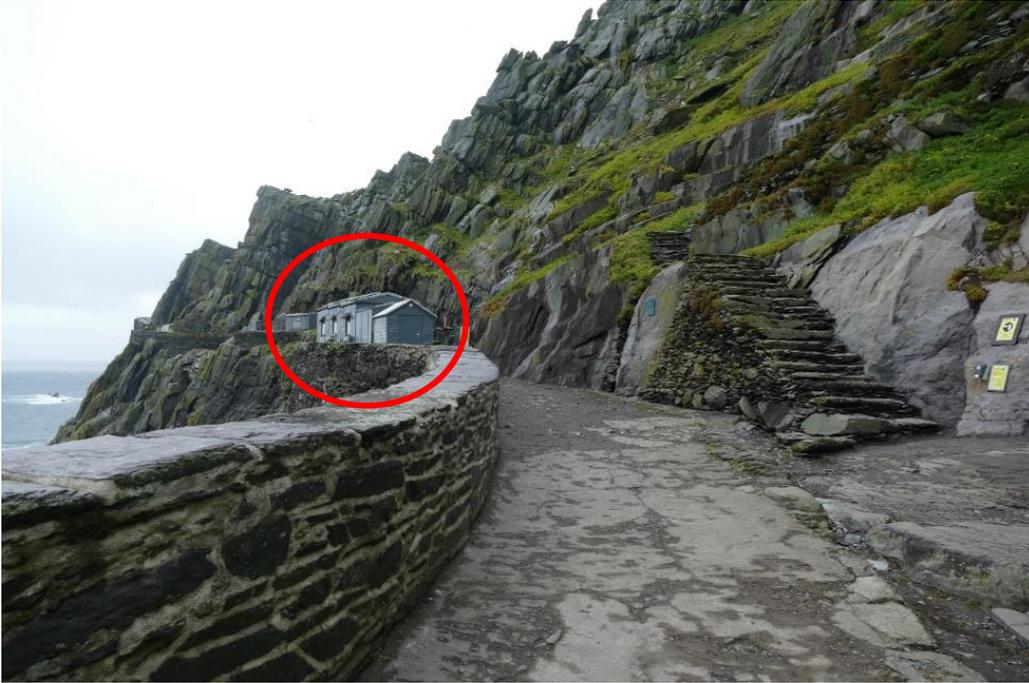
Figure 31 - View of the site huts on the Lower Lighthouse Road

The OPW undertake a site set up at the start of each season that involves cleaning and making good of the site accommodation huts and welfare facilities. This includes the checking of all appliances i.e. fridges, gas cookers, etc. The works also include any maintenance required externally to the huts and the inspection of the existing solar panels on the roofs of the huts. OPW carpenters carry out an inspection of the site huts and make a list of all the repairs required. In addition, the OPW carry out maintenance works to the OPW composting toilet located near the OPW guides huts.

The OPW replaced the solar panels and batteries in the guides huts in the 2024 season. The OPW will be investigating into replacing the solar panels and batteries in the workers huts in the 2025 season. The OPW will also carry out painting works to the site huts and toilets in the 2025 season.

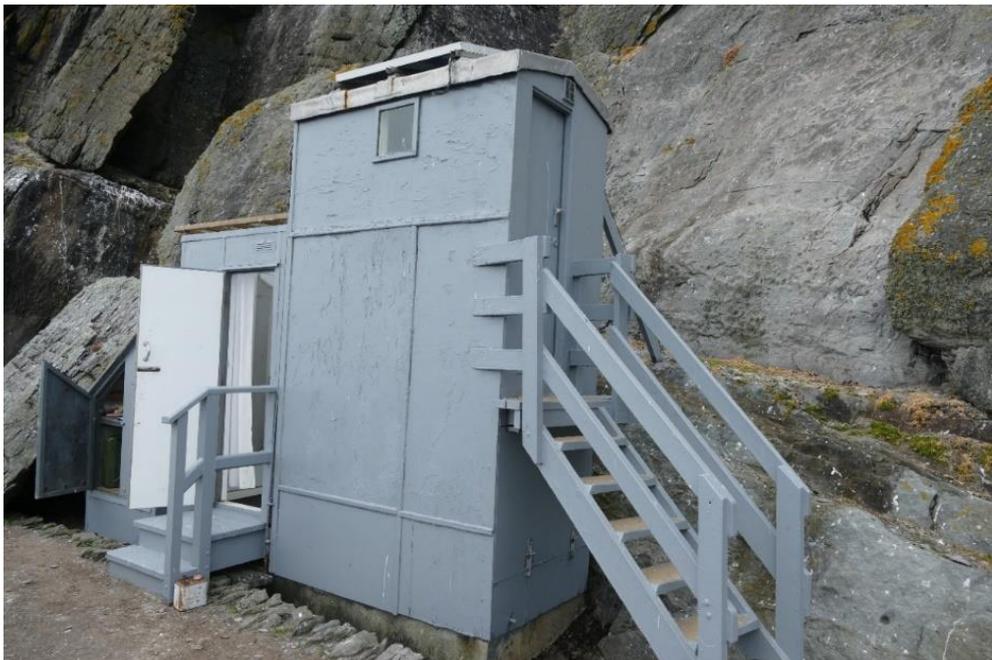
Figure 34 - View of the composting toilet used by OPW guides located on the Lower Lighthouse Road

To relieve the pressure from the existing OPW composting toilet near the OPW guide accommodation huts, OPW will be installing another external workers composting toilet in the compound of the Lower Lighthouse early in the 2025 season.

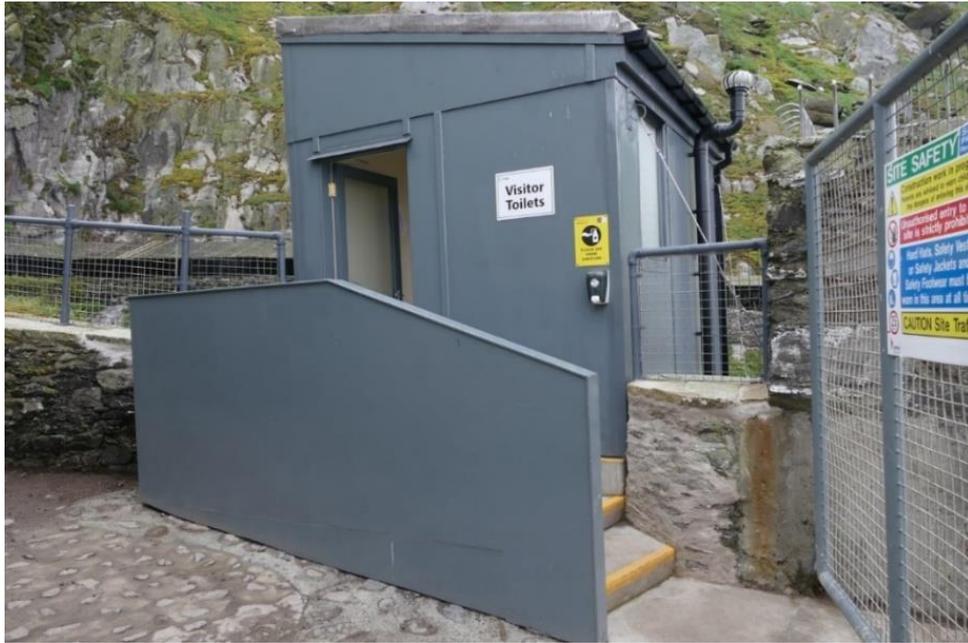
OPW staff clean the toilets, empty the bins and replace the toilet rolls daily. They also complete the daily log sheet to document who carried out the cleaning, the time the cleaning was carried out at and what was cleaned, checked and changed. As part of the OPW cleaning regime for the visitors' toilets, tanks are inspected regularly to ensure that they don't overflow and that there is no sign of leachate around the tanks.

*Figure 36 - View of the visitor toilets near the helipad*

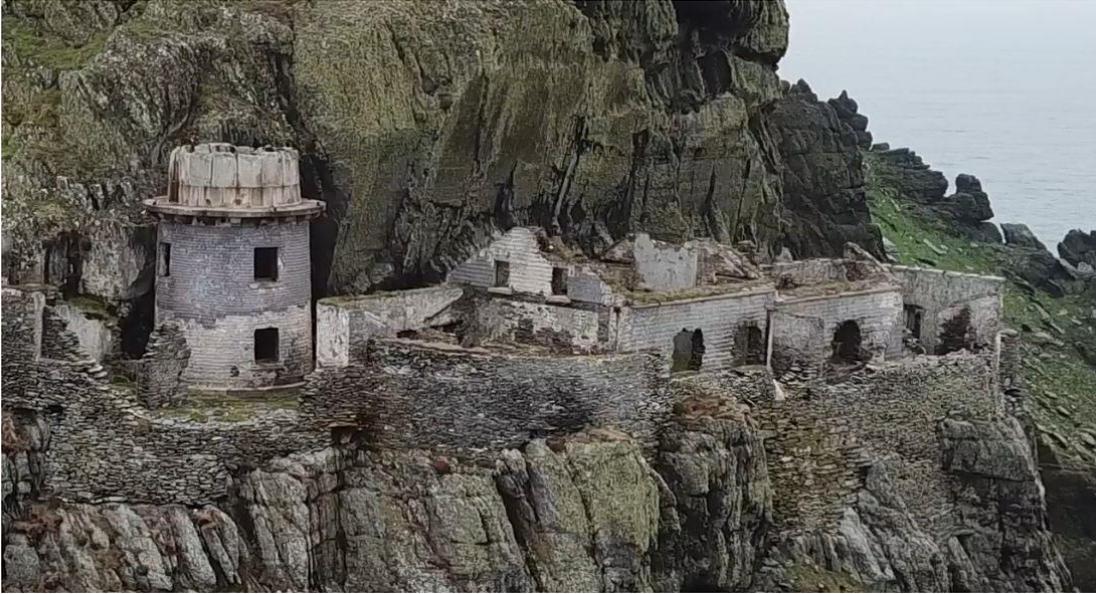
In 2023 the floors slabs of the Upper Lighthouse were covered with plywood sheets for protection. The plywood sheets degraded in 2024 following the winter season. The OPW removed the damaged plywood sheets and replaced them with new plywood sheets in the 2024 season.

Figure 39 - View of the Upper Lighthouse Drone footage

The OPW will carry out a site inspection in the 2025 season to assess if any replacement to the plywood sheets is required.

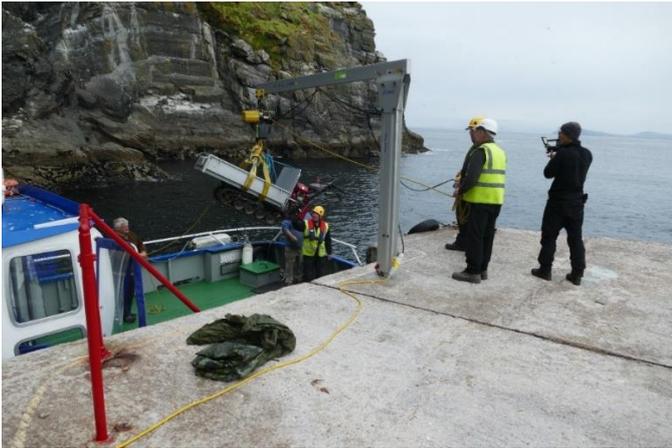
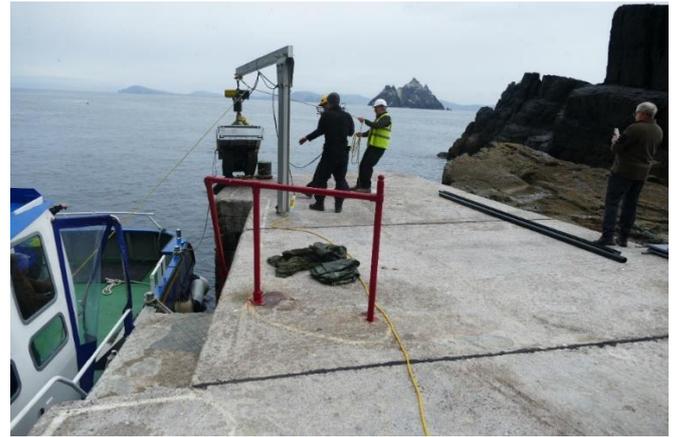
Figure 41 - View of the demountable hoist at the landing pier

Figure 42 - View of the demountable hoist at the landing pier

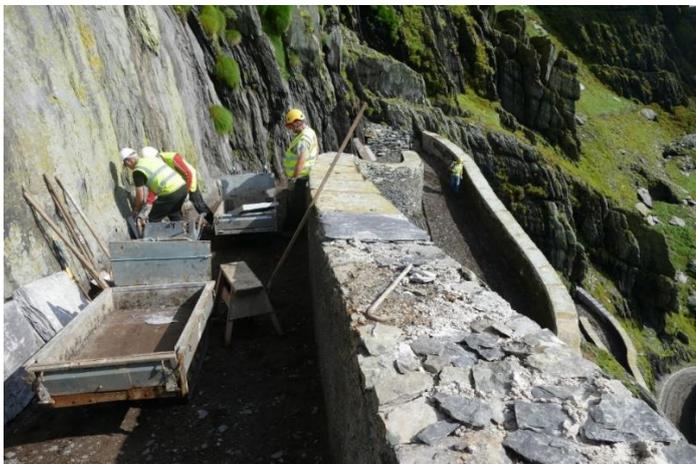
Figure 43 – Mechanical machinery on the island

The OPW carry out an inspection of the mechanical machinery that will be used on the island throughout the season. These include a mechanical transporter, a small demountable hoist at the landing pier, cement mixers, muck trucks, and generators.
