Sceilg Mhichíl WHP Annual Report

NMS Archaeological Review

2025 Season

Prepared by the National Monuments Service (NMS)
gov.ie

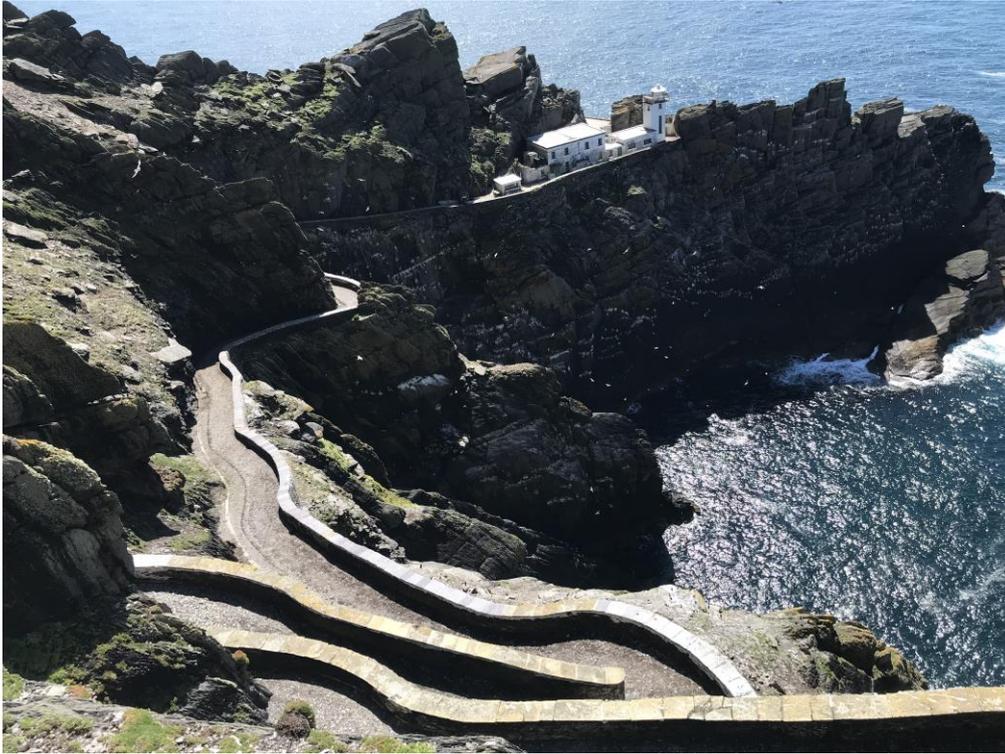
Figure 2. Lower Lighthouse and Lighthouse Road from the Upper Lighthouse.

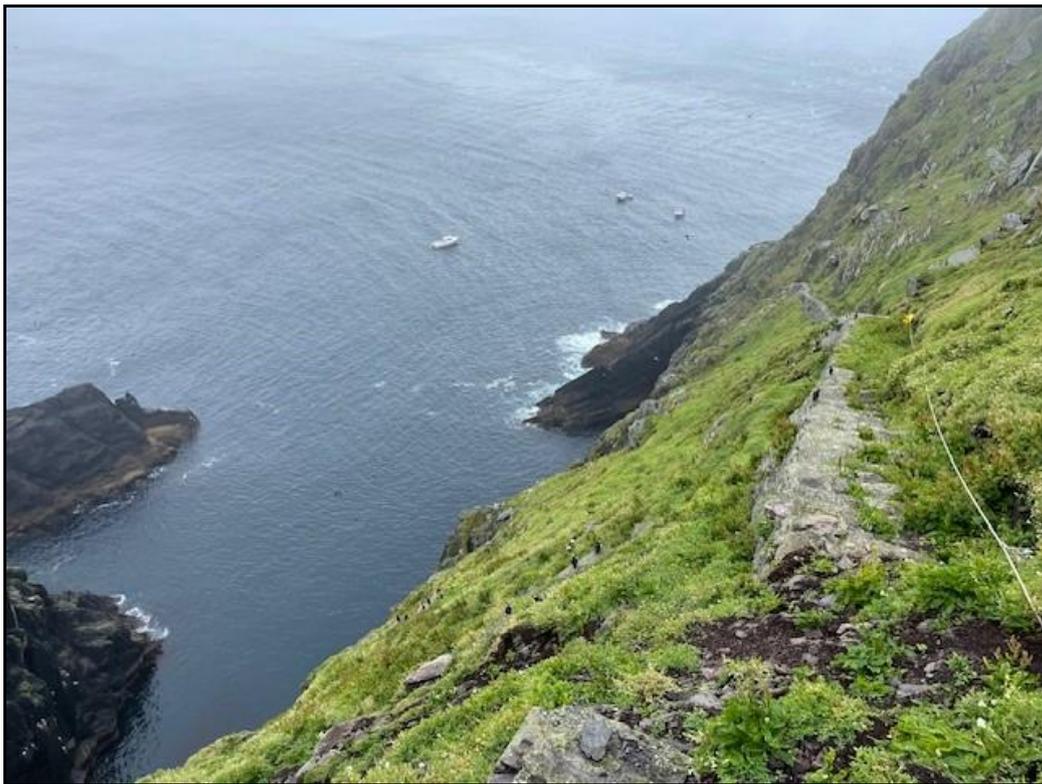
Figure 6. View of North Steps and damage immediate to lower right corner Elevation and complexity of site is apparent.

While the impact to the crash deck was minimal – and confirmed that the decking was doing its job in protecting anyone travelling underneath, the damage to the steps was much more extensive. An inspection was carried out in June, to view the damage and

come up with a plan on how to repair and conserve the steps. A section of about 10 steps had been completely take out by what appeared to be a small landslide of rock and earth. The steps had been pushed over the side of the steep incline. A safety rope was set up and we were able to inspect the full length of the area but it was clear that the original steps were now gone.

Discussions on how best to do the repair took place on site, as did the need for a pre-and post-impact archaeological survey, accompanied by onsite monitoring during the works. A similar approach was put in place with the resident ecologist by the NPWS. It was agreed that suitable stone would need to be brought in, which added to the complexity of the work. Following the inspection, OPW submitted their application for Ministerial Consent and all proposed methodologies were approved by NMS. The work was undertaken in July, though delayed intermittently by bad weather. Stone was sourced locally, from loose rock and lowered down the slope before being put in place by the OPW onsite staff. A pre-and post-works plan was made of the works and steps.

An archaeological report has been submitted on the works.

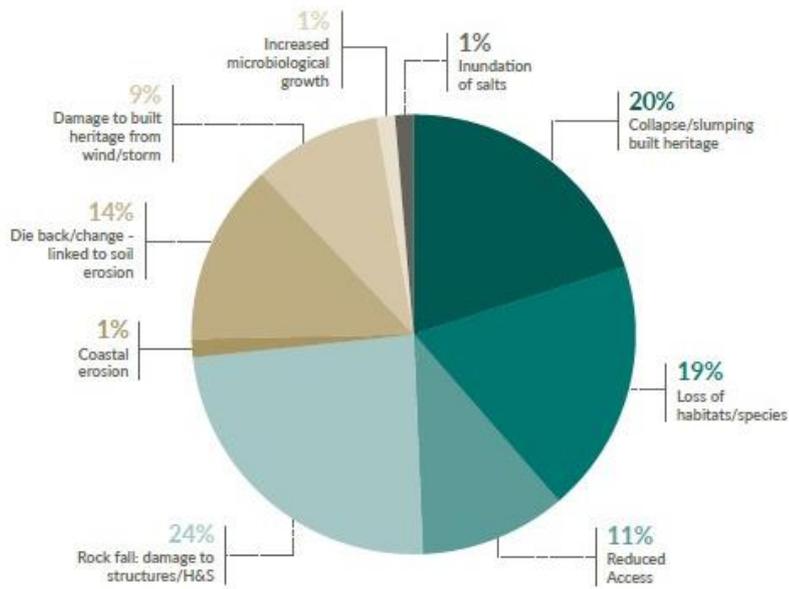
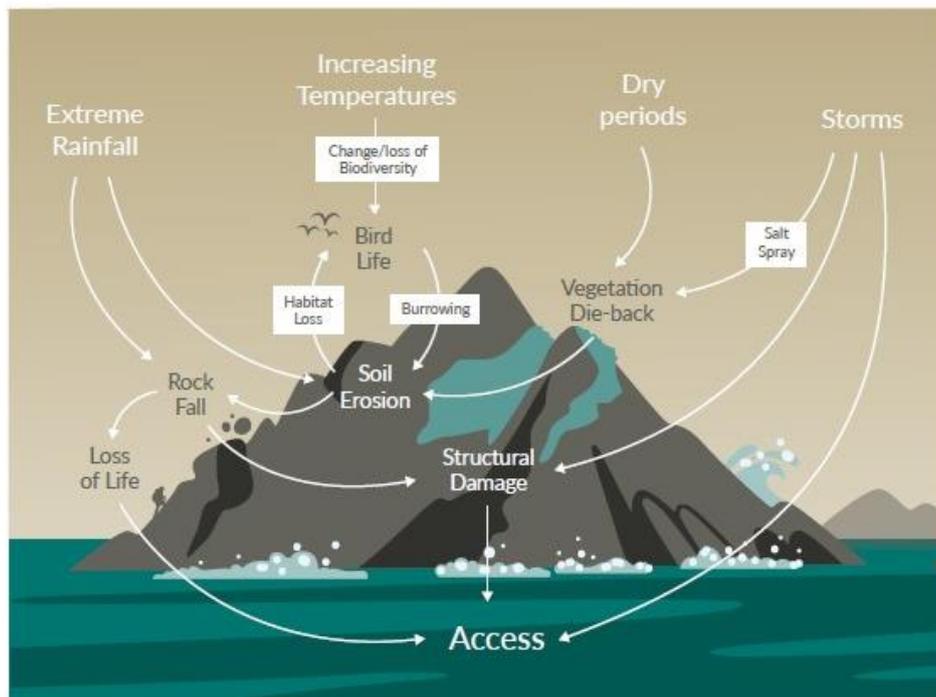
Figure 6: Impacts of most concern based on technical stakeholder surveys (n=28)

Figure 7: Visual representation of interacting climate hazards and impacts for Sceilig Mhichil

Figure 7. Diagram of primary findings from Sceilig Mhichil WHP CVA Report.

The results of the CVA identified five primary areas for ongoing discussion and collaboration in regard to climate adaptation options:

1. Visitor management;
2. Human resources;
3. Monitoring & Research;
4. Experimental options;
5. Climate Action.
