OPW Oifig na
nOibreacha Poiblí
Office of Public Works

Sceilg Mhichíl World Heritage Property

OPW Works Season 2025 UNESCO Report

Date of Issue to DHLGH 04/12/2025

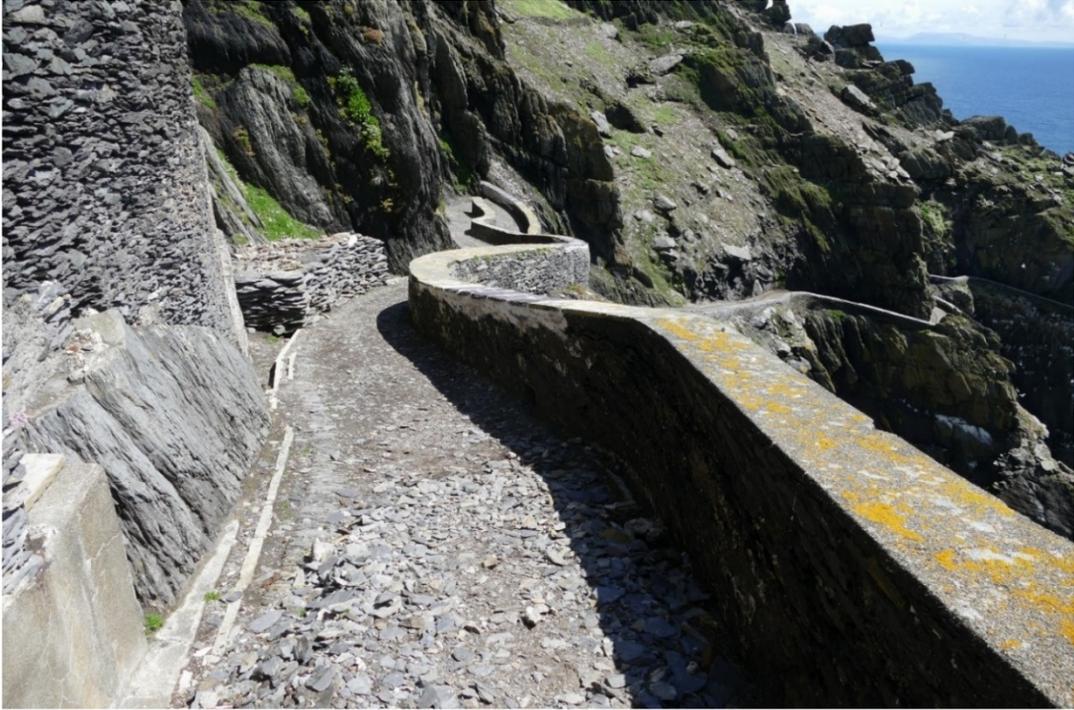
*Figure 7 - View of the Upper Lighthouse Road View of the Upper Lighthouse Road
© Photographic Archive, National Monuments Service, Government of Ireland*

Repair works to the Lighthouse Road commenced in the 2017 season and continued through the 2021 season. The repair works to the Upper Lighthouse Road are now complete. Maintenance works to the Lighthouse Road were carried out in the 2025 season by placing sandbags in certain locations to redirect rainwater runoff and by compacting any loose stones. The main purpose of the repair and maintenance works to the Upper Lighthouse road is to provide safe access for workers and future visitors to the fog signaling platform and Upper Lighthouse complex.

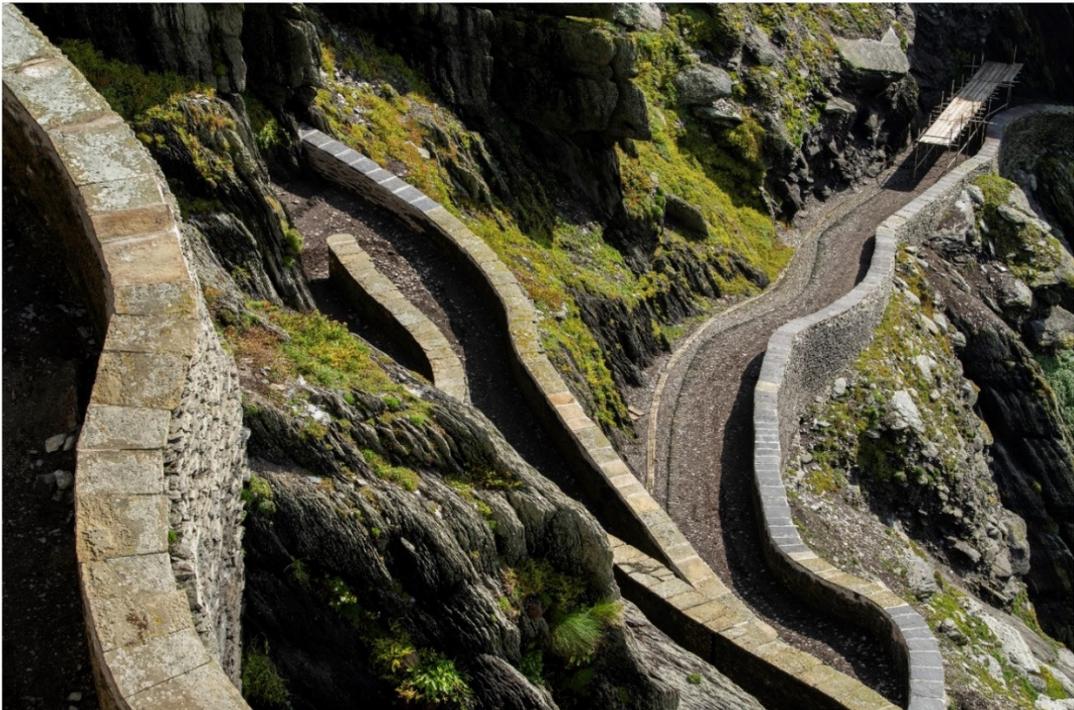
*Figure 8 - View of the Upper Lighthouse Road from the Upper Lighthouse gate
© Photographic Archive, National Monuments Service, Government of Ireland*

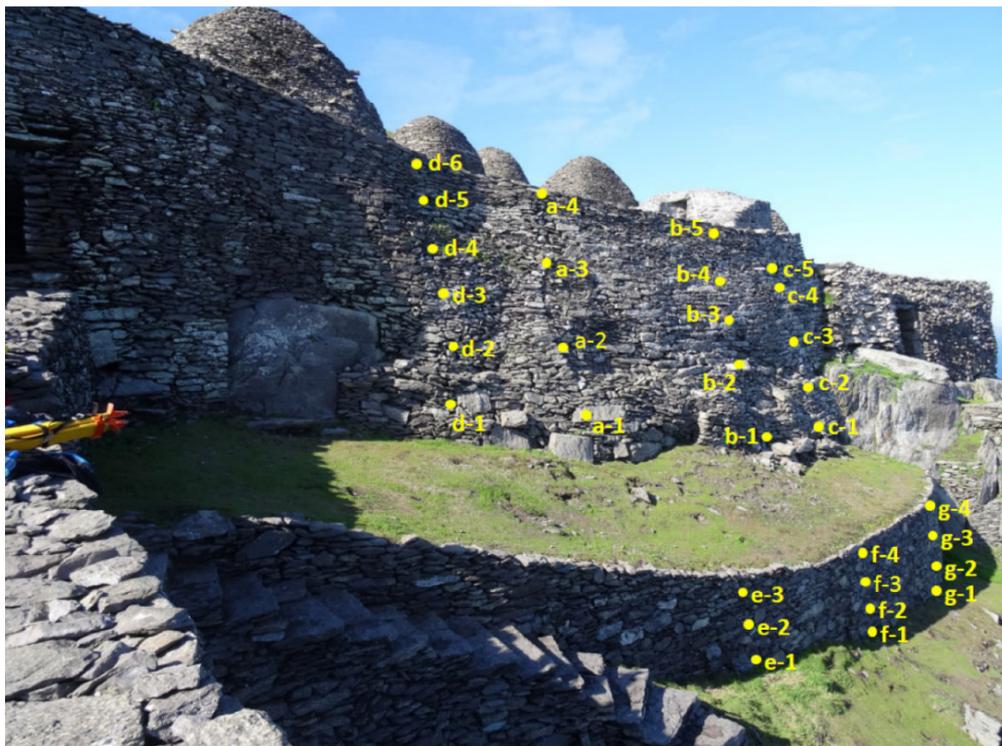
Figure 9 - Discovery Programme marker point locations at monastery retaining wall

The Discovery Programme carried out their site visit and surveyed the monastic settlement during the 2025 season. The Discovery Programme issued their final report to OPW in June 2025 (see Appendix E). The largest movements in the retaining wall are occurring in lines A, B and C over the ten years monitoring period. According to the Discovery Programme monitoring report, the magnitude of movement in lines A, B and C were smaller this year compared to the previous year.

Due to increased rainfall and pressure from runoff rainwater, the OPW will be undertaking repairs to this section of the retaining wall over the coming years. The OPW commissioned a digital survey of the Monastery in 2021 to facilitate the future repair works. All works will be subject to DHLGH Ministerial Consent and best conservation practices will be implemented. All proposed repair works will be subject to an agreed archaeological mitigation strategy with DHLGH.

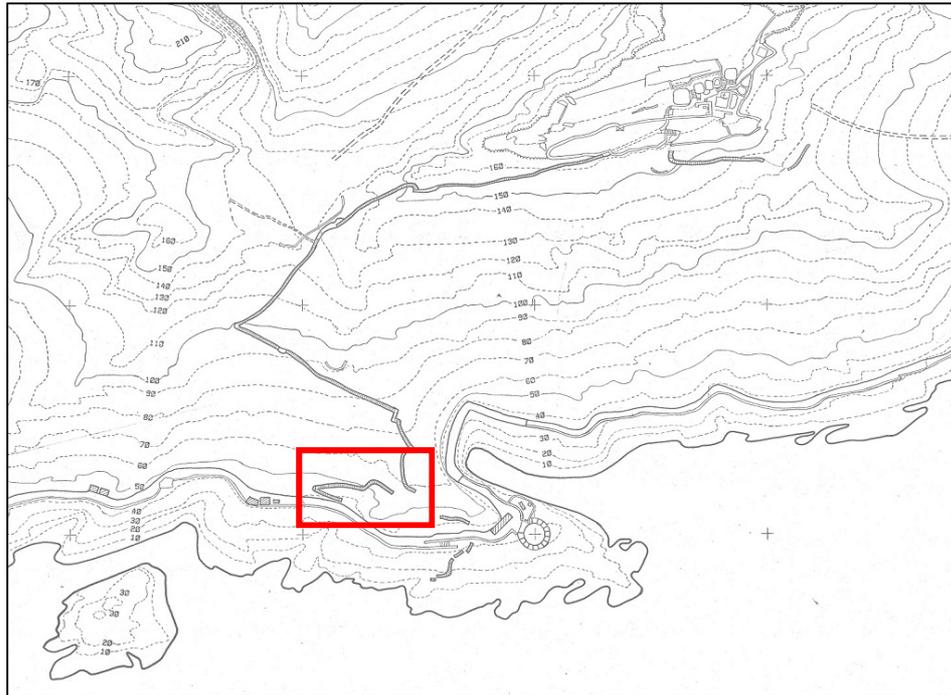
Figure 11 - Monastery Steps extent of digital survey works

The OPW commissioned PCA surveyors in September 2025 to carry out a digital survey of the lower section of the Monastery steps and issue digital survey drawings to OPW. PCA issued the digital survey drawings to OPW in October 2025.

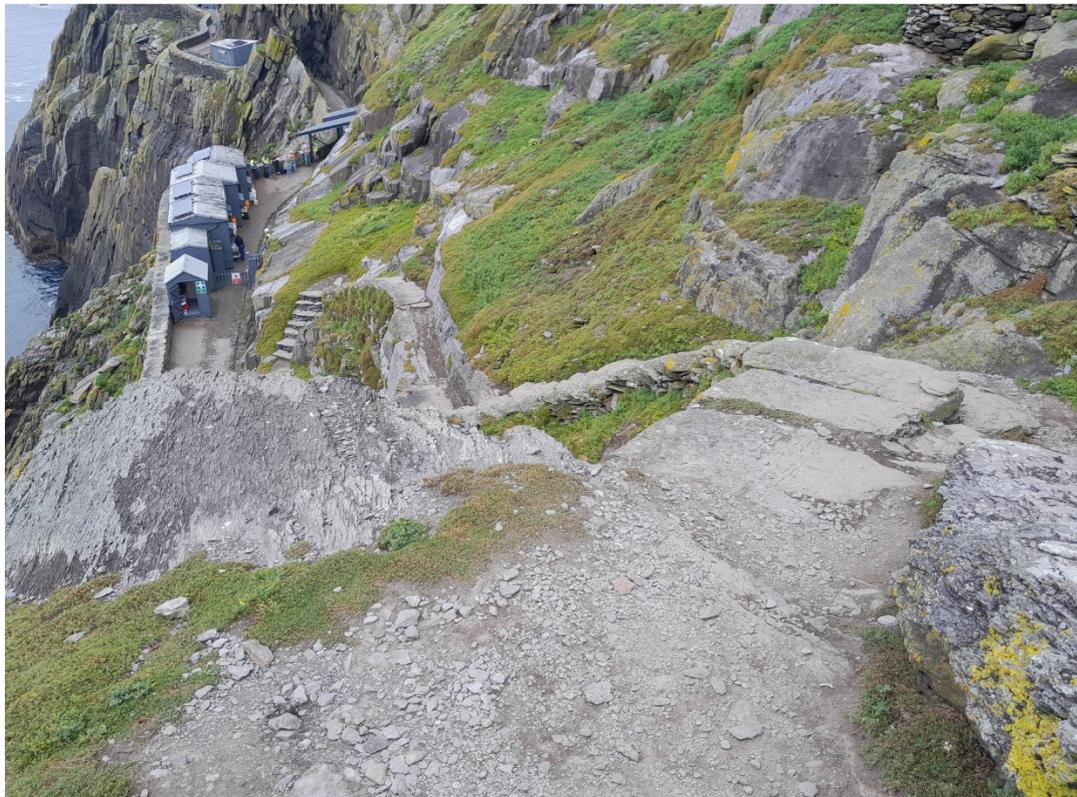
Figure 12 - View of the lower section of the Monastery Steps

The Monastic steps present physical challenges to visitors to the Monastery at Sceilg Mhichíl. Visitors to the island are required to ascend and descend circa 600 medieval steps during their visits. The Monastic steps are uneven and present a trip hazard for visitors to Sceilg Mhichíl.

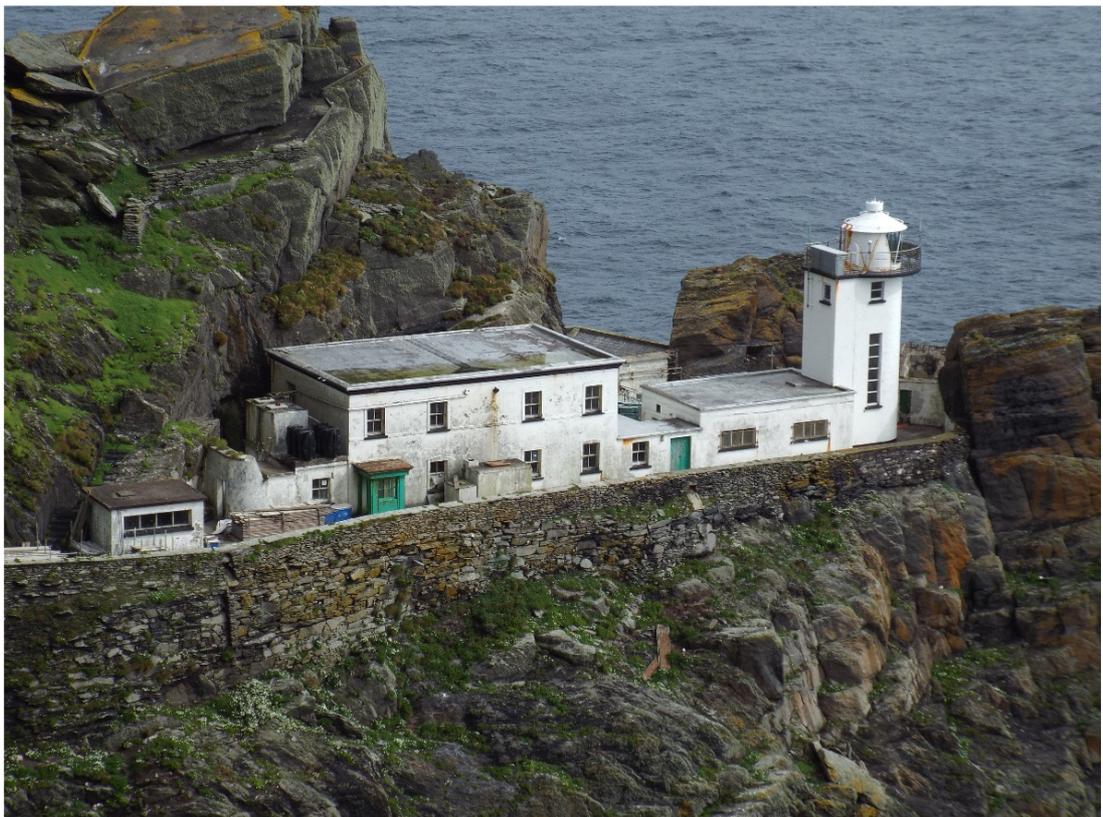
Figure 15 - View of the Lower Lighthouse

In 2019, with the permission of CIL and approved Ministerial Consent, the OPW commenced internal stripping out works including the removal of the existing dry lining to expose the original building fabric beneath.

It is proposed to refurbish the Lower Lighthouse to accommodate OPW staff, as well as NMS, NPWS and external consultants that visit the island. The aim of these works is to provide safe accommodation with sleeping, washing, cooking, administrative and communication facilities for OPW site operatives, consultants and visiting academics.

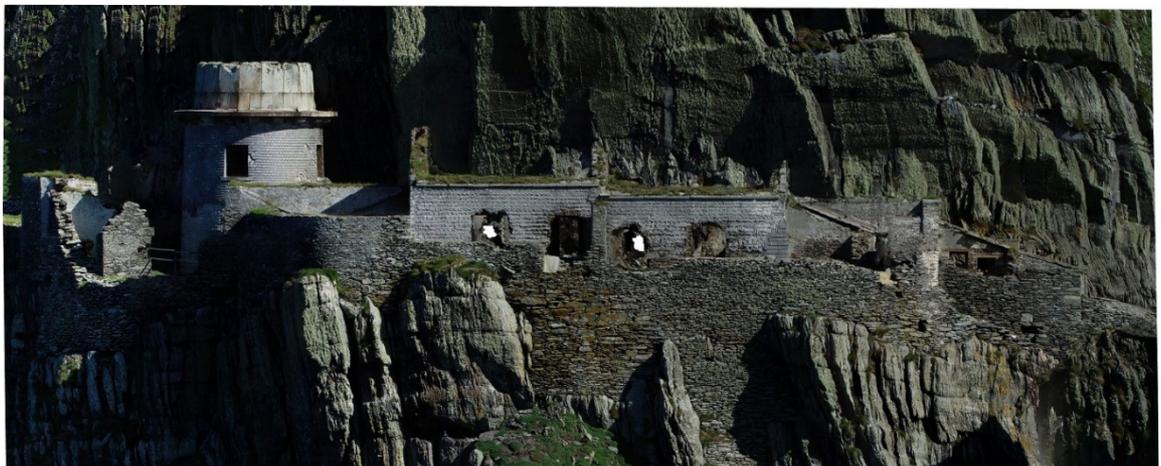
Figure 17 - Aerial view of the Upper Lighthouse and sea wall

The OPW appointed Alan Hayden Consultant Archaeologist in the 2021 season to carry out extensive archaeological excavations and removal of the existing debris at the Upper Lighthouse. A section of the debris was left *in situ* due to the presence of nesting birds at the time. Alan Hayden carried out archaeological excavations of the remaining debris at the Upper Lighthouse in the 2022 season. The original floors were exposed following the archaeological excavations. The OPW installed plywood protection to the exposed floors to protect them from the elements.

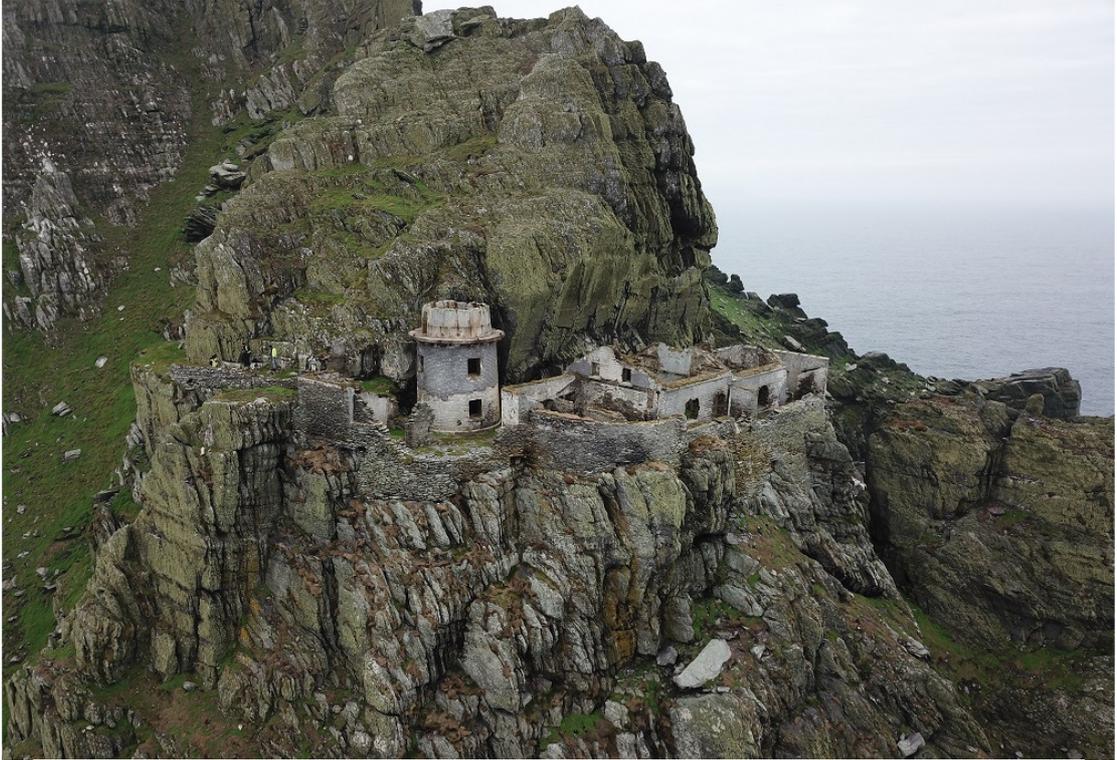
Figure 18 - Aerial view of the Upper Lighthouse and sea wall

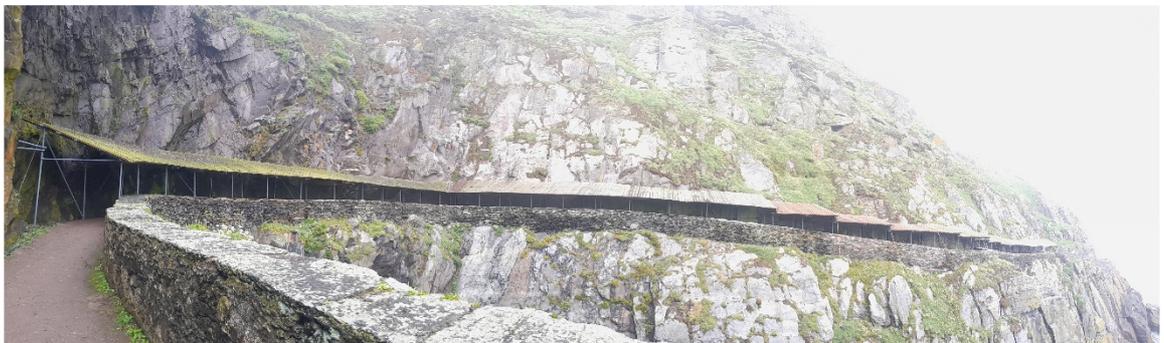
Figure 24 - View of the protection timber canopy at Cross Cove

A rock fall occurred on the lower lighthouse road at Cross Cove early in the 2025 season that damaged the 2016 section of the protective timber crash deck. A rock fall also occurred in the same area and caused damage to the new section of timber boarding at Cross Cove. OPW Architects carried out a site inspection on 30th April 2025 to inspect the rock fall and the damaged timber boarding.

The OPW replaced the timber decking of the 2016 section of the existing protection crash deck at Cross Cove. Alan Hayden Consultant Archaeologist issued an archaeological impact assessment to the OPW in April 2025 to confirm that the works did not have an impact on the cultural and natural heritage on the island (see Appendix C).

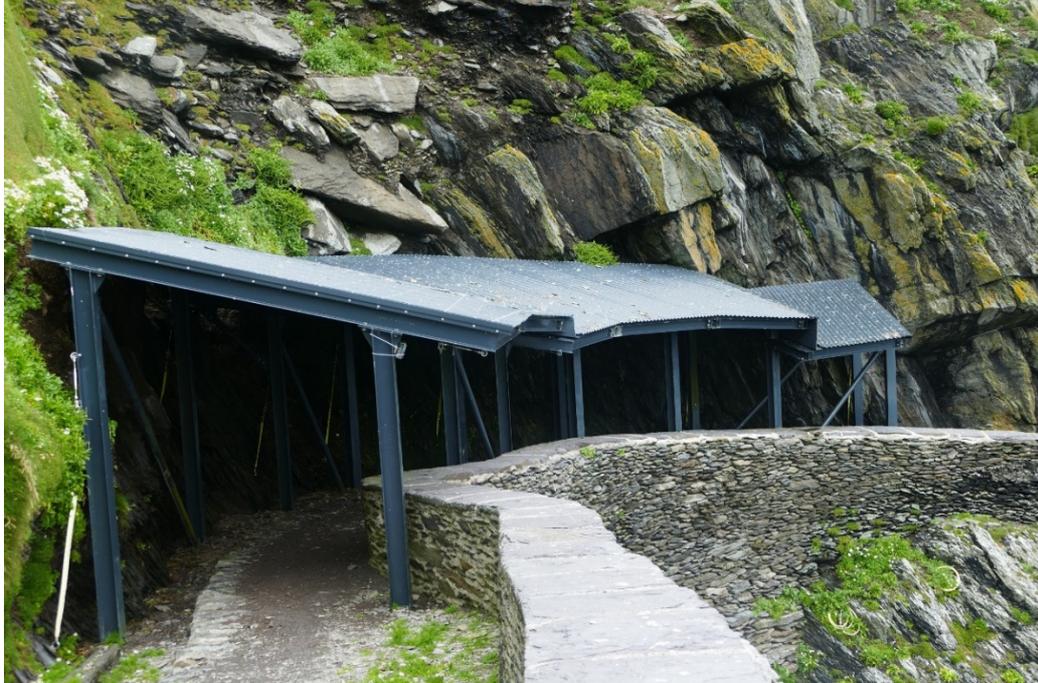
Figure 30 - View of the crash deck metal decking prior to the repair and maintenance works

The OPW repaired the metal decking to the 3 no. crash decks on the lower and upper lighthouse roads in the 2025 season. The metal decking were damaged by rock falls and stone debris. The repairs and replacement of the damaged metal decking is required to ensure the structural integrity of the 3 no. cash decks.

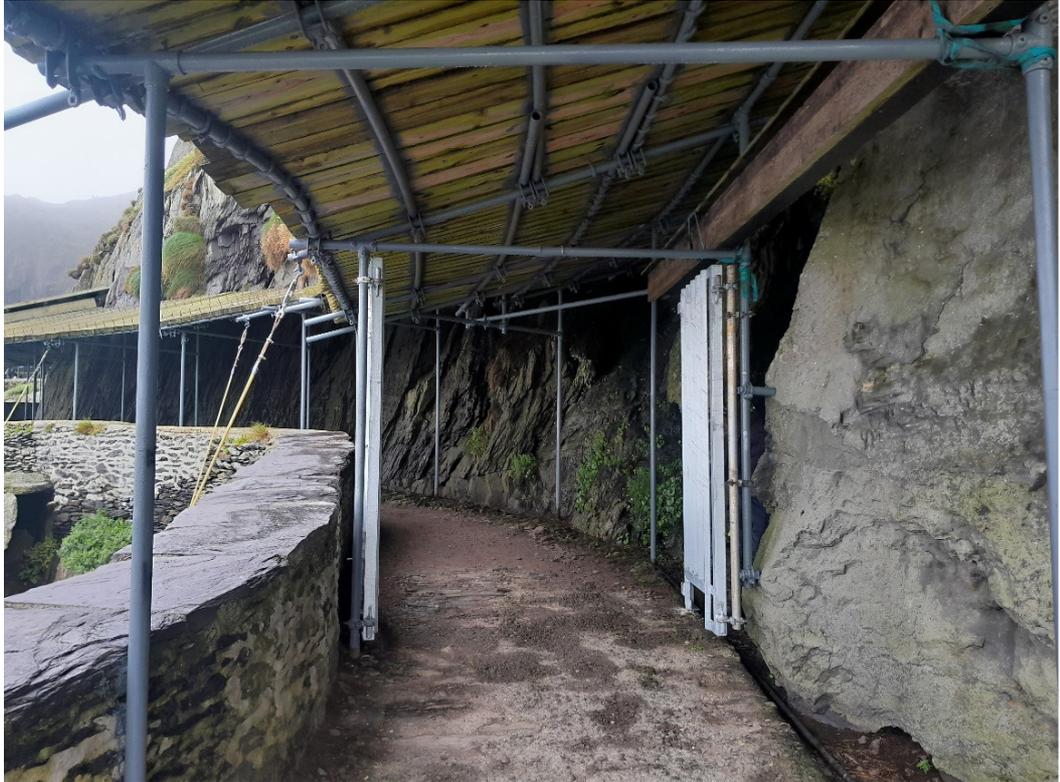
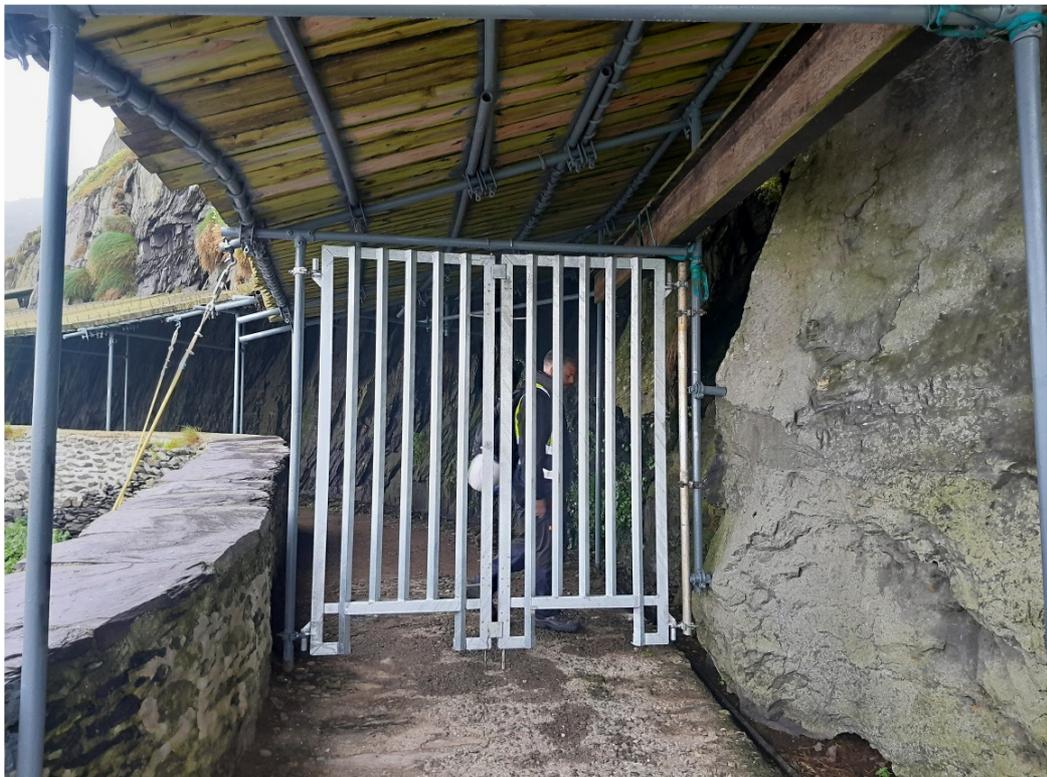
Figure 32 - View of the new security gate installed at the end of bay of the timber protection canopy at Cross Cove

Figure 33 - View of the new security gate installed at the end of bay of the timber protection canopy at Cross Cove

The OPW obtained Ministerial Consent from DHLGH in July 2025 for the installation of a security gate at the end of bay of the protection canopy at Cross Cove. The OPW completed the installation of the security gate in the 2025 season. The purpose of the security gate is to deter unauthorised access when the island is closed. The new security gate was closed and locked by the OPW at the end of the 2025 season.

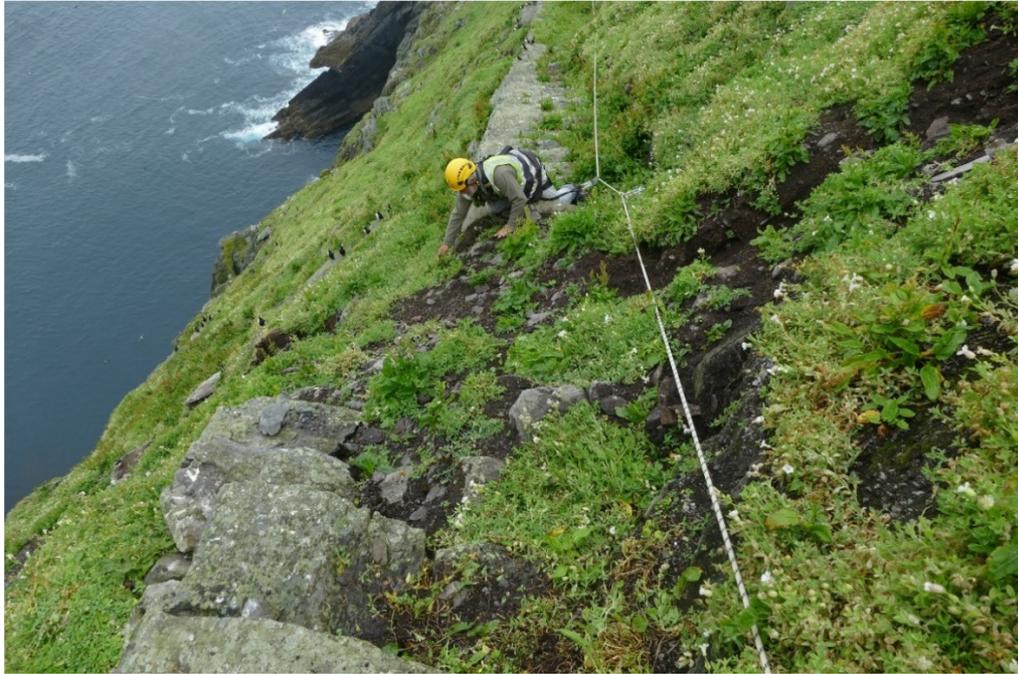
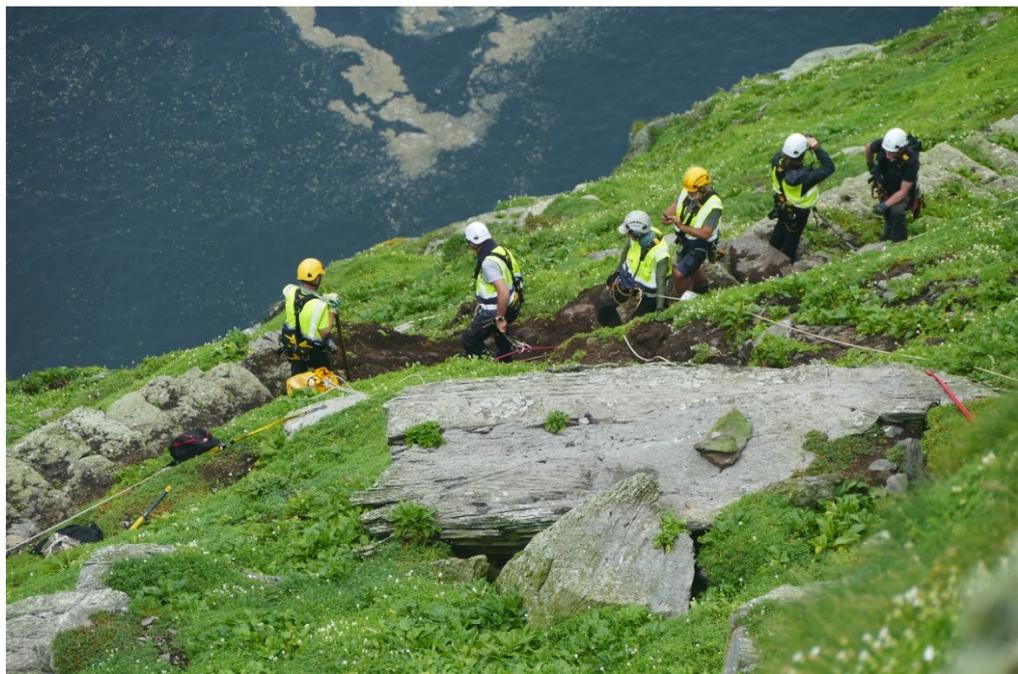
Figure 34 - Repairs to the damaged section of the North Steps

A section of the North Steps at Sceilg Mhichíl was damaged by rock fall during the winter period. The OPW obtained Ministerial Consent from DHLGH in July 2025 for the proposed masonry repair works to the damaged section of the North Steps. The Ministerial Consent was accompanied by an NIS / AA screening document (see Appendix I). The OPW carried out the repair works to the North Steps in the 2025 season under archaeological supervision.

Figure 35 - Repairs to the damaged section of the North Steps
