Skellig Michael World Heritage Site Works Season 2020 UNESCO Report v. 2.0

1. Introduction

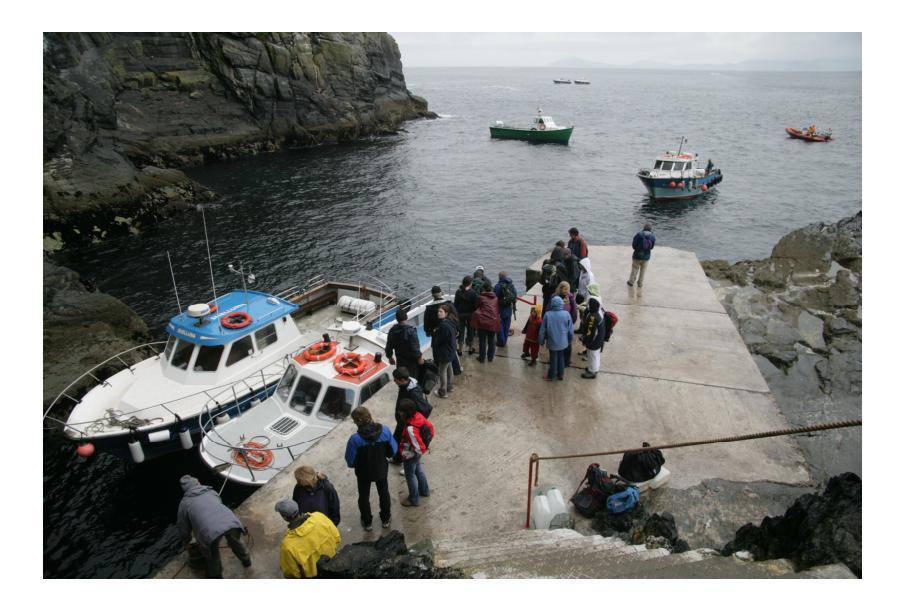
Fig. 8. - Landing Pier

OPW are considering repair and enhancement works to future proof the landing pier against the effects of climate change. A pier wall will be constructed to protect visitors from increased swells and higher tides. There is a more long-term strategy of increasing the height of the pier to accommodate predicted sea level rises due of climate change.

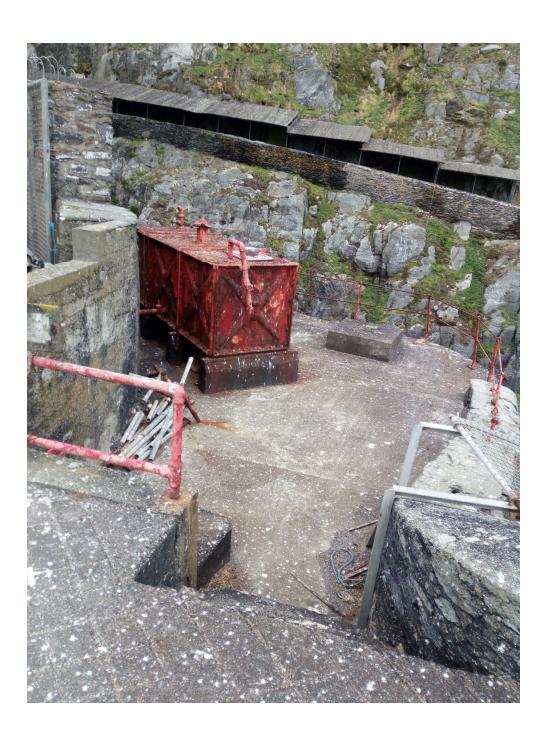
Fig. 9. – Proposed location of public toilets at Helipad.

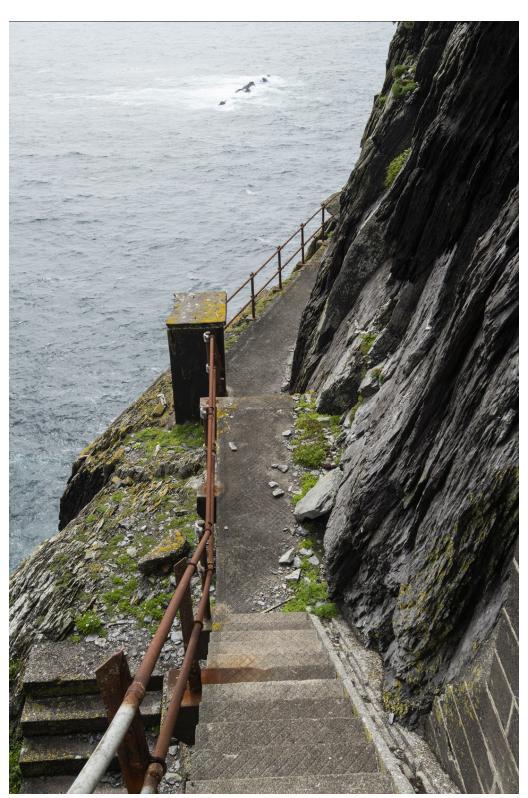
Fig. 10. – *Existing fog signalling station walkway.*

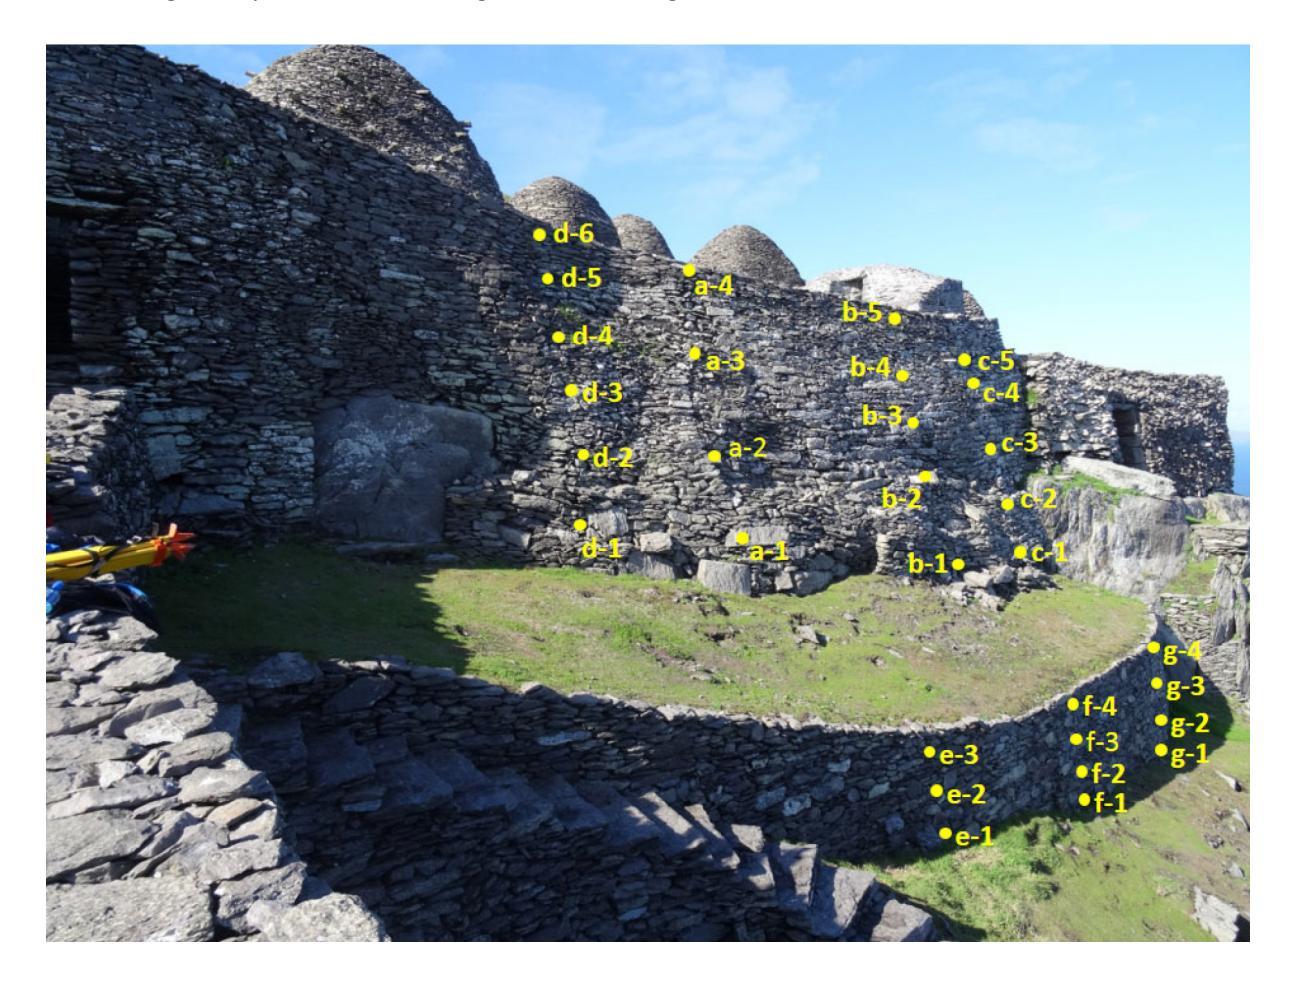
Since 2015, the Discovery Programme have been monitoring the movement of the main retaining wall of the monastic settlement. Markings were added in 2017 to the South Peak to determine the stability of the structures at that location. The Discovery Programme issue an annual report to the OPW with their findings and recommendations. In August 2020, the Discovery Programme undertook a survey of the monastic settlement and published their findings in September 2020 (See Appendix B). The report concluded that a section of the retaining wall directly below St. Michael's chapel is currently undergoing slight movement beyond acceptable tolerances. This section of the monastic wall has been historically susceptible to collapse, with major reconstruction having been undertaken during the 19th century.

Fig. 13. - Discovery Programmed marker point locations at monastery retaining wall.

Due to increased rainfall and pressure from runoff rainwater, the OPW will be undertaking repairs to this section of the enclosing wall over the coming years. All works will be subject to consent and best conservation practices will be implemented. All proposed repair works will be subject to archaeological supervision, recording and monitoring.
