**Examination of a broken timber board fabric from the
Crash Deck Structure
at Cross Cove, Sceilg Mhichíl.**

TO: Office of Public Works, Attn: Mr Fergus Mc Cormick, Senior Architect

REPORT REF: 002413

REPORT BY: Gordon Knaggs F.I.W.Sc.

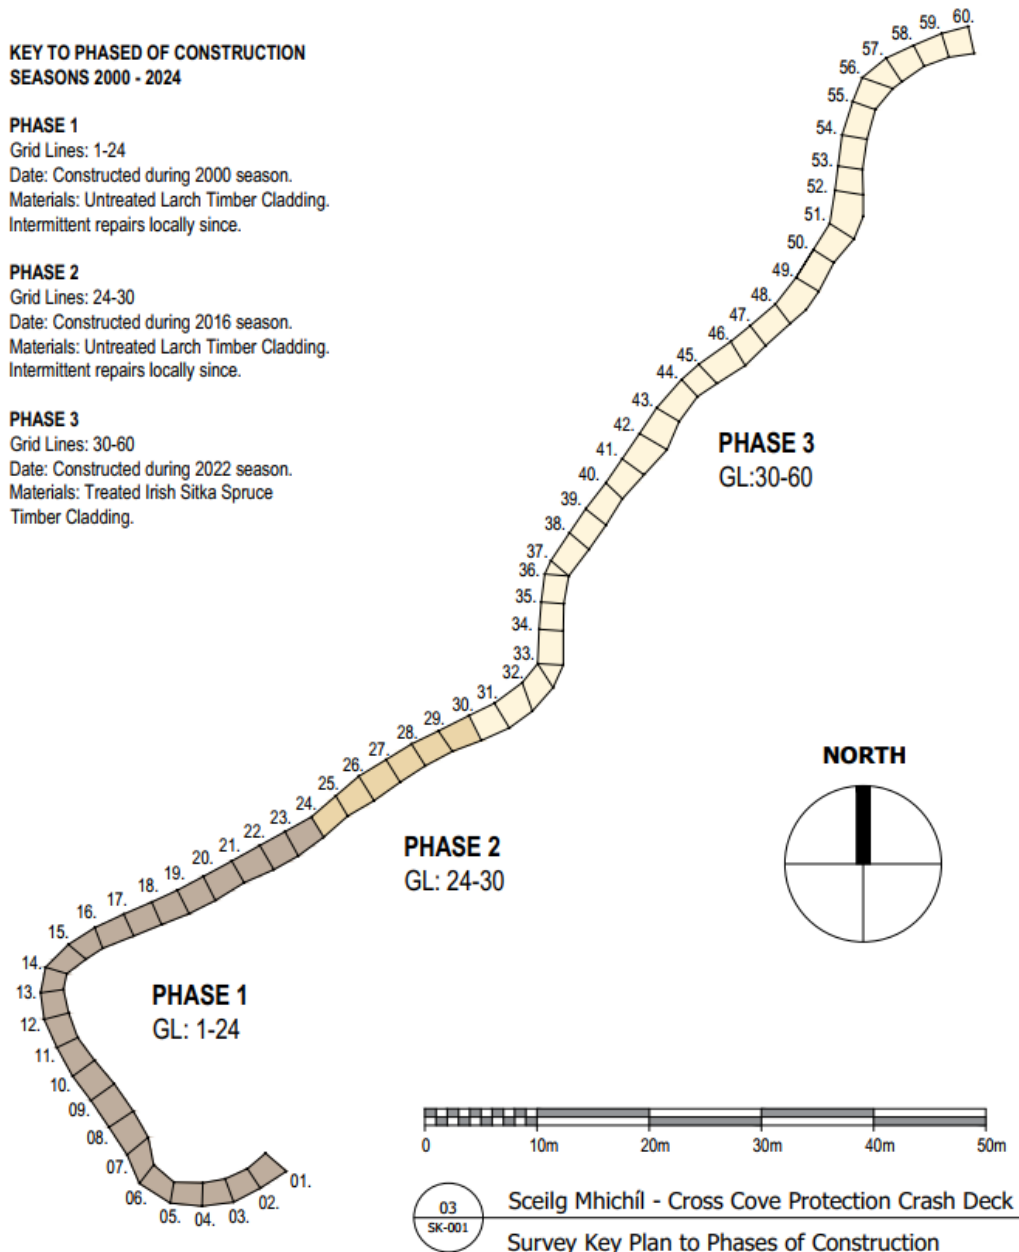
**KEY TO PHASES OF CONSTRUCTION
SEASONS 2000 - 2024**

PHASE 1

Grid Lines: 1-24
Date: Constructed during 2000 season.
Materials: Untreated Larch Timber Cladding.
Intermittent repairs locally since.

PHASE 2

Grid Lines: 24-30
Date: Constructed during 2016 season.
Materials: Untreated Larch Timber Cladding.
Intermittent repairs locally since.

PHASE 3

Grid Lines: 30-60
Date: Constructed during 2022 season.
Materials: Treated Irish Sitka Spruce
Timber Cladding.
