**Examination of timber boarding at  
the Crash Deck Structure,  
(Phases 1, 2 and 3)  
at Cross Cove, Sceilg Mhichíl.**

**TO: Office of Public Works, Attn: Mr Fergus Mc Cormick, Senior Architect**

**REPORT REF: 002414**

**REPORT BY: Gordon Knaggs F.I.W.Sc.**

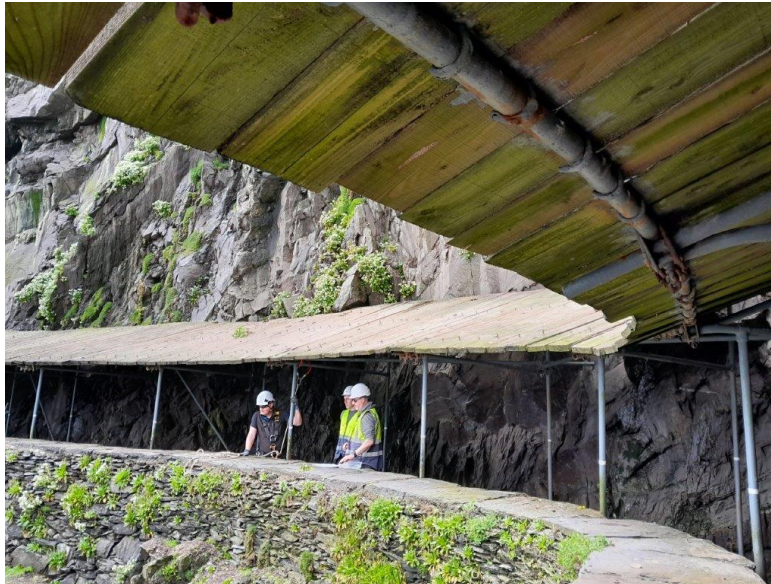
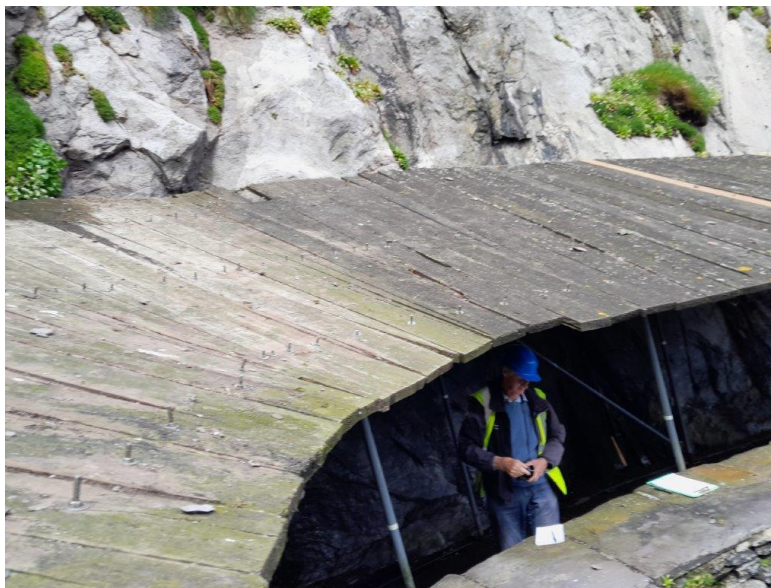
**OPW Images: General Views - Phase 1 of Cross Cove Crash Deck as of May 25<sup>th</sup> 2024**

Considerable decay was found in some of this boarding which has been in service since its initial phase of construction in 2000/2001, while later phases installed in 2016 and 2022 showed no signs of decay. Samples were taken from some of the boarding and the species present identified. An assessment was made of the expected service life of the more recently installed sections, with general recommendations for replacement material, as noted below.

Decay, and hence weakening of the boards, was widespread in the Phase 1 section of the Crash Deck at Cross Cove. These boards must be considered unfit for continued service and should be replaced. Note that loss of impact strength due to fungal attack

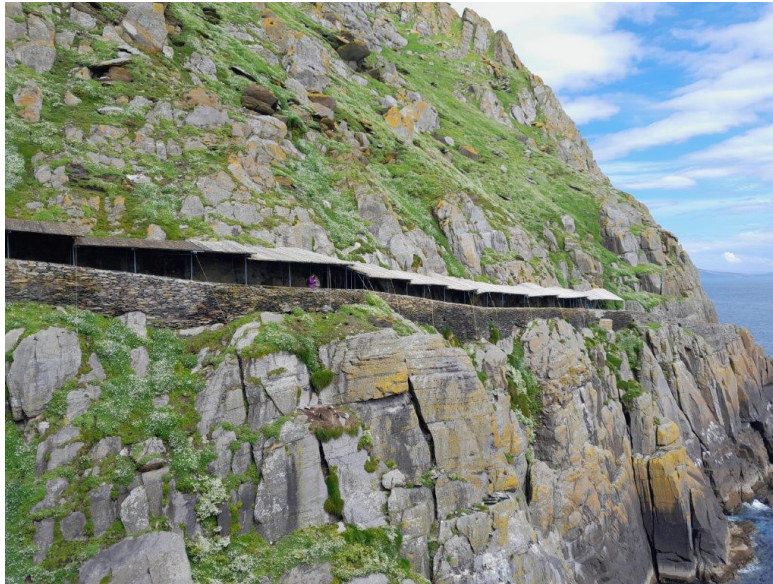
**Image: View looking north – Junction of Phases 2 and 3 of Cross Cove Crash Deck**

The Crash Deck structure at Cross Cove was extended further in 2022, utilising sustainable sourced Irish grown Sitka Spruce as the decking material. This material was noted as being typically of 75mm in thickness.

Boards to Phase 2 (2016) and Phase 3 (2022) sections of the overall Crash Deck at Cross Cove are still sound and a further useful service life can be expected, probably of the order of at least five years. Those boards of larch are inherently more durable than the spruce within the Phase 3 (2022) section and it is likely that the spruce boards will need to be replaced after a shorter total service period than the larch. Periodic inspections should be made to assess the condition of the spruce boards.

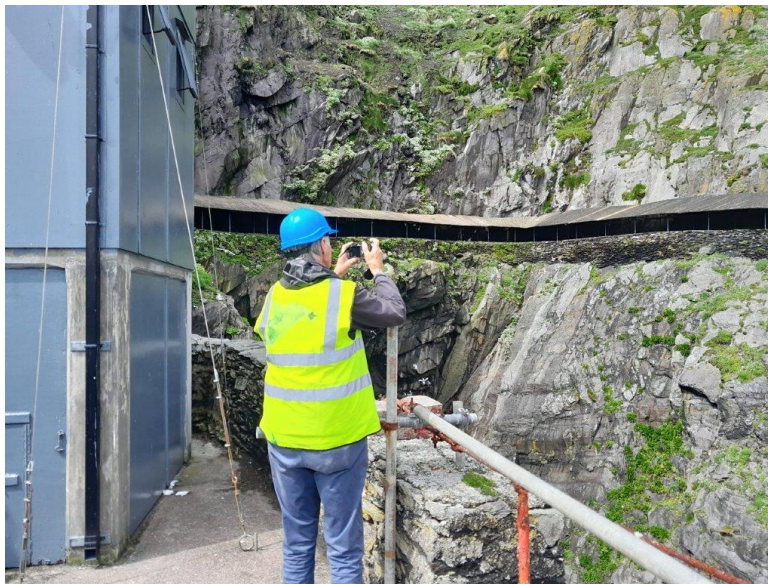
**OPW Image: Survey scanning of boarding in progress on site**

Initially the top surface of the boarding of the Crash Deck was scanned with a telescopic lens at a distance from the helipad area. This area was utilised as it provides a relatively clear line of sight of the overall structure, in particular the Phase 1 section and subsequent repairs. Four newer (ie replacement) boards were visible near the sharp curve in the boarding under a gully – see Figure 1.

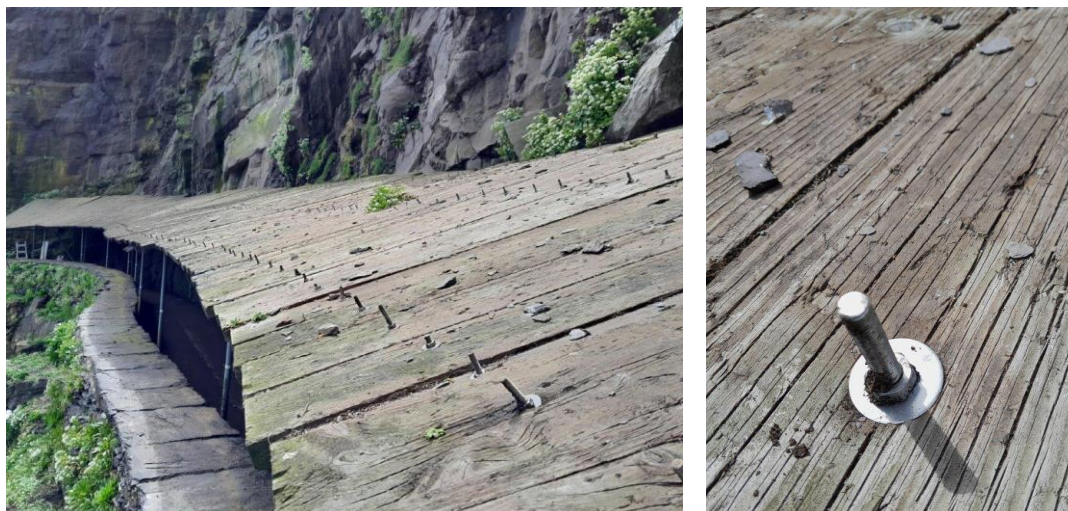
**OPW Image: Context and detail of exposed 'J' Bolts**

'J' bolts holding the boards to the supporting structure (scaffolding poles) were fixed through the boards and held by washers and nuts. A number of small stones, and some vegetation, were visible on top – see Figure 2.

- Sealing any perforations at the top surface (compressible washers under the washers to the J bolts).
- Leaving a gap between the boards to allow rainwater to drain freely
- In replacing boards, the following measures could be considered to enhance the service life:-
- Providing cladding to the top surface (metal sheeting)
- Replacement boards should receive preservative treatment – pressure applied water borne preservative such as Tanalith or Celcure.
- Any surfaces cut or drilled on site should receive two liberal coats of preservative.
- Of the available Irish-grown species, larch, preferably European larch, should provide the longest service life.
