Archaeological Method Statement
for the Monitoring of Repairs
to the North Steps,
Sceilg Mhichíl, Co. Kerry.

Alan R. Hayden

May 2025

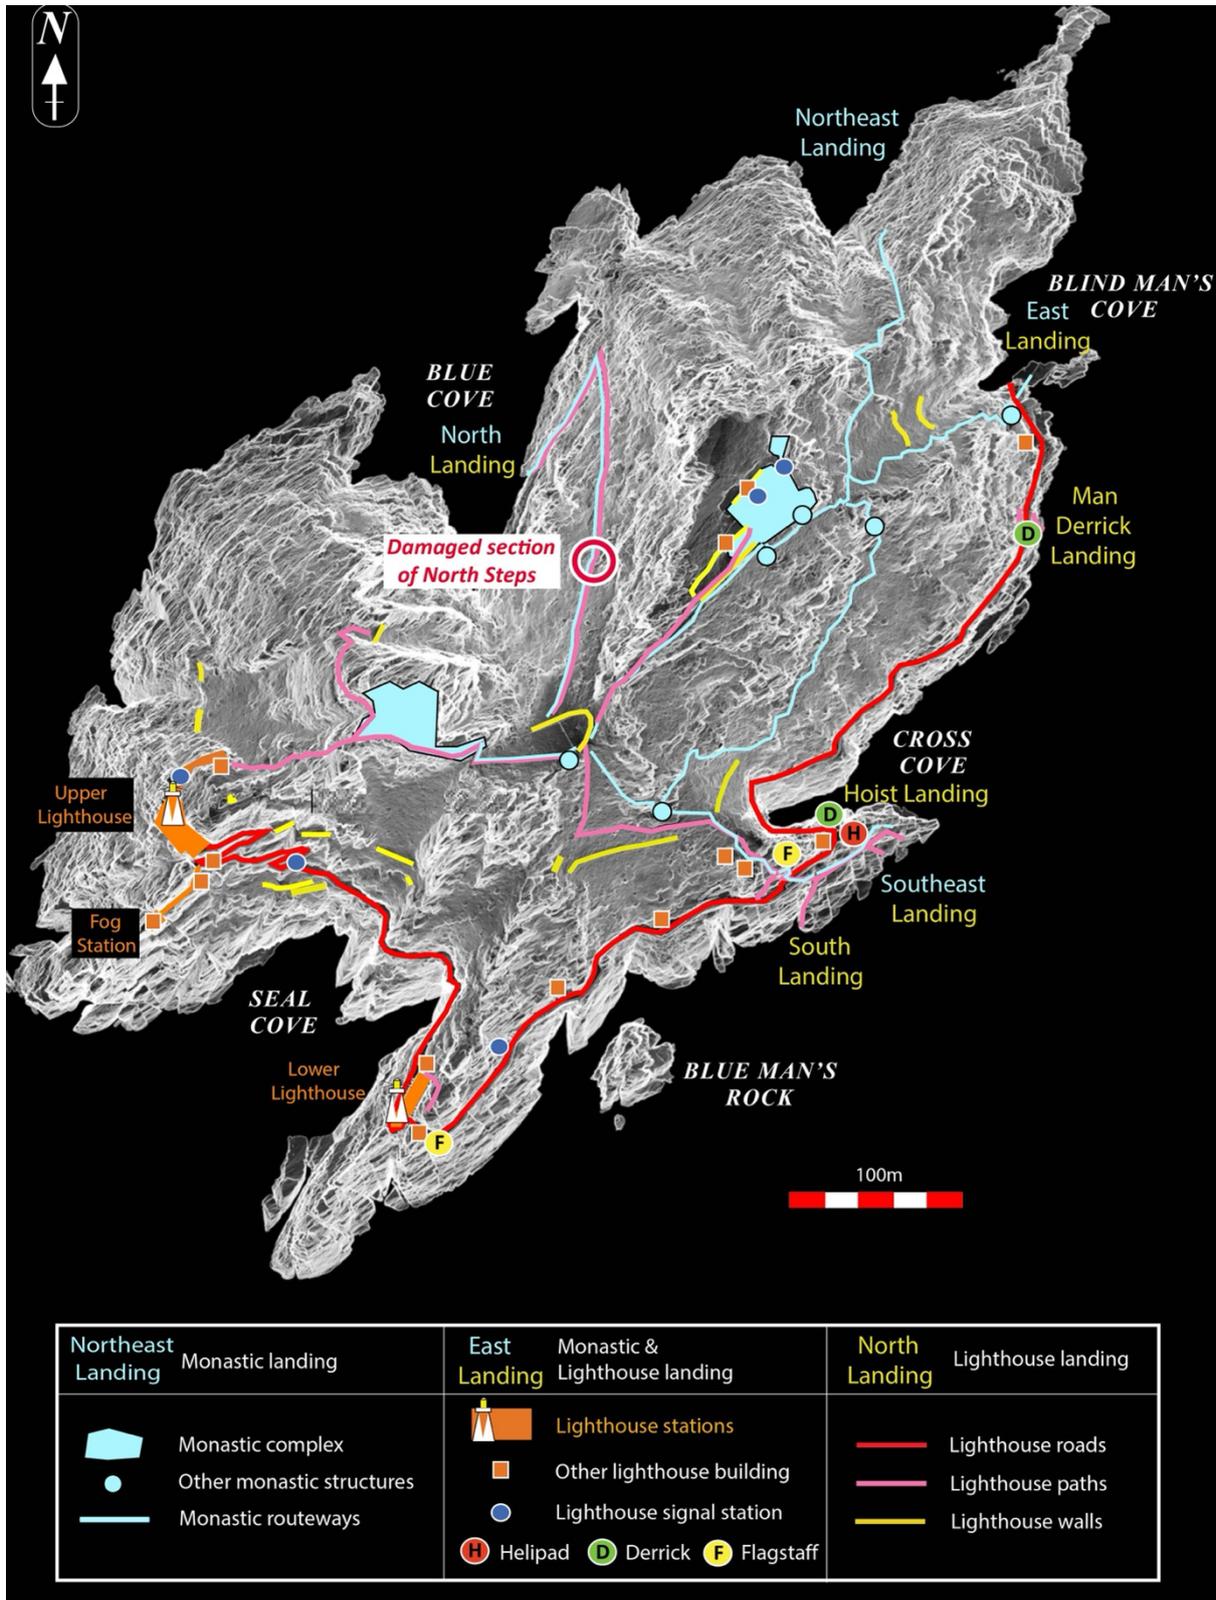
Fig. 1. The principal early-medieval and lighthouse features on Sceilg Mhichil with the location of the area damaged on the North Steps indicated.
