ARCHAEOLOGICAL EXCAVATION
of the
UPPER LIGHTHOUSE STATION,
SKELLIG MICHAEL, CO. KERRY.

Ministerial Consent No. C001045. Works No. W000428
Excavation Licence No. E005321. Detection device licence No. R00551

Alan R. Hayden,
31st October 2021

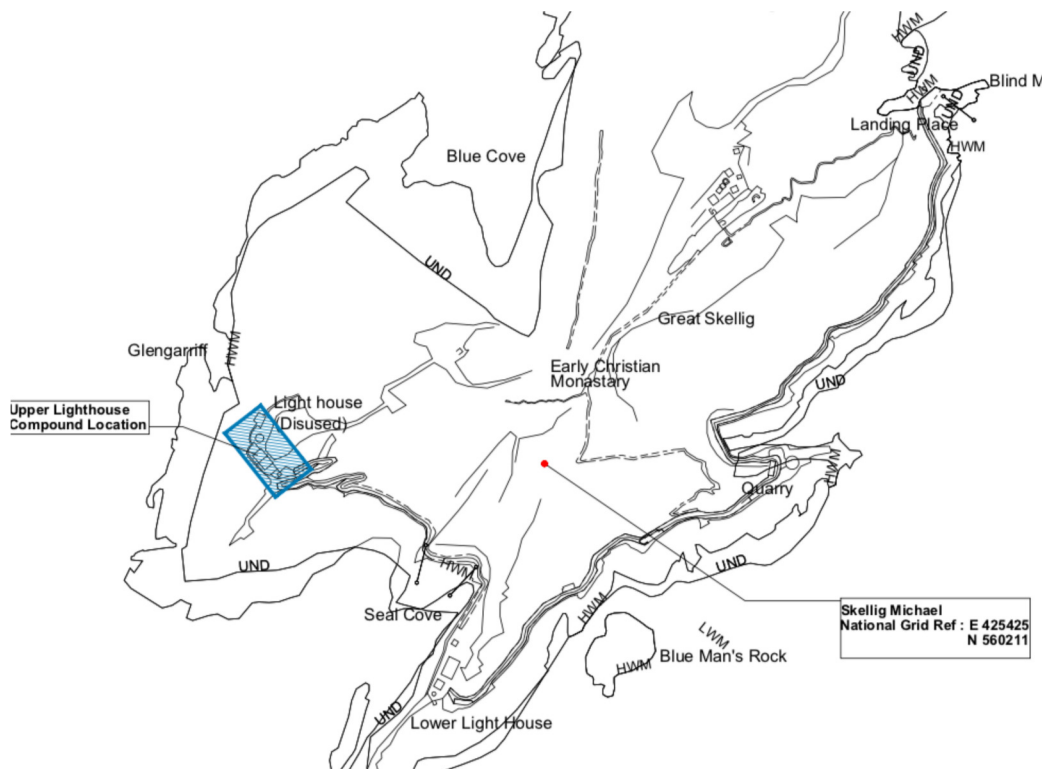
Fig. 1. The location of the Upper Lighthouse Station on Skellig Michael.

Following the completion of excavation and conservation work undertaken from 2018 to 2020 on the Upper Lighthouse Roadway, archaeological works in 2021 on Skellig Michael concentrated on the Upper Lighthouse Station itself (fig. 1). Almost all of the South Terrace of the Upper Station was excavated between the 17th of May and the 10th September 2021. No work was undertaken on the long North Terrace beyond the Upper Station. The graffiti carved in the rock and lighthouse structures on the island was also recorded.

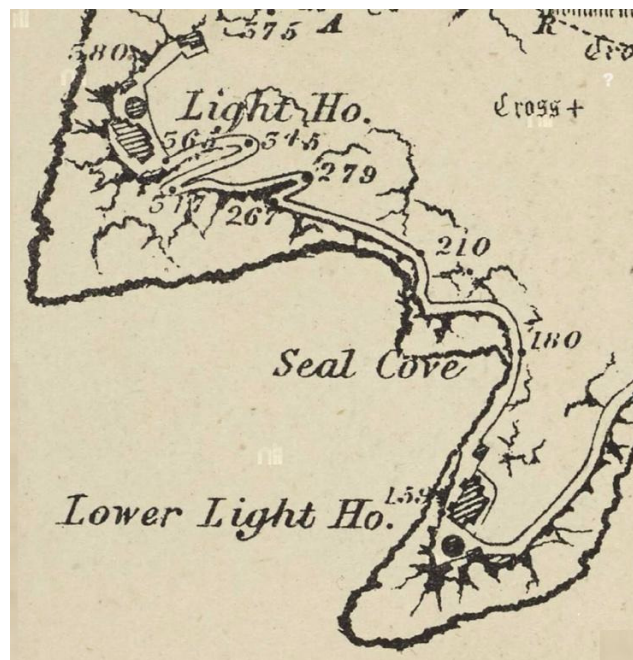
Fig. 3. The Skellig Michael lighthouse stations as depicted on the OS first edition 6" map of the 1830s.

The Upper Lighthouse Station was constructed on two linked terraces, North and South, blasted from the rock on their inner sides and supported and defined by masonry walls on the outer. No works have yet been undertaken on the long, narrow North Terrace. The 1830s OS first edition map (fig. 3) shows a building at its north end, but it is not visible today. The South Terrace, which holds the remains of the main buildings of the Upper Station was almost completely excavated in 2021, apart from four small areas (fig. 4) three of which were not disturbed due to the presence of nesting birds,¹ the fourth lay beneath the stockpile of stone uncovered during the excavations.

Both the archaeological evidence uncovered (figs. 4 & 5) and the OS first edition map of the 1830s (figs. 3) show that the original structures on the South Terrace consisted of:

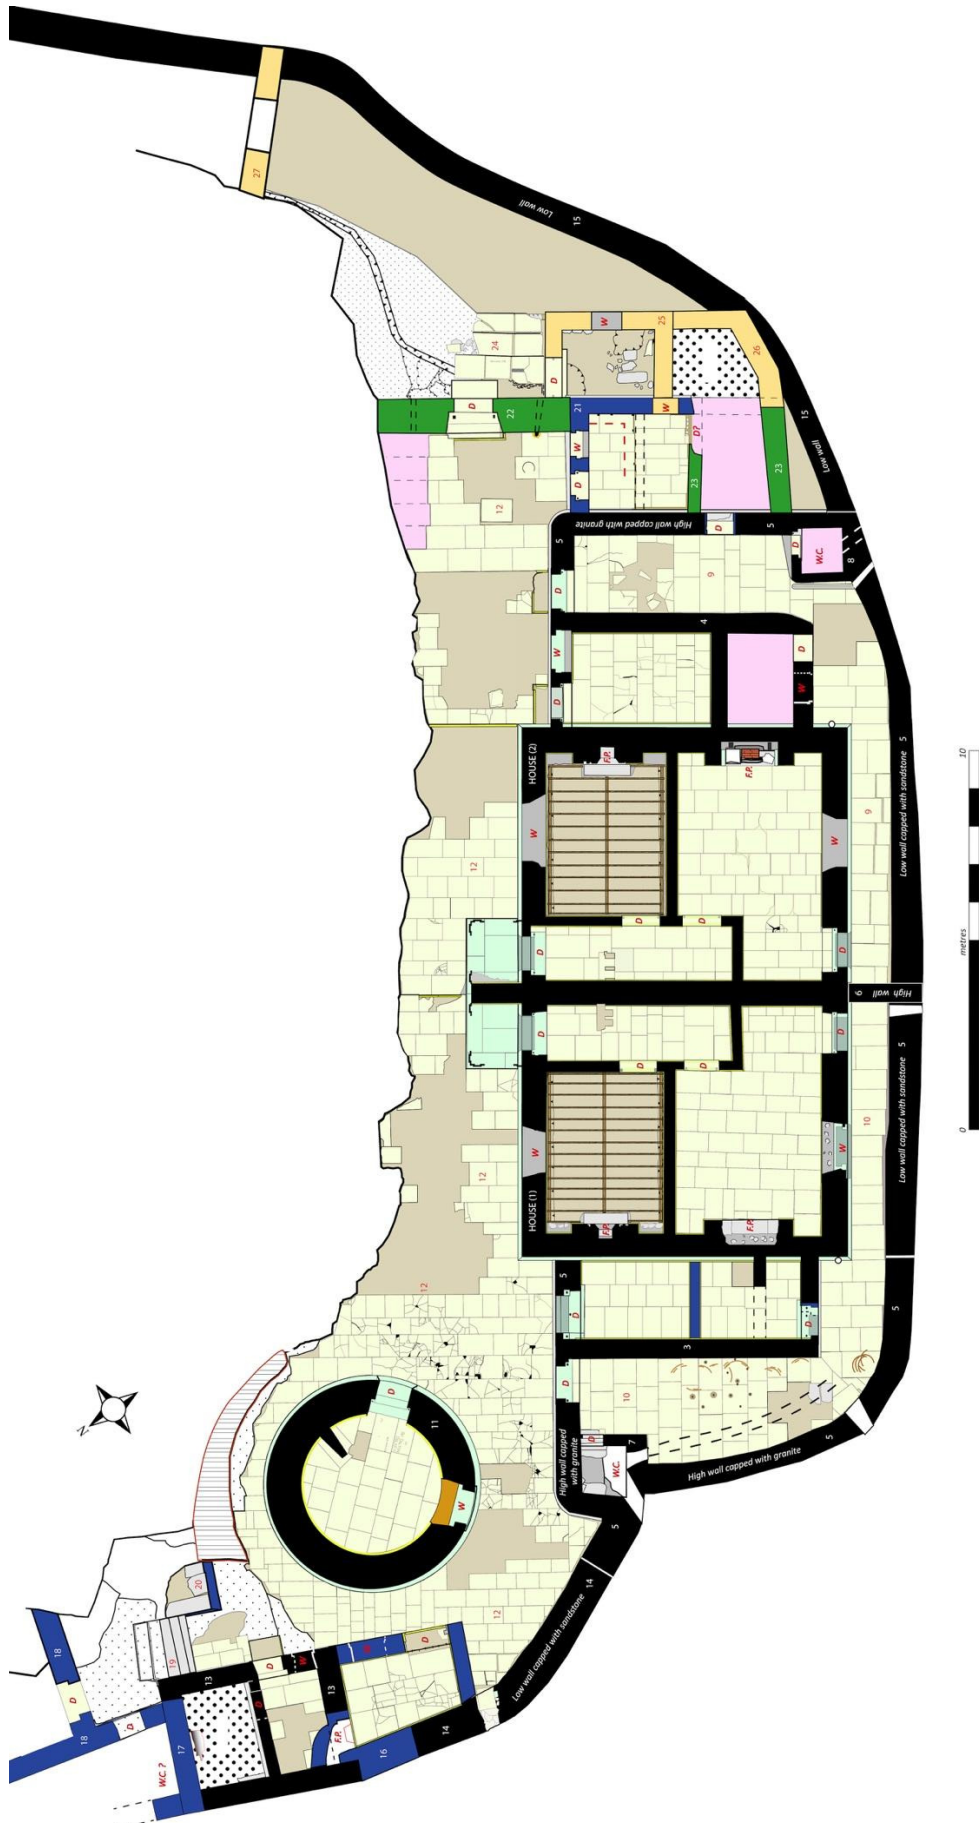
Fig. 4 Post excavation plan of the South Terrace of the Upper Lighthouse Station

- Terrace walls (14 & 15) with parapet walls above,
- Two semi-detached houses, (1) -west and (2) -east, each with a pair of attached outhouses (3 & 4) and each surrounded by a high-wall (5) and paved yard (9 & 10) containing an outside toilet (7 & 8);
- The lighthouse tower itself (11) and paving (12) around it and in front of the house;
- A coal store (13) located close to the lighthouse.

Further buildings were added in at least three phases before the Upper Station was abandoned in 1870. They consisted mainly of a number of additional sheds east of House (2), a high wall containing an entrance and an outer entrance gateway. An additional room (16) and toilet (17), possibly for a school teacher were also added against the ends of the coal shed.

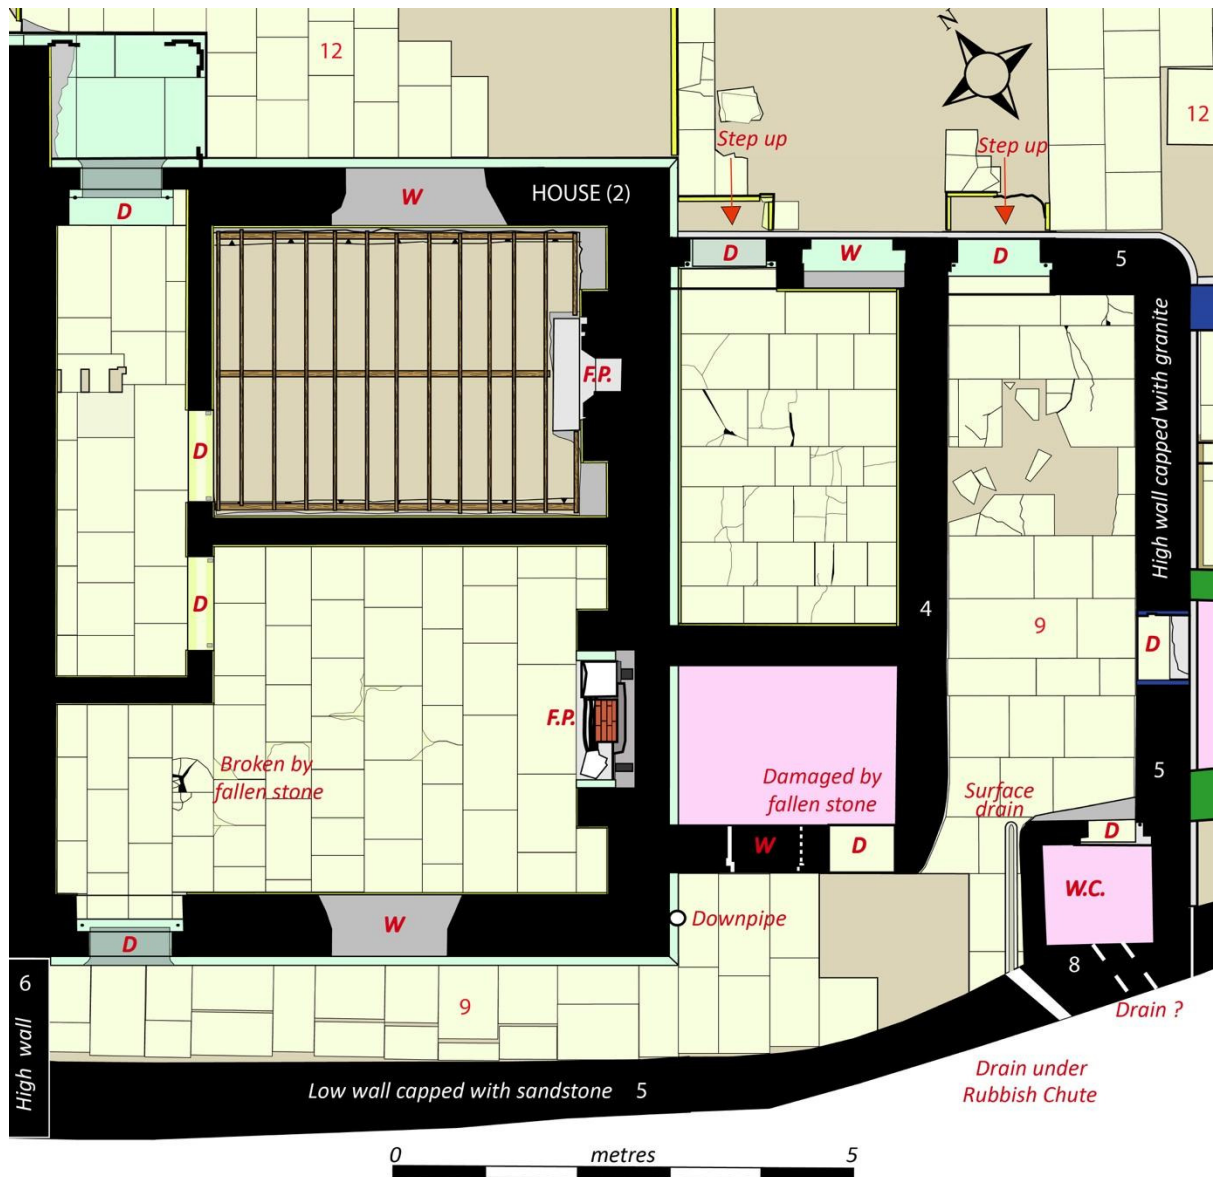
Fig. 7. House (2)

Two semi-detached houses (1 & 2) were erected with side and rear yards (9 & 10) defined by high masonry walls (5) on the north, west and east and by a lower parapet wall on the south side (figs. 6 & 7). The houses were built in mirror image of each other and were

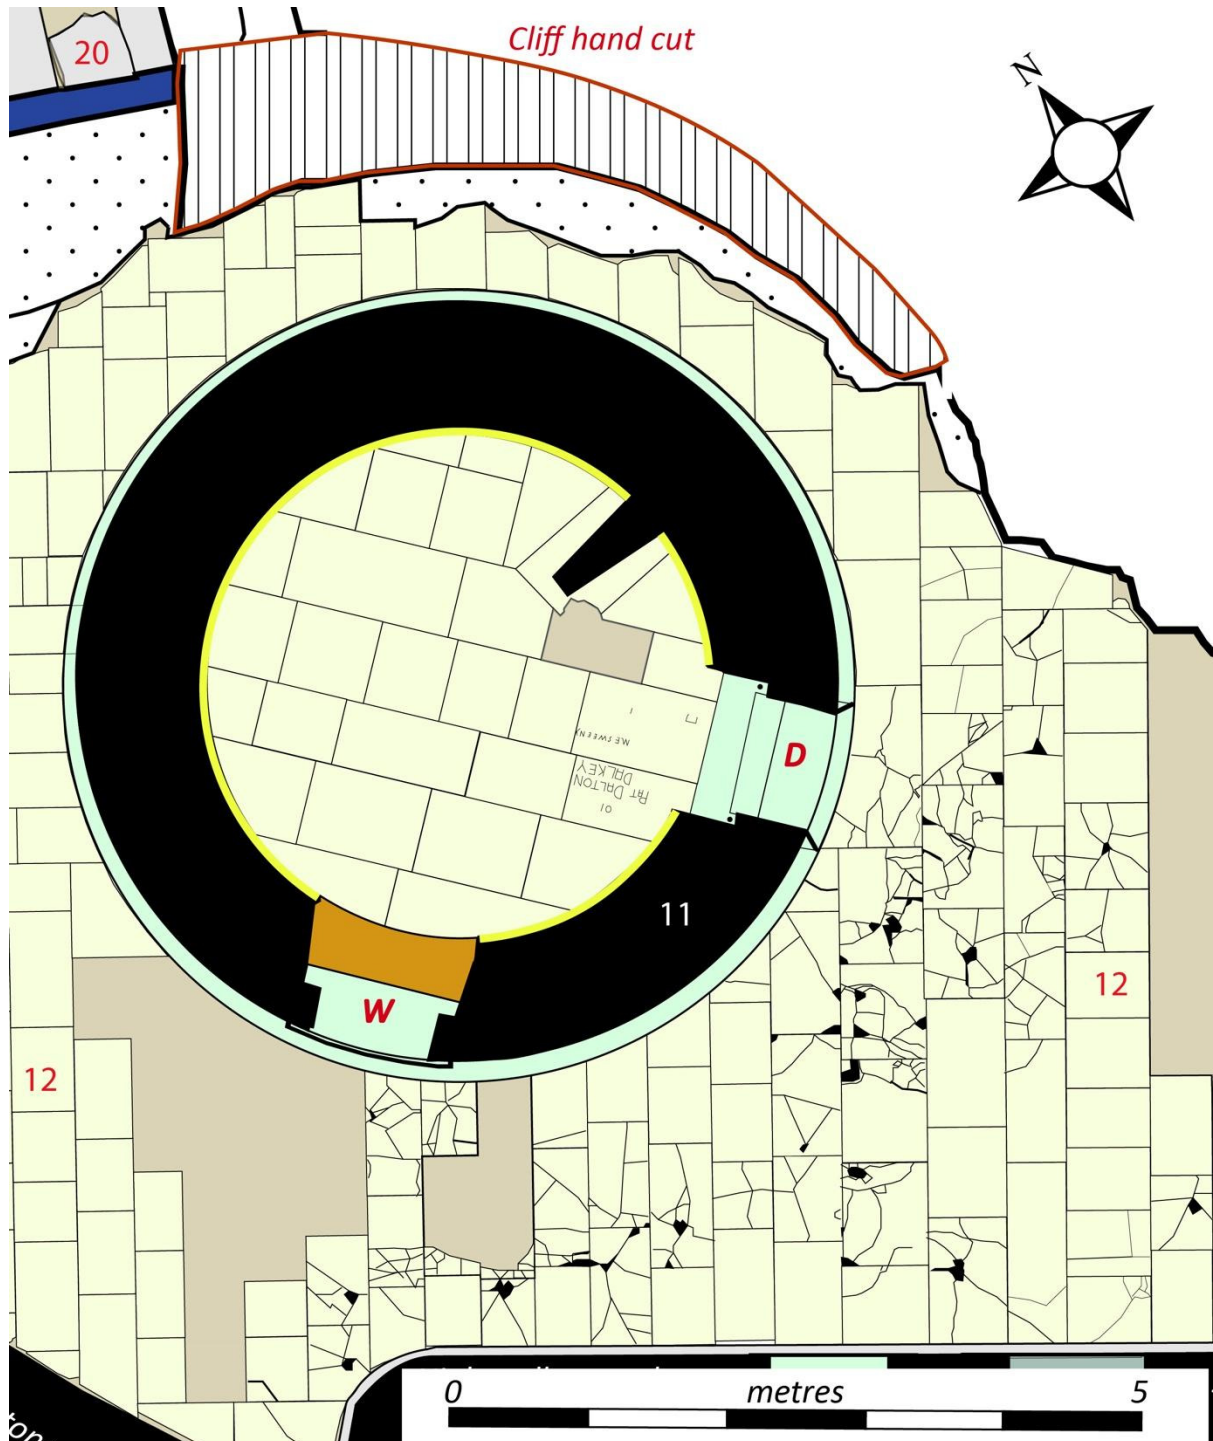
Fig. 8. Post excavation plan of ground floor of the Lighthouse (11).

The base of the lighthouse measures 2.60m in internal diameter, 5.75m in external diameter (including the chamfered, cut granite plinth on which it is built) and its wall is approximately 950mm in thickness. It is built of sandstone rubble masonry, heavily plastered on the interior and with plaster and Valentia slate weathering on the exterior (figs. 86 & 87). It is entered via a square-headed doorway on its southwest side (fig 88 & 89). The doorway

measures 900mm in width on the exterior, 1.10m in width on the interior and is 2.09m in height on the exterior and 2.16m high on the interior. The base of the doorway is composed of two granite cills, the outer is part of the basal plinth. There are round holes on the inner cill, which held iron spigots anchoring the base of the doorframe.

A square-headed, 1.22m-high window in the eastern side of the building lights the ground floor. The window measures 900mm in width on the exterior and 1.12m in width on the interior. The base of the outer half has a protruding granite cill with square upstands on which the window frame sat. The internal half of its base is composed of a now eroded, brown sandstone slab.

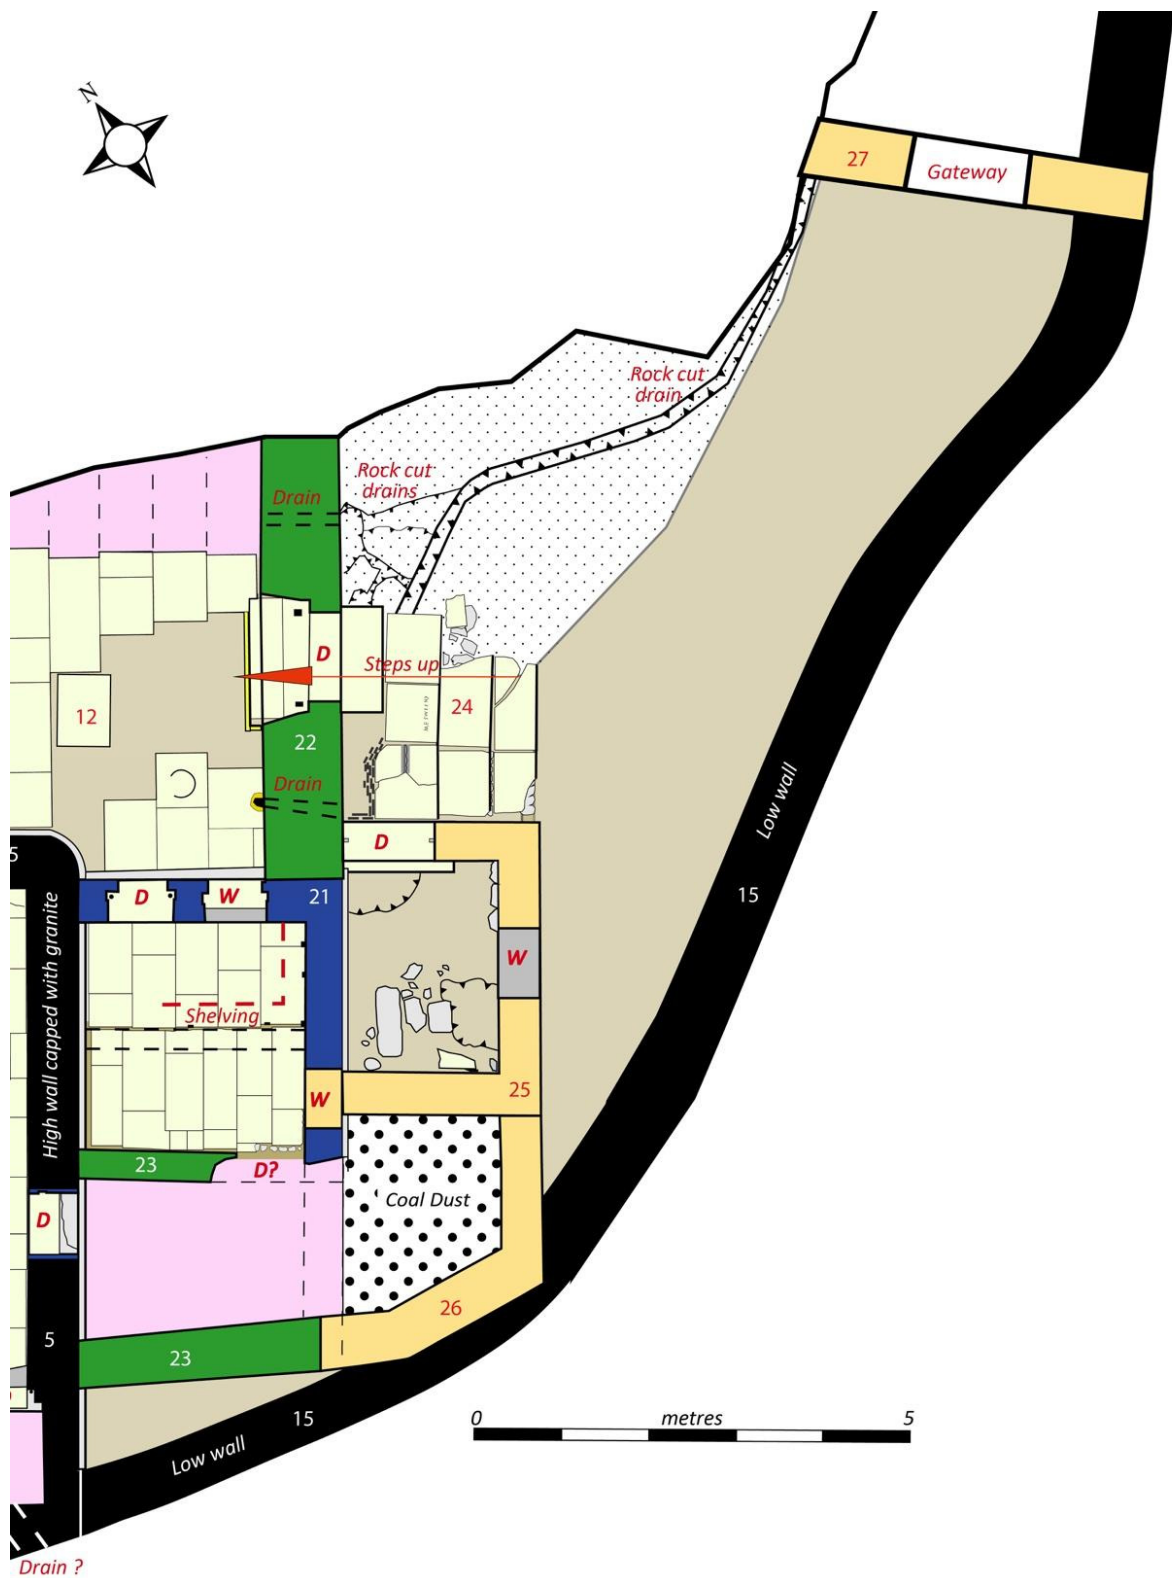
Fig. 10.. Post excavation plan of the structures and features added at the east end of the North Terrace.

A rectangular lean-to shed (21), divided into two rooms, north and south, was added against the outer (east) side of the perimeter wall (5) around the yard of House (2) (fig. 10). The southern side of the shed was later altered on probably two occasions. However, as this area was not excavated the full details of the sequence are not yet clear and nor is it certain where the original south wall of the (21) building lay.

The new building measured 2.62m in width internally. Its north and east walls which respectively measured 560mm and 480mm in width were erected on top of a projecting sandstone plinth of the same form, on which Houses (1) and (2) were built (fig. 123).

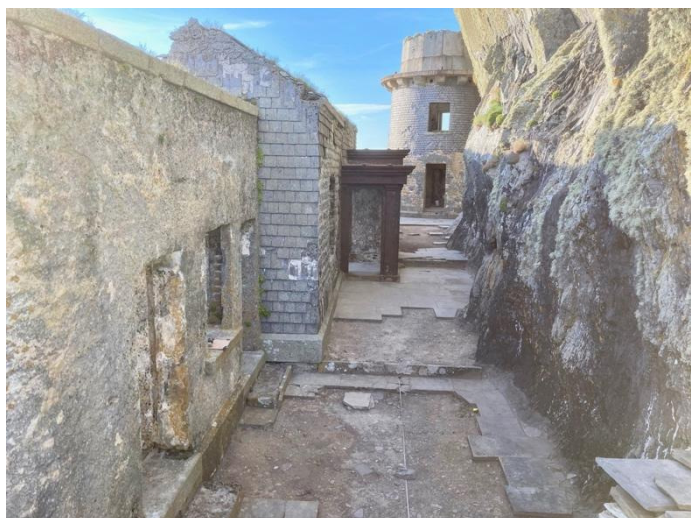
Fig.11. Front to back, yard enclosure wall, House (2) & lighthouse.

The walls were rendered on both faces with lime plaster laid over a scratch coat and lime scudding. The external faces of the walls were further weathered with rectangular slates set into the wet plaster and each slate was further secured with two iron nails (fig. 11). It is noticeable that the slates on the house walls were larger (350mm long by 170mm wide on average) than those (330-350mm in length and up to 135mm in width) used to weather the external face of the lighthouse, due no doubt to the curve of the walls of the latter. The slates used on the exterior of the houses were a mixture of good quality Valentia slates and locally

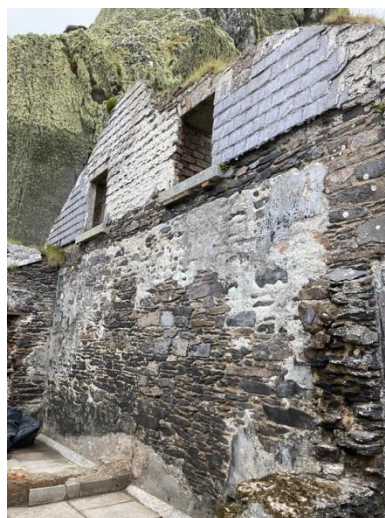
Fig.12. House (1), exterior west gable.

derived slate of a lesser quality.² The slating on the seaward side and gable ends of the houses was almost exclusively Valentia slate while on the less exposed front walls local slate was used more extensively. The slating on the gable ends finished at the base of the window cills of the upper storey / the line of the top of the roof of the adjoining outhouses (3 & 4) (fig. 12).

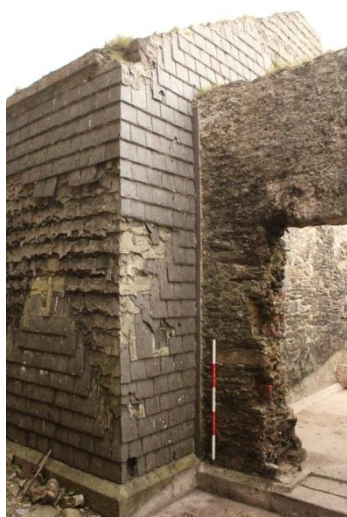
Fig.13. House (1), NW corner.

On the north end of the gable wall of House (1) the slating abutted a vertical line of longer slates, not overlapped, set on the face of the high wall (5) delimiting the yard at the side of the house (fig. 13), while at the rear corner of House (1) a single vertical line of smaller overlapping slates was laid on the wall of the outhouse before the main house was slated (fig. 14). There were no weathering slates laid on the equivalent walls of the outhouses attached to House (2) which were rendered after the slate had been applied to the walls of House (2) (fig. 15). The relationship of the slating of the houses and outhouses shows that all were finished at the same time. The slating was limewashed originally and traces of it survived in many places.

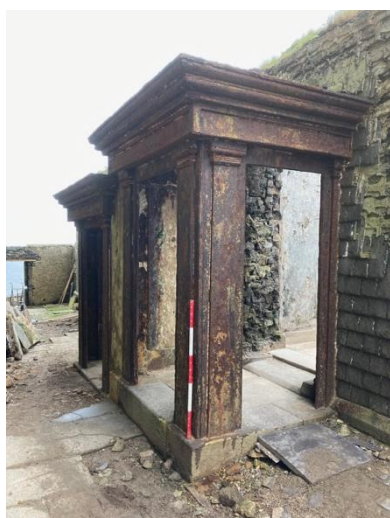
Fig.16. Porches, House (1) at front.

Each of the houses were entered via a cast iron porch of the same form that was used on the Lower Lighthouse accommodation (figs 1 & 16-17). The porches were each erected on a raised granite plinth, each of which measured 2m (e-w) by 1.40m (n-s). The surface of the plinth of the porch to House (1) lay 400mm higher than that of House (2). The porches were placed side by side and the gap between them was infilled with masonry, the base of which on the interior of the porches had sandstone skirting of the same type used in the interior of the houses. The porches consisted of identical units which made up each of their three sides. They had sides and heads made up of overlapping plain rectangular section, cast iron framing supporting a simplified neo-classical capital, entablature and cornicing. The front opes in the porches measured 920 mm and 940mm in width and the side ones 750 and 770mm in width and all were 2.00m in height. There were protruding bolts on the inner side of the doorways where the heavy rectangular section architraves (which still survive in the porch of the Lower Lighthouse) had been removed for some unknown reason. The roofs of the porches, which

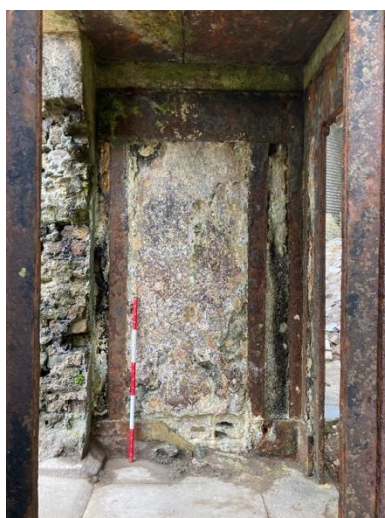
Fig.17. House (2), Interior of porch.

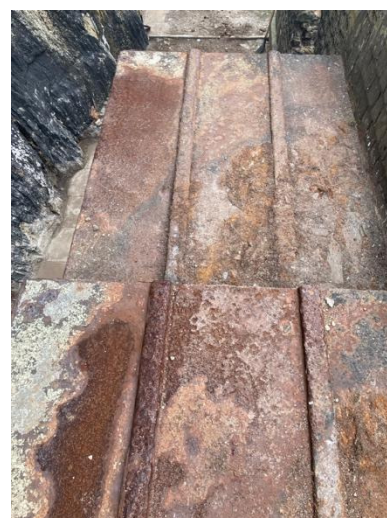
Fig.18. Roofs of porches, House (1) at bottom.

lay 2.52m above floor level, were each composed of three cast iron sheets with narrow rectangular panels sealing the joints (fig. 18).

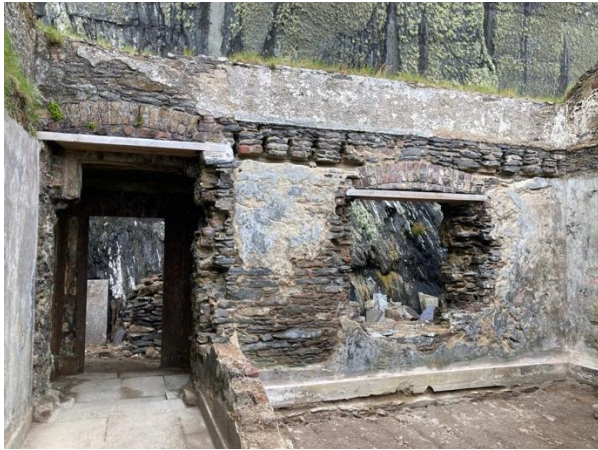
Fig.19. House (2), inner face of front wall.

Each house had a doorway and window in both its front and back wall (figs 19 & 20). The external and internal quoins of the windows and doors were lined with block-and-stop red brick. The reveals were of brick and stone masonry and the opes were topped with almost flat, one brick-thick arches with a timber head below on the interior. The internal timber heads had largely rotted away and the OPW replaced them with modern timber heads a few years ago. The cills of the external doorways were formed from a large slab of granite, with the central part cut down to aid drainage (figs 21-25). Round or square holes at the sides, contained the remains of iron spigots which would have secured the base of the timber doorframe. The doorways all measured in the region of 900mm in width on the exterior and 1100mm in width on the interior and were 1.98-2.01m in height on the exterior and 1.90-1.94m in height on the interior. No timberwork survived in any of the external doors but parts of the side frame of the front door (with stump of hinge attached) and part of the other heavy brass hinge (find nos. 53 & 55, fig. 157) were found inside House (2). The hinge is identical to those on the surviving original door of the northern house in the Lower Lighthouse Station.

The base of the slots for the first floor joists (see below) lay 2.44m above the surface of the ground floor in the houses (figs. 19 & 20) but as none of the first floor joists survived it is unclear whether the ceilings of the ground floor was planked or composed of lath and plaster.

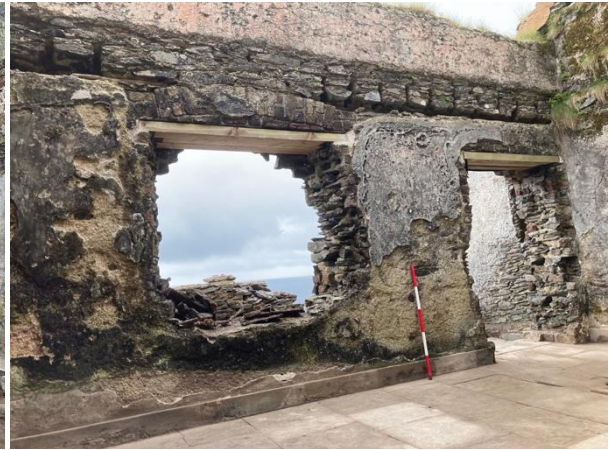
Fig.20. House (2), inner face of back wall.

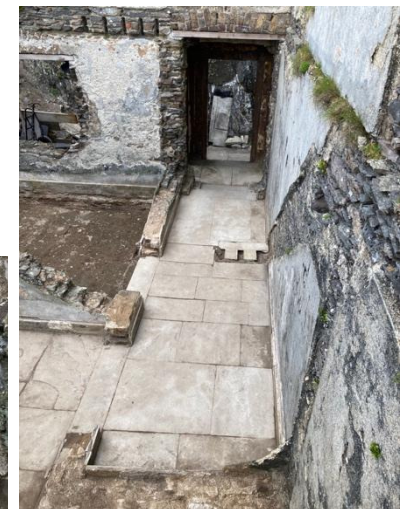
Fig.26. House (1), hall from south.

There were sockets in the floor of the hallways adjacent to the party wall to hold the 100mm square-section base of the newel post and the three raking timbers supporting the stairs (figs 26-29). The scars of the side of the stairs also survived in the plaster on both sides of the party wall (figs. 30 & 31). The stairs would have been narrow measuring only 680mm in width. Fragments of some of the turned timber balusters of the side of the stairs were uncovered in House (2) (find Nos. 54 (fig. 147) & 59 (fig. 158)). In House (2) the base of the sandstone skirting turned upwards along the line of the stairs (fig. 31). However only the basal stone survived so it is not clear whether it was continued upward in stone or timber. None of the stair skirting survived in House (1).

The hallways each contained two 900-1000mm wide doorways leading to the two main rooms (front parlour and rear kitchen) of the houses (figs. 26 & 28). The base of the each doorway had a yellow sandstone saddle, of the same profile as more usual timber saddles. There were a small 10-15mm deep rectangular cut out at each end of the saddle that would have held a tenon at the base of the doorframe. A brick-sized hole in the base of each reveal held a 4" x 2" timber to which the frame would have been further secured.

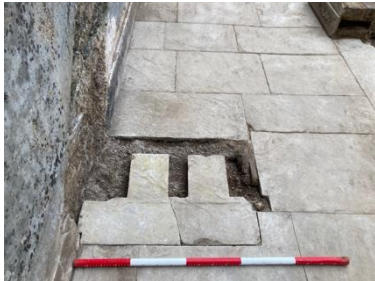
Fig.27. House (1), slots for stairs.

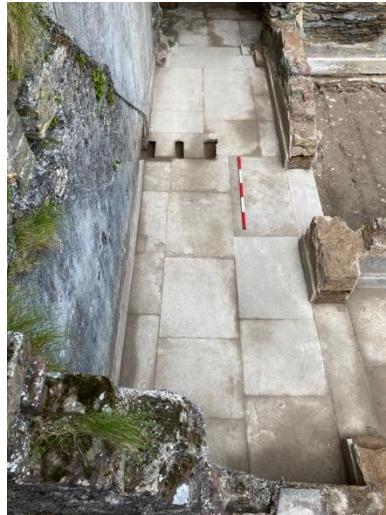
Fig.28. House (2), hall from south.

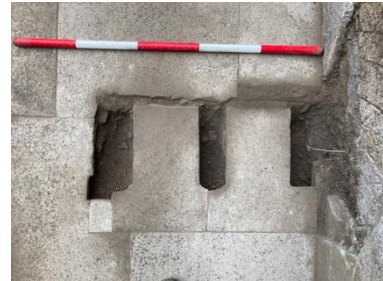
Fig.29. House (2) slots for stairs

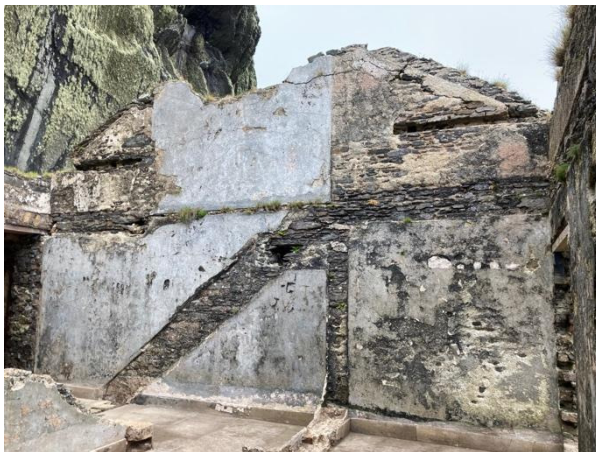
Fig.30. House (1), east gable (party wall).

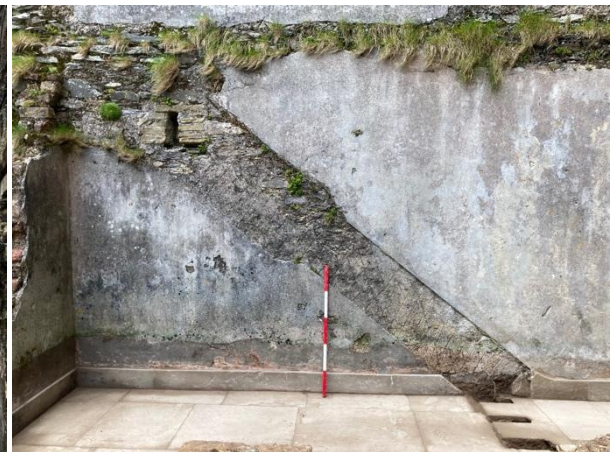
Fig.31. House (2), ghost of stairs on west gable.

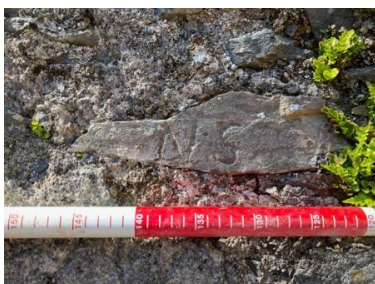
Fig.32. House (2) stairs, inscribed stone.

In House (2) one of the stones in the wall exposed by the removal of the stairs had what appears to read 'N S' carved into its surface (fig. 32).

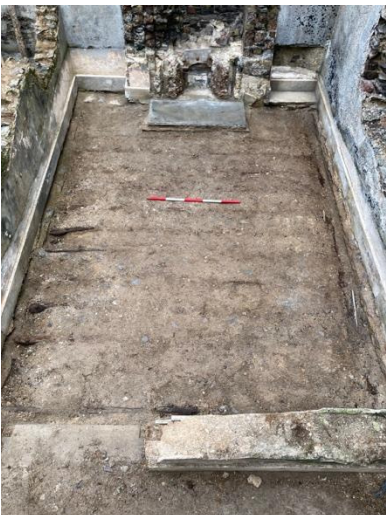
Fig. 33. House (1), front parlour.

The front parlours of the houses each measured 4.30m in length by 3.90m in width (figs. 33 & 34). They each had a small, decorated, cast iron fireplace, set in a 1.78m-wide (House (1)) and 1.85m-wide (House (2)) and 230mm-deep projecting chimney breast at the outer end

The parlours had suspended timber floors but the floorboards had been removed. They were supported on north-south aligned, 2" wide by 4" thick joists spaced roughly at 300mm centres, resting on three east-west aligned 4" by 2" timbers laid in shallow trenches cut into the underlying rubble fill (figs 33 & 34). Bedrock rose to the surface at the southwest corner of the front parlour of House (1) but was not exposed elsewhere. The base of the walls had the same sandstone skirting as had the other rooms of the house.

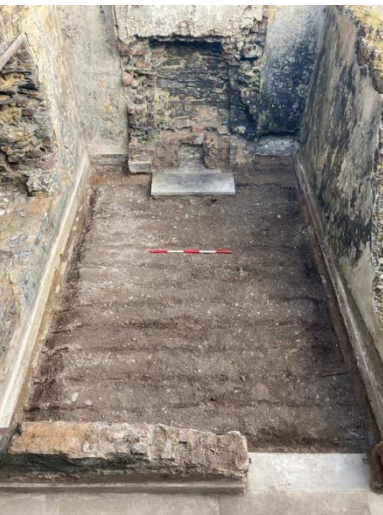
Fig. 34. House (2), front parlour.

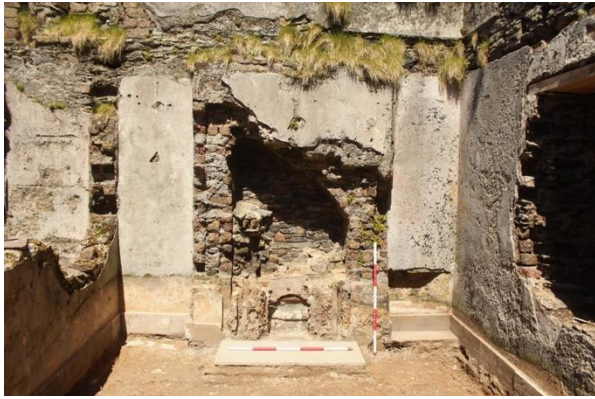
Fig.35. House (1), front parlour, fireplace.

of the house (figs 35-37). The slate surrounds and mantelpiece of the fireplace in House (1) were found loose in the vicinity of the fireplace (find No. 1, figs. 140 & 141) but none survived in House (2). Fragments of the base of the decorated cast-iron grate and fire surround survived in both houses (figs. 35-7) and other fragments were found loose in the houses (find Nos. 58 & 59, fig. 158) and in the Lighthouse (11) (find no. 43, fig. 155). The single flue from each the fireplace extended upwards between the northern window and fireplace on the first floor (fig. 43). The base of the alcove on the right-hand-side of each fireplace had a low 200mm deep recess, the function of which was not clear.

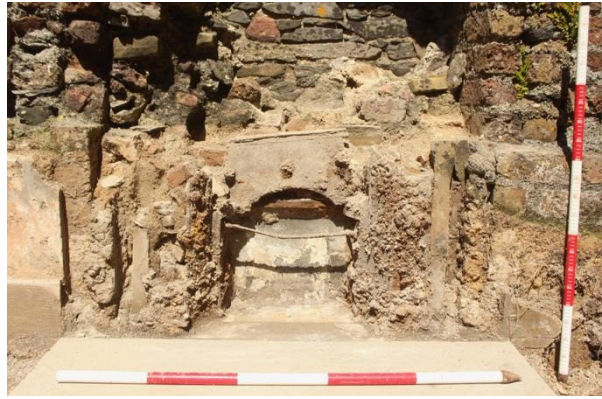
Fig.36. House (1), detail of front parlour fireplace.

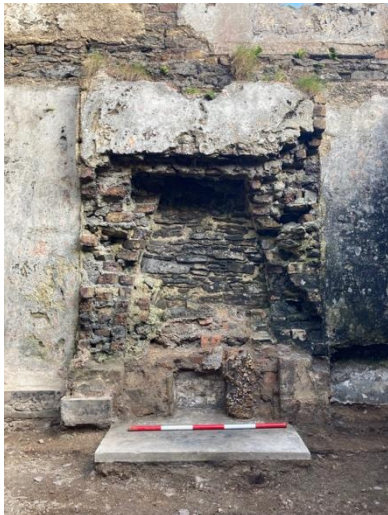
Fig.37. House (2), front parlour fireplace.

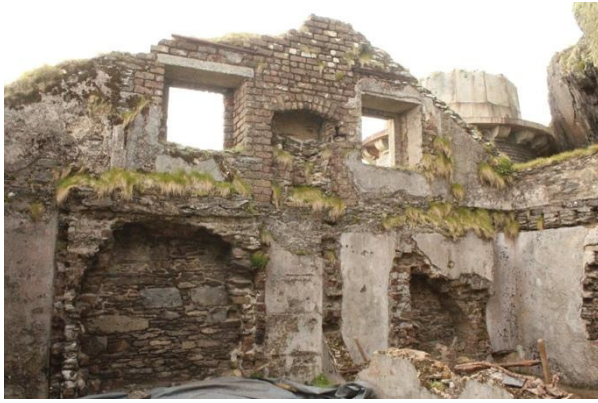
Fig.42. House (1), interior west gable.

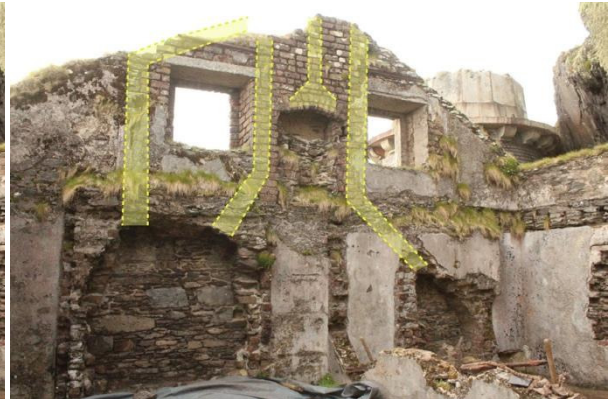
Fig.43. House (1), interior west gable, with lines of flues from fireplaces shown.

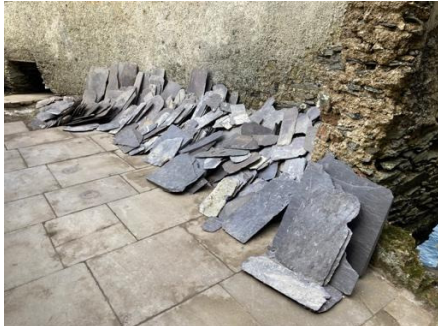
Fig.49. Wall & roof slates found during the excavations.

The largest fragments of roof slates that uncovered in the fills of the houses measured 700mm in length by 400mm in width and 620mm in length by 360mm in width (fig. 49).

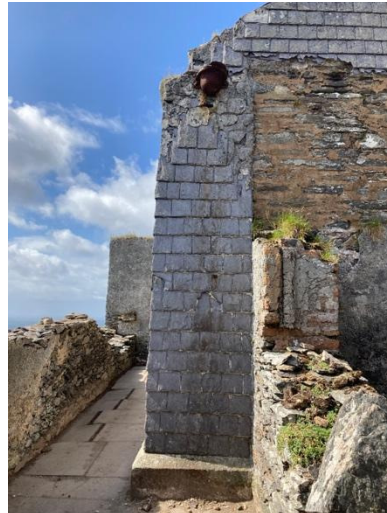
Fig.50. House (2), SE corner, hopper & downpipe.

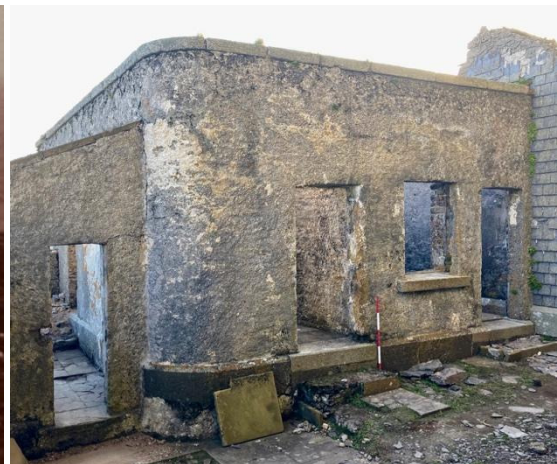
Fig.53. House (2), front wall of yard (10) & outhouse (4).

The high north wall of the yards also held the entrance to the front room of the two-roomed outhouse (3 & 4) attached to each house (figs 53 & 54). Each yard also contained a long-drop toilet (7 & 8) in a different corner of its outer wall.

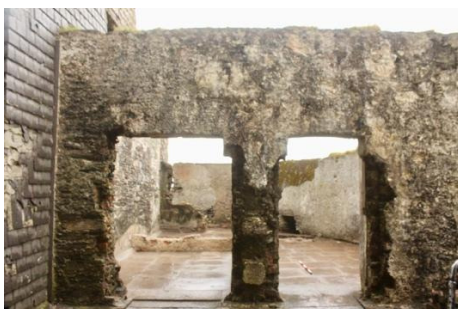
Fig.54. House (1), front wall of yard (10) & outhouse (3), outhouse doorway on left.

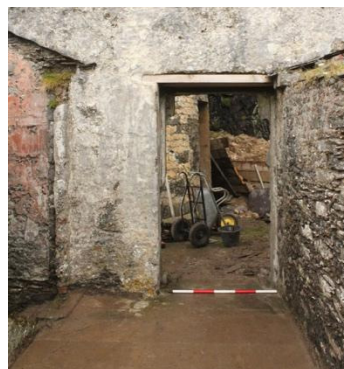
Fig.55. House (1), inside of doorway to yard (10).

The side wall stands to a maximum height of 2.04m above the floor of the house (figs. 55, 73 & 74). There is a 1m long by 0.78m high breach in the top of the wall towards its north end but nothing survives to indicate that it was originally a window; its base lies much higher than that of any of the other windows in the complex. Only one of the original, rectangular section (200mm wide by 100mm thick) granite external cornice stones survives at the north end of the wall (fig. 55). The surviving granite capstone protrudes 60mm out from the outer face of the wall and has a drip groove carved on its underside. The top of the external face of the wall beneath the caps was levelled in a number of places with fragments of dressed yellow sandstone flags (as used on the floors). The stump of one iron bracket to hold the gutter survives. The downpipe from the gutter must have lain at the southwest corner of the building and either emptied into a water butt or the water simply ran onto the yard surface and out through the adjacent drain in the parapet wall.

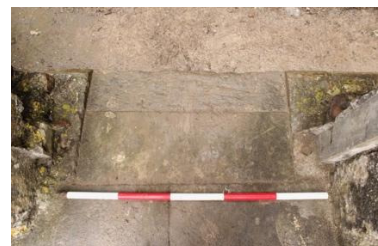
Fig.56. House (1), cill of doorway to yard (10).

had flat granite cills with a pair of holes to hold iron spigots securing the base of the doorframe (figs. 56 & 57).

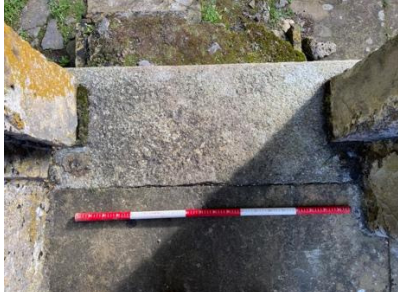
Fig.57. House (2), cill of doorway to yard (9).

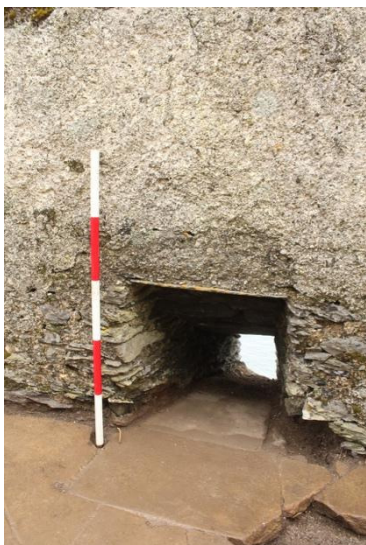
Fig.63. Drain at SW corner of yard (10).

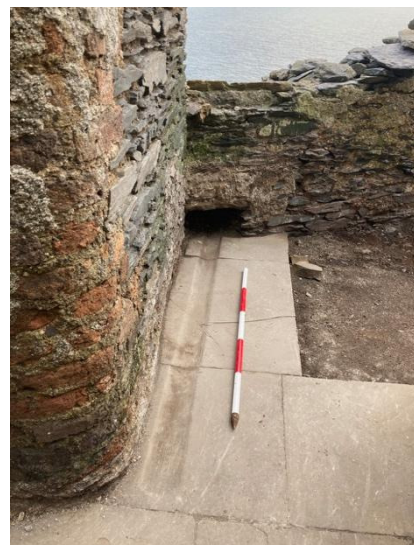
Fig.64. Drain at SE corner of yard (9).

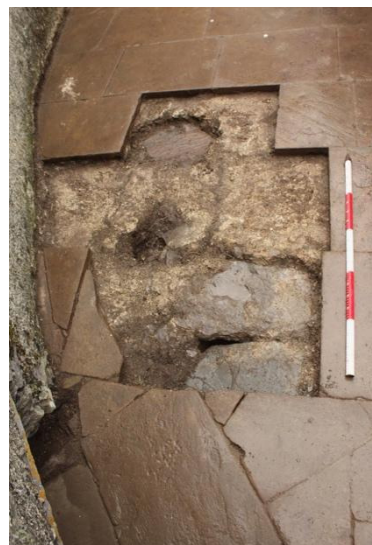
Fig.65. Capstones of drain under surface of yard (10).

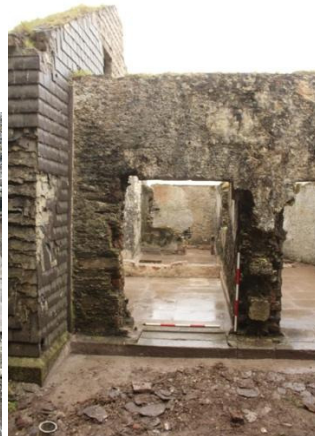
Fig.67. Front doorway of outhouse (3).

The front room was accessed via a 2.00m high doorway, 1.13m in width on the exterior and 1.37m in width on the interior (figs. 67). It has red brick reveals, block-and-stop red brick faces and an almost flat, red brick, arched external head. The interior had a timber head but this was replaced with a modern one by the OPW. The cill of the doorway (fig. 68) is composed of the limestone chamfered plinth, with a large granite floor slab inside it. The top of the two slabs were cut down about 15mm in the area of the doorway for drainage. Two holes in the cill held iron spigots securing the base of the doorframe. This doorway is the widest in the complex and the cill had a central hole to hold a vertical bolt suggesting it had double doors.

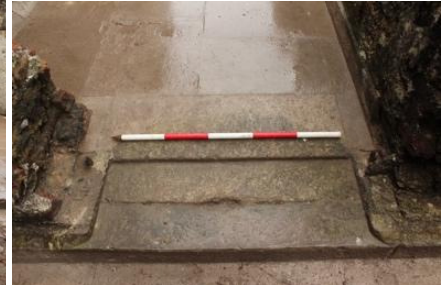
Fig.68. Outhouse(3), cill of front door.

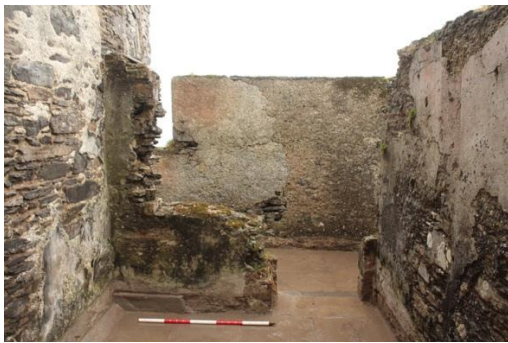
Fig.69. Rear wall & doorway of Outhouse (3).

The full height scar of the back wall survives on the external wall of the house but the wall itself survived to not much more than a metre in height (fig. 69). The back wall contains the remains of a window and doorway (figs 69 & 70). The doorway and its reveals are defined by red brick, with red brick block-and-stop external faces and it is 740mm in width on the interior, 870mm in width on the exterior. The south side of doorway was later cut back and rebuilt (see below). It originally measured only 500mm in width. The round (with drain slot) and square holes (containing lead and iron staining) to secure iron spigots in the base of the doorframe survive. The original doorway corresponds in width to the cut out part of the base

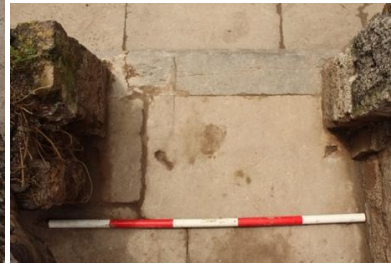
Fig.70. Outhouse (3), rear doorway.

The doorway of the southern outhouse was also widened at this or another time (fig. 70). Its east jamb was cut back and rebuilt 200mm east of its original line, and a new hole to hold a spigot to secure the base of the new doorframe was drilled into the granite cill.

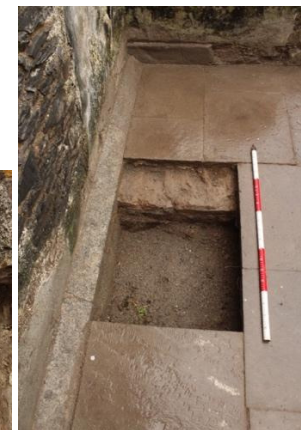
Fig.71. Outhouse (3), stump of original internal wall.

The remains of the 240mm-wide base of the original internal wall dividing the building into two rooms, north and south, were uncovered where one of the floor paving stones had been removed (fi. 71). Scars for this wall are also evident in the plaster on the side walls (figs. 72 & 73) showing that it originally stood to the full height of the building. The wall is of rubble masonry construction bonded by the same lime mortar used in the external walls and it was

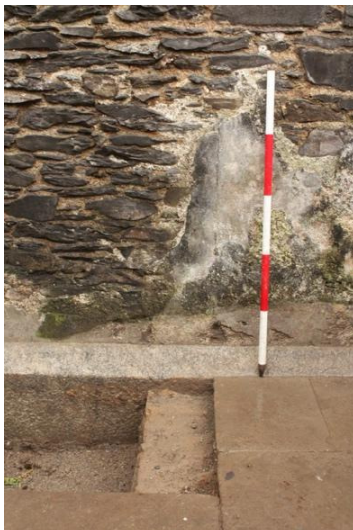
Fig.72. Outhouse (3), scar of original internal on west gable of House (1).

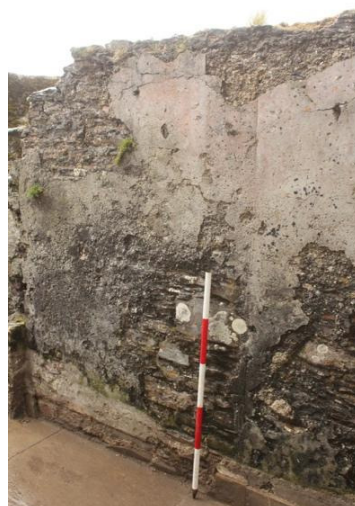
Fig.73. Outhouse (3), scar of original internal wall on west side wall.

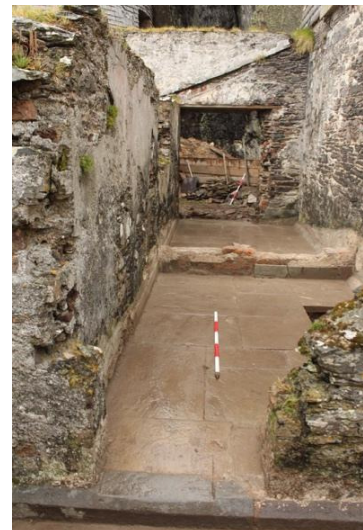
Fig.74. interior of outhouse (3) looking North.

A short section of the base of the original slate roof cladding survives at the front end of the building but the roof scar of the entire front end of the roof is preserved on the inner face of the front wall (fig. 74). The surviving slates are both pinned with iron nails and mortared in place. The base of the joists of the lower end of the roof lay 2.10m above the internal floor level and the base of the wall plate of its upper end lay 3.02m above the internal floor level. The scar of the upper end of the roof against the house survives at the base of its external slate-weathering and two lines of the eroded ends of iron wall hooks, which held the timber roof plate in place, also survive (fig. 12). There is also mortar flashing onto the roof surviving beneath the granite windows sills.

founded on rock. The wall was abutted by the stone skirting on the base of the side walls. After it was removed and replaced (see below) it was covered with relaid paving (fig. 74).

The floor of the building is composed of rectangular yellow sandstone flags (fig.74). The slabs were laid very closely together (5-10mm apart at a maximum) and were set on a thick mortar bed laid directly on bedrock or a filling of broken rock debris over bedrock. The floor slabs abutted a skirting composed of rectangular yellow sandstone slabs which lined the base of the internal faces of the walls of the building.

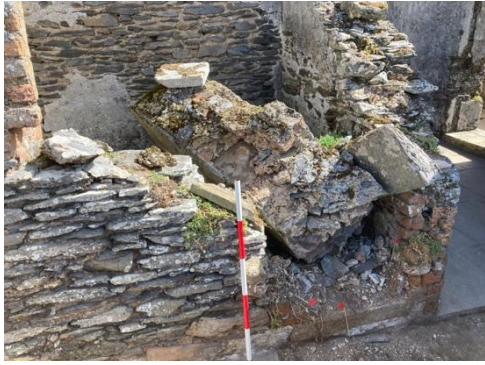
Fig.75. Outhouse (4), rear wall and room.

The rear room had a 750mm-wide doorway with a granite cill and the red brick-lined west side of its 540mm-wide window also survived *in situ* (fig. 75).

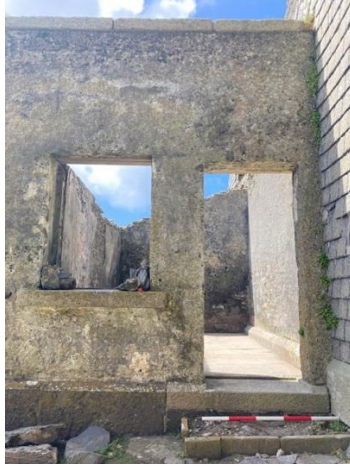
Fig.76. Outhouse (4) front wall.

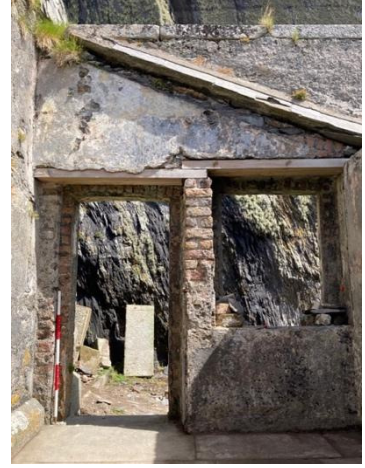
Fig.77. Outhouse (4), inner face of front wall.

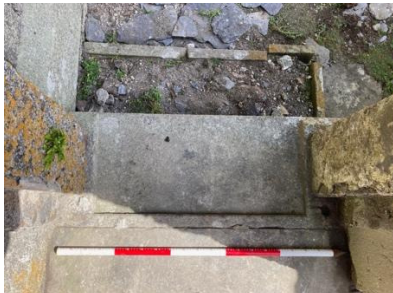
Fig.78. Outhouse (4), step and front door cill.

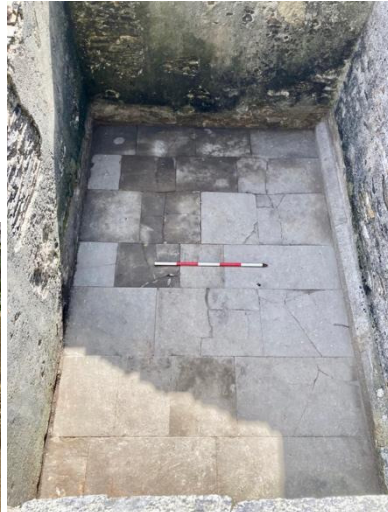
Fig.79. Outhouse (4) floor of front room.

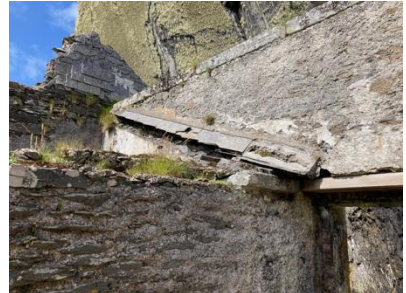
Fig.80. Outhouse (4) detail of roof.

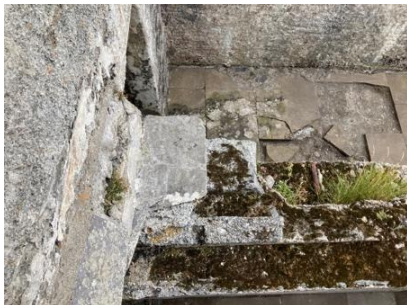
Fig.81. Outhouse (4) detail of roof.

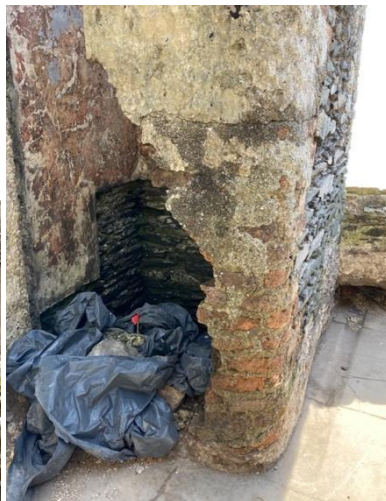
Fig.82. Toilet (8).
