ARCHAEOLOGICAL EXCAVATION
of the
UPPER LIGHTHOUSE STATION,
SKELLIG MICHAEL, CO. KERRY.

Ministerial Consent No. C001045. Works No. W000428
Excavation Licence No. E005321. Detection device licence No. R00551

Alan R. Hayden,
31st October 2021

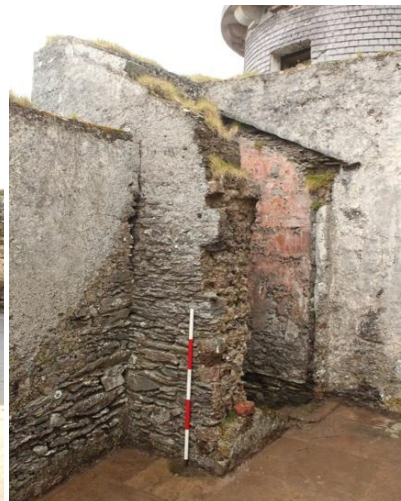
Fig.83. Toilet (7).

The west and north walls of Toilet (7) were similarly formed by the wall (5) of yard (10) (fig.83). Its south wall were also composed of a masonry but its east wall seems largely to

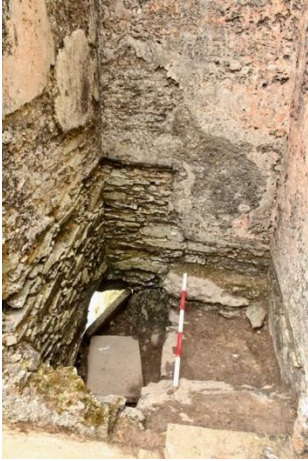
Fig.84. Mark of seat in toilet (7).

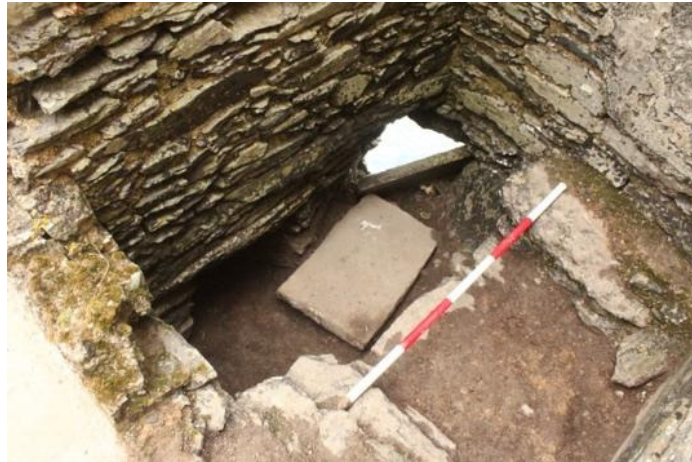
Fig.85. Subsurface drain entering (left) and drain exit (top) in drop of toilet (7).

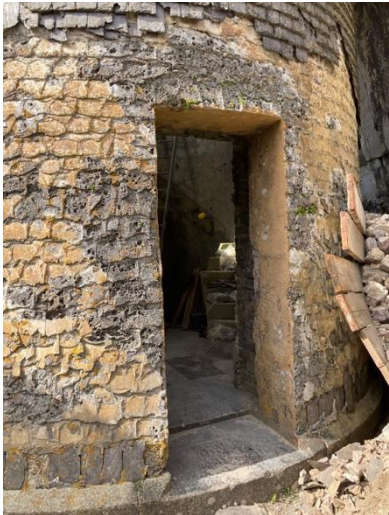
Fig.88. Doorway of lighthouse.

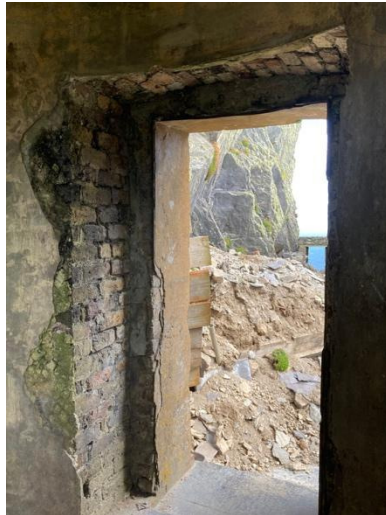
Fig.89. Interior of lighthouse doorway.

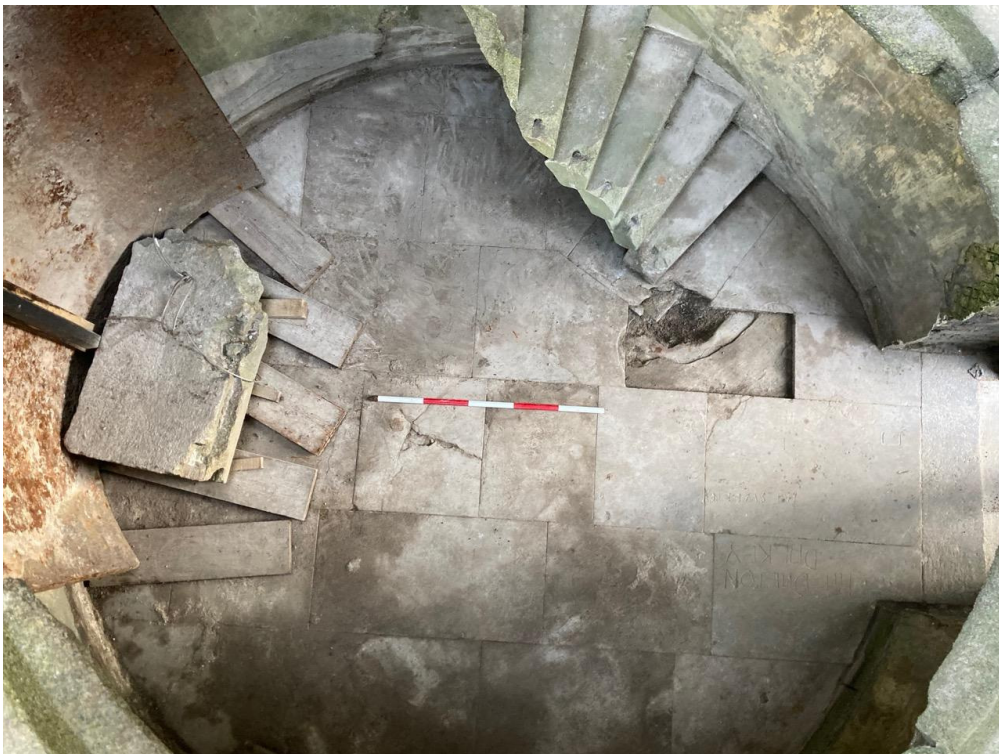
Fig.91. Ground floor of lighthouse after excavation. Back of lantern and fragment of mantlet wall stored at left.

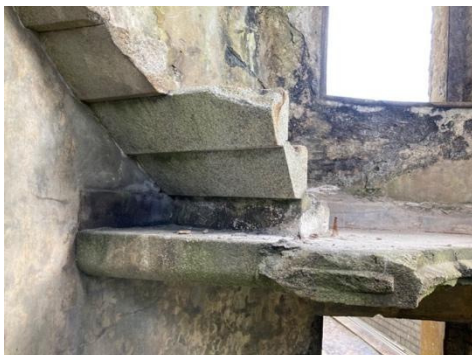
Fig.92. Detail of ope in first floor & stairs up to second floor.

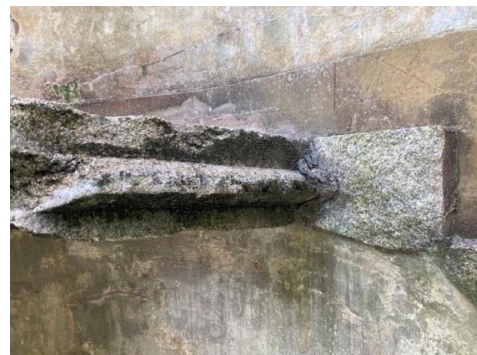
Fig.93. Detail of tongue of first floor granite slabs.

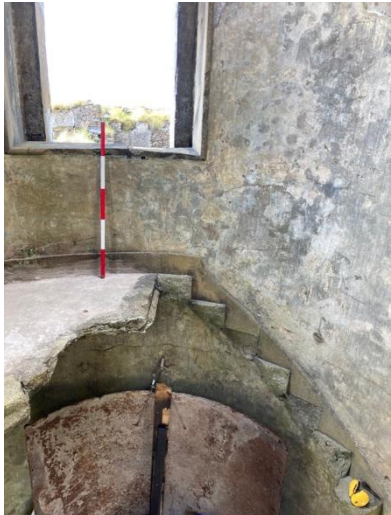
Fig.94. Top of stairs to first floor.

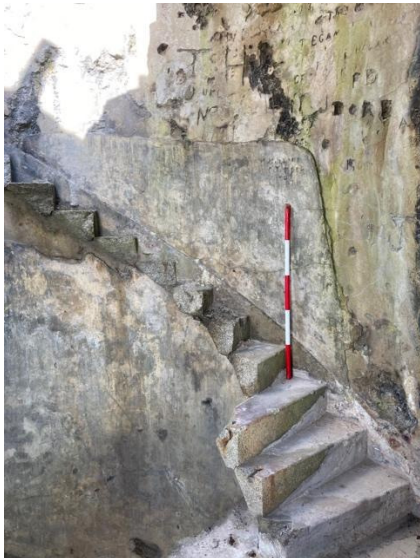
Fig.97. Stairs up to second floor.

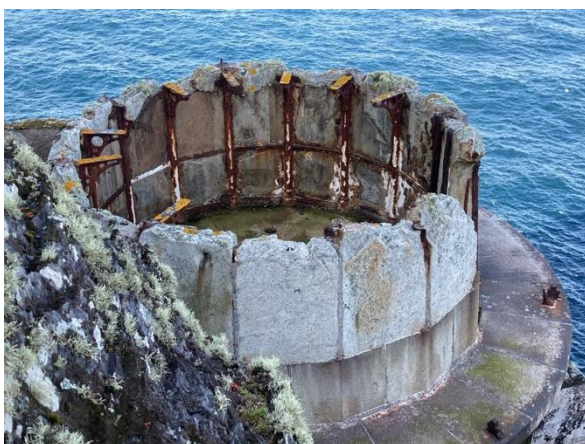
Fig.99. Second floor, balcony and mantlet from the north.

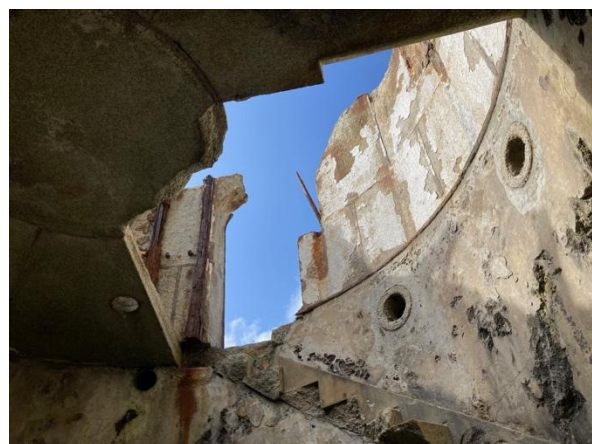
Fig.100. Doorway to balcony in mantlet wall.

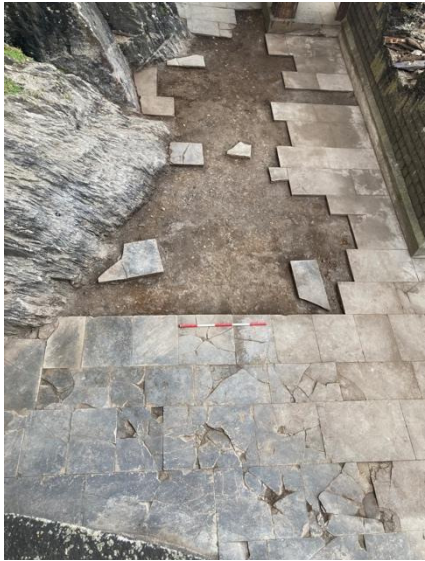
Fig.101. Cracked paving south of the lighthouse (11).

The open area of the terrace north of the Houses and around the Lighthouse and Coal Shed was paved with the same rectangular, yellow sandstone paving slabs used in the floor of the buildings and the enclosed yards (figs. 101 & 108). The paving descended three steps,

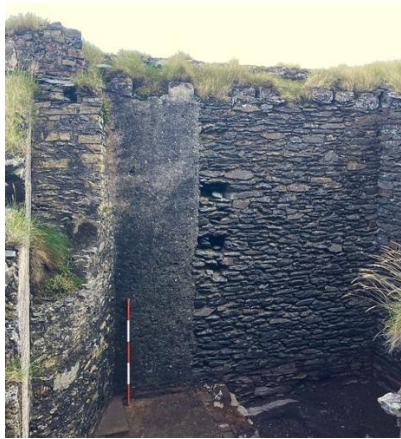
Fig.103. Coal Shed (13), west wall with later Chimney on left.

internal faces of the walls in this room were not rendered and it was windowless (fig. 103). The interior of the room contained a thick layer of coal dust and coal fragments and it was clearly used as a coal store.

The west end of the southern wall of the shed was later rebuilt, a chimney was inserted inside its southwest corner of the building (fig. 103) and masonry was added to the top of its northern wall when a room (16) and a toilet (17) were added to its two ends (see below).

To heat the new building, the west end of the south wall of the older Coal Shed was cut through to form a small and rough 800mm-wide fireplace, the top of which had a cast iron lintel (fig. 112). The flue from the fireplace extended into the southwest corner of the Coal Shed where a rounded, sub-triangular plan, masonry chimney was constructed to accommodate it, on top of the original paving slabs of the Coal Shed floor (fig. 103).

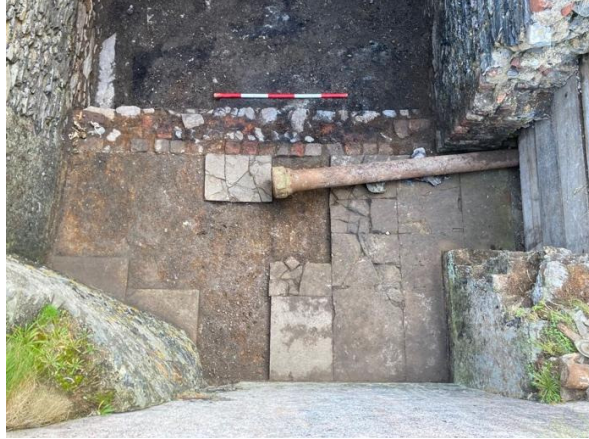
Fig.104. Coal Shed (13), floor of southern room.

survived at the east end of the wall. The southern room, which measured 2.60m by 1.50-1.56m was floored with rectangular, yellow sandstone slabs, many of which were later removed and those that survived were heavily cracked and broken (fig. 104). The walls of this room were rendered with lime mortar and part of the red brick-lined southern jamb of a window survived in its east wall.

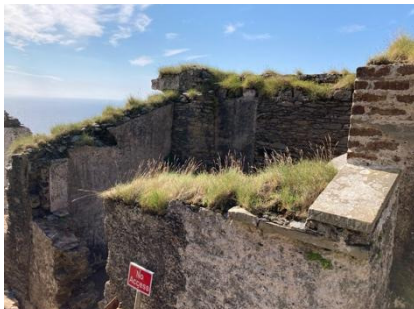
Fig.105. Roof level of Coal Shed.

The shed had a mono-pitch roof sloping down from west to east (fig. 105). The base of the upper ends of the timbers rafters, which were held in slots in its west wall lay 2.85m above floor level at the west side of the room. The roof was composed of large rectangular slates held in place by the top of the parapet wall on the west and by masonry, originally capped by yellow sandstone slabs (only one of which survived) on the gable ends (fig. 105). No traces of gutters or downpipes survived. as the top of the east wall did not survive.

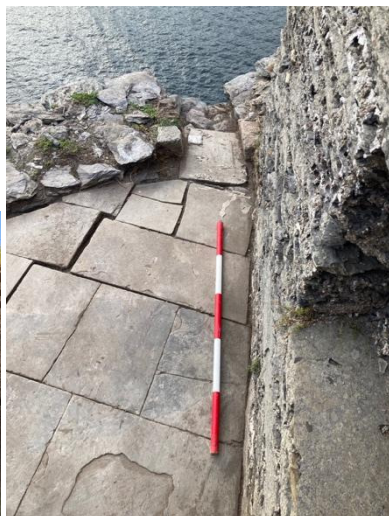
Fig.106. Drain through parapet wall south of Teacher's House

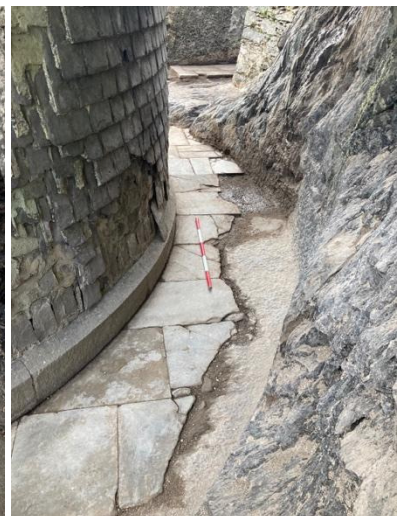
Fig.107. Hand-cut cliff section to NE of Lighthouse.

The cliff defining the inner side of the terrace retained several of the holes drilled to hold explosives used to create the terrace. To the east and northeast sides of the Lighthouse the base of the cliff was further cut back by hand to allow space for the construction of the lighthouse and clear toolmarks survived (fig. 107). The edge of the ground surface of this area was also partly rock-cut and again clear toolmarks survived.

In the area north and northeast of the Lighthouse the closeness of the underlying rock to the surface meant that there was not sufficient depth to lay the usual paving slabs and either the rock surface was left exposed or thinner slatey slabs were used as flooring (fig. 107).

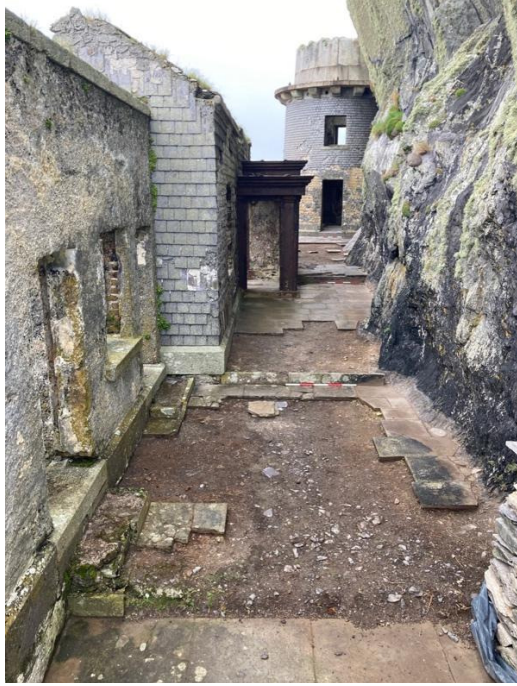
Fig.108. The front yard (12) looking west.

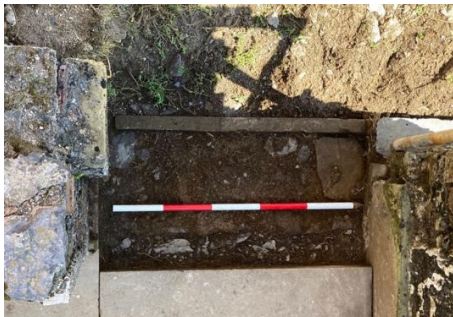
Fig.110. Doorway of Teacher's House (16).

Due to the proximity of the Lighthouse (11) on the east and the inward turn of the parapet wall (14) on the west, the building added to the south end of the Coal Shed (13) was trapezoidal in internal plan (figs. 9 & 113). It measured 3m in length and 1.62-2.44m in width internally, its east wall measured 520mm in width and its southern wall 420mm in width. The western wall was composed of additional masonry built on top of the sandstone coping slabs of the parapet wall (14) (fig. 111). Its southern end and the parapet wall beneath it had collapsed and was no longer extant, while the upper part of its northern end, which was not keyed into the wall of the Coal Shed, had slumped outwards by 200mm or so (fig. 111). The southern wall also simply butted up against the inner side of the parapet wall (14). The building was accessed via a 1.04m-wide, red brick, yellow sandstone and masonry lined doorway at the south end of its east wall (fig. 110). A yellow sandstone slab, set vertically

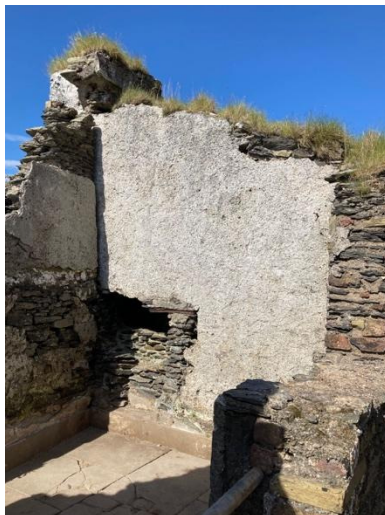
Fig.111. North wall of Teacher's House (16).

The internal wall faces of the building were lime-mortar rendered and the base of the wall was also lined with a sandstone skirting of the same type used in the main houses (figs. 111-112). The floor was composed of nearly laid, rectangular yellow sandstone flags, which were badly cracked and broken along the west side of the building where its outer wall had fallen (fig. 113)..

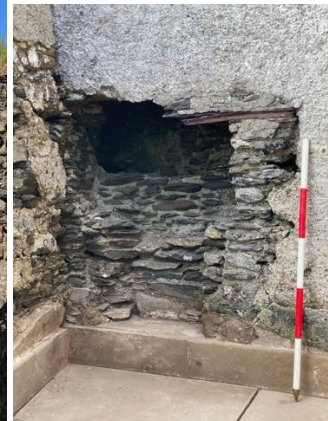
Fig.112 Fireplace in Teacher's House (16).

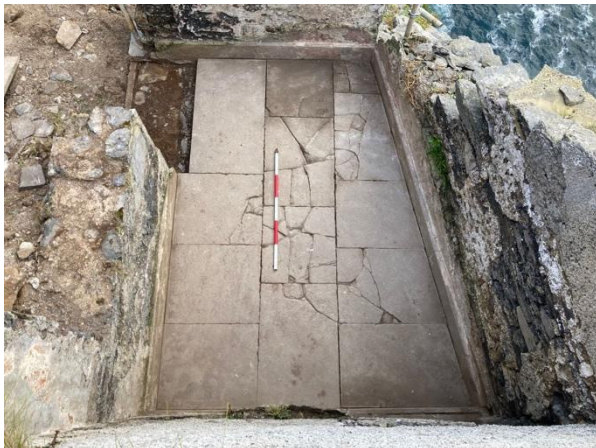
Fig. 113. Floor of Teacher's House (16).

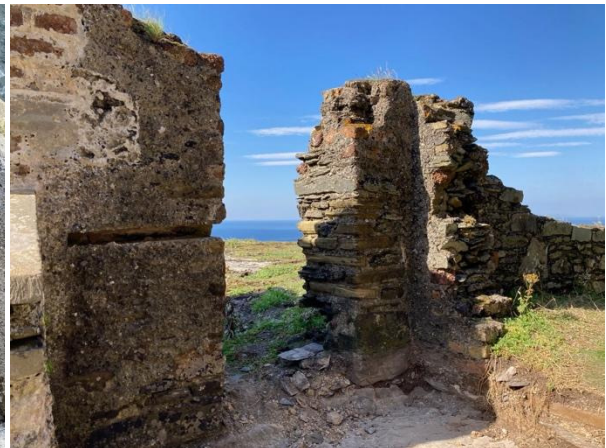
Fig. 114. Doorways to Toilet (17) (left) and (18) to North Terrace (right).

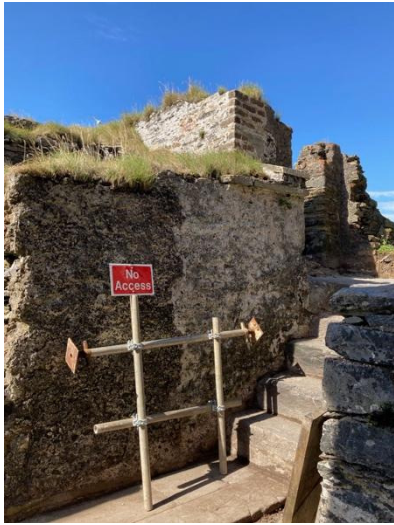
Fig.115. Brick masonry added to Coal Shed, part of Toilet (17).

The scar and stump of a 500mm-wide wall, which had otherwise collapsed, survived against the outer face of the north wall of the coal shed (13) (fig. 9). To its east, another wall containing a simple 800mm-wide doorway, whose base was the underlying bedrock, was built at a slightly different angle abutting the outer wall of the coal shed (fig. 114). These two walls formed the sides of a 2.00m internally-wide structure (17). This interior of the structure was not excavated so is not clear what, if anything survives of its north wall. Mortar-bonded stone masonry with a red-brick east end was also added on top of the sloping parapet of the gable of the north wall of the coal shed to complete the south wall of the new structure (fig. 115). There was a gully in the bedrock inside the new building, which would have facilitated

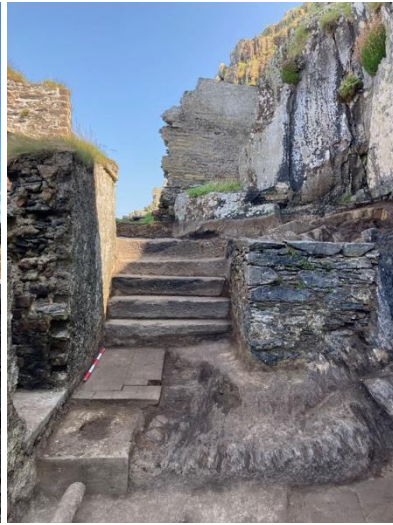
Fig.116. Steps up to North Terrace.

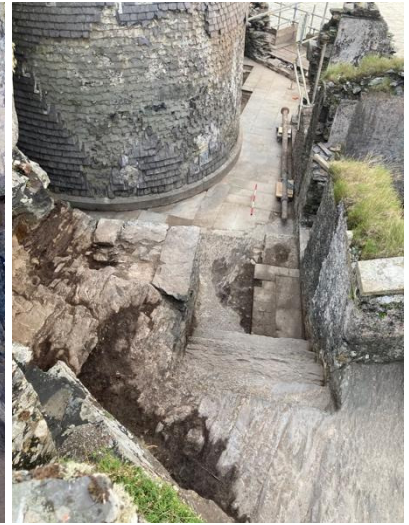
Fig.117. Steps up to rock-cut area leading to North Terrace.

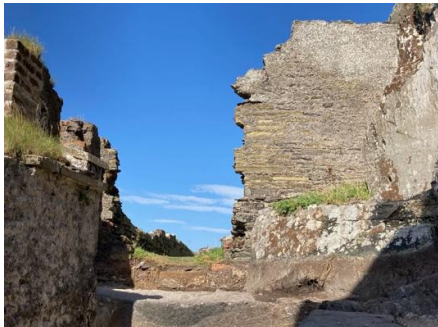
Fig.118 Doorway in wall (18) leading to North Terrace.

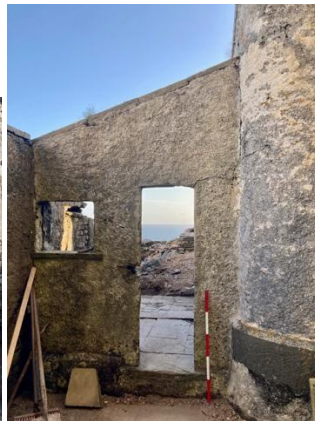
Fig.119. Front wall of Shed (21).

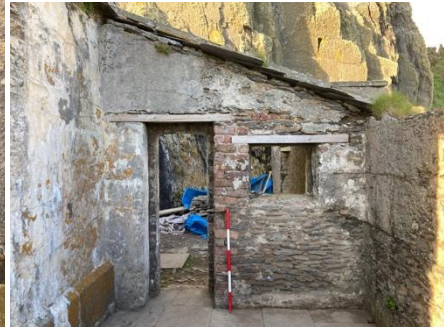
Fig.120. Inner face of front wall of Shed (21).

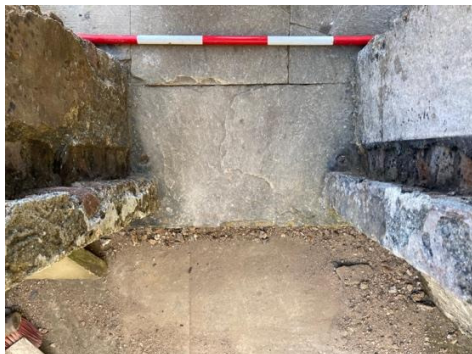
Fig.121. Base of doorway to Shed (21).

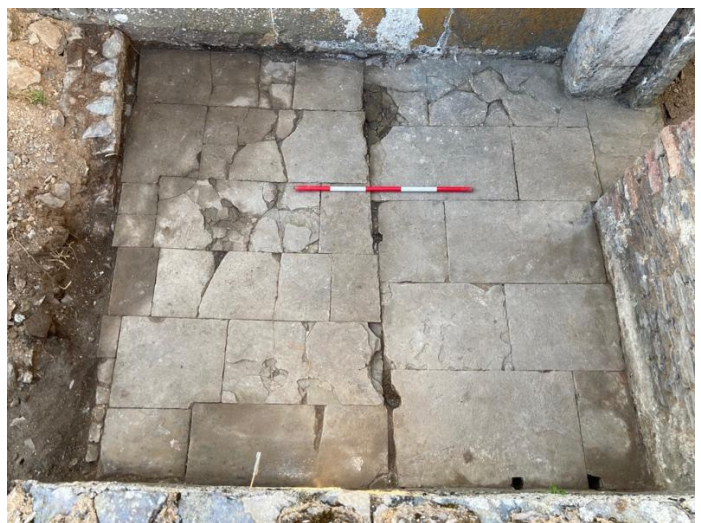
Fig.122. Floor of Shed (21).

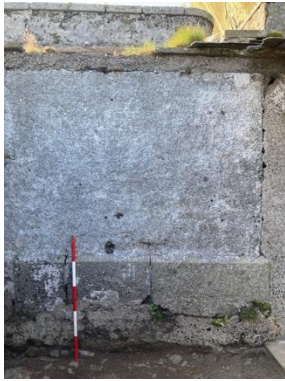
Fig.123. Plinth at base of east wall of Shed (21).

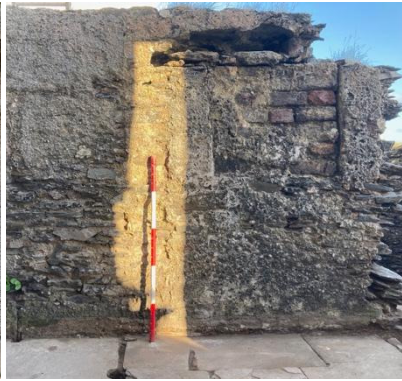
Fig.124. East wall of Shed (21) with wall scar (sunlit) & blocked window.

There was a window in the east wall of the southern room. It measured 620mm in width on the interior (fig. 124). It was later blocked with masonry (see below).

The window in the east side of the Phase 2 shed (21) was blocked (fig. 124) and a small, lim-bonded masonry walled lean-to shed (25) was built abutting its outside wall and the outside of the Phase 3 wall (22) (figs. 10 and 133). The shed measured 2.44m by 1.8m internally and had walls measuring 450mm in width. The external face of its walls were composed of very distinct stonework, featuring large stones set upright on their narrow edges (fig. 133). It is identical to the masonry of the isolated gateway (27) erected further east (fig. 139) and both were likely built by the same hand.

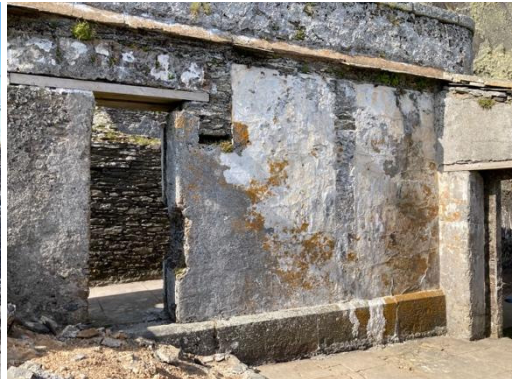
Fig.125. Wall scars and roof line of Shed (21) on Outer face of wall (5) around yard (9).

There was a crude rectangular doorway in the adjacent outer wall (5) of the yard around House (2) just south of shed (21) (figs. 125 & 128). It had a fully timber head (replaced by the OPW) and the inner two thirds of its base had a yellow sandstone cill while the outer side was formed by the top of the granite plinth of the wall. There were scars of the timber doorframe in the plaster on its reveals and the stump of one iron wall hook which held it in place survived. The presence of the sandstone cill, the lack of a brick covering arch and the crude form of the doorway suggest it was broken through the earlier wall (5), probably to allow access to the back room of shed (21). The faces of wall (5) were rendered hiding the reworking.

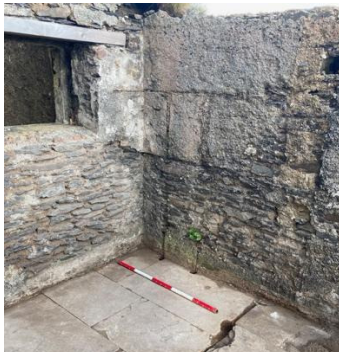
Fig.126. Scars of shelving in Shed (21).

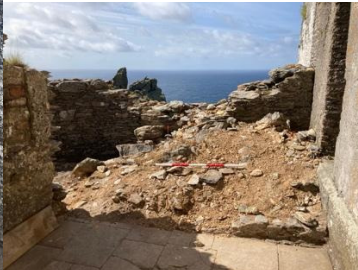
Fig. 127. The unexcavated end of Shed (23)

It appears that Shed (21) was extended southwards by approximately 2.3m and a new 600mm-wide south end wall was built of masonry with a distinctive tan-coloured, lime bonding butting against the outside the face of the high wall (5) enclosing the yard of House (2) (figs 10, 127 & 128). The new wall built extending the length of east side of the old shed did not survive as it was later removed (see below). The old internal wall was demolished and replaced by a new one, which only barely survived above footing level, 1.4m further south (figs. 122 & 127). This new wall had the same distinctive tan-coloured mortar bonding as the new external south wall and may have had a doorway in its east end. It was also butted against the outer face of wall (5) but a small rectangular area was levered out of wall (5) to key in the top of the new wall (fig. 128). The extended northern room of the shed measured 2.62m in length. New sandstone slab paving was installed in the extended part of the north room covering the truncated remains of the original internal wall. The floor level of the new

southern room of the shed was not reached as this area was left undisturbed due to the presence of nesting birds (fig. 127).

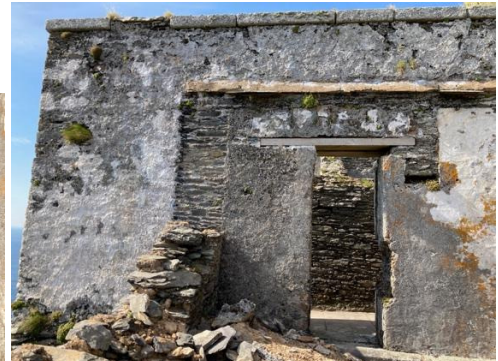
Fig.128. Scar of south wall of Shed (23).

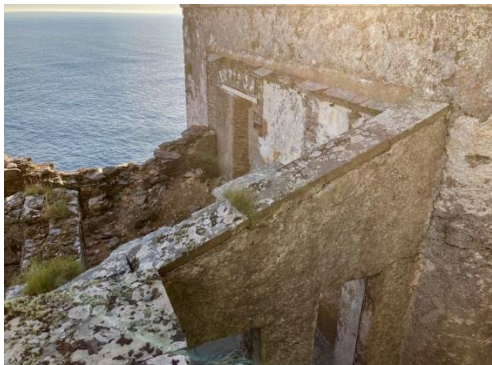
Fig.129. Roof of Sheds (21) and (23).

The north end of the lean-to slated roof of the building was capped with yellow sandstone slabs of the same type used for paving in the complex (fig. 129). The upper end of

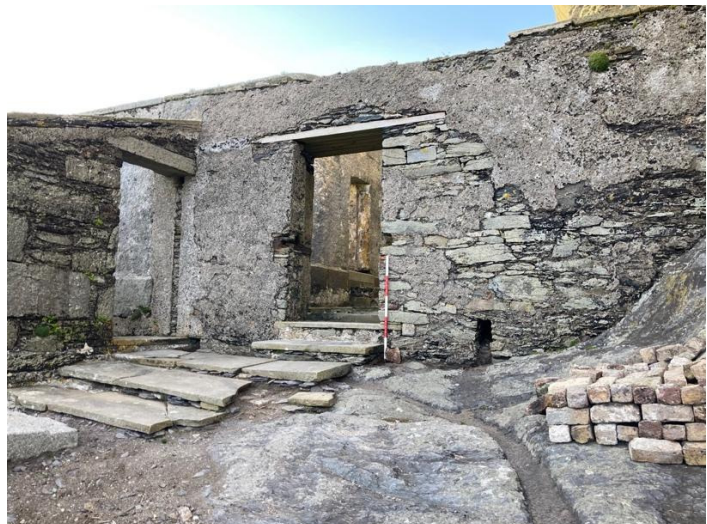
Fig.130. Phase 3 wall (22) with doorway, from the east.

The doorway measured 2.03m in height, was 1.06m in width on the exterior and splayed unevenly to a width of 1.5m on its interior. It had a flat timber head (replaced by the OPW) and masonry faces and reveals reinforced with horizontal cast iron bars (fig. 130). Its cill was formed of two rectangular yellow sandstone paving slabs, the outer of which had rectangular recesses to hold tenons securing the base of the timber doorframe. There was also a round off-centre hole which would have held a vertical bolt securing one of its probable double doors.

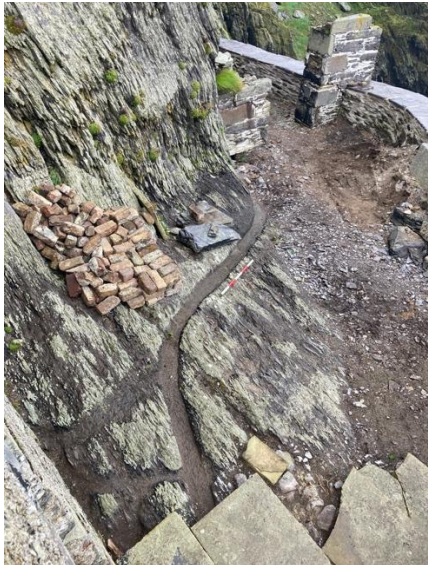
Fig.131. Rock-cut drains outside wall (22).

On exiting the outer side of the wall the drains fed into a series of crude and shallow, rock-cut channels which led north to a deeper and better defined rock-cut drain (fig. 131).

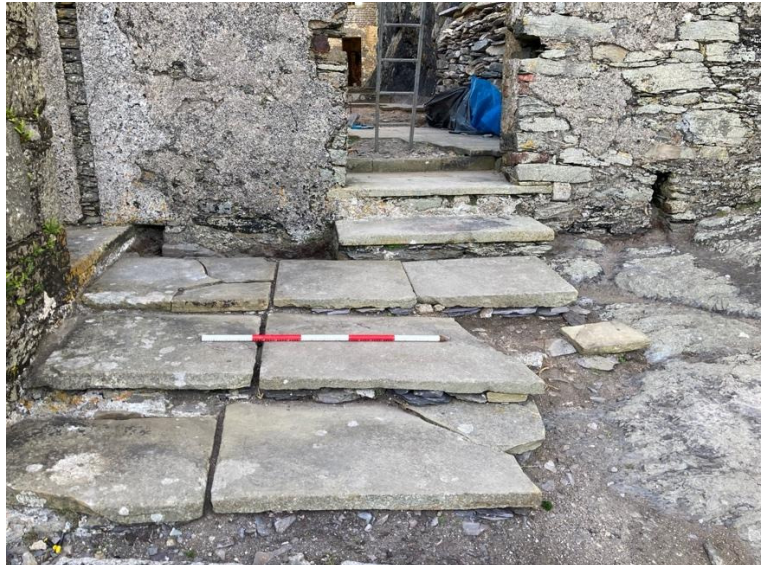
Fig.132. Paved steps (24) outside wall (22).

A series of three shallow and one higher step (24) all with wide treads composed of rectangular, yellow sandstone paving slabs led up to the outer side of the doorway (fig. 132). The slabs were laid partly over the main rock-cut drain. A small area against the wall (22) to the south of the entrance was floored with vertically set slatey stones, as used to form the beds of the lateral drains on the Upper Lighthouse Road.

The yellow sandstone steps (24) to the north of the shed (fig. 132) are likely to have been altered when the shed was built.

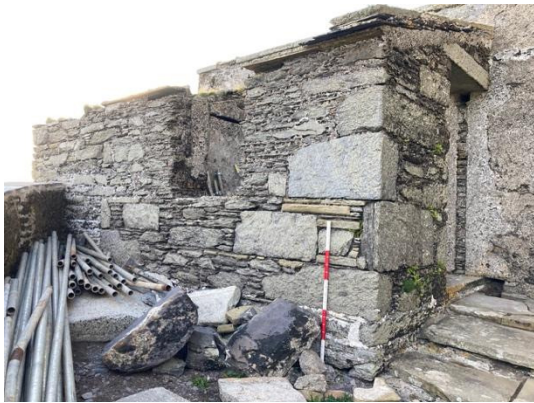
Fig.133. Shed (25), exterior.

As noted above, the gateway (27) at the east end of the terrace was built of the same distinctive type of masonry as the external face of the walls of shed (25) and so is likely to be contemporary with it. The east side of the gateway was erected partly on top of the original parapet wall (15), which has slumped outwards as a result of the weight resulting in the cracking of the masonry of the east pier of the gateway (fig. 139). The west side of the gateway was built over the rock cut drain (24) leaving a square ope for the drain against the cliff face on the inner side of the terrace. The gateway was originally capped with very large granite slabs with double sloping tops. None survived *in situ* but several lay on the ground in the area (figs 133 & 139).

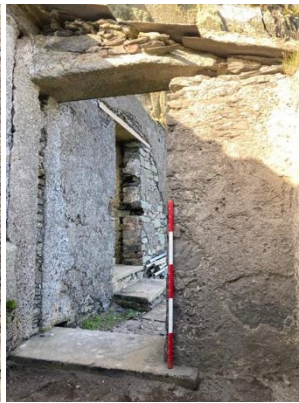
Fig.134. Shed (25), doorway.

The shed was entered via a 1.08m-wide doorway with a flat yellow sandstone cill in its north wall (figs. 134 & 135). There were two 20mm deep rectangular holes to hold tenons from the base of the door frame in the cill. There was a 100mm-wide scar in the plaster of the west side of the doorway where the doorframe had stood. The head of the doorway was a large granite slab with a 4" square timber beneath it socketed into the walls on either side. There was a simple 800mm-wide window in the east wall (fig. 136). Its head did not survive. Much of the top plaster coat was missing on the internal faces of the walls and the underlying scratch coat was visible. The interior of the shed may originally have been floored with rectangular, yellow sandstone slabs but only a single fragment of one remained *in situ* (fig. 137). There were two shallow pits in the building and a group of flat, irregular, grey sandstone

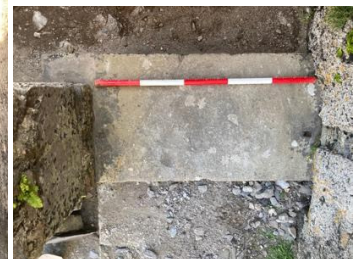
Fig.135. Shed (25), cill of doorway.

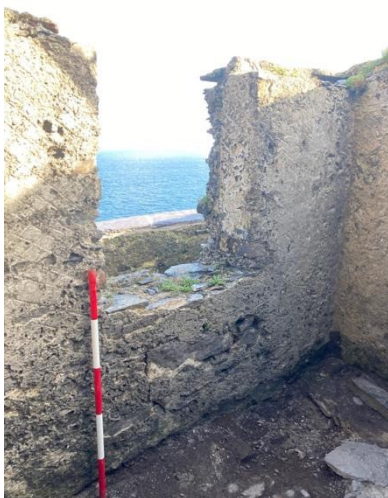
Fig.136. Shed (25), window.

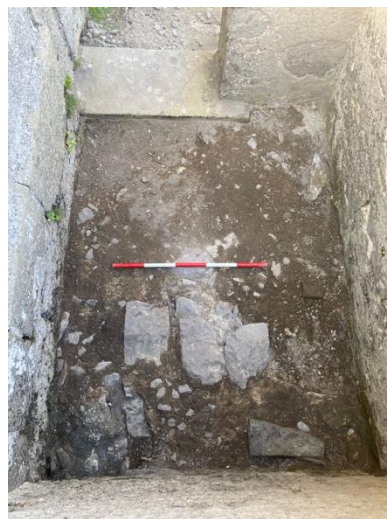
Fig.137. Shed (25), floor.

slabs which might have covered a drain. There was a hole in the base of the wall at the southwest corner of the building which may have been for drainage (fig. 137).

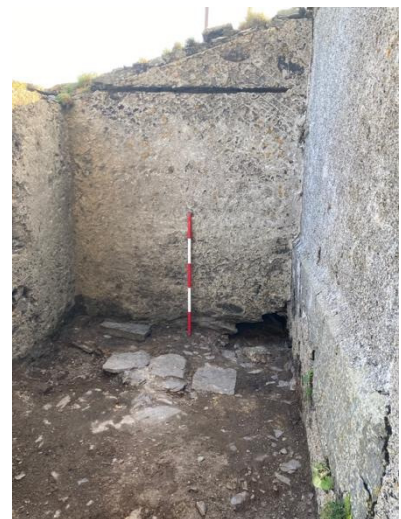
Fig.137. Shed (25), interior looking south.

A horizontal timber was set in the inner face of the north and south walls, probably to anchor the roof (fig. 137). The ghost of the timber roof plate also survived on the top of the east wall and a few large square slates of the roof survived at the northwest corner of the building (fig. 138). The gable ends were capped with sandstone slabs as was the upper end of the roof. No traces of guttering or downpipes survived.

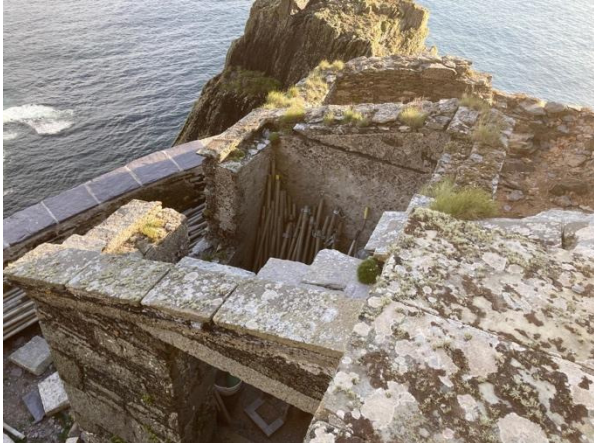
Fig. 138. Shed (25,) roof level, with shed (26) behind.

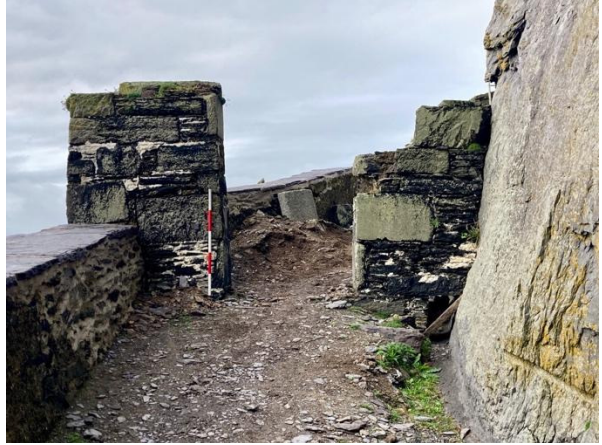
Fig. 139. The outer face of Gateway (27), note capstone behind.

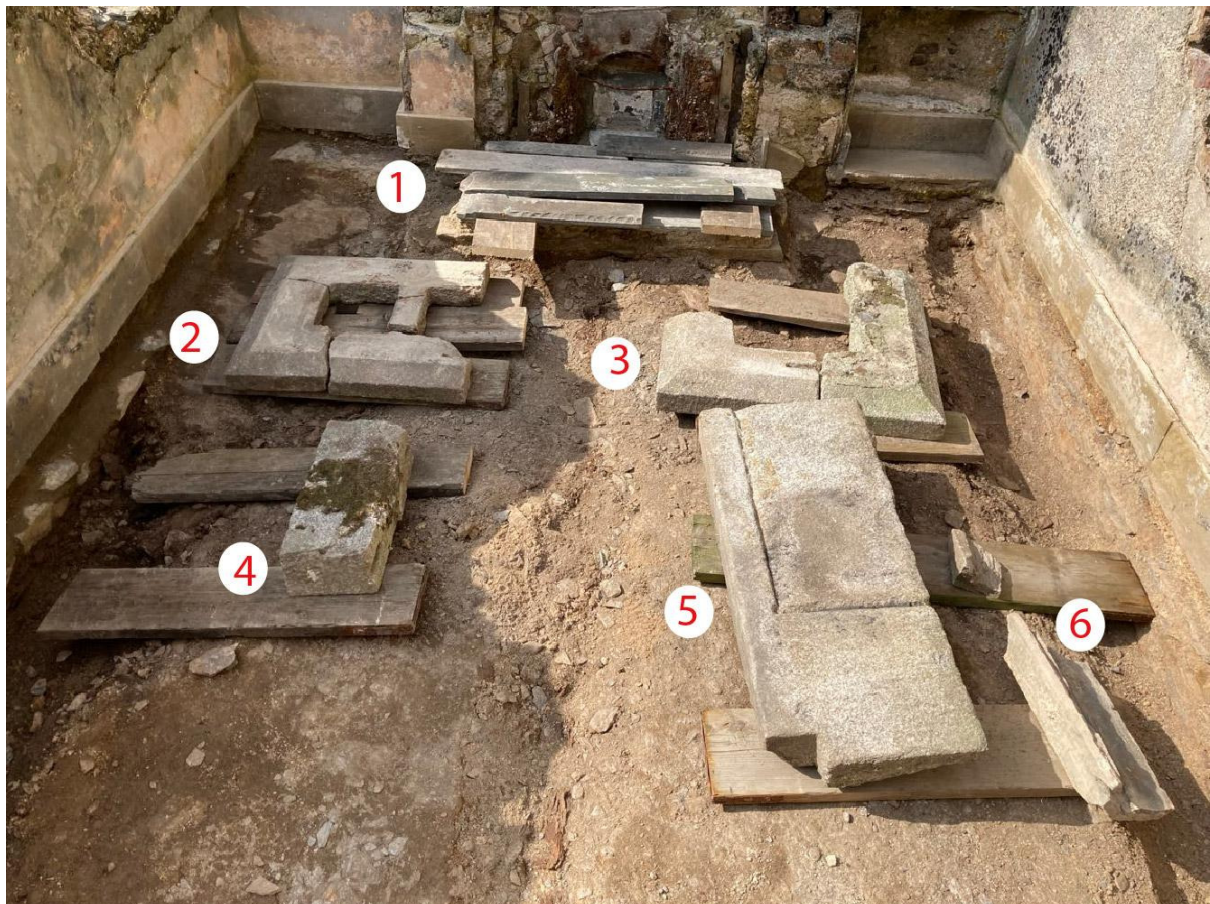
Fig.140. Architectural stone placed in House (1) front room

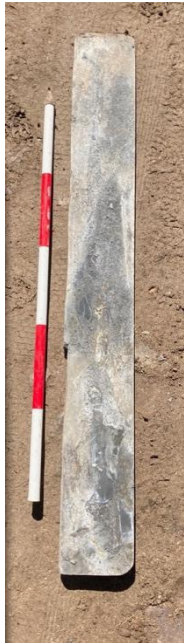
Fig. 141. No. 1.

1- Five lengths of grey sandstone flags, 270-1020mm in length, 150mm in width and 30mm in thickness from the sides of the fireplace and one 1360mm long, 165mm wide and 30mm thick grey sandstone mantelpiece from the fireplace of the front parlour of House (1). All found loose adjacent to the fireplace in the front parlour of House (1).

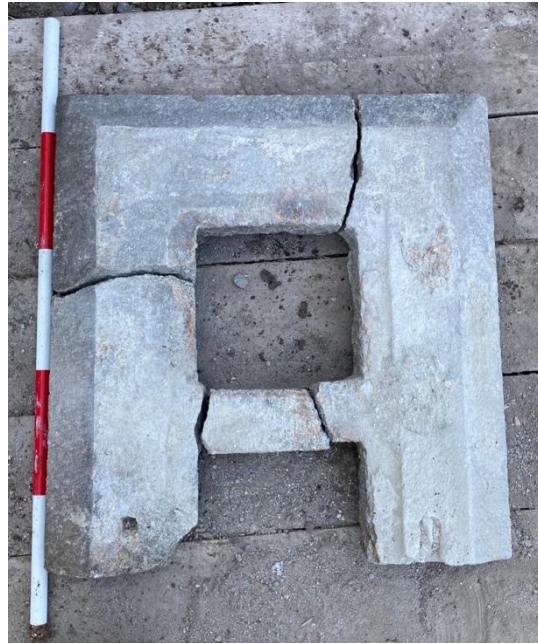
No. 2.

2- Granite chimney top, found in Yard (10). Sockets for base of chimney pots around square (260mm across) opes. L. 760mm. W. 710mm, T. 95mm.

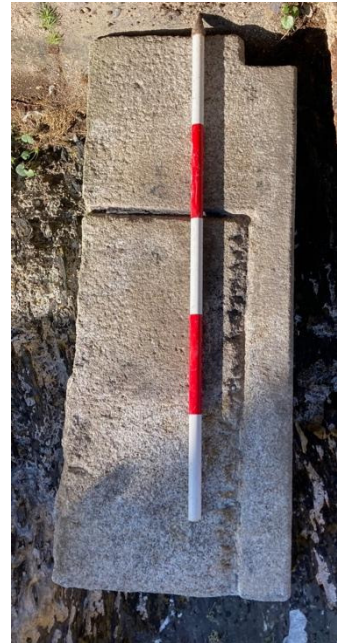
No. 5.

5- Granite side of fireplace in kitchen, with L-shaped channel to hold front and top of range. L. 1150mm, W. 470mm, T. 130mm. Found adjacent to fireplace in kitchen of House (1).

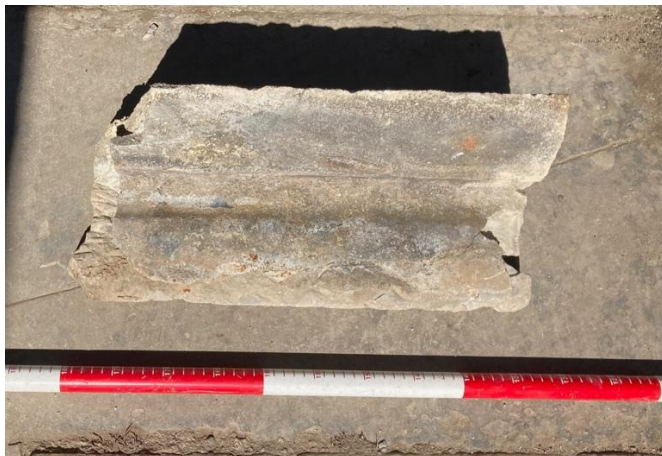
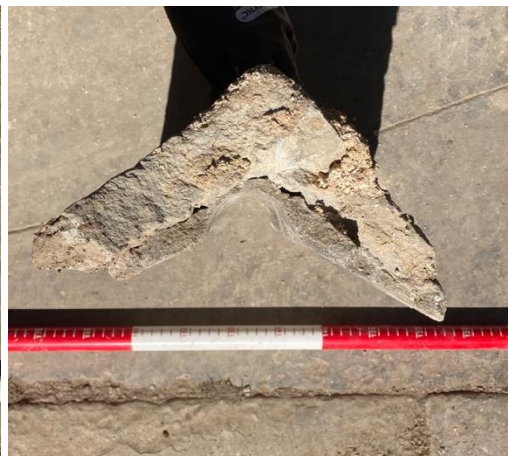
Fig. 142. No. 6, underside.

6- Two fragments of sandstone ridge tile. Longest is 480mm in length and 230mm in width. Found in front parlour and kitchen of House (1).

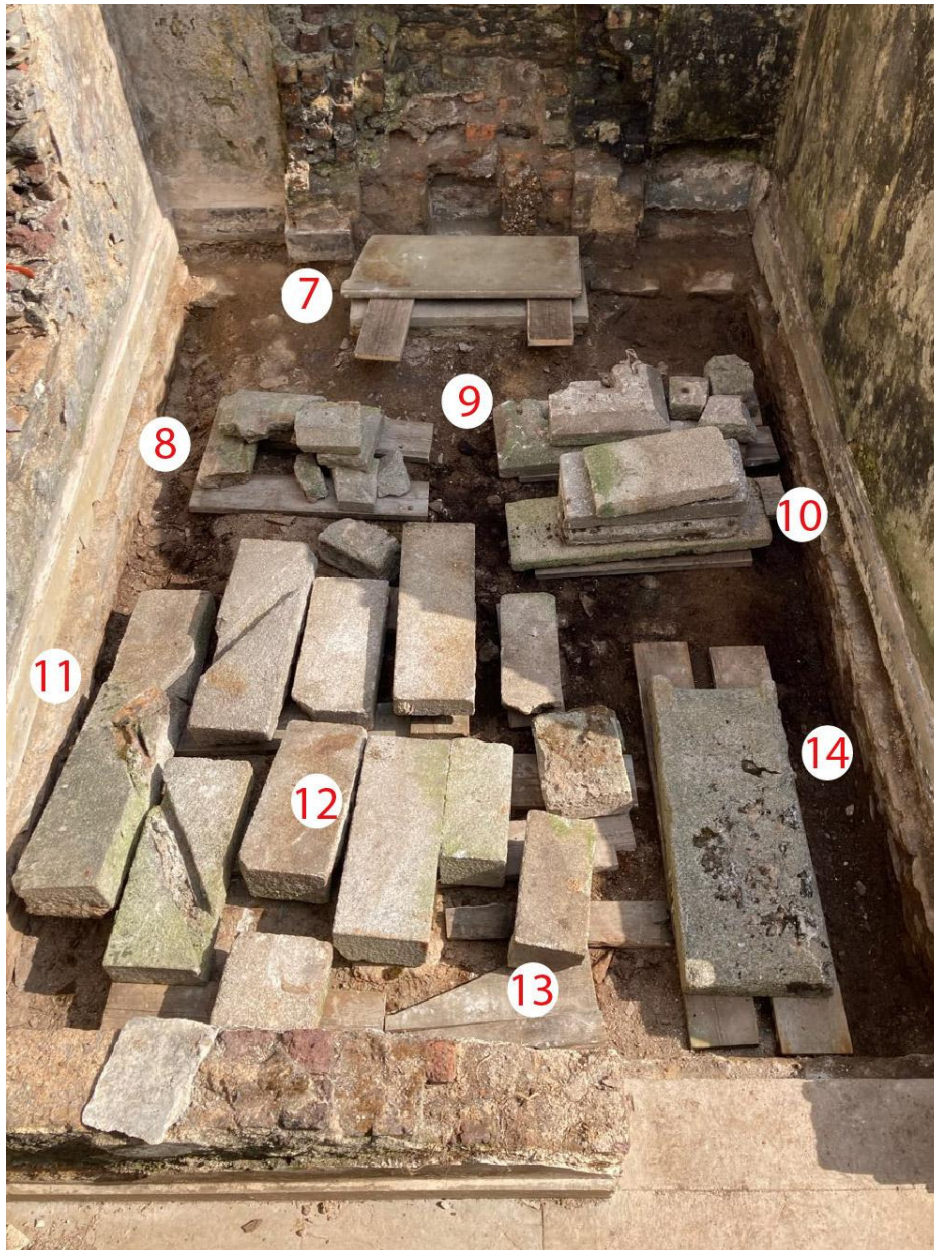
Fig.143. Architectural stone placed in House (2) front room

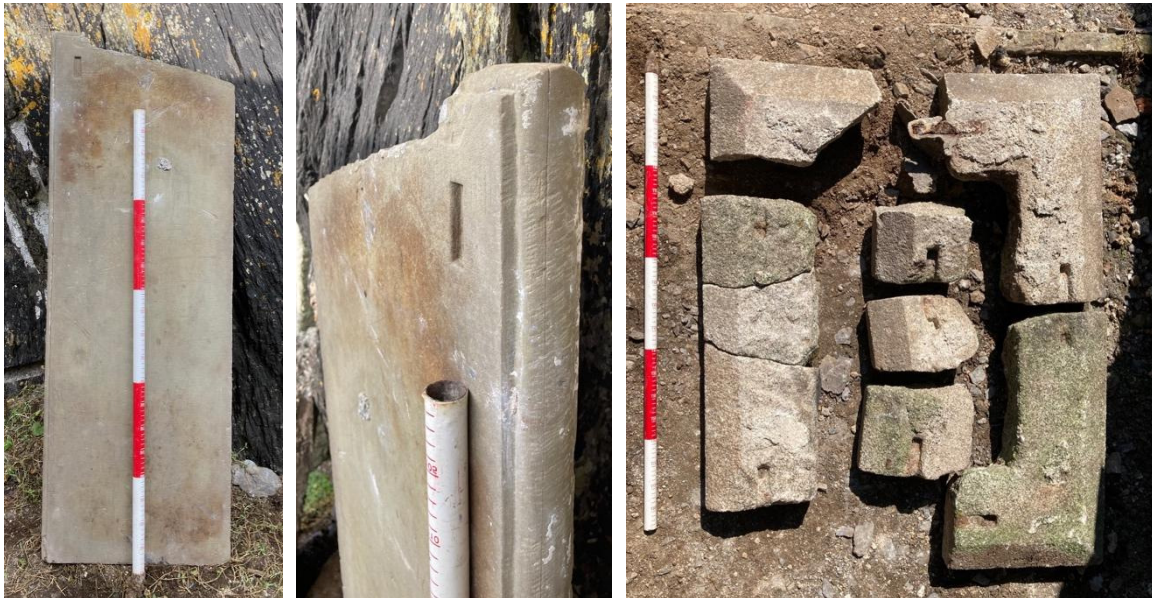
Fig.144. No. 7 & detail of moulded edge.

7- Brown sandstone slab found in front parlour. One end square cut, other end roughly cut on angled line. Nose on front end with raised central flat topped rib. Rectangular (L. 50mm, W. 20mm, deep 5mm) socket cut on top side. Mortar on underside. This slab is a bit of a mystery. The stone of which it is composed appears to be similar to that lining the windows in the Lighthouse. The slab however is the wrong shape to have been a part of one of the lighthouse windows. The slab is clearly reused, the crude cutting of the angled end contrasting with the neath finishes on the other sides. The line of the later cut suggests it may have been reused as a window cill. However the cills of the windows in the houses are all of granite. It was found close to the fireplace in the front room of House 2 but could have derived from the first floor above or from somewhere else entirely.

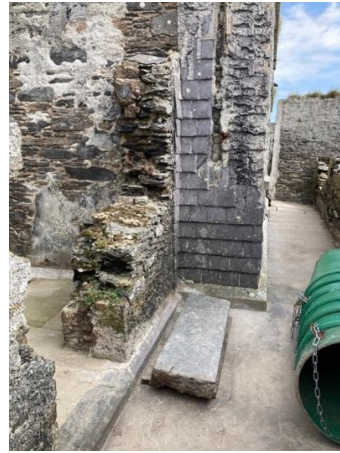
No. 16.

16- Grey sandstone cap, with one sloping end, from the rear wall of shed (3). Found in shed (3). L. 1110mm, W. 360mm, T. 120mm.

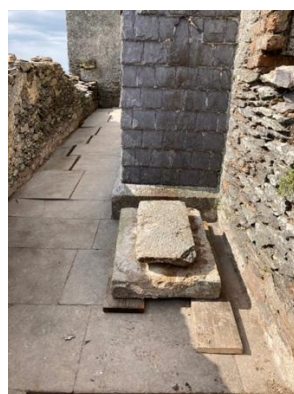
No. 18.

18- Two granite blocks. The smaller one was a capstone from the rear wall of the House (2). The larger one (L. 820mm, W. 610mm, T. 130mm) appears to have been a cap stone from the yard wall south of the shed. None of the other capstones of this wall survived. Found in southeast corner of yard at rear of House (2).

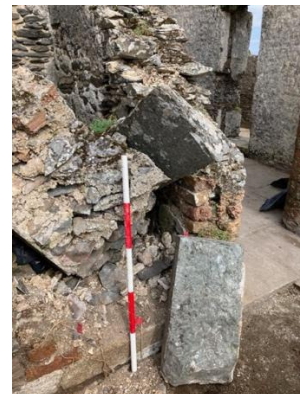
No. 19.

19- Grey sandstone wall cap from south wall of shed (4). L. 670mm, W. 350mm, T. 120mm. Found in southeast corner of yard (9) at rear of shed (4).

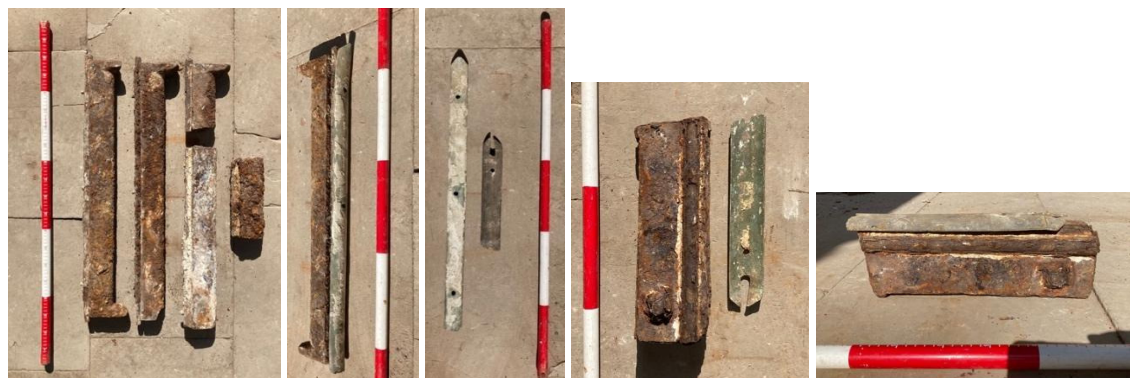
Fig.149. No. 22.

No. 22 with
No. 23 in place.

23- External brass cover of a No. 22. Curved in profile, 37mm in width, with pointed ends and three 12mm dia. holes for bolts. These and the covering brass sections (Nos. 23 & 25) are, and indeed much of the rest of the metalwork from the lighthouse is identical to that on many other lanterns, that on the Valentia lighthouse for example (fig.175.).

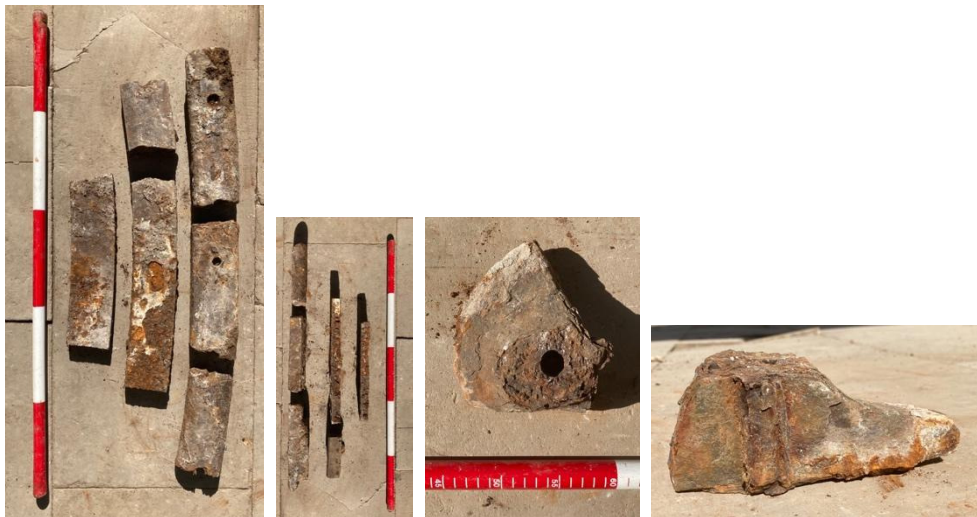
27- Cast iron base of vertical framing of lantern, with 20mm dia. hole in top and 20mm wide and 1.5mm high vertical bar at back to hold glass. L. 155mm, W. 125mm, T. 60mm. Two identical objects (No. 75) were found in Outhouse (3) -see below.

Fig.150. No. 26, tops. No. 26, sides. No. 27, top. No. 27, side.

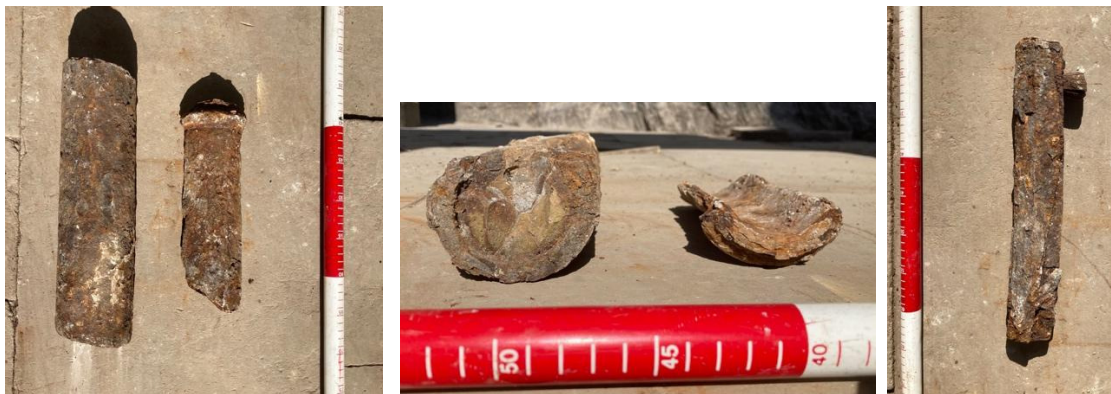
28- Hollow, round section, cast iron columns from the shelf supports inside the mantlet wall.

29- Cast iron bar with attached spike.

Fig.151. No. 28, fronts. No. 28, ends. No. 29.

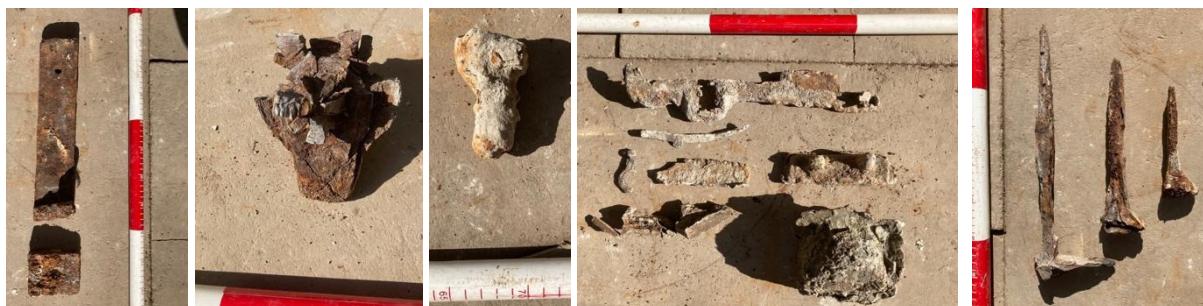
- 30- Fragments of L-shaped and rectangular section cast iron bars.
- 31- Perforated round head of fixture at base of external railings.
- 32- Iron bolt.
- 33- Fragments of lead jointing from mantlet wall or lantern.
- 34- Cast iron spikes.

Fig.152. No. 30. No. 31. No. 32. No. 33. No. 34.
