ARCHAEOLOGICAL EXCAVATION
of the
UPPER LIGHTHOUSE STATION,
SKELLIG MICHAEL, CO. KERRY.

Ministerial Consent No. C001045. Works No. W000428
Excavation Licence No. E005321. Detection device licence No. R00551

Alan R. Hayden,
31st October 2021

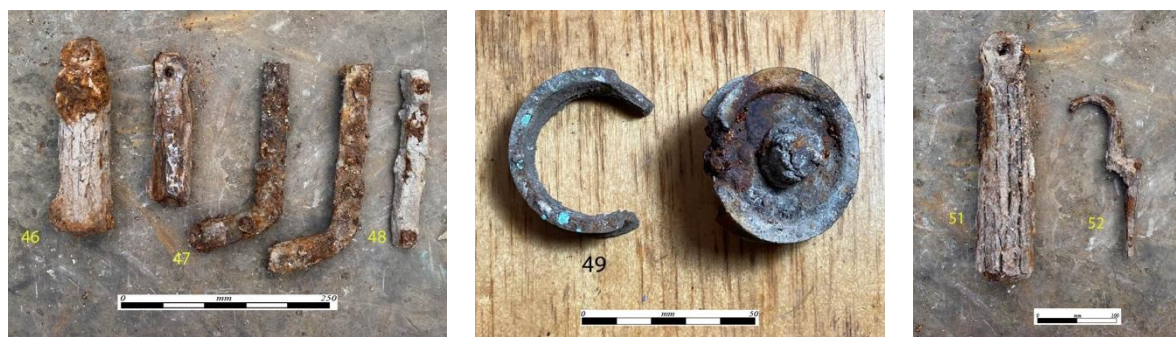
Fig. 156. Find Nos. 46-52.

50- Kitchen. Cast iron bar originally set as reinforcing over the arch over the fireplace. Found in the fireplace. L 1620mm, W. 70mm, T. 40mm. After excavation, placed in fireplace.

The first floor of each of the houses was supported on 40mm wide and 200mm high joists set into sockets in the external walls and laid on a 100mm by 40mm timber wall plate laid in a slot in the wall (figs. 19 & 20). None of the internal walls survived to the height where they would have supported the inner end of the joists. The joists were spaced roughly 300mm apart but there were no joist holes above the shallow arches over the front and rear windows. Instead, the last joist to each side of the window head was doubled up and they would have supported a transverse timber holding the outer end of the joists inside the window. There were also large slots to hold the top of the stairs and to support the floor over the hallway in front of the stairs on either side of the party wall. (figs. 30 & 45). Apart from a few *in situ* rotted fragments of the ends of some of the joists and bits of the wall plate no timbers of the floor survived and they were likely removed for firewood or reuse elsewhere. The stumps of a few cast iron wall hooks to secure the timber wall plates survived *in situ* and a larger number were loose (find nos. 52 (fig. 156), 69 (fig. 159) & 82 (fig. 163)) in the fills of the houses.

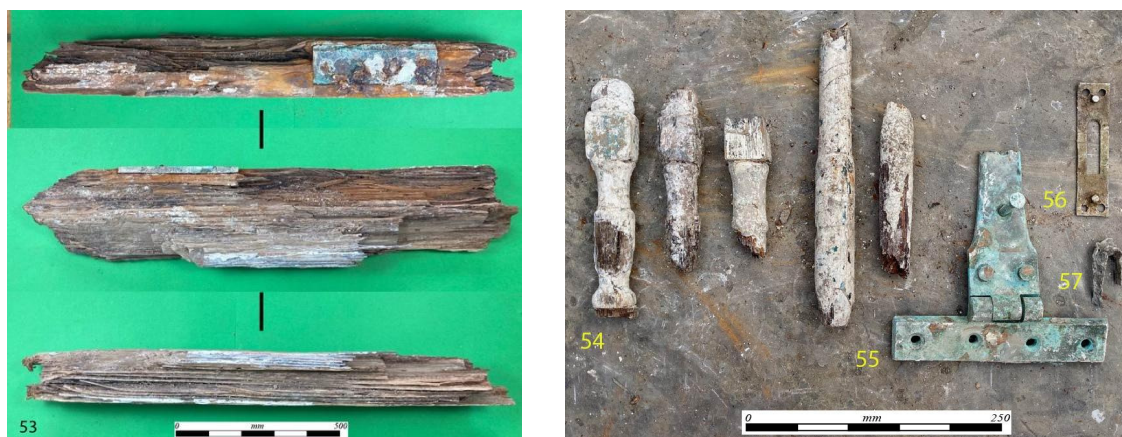
Fig. 157. Find Nos. 53-57.

55*- Hall. Hinge from front door- identical to hinges on front door of northern house in the Lower Station (fig. 171).

56*- Hall. Brass plate for receiver of door lock.

However, not surprisingly, in terms of structural detail and architecture the houses of the two stations are identical. The sandstone rubble and red-brick walls of the houses and yards were erected on top of chamfered granite and sandstone plinths. The houses had identical cast iron porches, granite door and window cills, doors and windows. Photographs from 1906-9 show that the Lower Station houses also originally had pitched roofs and external slate weathering and that the water from the gutters on the front of the houses was fed to downpipes on the back of the houses (fig. 167). There were also the same sandstone skirting in the rooms of the Lower Station houses although only one slab appears to survive there (fig. 171) and the same hinges were used on the front doors of the houses of both stations (figs. 157 & 171).

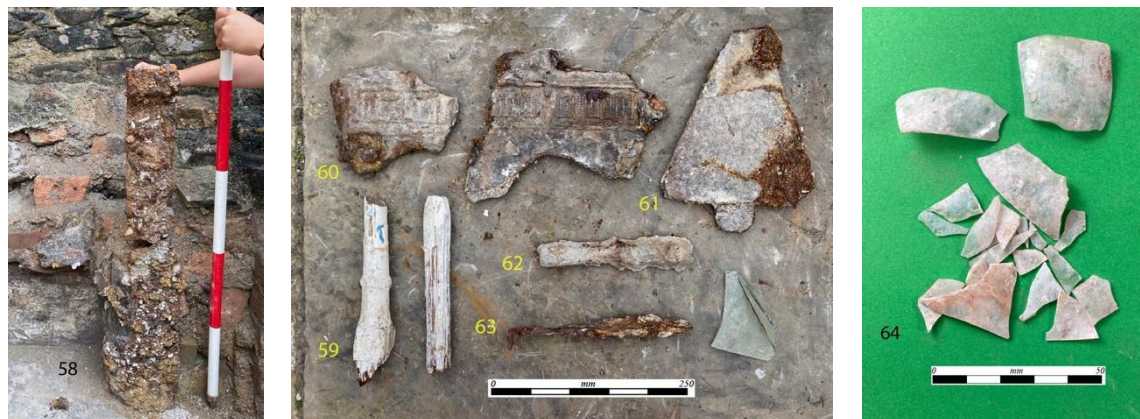
Fig. 158. Find Nos. 58-64.

- 58- Front parlour. Decorated fragment of cast iron from the south side of the fireplace. After excavation placed in fireplace.
- 59*- Front parlour. 2 fragments of turned wooden balustrades from bannisters of stairs.
- 60- Front parlour. 2 decorated cast-iron fragments from fireplace in front parlour.
- 61- Front parlour. Cast iron piece from range in rear Kitchen.
- 62- Front parlour. Lead encased iron jointing bar.
- 63- Front parlour. L-shaped iron bracket
- 64*- Front parlour. Fragments of fine glass vessel or drinking glass.

Each kitchen had a cast iron range flanked by large upright granite slabs set in a 2.30m wide chimney breast at its outer end. The range, along with one of the granite side stones had been removed in House (1) (fig. 39) while its other side stone (find No. 5, fig. 141) and fragments of cast iron elements from the range lay loose on the floor. The arch above the range had also been removed and an iron bar (find No. 50) which originally lay over it was found in the fireplace. In House (2) the range was more intact, although far from complete (figs. 40 & 41). It consisted of two cast iron ovens / fireboxes each with a small flue behind them flanking the central brick-backed fireplace with firebars and grate, all between two large upright granite slabs which had carved grooves in them to hold the front and top of the range. Many loose fragments (find nos. 61 (fig. 158) & 65 (fig. 159)) from the range were found

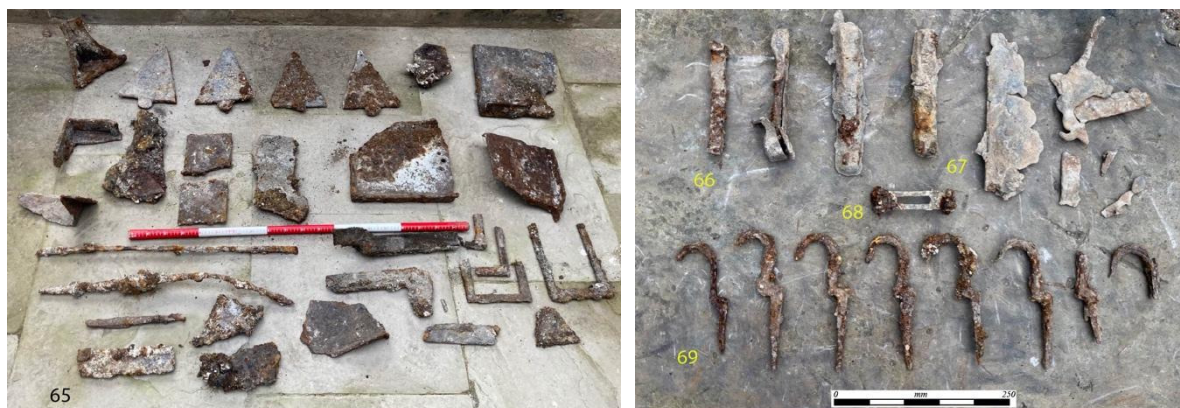
Fig. 159. Find Nos. 65-69.

- 65- Kitchen. Cast iron fragments from the kitchen range. After excavation placed under range in kitchen fireplace.
- 66- Kitchen. 4 Lead encased iron jointing bars.
- 67- Kitchen. Fragments of melted lead.
- 68*- Kitchen. Brass plate for lock receiver.
- 69- Kitchen. 8 iron wall hooks.
- 70*- Kitchen. 2 fragments of wooden mullion with grooves on sides for glazing.
- 71- Kitchen. Folded sheet of lead flashing.
- 72- Kitchen. Threaded and square-headed iron bolt.
- 73*- Kitchen. Fragments of glass vessel or drinking glass.
- 74*- Kitchen. Copper alloy thimble.

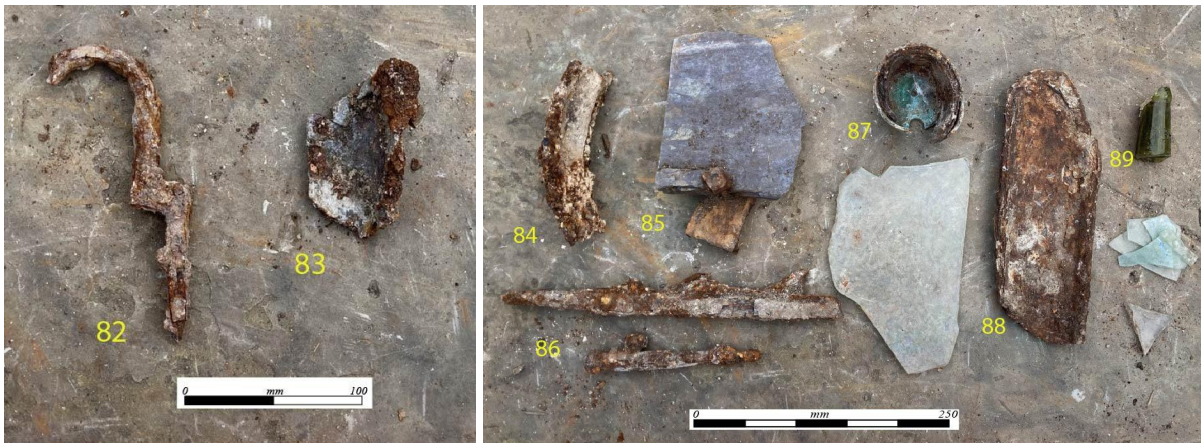
Fig. 163. Find Nos. 82-89.

- 84- Fragment of curved cast iron with ribbed edge.
- 85- Thick perforated Valentia slate attached by iron bolt to timber fragment.
- 86- 2 pointed iron spikes, probably to hold pipes or guttering
- 87*- Thick copper-alloy cylinder with central hole and semi-circular opening at edge of base.
- 88- Fragment of column supporting cleaning shelf in upper floor of Lighthouse (11).
- 89- Neck sherd of 20th-century ½ pt beer bottle.

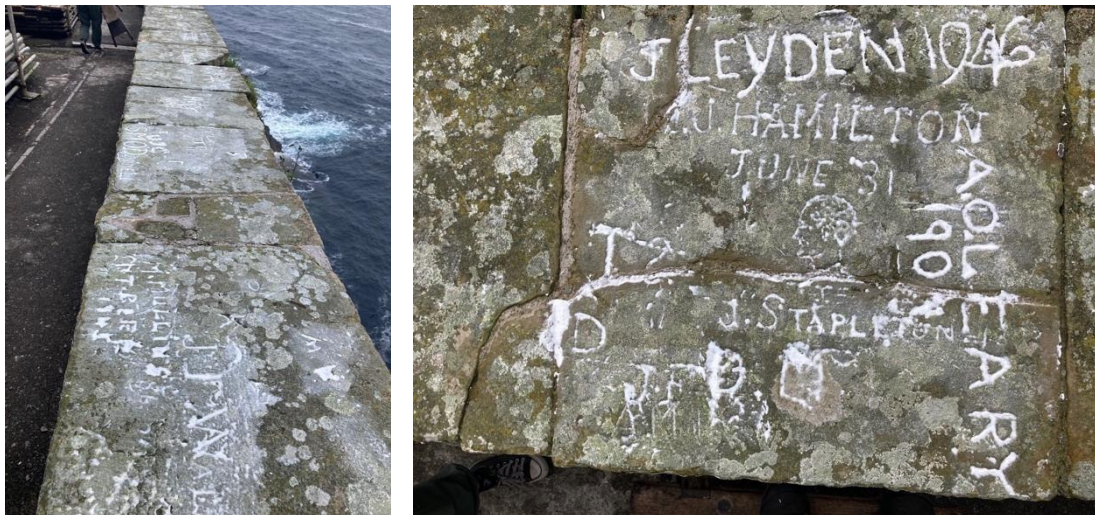
Fig.166. Some of the names carved into the top of the parapet wall beside the Lower Station filled with shaving foam to aid their recording.

In addition to the excavation works undertaken on Skellig this year, the graffiti carved into the rocks and structures on the island has also been recorded as part of a proposed anthropological study of the lighthouses and lighthouse men (fig. 166). The names of several keepers, as well as individuals from Valentia and Castletownbere are included. It is probable that some of the names recorded may also have been carpenters, masons (especially the very finely wrought signatures) or others who worked on the Lighthouses. The 1901 and 1911 census returns, for example, record carpenters, masons and workmen along with the keepers on the Island.

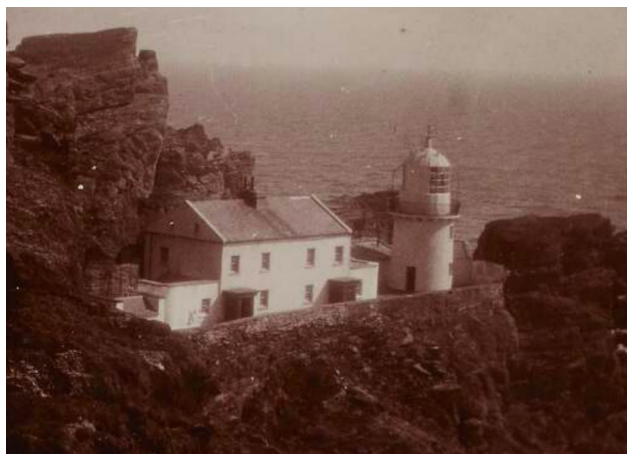
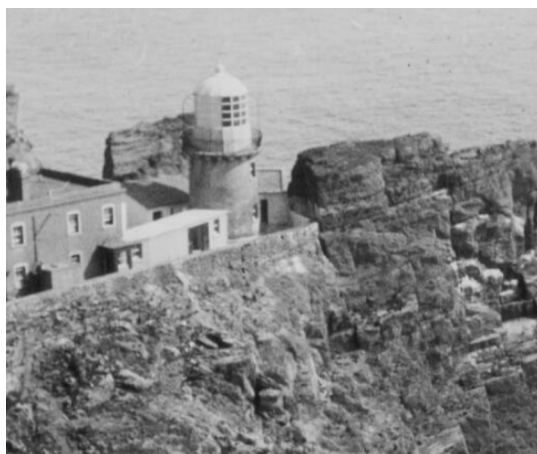
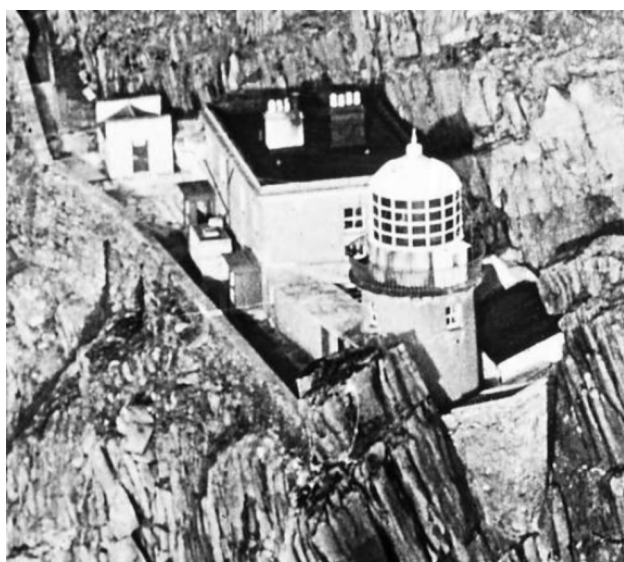
Fig. 167. The Lower Station in 1906.

Fig. 168. The Lower Station before the 1960s after the original roof of the houses was removed & the corridor was added to the tower.

Fig. 169. Another pre-1960s view of the Lower Station.

In its plan, architecture and construction, the Lower Station was originally very similar to the Upper, although there were of course some significant differences. The Lower Station was heavily altered in c.1911 and again in the 1960s and today bears but little resemblance to its original form. Several old photographs survive showing it at different stages of its evolution (figs. 167-170).

The original pitched roof of the Lower Station buildings was replaced with a flat one in c. 1911 and a corridor was added linking the houses to the Lighthouse, which involved the removal of the walled side yard of the southern house (figs. 167-169). The line of its rounded corner is however still preserved in the paving outside the house. After the moving of the lighthouse families ashore to the new houses on Valentia Island there was no need for two

The Lower Lighthouse was demolished in the 1960s but photographs of it survive (figs. 167-169). It and its lantern are identical to the Upper Lighthouse and it differs only in the orientation of its windows and doors. While it is not totally clear it also appears to have had the same external slate weathering as the Upper Lighthouse.

The 1820s shed to the north of the Lower Station still stands but its original pitched roof and high gables visible in old photographs were replaced with a flat roof (figs. 167 & 169).

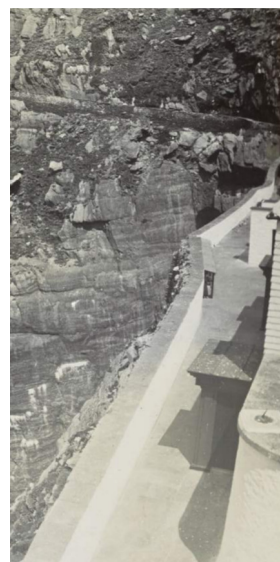
Fig. 170. The slate weathering on the Lower Station.

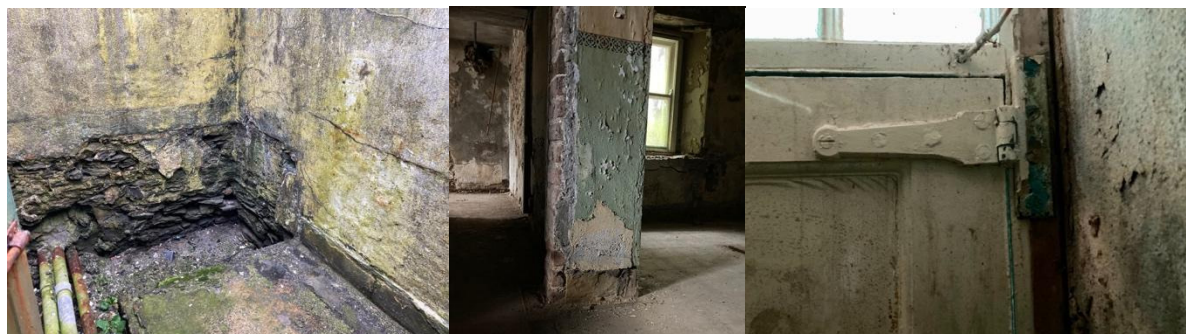
Fig.171. (l. to r.). The toilet of the Lower Station with its sandstone skirting; possibly the last surviving original sandstone skirting in the houses of the Lower Station, and a hinge on the original front door in the Lower Station Houses, which is identical to that found in the Upper Station (see find. No 55, fig. 157).

existed at the time as it is very similar (although larger) than those in the Upper Station. It has the same sandstone skirting as in the Upper Station buildings for example (fig. 171). It was not possible to locate toilets in the yards of the Lower Station as they were not on the cliff edge.

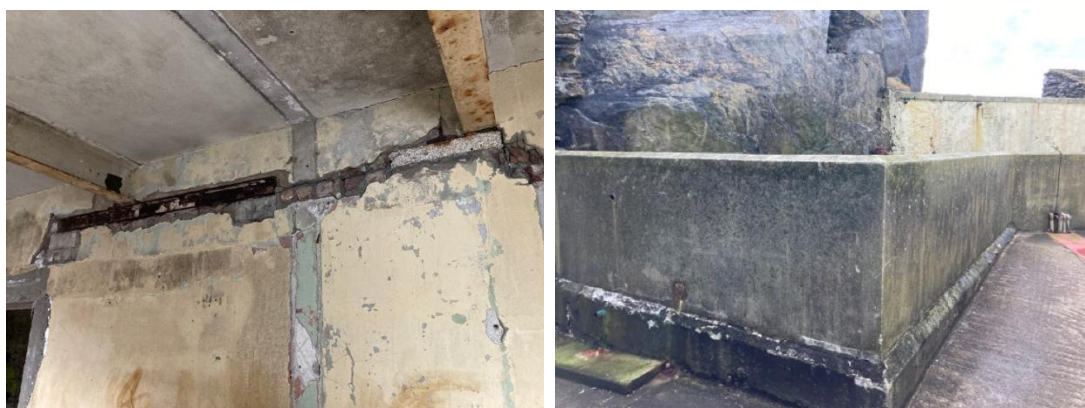
Fig. 172. (l.) Granite reused from the Upper Station, in this case a granite wall cap & (r.) The surviving chamfered plinth at the base of the demolished sheds in the Lower Station.

The early lean-to sheds at the back of the Lower Lighthouse tower were demolished to allow for the installation of diesel storage tanks. However, the base of the original wall of the eastern sheds survive. It consists of the familiar chamfered granite and sandstone plinth (fig. 172).

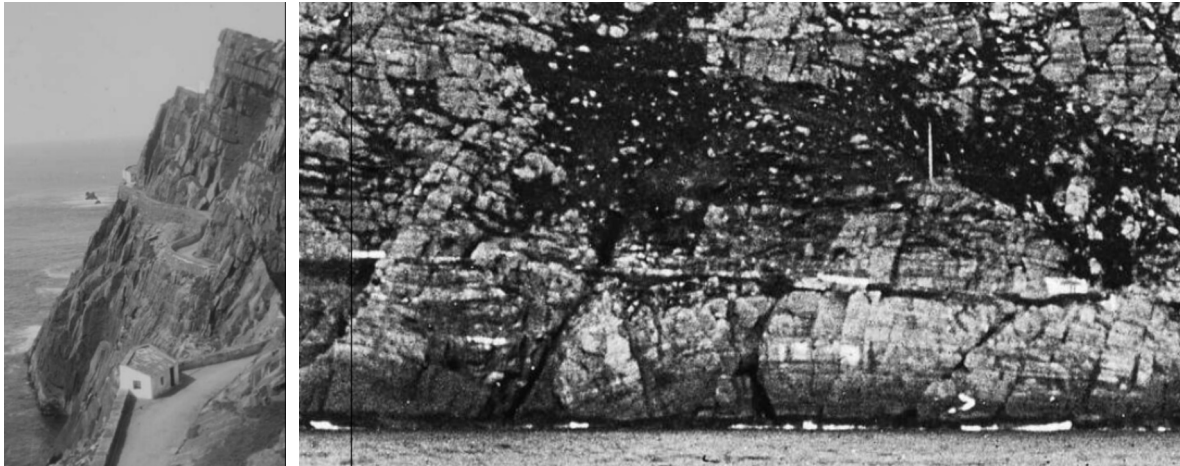
Fig. 173. Photographs showing the sheds on the Lower Lighthouse Road & the flagstaff by the Wailing Woman.

The 1830s map and old photographs shows a number of other sheds on the roadway up to the Lower Station and one on a broad platform just below the flagstaff off the South Steps (fig. 173). The base of the latter building and its terrace survives and was excavated in 2012. The toilet servicing it also still survives slightly higher up. The sheds which stood where the guides' and workmens' huts now stand were demolished. However, that by the helipad still survives (fig. 174). Its original roof, the tops of its gables and its doors and windows were replaced and its walls were rendered with sand and cement. However, the original walls with their rounded corners still stand on a chamfered granite and sandstone plinth and the door cills have the same cut down centre evident in the Upper and Lower Station houses. The hinges on the replaced doors are identical to those in the small lean-to sheds erected east of the Lower Station. The style of the hinges suggests they date to the Edwardian period.

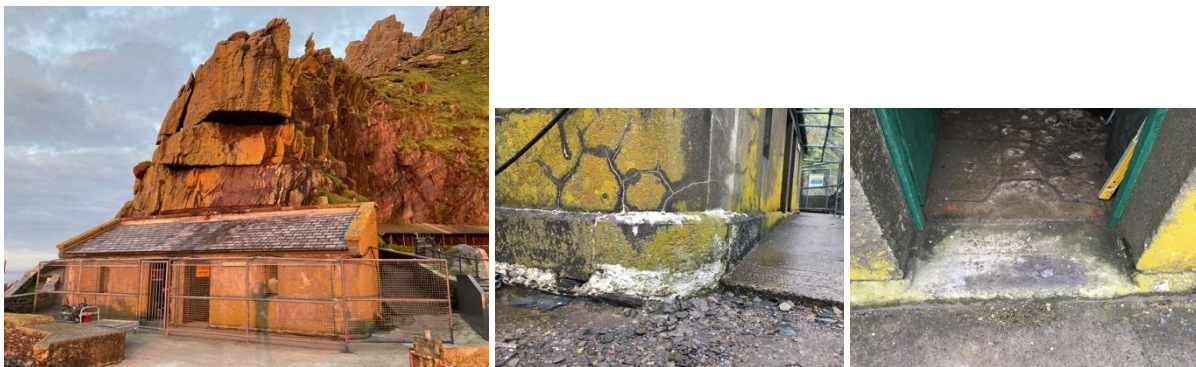
Fig. 174. The shed by the helipad and details of its plinth & door cills.

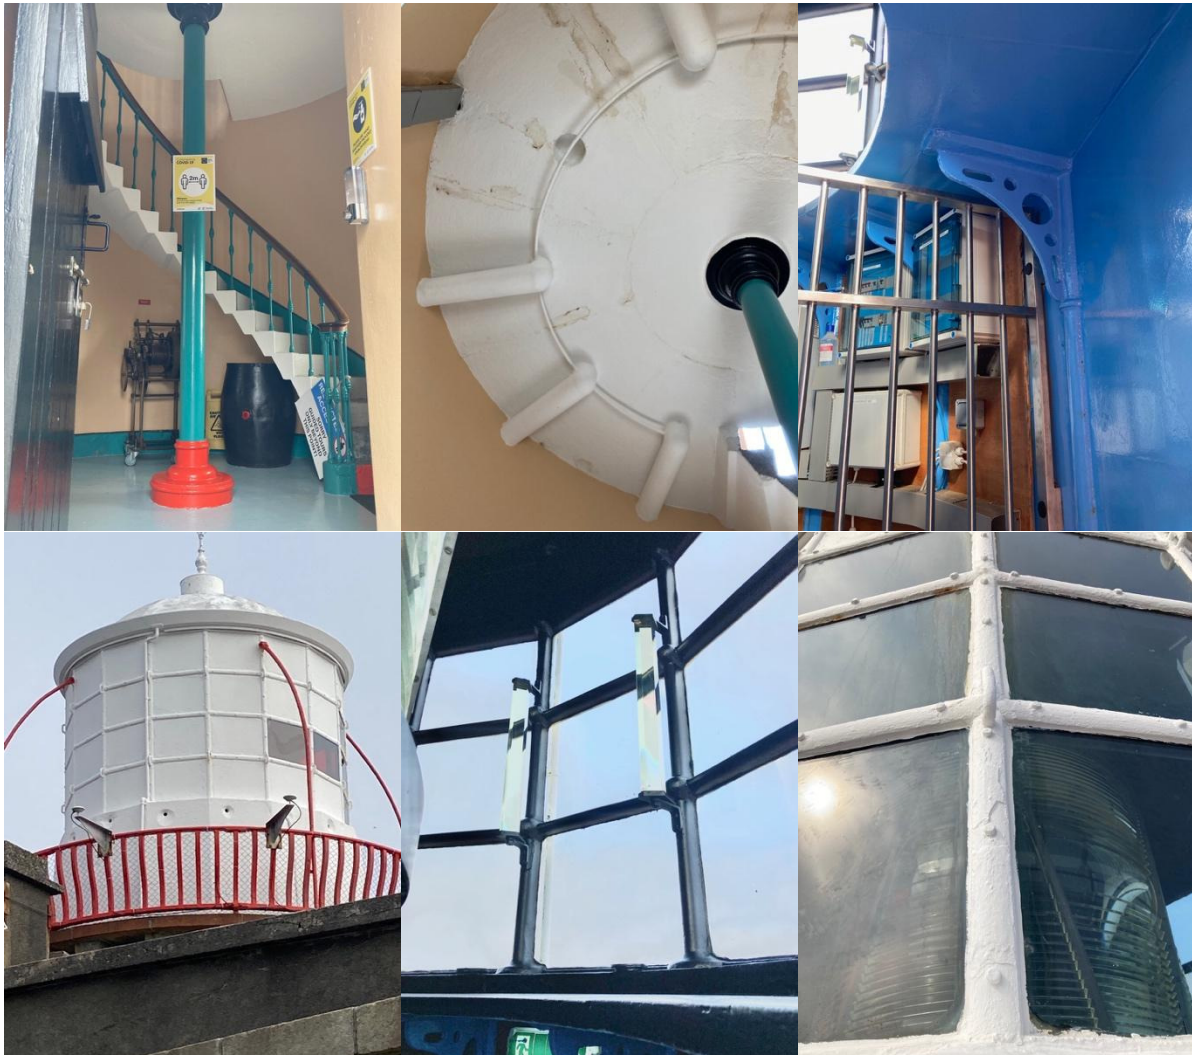
Fig.175. Details of the stairs, underside of the top floor & the lantern of the Valentia Island lighthouse. Virtually identical to the lighthouses on Skellig, apart from the (possibly later) central column supporting the floors. Other details of the station, such as the use of the same yellow sandstone paving and granite wall caps closely parallel those of the Skellig stations.

23- External brass cover of a No. 22. Curved in profile, 37mm in width, with pointed ends and three 12mm dia. holes for bolts. These and the covering brass sections (Nos. 23 & 25) are, and indeed much of the rest of the metalwork from the lighthouse is identical to that on many other lanterns, that on the Valentia lighthouse for example (fig.175.).

45- Extremely heavy, 4.11m-long cast iron pole, found west of lighthouse. Composed of three sections of pipe, of 140mm dia., 100mm dia. and 95mm dia. separated by moulded collars. It has a 210mm dia., 140mm high basal collar with two bolts in its base. Solid, 550mm-long narrow end with central hole. It is not clear what this object was. Its length and the distances between the collars do not correspond to the floor levels in the lighthouse and so it may not have been a central supporting column in the ground and first floors, as noted in the Valentia Lighthouse (fig. 175).

The Skellig lighthouse towers and their lanterns are similar to many others, built both before and after and attest to the success of the design. Fig. 175 shows details of the lighthouse on Valentia Island, which is almost identical to those on Skellig but was completed in 1841. It is however not yet clear where this design originated; it seems most likely it came

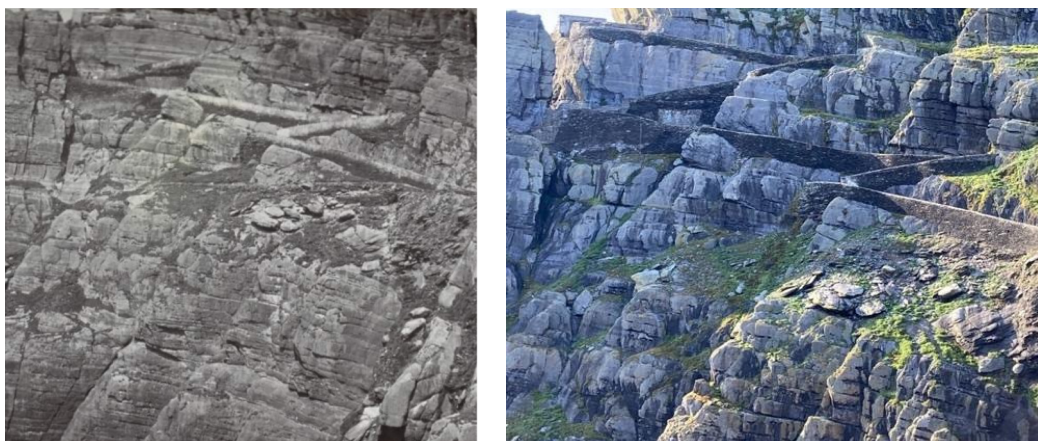
Fig. 176. The wall below the Upper Lighthouse Roadway in 1906 (l.) and today (r.).

There is a very ruinous drystone wall following a long sloping ledge below the longest steepest section of the Upper Lighthouse Roadway. It has substantially deteriorated and in danger of disappearing altogether (fig. 176). While it is likely to have been built by the Lighthouse men to stop rocks falling down into Seal Cove, its alignment around an area of solid rock seems unusual. It also appears to be joined with the outer wall of the Lighthouse Roadway at its east end, where it appears on old photographs to possibly be of mortar bonded construction. It is not beyond the bounds of possibility that it could represent a first attempt to cross this difficult area with its steep slopes which was abandoned in favour of the completed route of the roadway.
