**Archaeological Impact and Mitigation Strategy for the installation of  
Three Crash Decks, Lighthouse Roadway, Skellig Michael, Co. Kerry**  
*Ministerial Consent C0001053, Excavation license no. E005336 & detection license no. R000560*

*Alan R. Hayden  
Archaeological Projects Ltd.,  
July 2022.*

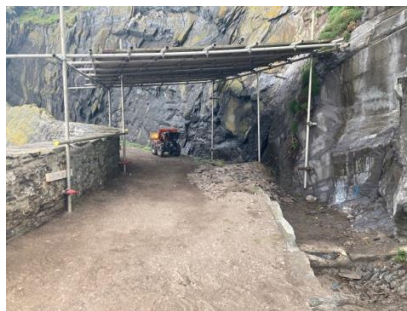
Fig 2. Photograph of location of Crash Deck 1 and plan of proposed foundations Crash Deck 1.

**Crash Deck 1-** (fig. 2). Lower lighthouse roadway, beside men's huts. Not archaeologically excavated and recorded. Fallen material from a recent sweep is obscuring the archaeological features will have to be removed to reveal the underlying archaeological features and the area will have to be planned and recorded archaeologically before construction begins

The foundations for the beam on the inner side of the roadway will be cut through the vertically set stone floor of the lateral drain. Two of the cross beams will cut through the edging on the inner side of the roadway and the third will cut through the concrete wall of the 'pond'. The inner end of the first beam (as marked by a blue painted rebar on site) and the line of the inner beam at the back of the first bay appears to lie too far towards the cliff face and would require removal of a substantial part of the cliff face above modern ground level. This would be unacceptable and so the lines of these beams will have to be altered to avoid this impact
