Excavations in the Upper Lighthouse Station, Skellig Michael, Co. Kerry

Ministerial Consent No. C001045. Works No. W000428

Alan R. Hayden

Archaeological Projects Ltd.

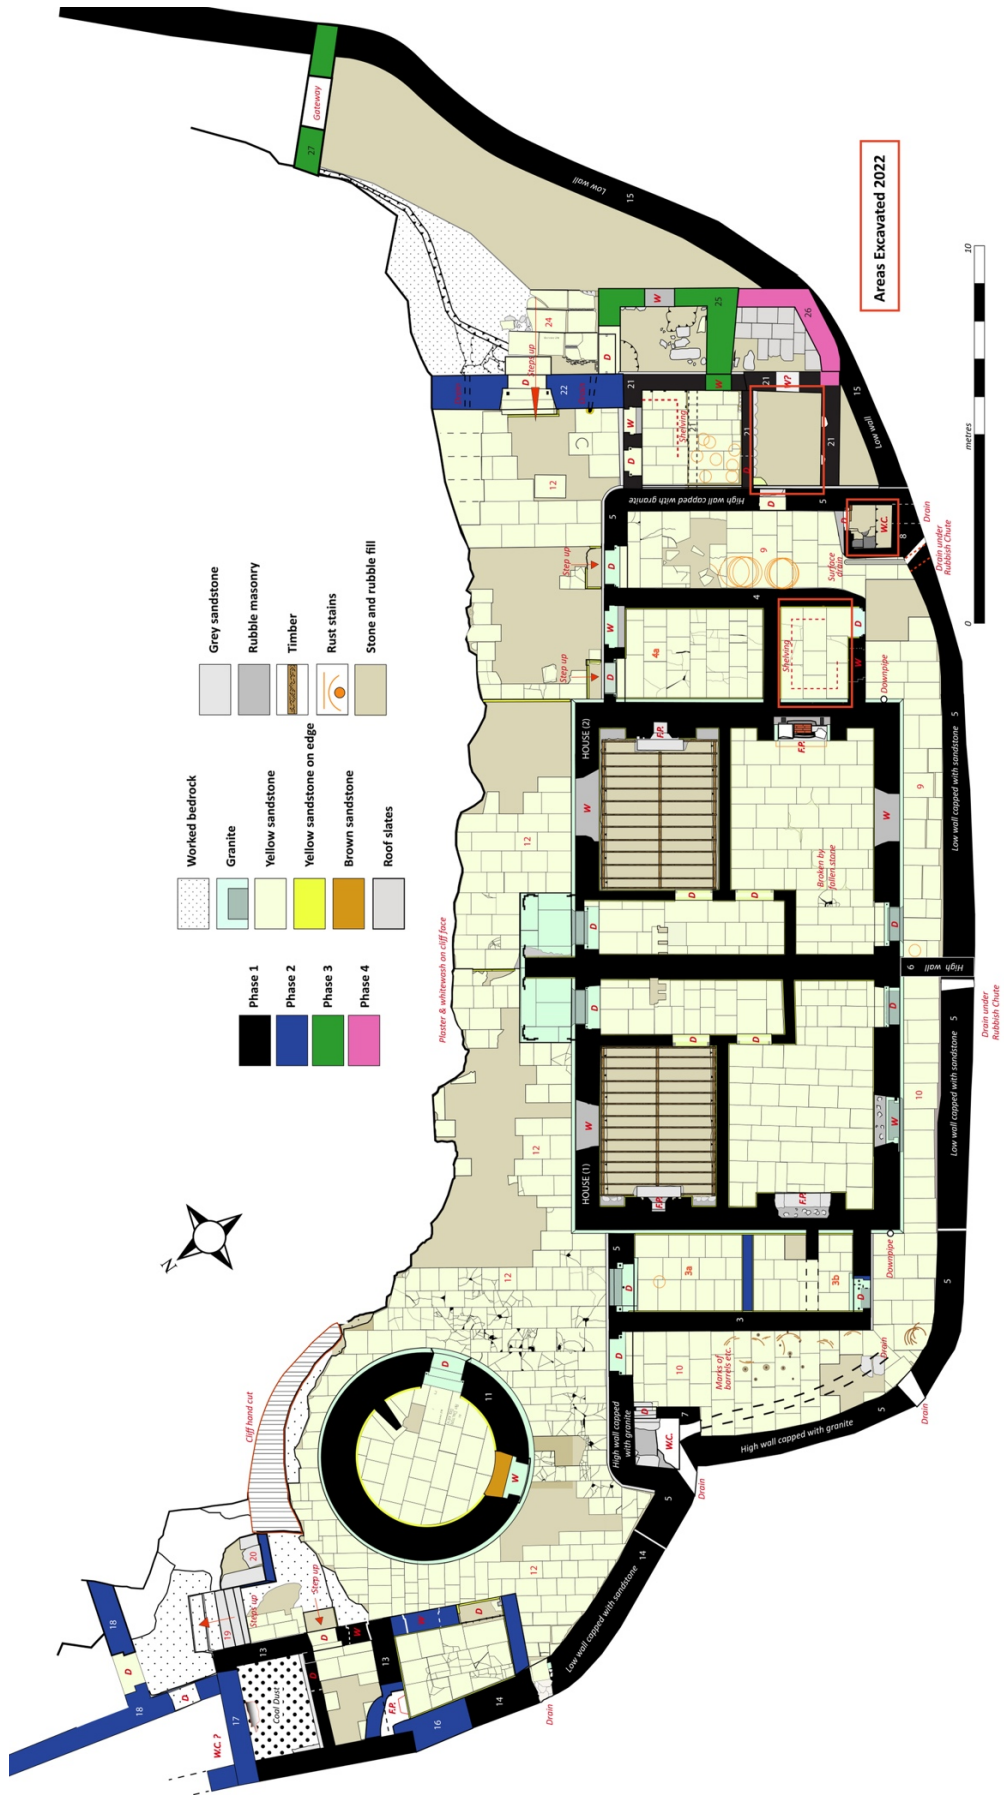
Fig. 1. Plan of areas excavated in 2022 and resulting changes to phasing.

Three small areas within the Upper Lighthouse station which could not be excavated in 2021 due to the presence of bird nests were excavated in June 2022 (fig. 1). The three areas were:

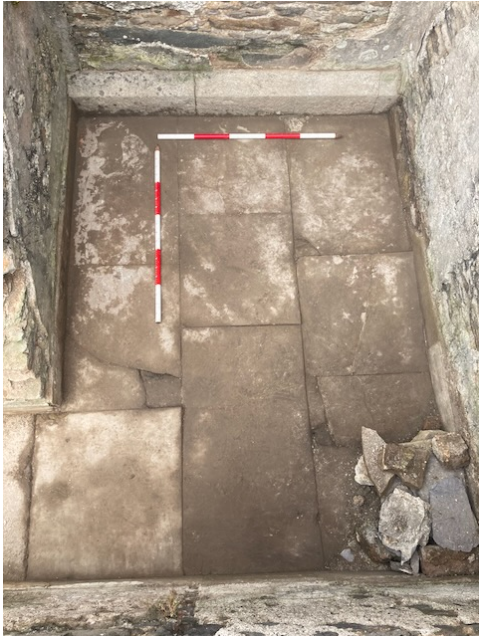
Fig. 2. Shed 4a after excavation.

This small room was cleared of the remaining rubble which revealed its intact yellow Yorkshire Sandstone flagged floor (figs 2 & 3). It was cracked in places due to the impact of a large fallen stoner which demolished its southern wall that held a window and the doorway into the shed. There were also yellow sandstone skirtings on the internal faces of the walls, except the west wall where the plinth supporting the adjoining house was exposed (fig. 4.) Vertical scars of timber uprights supporting shelving survived on the internal face of the walls with corresponding small sockets in the sandstone floor slabs (figs 4 -7).

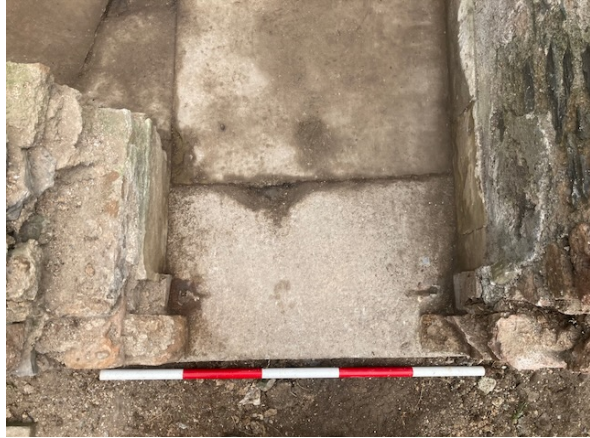
Fig. 3. Detail of doorway of shed 4a.

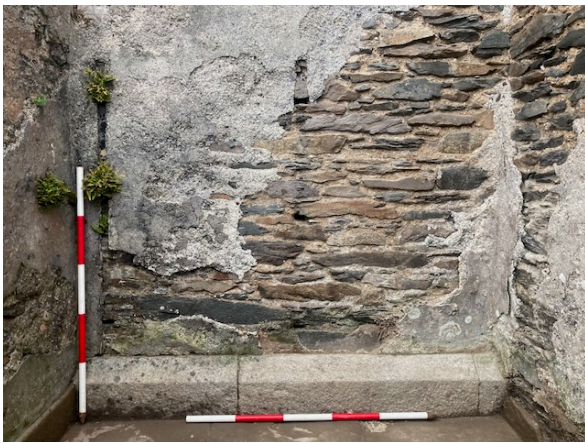
Fig. 4. West wall of shed 4a, scars of shelving.

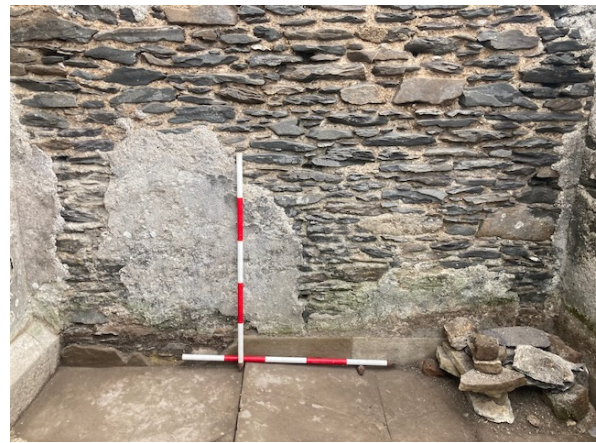
Fig. 5. North wall of shed 4a, scars of shelving.

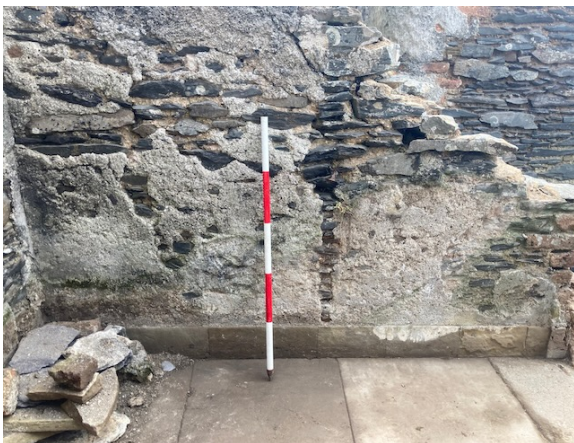
Fig. 6. East wall of shed 4a, scars of shelving.

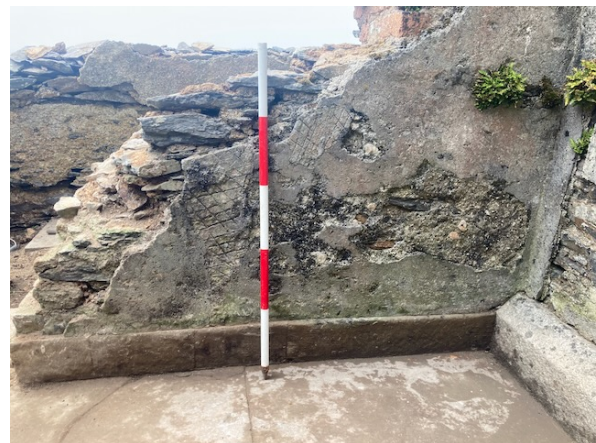
Fig. 7. South wall of shed 4a, scars of shelving.

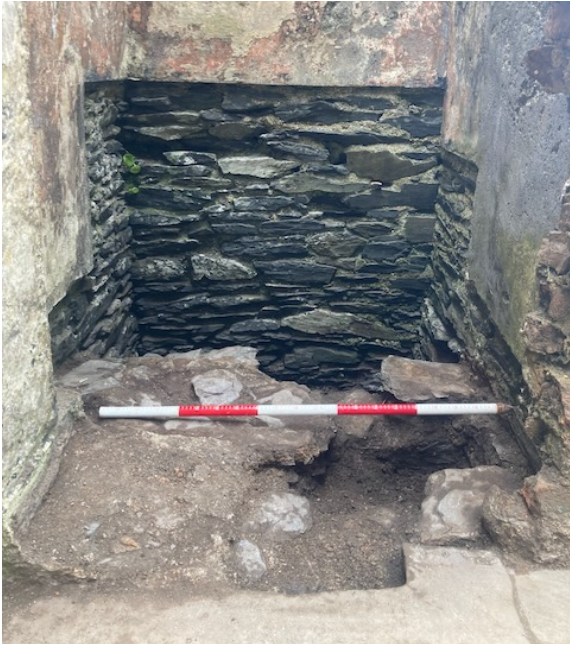
Fig. 8. Toilet 8 after excavation from north.

All but the basal 300mm of deposits were removed from the chute of the toilet (figs 8 & 9). The basal deposits were left *in situ* as they contained a puffin nest but can be easily removed at a later stage when required. There were no signs of an underfloor drain entering this toilet as had been discovered in that of House 1.

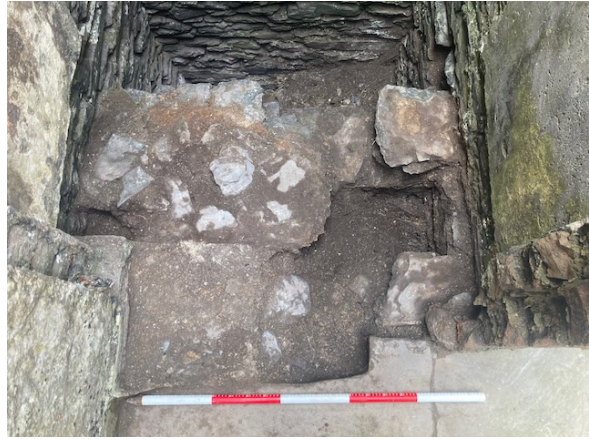
Fig. 9. Toilet 8 after excavation from above.

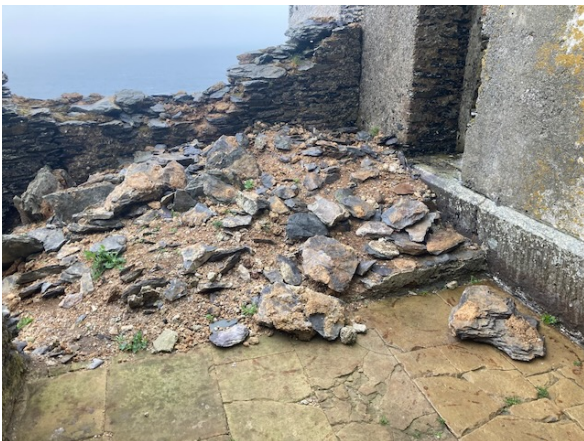
Fig. 10. Shed 21, south end before excavation.

The southern element of shed (21), which consisted of three rooms, was excavated in 2022. A depth of more than a metre of rubble survived in the south room (fig. 10). This excavation evidenced that its floor had been removed and its internal ground level was lowered (fig. 12) when shed (26) was later added to its east end (see below). It is possible that it originally or at one time had a suspended floor as there were three holes in the south wall at the same level as the floor of the other two rooms of the shed (fig. 11).

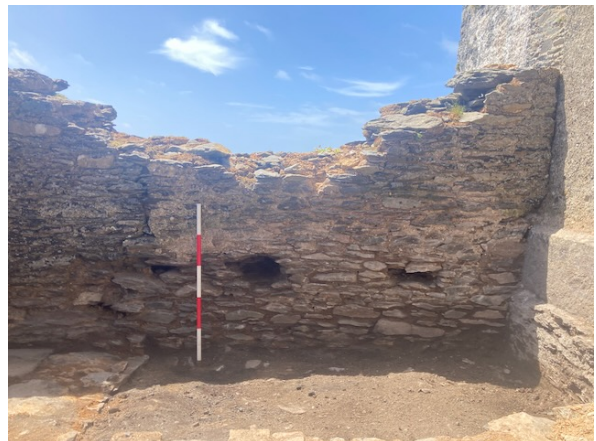
Fig. 11. Shed 21, slots in north wall.

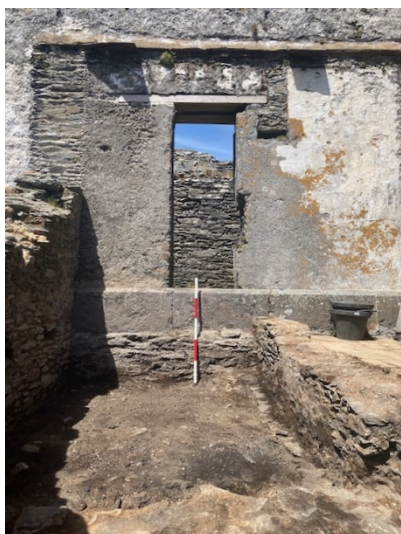
Fig. 12. Shed 21, after excavation, looking west.

There were traces of mortar foundations in the northwest corner of the east room (fig. 12) outside the doorway which led out from the main enclosure. These might have formerly held steps leading down to the lowered floor level. The fills of shed (21) consisted largely of the collapsed remains of the walls on its north and south sides. A large part of the brick wall on its north side collapsed as one large chunk which was overlain by the collapse of a smaller area of the upper part of the external sandstone masonry wall on the south.

In 2021 it was thought that the three roomed shed (21) was a later addition to the complex. However the remains revealed in 2022 suggested it was part of the original design although built abutting the east side of the wall of the complex. The doorway in the east wall of the main enclosure (fig. 12) which leads to the southern of the three rooms in shed (21) displayed no signs of having been broken through the wall and therefore on present evidence was primary.

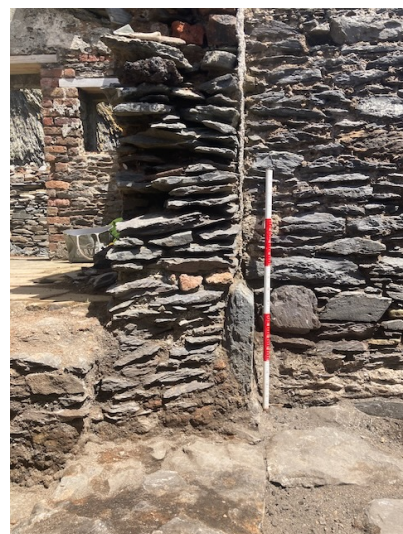
Fig. 13. Shed 21, east wall with fake plinth.

The wall dividing the north and central sheds was removed joining the two rooms into one when shed (26) was added, as the addition of the shed blocked the window of the central room. The central room was refloored with Yorkshire sandstone slabs after the removal of the wall. None of the (21) shed rooms had sandstone skirting. The east wall of the three rooms had a fake plinth on its external face (fig. 13). This consisted of large 100mm-thick sandstone slabs with chamfered tops which were attached to the outside face of the wall differing from the actual plinth of the main complex which supported the walls.

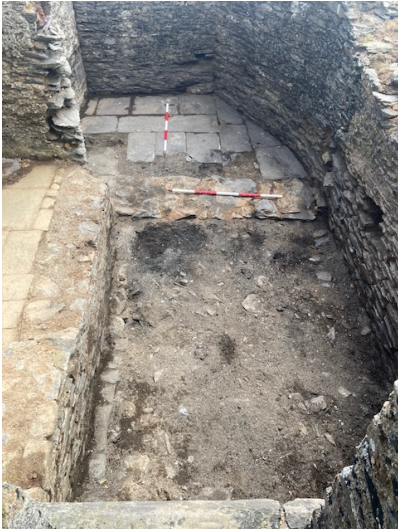
Fig. 14. Interior of shed 21, with shed 26 in background.

The northern room of the shed had a window and doorway in its north wall. The central had a window in its east wall. The third room which was excavated in 2022 likely had a window in its east wall but this wall was lowered to foundation level when shed (25) was later added (fig. 14).

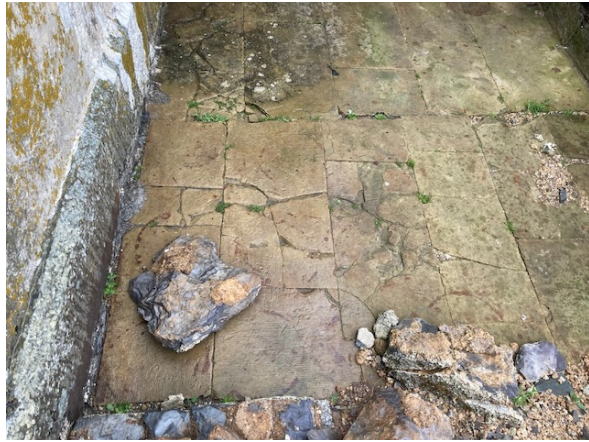
Fig. 17. Shed 21, centre room, cask rust marks.

Rust marks of the iron base hoops of barrels which were not visible in 2021 showed up on the floor of shed (21)- 300mm-diameter casks- (fig. 17) and in the side yard of House 2 -800mm diameter water butts- (fig. 18). The rust mark from an iron fire fender also showed up on the floor in front of the kitchen fireplace in House 2. (fig. 19)

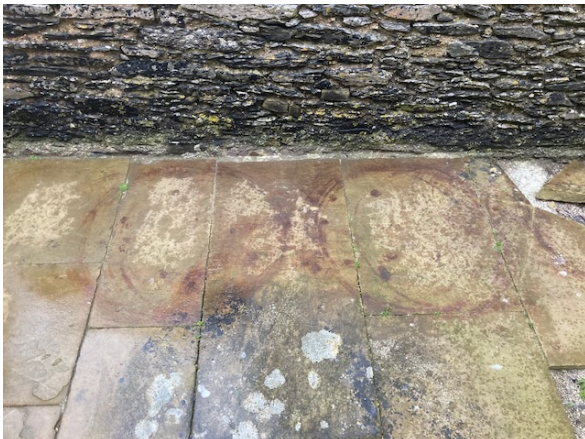
Fig. 18. Side yard, House 2, rust stains of barrels.

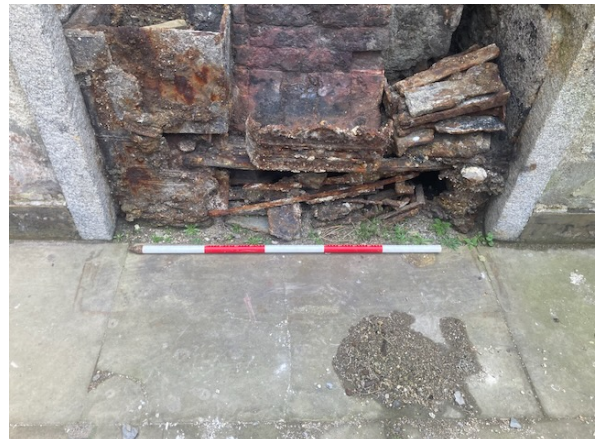
Fig. 19. House 2, kitchen, rust stain of iron fender.
