**Method Statement for Archaeological Monitoring of repair of part of Upper Lighthouse
Roadway wall, Skellig Michael, Co. Kerry 2023.**

Ministerial Consent C0000819, Excavation license no. E004885, detection license no. R000463.

Archaeological Projects Ltd,

May 2023.

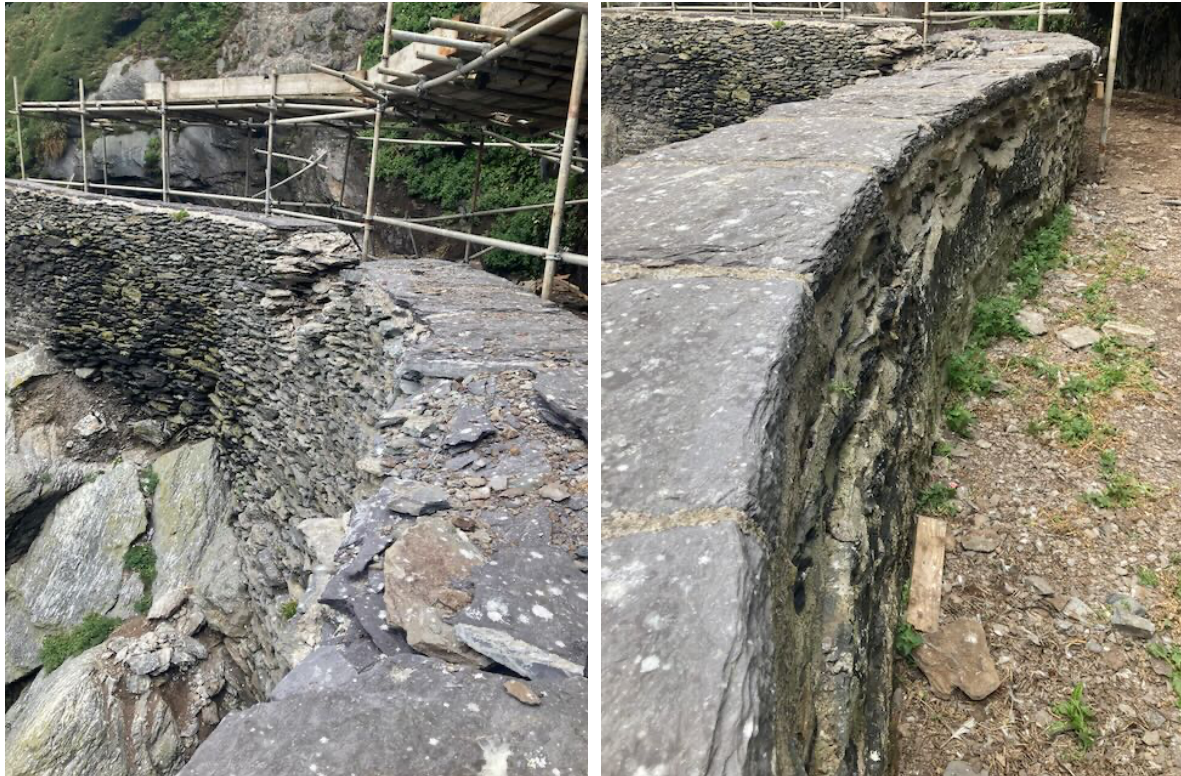
Photographs of the damaged section of the wall.

A c.25m length of the parapet wall of the upper lighthouse roadway was damaged by stones fallen over the winter of 2021/2022 and is to be repaired. Much of the wall and roadway in this area was previously removed by a significant rockfall in 1951 and some of the wall to be repaired was only built in 2018. This length of the roadway was fully excavated, recorded and refilled in 2017-2018.

The repair of the wall will be undertaken by the OPW masons and crew following the usual method used on the lighthouse walls on Skellig. Local stone, matching that in the wall in size and character will be used for repairs. Lime mortar will be used as bonding, as in the original work, but the faces of the wall will not be pointed and gaps and small chambers will be left to allow birds utilise them for nesting. The parapet wall will be capped with Valentia slate slabs, as again previously used on the lighthouse roadway walls on Skellig.
